REPORT OF INACTIVE MINE HAZARDS

BRENNER MINE

23 April, 1991

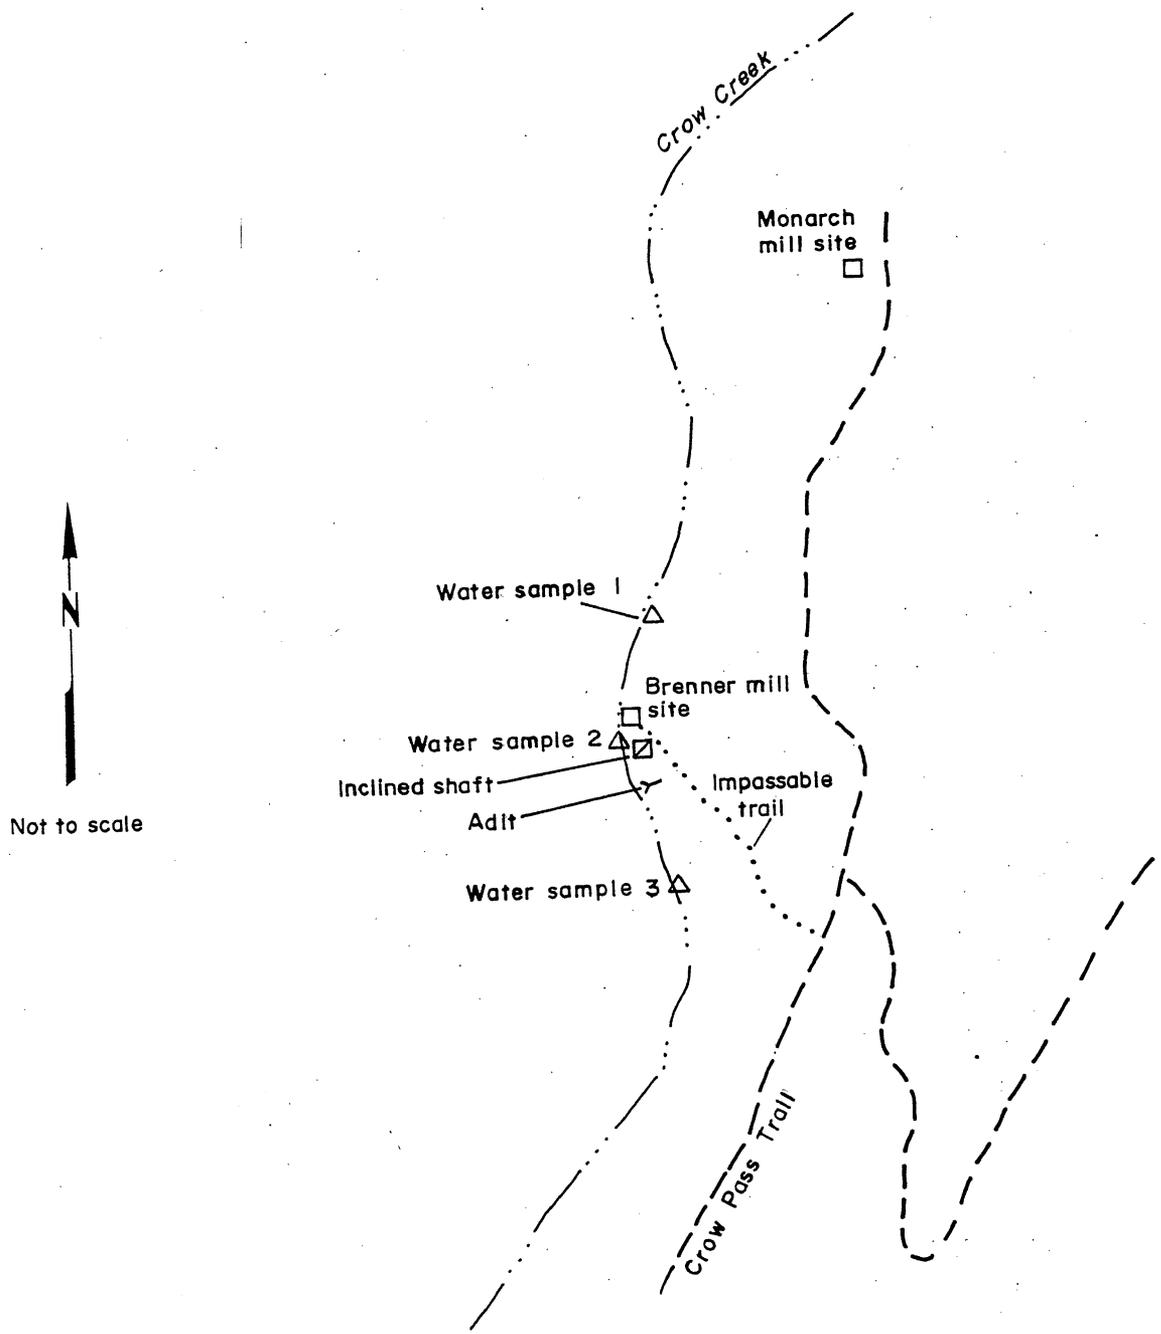
- 1) Sample 1- 100 feet upstream from the mill site,
- 2) Sample 2- next to the mill site, and
- 3) Sample 3- 100 feet downstream from the mill site. See figure 2.

These results indicate that the concentrations of arsenic and mercury are very low and do not change at all when passing by the mill site.

Figure 2.- Sketch map showing the main features of the Brenner Mine area and the locations of the water samples.

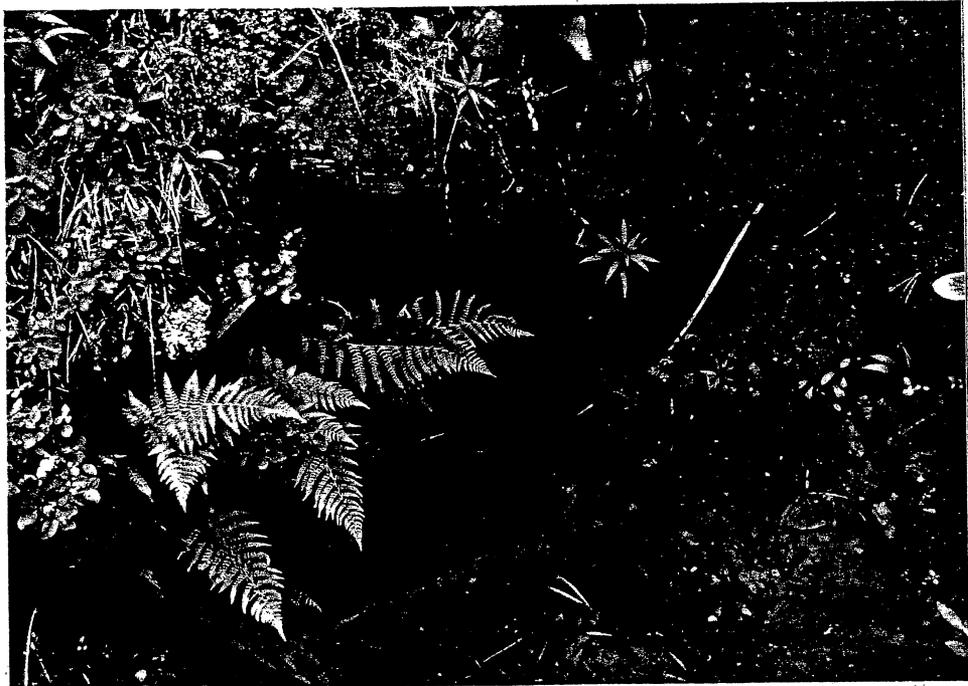
The portal of the inclined shaft was found next to and 2 feet above the creek. The shaft is flooded up to the portal. The original dimensions were about 5 feet high by 5 feet wide, but soil and debris have sloughed down from above and partially blocked the portal. It appears that a few of the mine timbers are holding up this debris. If this is the case, the timbers could collapse if someone happened to stand on the debris, causing them to fall into the flooded shaft. This is a dangerous situation. Also, the shaft appears to be supported by closely spaced timbers along its length, indicating that the material around it is not very stable. This would be dangerous for anyone attempting to descend into the shaft, because after being underwater for at least 50 years, the timbers are probably rotten and could possibly fail at any time. See figure 3.

The inclined shaft contains many timber supports. Practically all of this timber is under water and rotten. The timbers appear to be holding up debris that has fallen into the entrance of the shaft. As this wood rots and loses its strength, it will allow the debris and anyone standing on it to fall into the flooded shaft.

Figure 3.- The inclined shaft at the Brenner Mine
which is partially hidden from view.

1. Warning signs could be displayed around the property to advise the public about the dangerous conditions which are present, especially the inclined shaft.

2. A chain link fence could be installed around the inclined shaft as a temporary means of keeping people away from this hazard until a permanent closure is completed.

3. Permanent closure of these mine openings could be considered because they are very hazardous, they will be very expensive to reopen, and there is no known claimant for this property. The openings could be closed by blasting them shut or by backfilling them with earth.
