Monarch Mine - 1

C. ENVIRONMENTAL HAZARDS

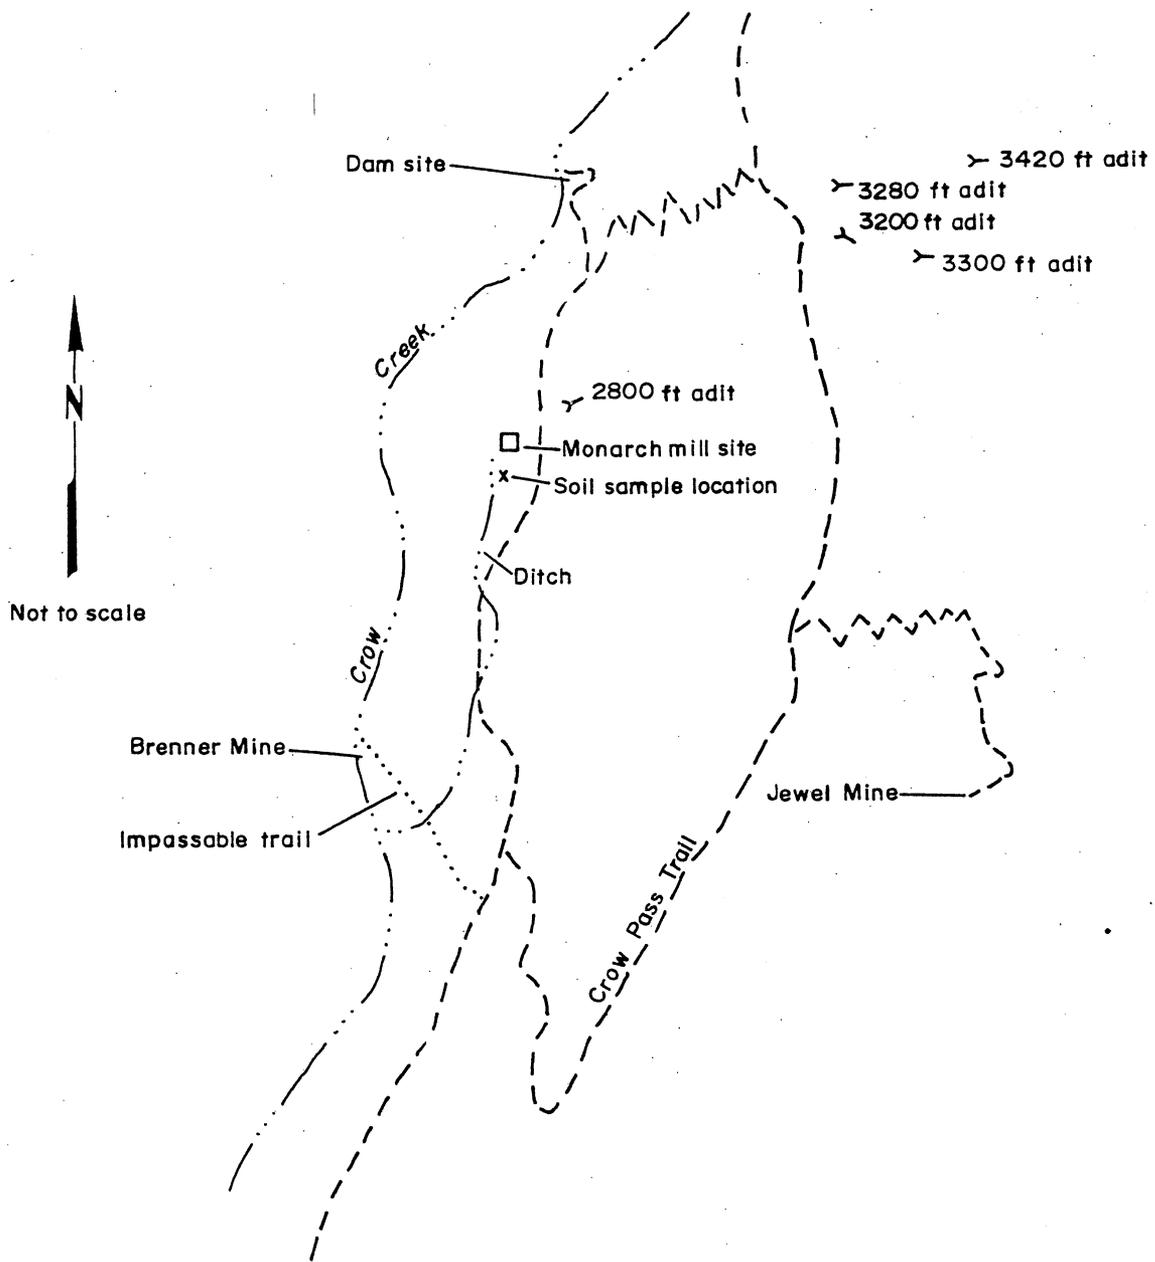
Figure 2.- Sketch map showing the main features of the Monarch Mine area and the location of the soil sample.

Another ditch is located south-southwest of the mill site. It begins about 100 feet south west of the old vertical water tank and heads south for 50 yards. It joins an intermittent stream which in turn intercepts Crow Creek several hundred yards south-southwest of the mill site. In places, the ditch is 3 feet deep and 3 feet wide with vertical sides. It is overgrown with vegetation and difficult to see until a person is about to step into it. See figure 2.

and had it analyzed. See figure 2 for the location. The results are as follows;

These results are very high, especially for arsenic. This may be due to the natural release of arsenic in the area or it could be due to the past mining activities. More detailed soil sampling would help to determine the extent of these high values.

Crow Creek flows from north to south on the west side of the mill site. The stream and mill site, however, are separated by a ridge or bluff which forms the east bank of the stream for several hundred yards. To the east of this ridge, a ditch leads from a point southwest of the mill site and heads south and then southwest, as mentioned previously. It connects with an intermittent stream which eventually joins Crow Creek approximately a quarter mile south-southwest of the mill site and 100 yards downstream from the Brenner Mine. See figure 2.

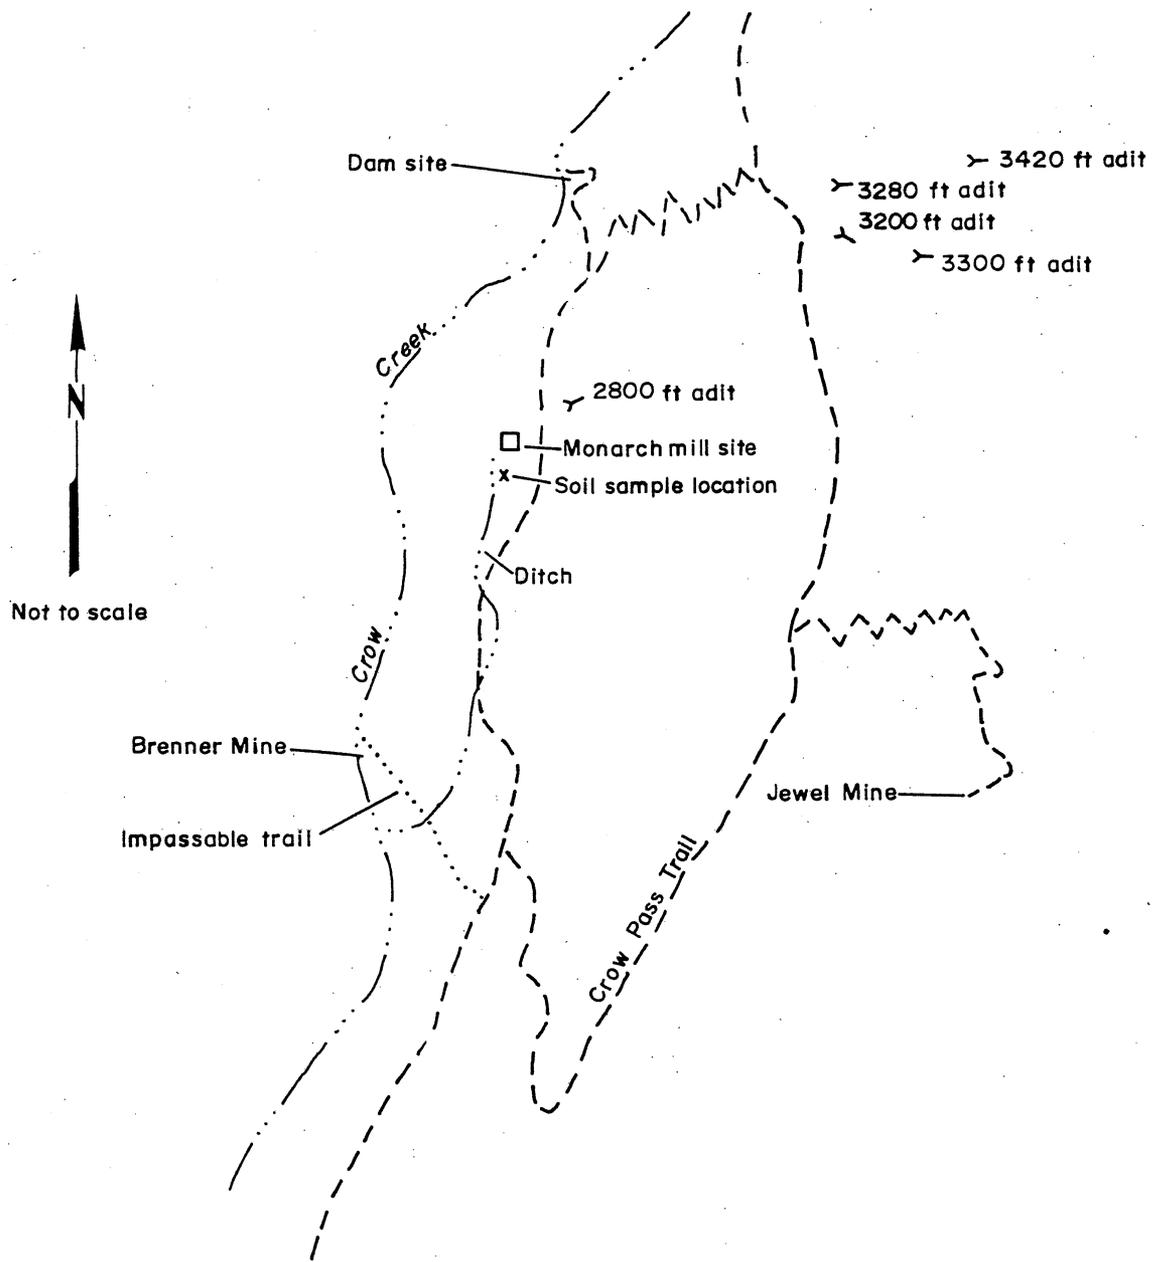
Figure 2.- Sketch map showing the main features of the Monarch Mine area and the location of the soil sample.

Another ditch is located south-southwest of the mill site. It begins about 100 feet south west of the old vertical water tank and heads south for 50 yards. It joins an intermittent stream which in turn intercepts Crow Creek several hundred yards south-southwest of the mill site. In places, the ditch is 3 feet deep and 3 feet wide with vertical sides. It is overgrown with vegetation and difficult to see until a person is about to step into it. See figure 2.

and had it analyzed. See figure 2 for the location. The results are as follows;

These results are very high, especially for arsenic. This may be due to the natural release of arsenic in the area or it could be due to the past mining activities. More detailed soil sampling would help to determine the extent of these high values.

Crow Creek flows from north to south on the west side of the mill site. The stream and mill site, however, are separated by a ridge or bluff which forms the east bank of the stream for several hundred yards. To the east of this ridge, a ditch leads from a point southwest of the mill site and heads south and then southwest, as mentioned previously. It connects with an intermittent stream which eventually joins Crow Creek approximately a quarter mile south-southwest of the mill site and 100 yards downstream from the Brenner Mine. See figure 2.
