# MEMORANDUM

SUBJECT: Seward Peninsula  
Field Trip,  
6/22-26/87

FROM: Alan Townsend and *APM*  
Robert McLean *McL*  
Habitat Biologists  
Habitat Division  
Department of Fish and Game

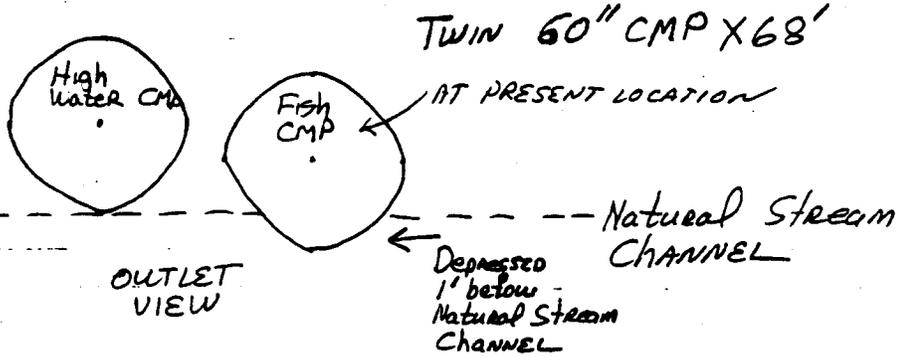
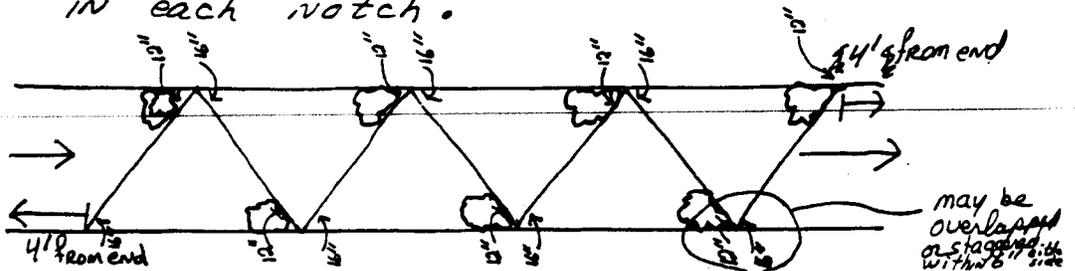
DARLING CREEK STATION 1084+40  
 ADF#6 6/25/87 AUTHORIZED RETROFIT  
 AHT & MAC

- ° Inspected 6/22/87 at 2055 hours and 6/24/87 at 1300 hours.
- ° 60 inch CMP; non-bedded outlet, perched 2 feet above scour pool thalweg; inlet perched 8 inches above stream thalweg; approximate slope of culvert invert was 2 to 2½ %.

- ° Cross-check with permit authorizations indicated that the 60 inch CMP was suppose to have been installed at STATION 1081. The 11'5" by 7'3" pipe arch installed at STATION 1081 was suppose to have been installed in Darling Creek. A meeting was requested with Ron Davenau, ADOT&PF Maintenance Supervisor, and Mr. Adams, ADOT&PF Project Supervisor, on 6/26/87 at 1000 hours to discuss the permit non-compliance. ADOT&PF acknowledged that a "station bust" had occurred. Several options were suggested by ADOT&PF to correct the non-compliance:

Townsend and McLean denied further consideration of Option #1, citing loss of downstream fish habitat, inadequate hydraulic capacity for the combined flow of the two drainage areas, and unacceptable velocities for

fish passage. Davenau and Adams agreed to replace the 60 inch CMP with a pipe arch; however, it was determined that the only available 11'5" by 7'3" pipe arch was located in Nebraska and would cost approximately \$100K to obtain. Davenau and Adams requested that consideration be given to other alternative CMP combinations. Numerous options were considered and hydraulically modelled utilizing ADOT&PF Environmental's computer modelling program (via phone link to Fairbanks). An experimental twin 60 inch CMP culvert battery was approved subject to the following express understandings:

1. The remedial authorization was experimental;
2. The experimental prototype would be evaluated by ADF&G for 2 to 3 years; and
3. If the experimental prototype was ultimately determined inadequate for fish passage, it would be replaced with the originally permitted 11'5" by 7'3" pipe arch during construction of the next adjoining road project segment (FY 90-91?).

A schematic diagram of the approved experimental culvert battery is depicted in Enclosure 4.

$Q_{1.25} = 33 \text{ cfs}$   
 $Q_{2.33} = 54 \text{ cfs}$   
 $Q_5 = 66 \text{ cfs}$   
 $Q_{50} = 165 \text{ cfs}$   
 $Q_{100} = 210 \text{ cfs}$

Hydraulics (Twin 60" CMP w/ 2' buried  
 1 foot below thalweg)  
 $2.8 \text{ fps}$   
 $2.9 \text{ fps}$  Depth of Flow 2.0'  
 $3.4 \text{ fps}$  Depth of Flow 3.2'

Both 60" CMP set @ stream gradient not to exceed 0.5%  
 One CMP set 1 foot below thalweg  
 ONE CMP set @ thalweg

Baffle system installed in fish passage CMP  
 (depressed invert) consisting of rebar baffles  
 with hand placed CLASS II RIP RAP set  
 in each notch.
