SUBJECT: Petersburg Hammer Slough Creek  
Inspection

Waterbody Inspection and Monitoring Report

Waterbody / Watershed: Hammer Slough Date & Time: March 14, 1996 . 9:00 am through 4:00 pm.

## DETAILED REPORT OF MONITORING DATA AND OBSERVATIONS OF HAMMER SLOUGH WATER QUALITY

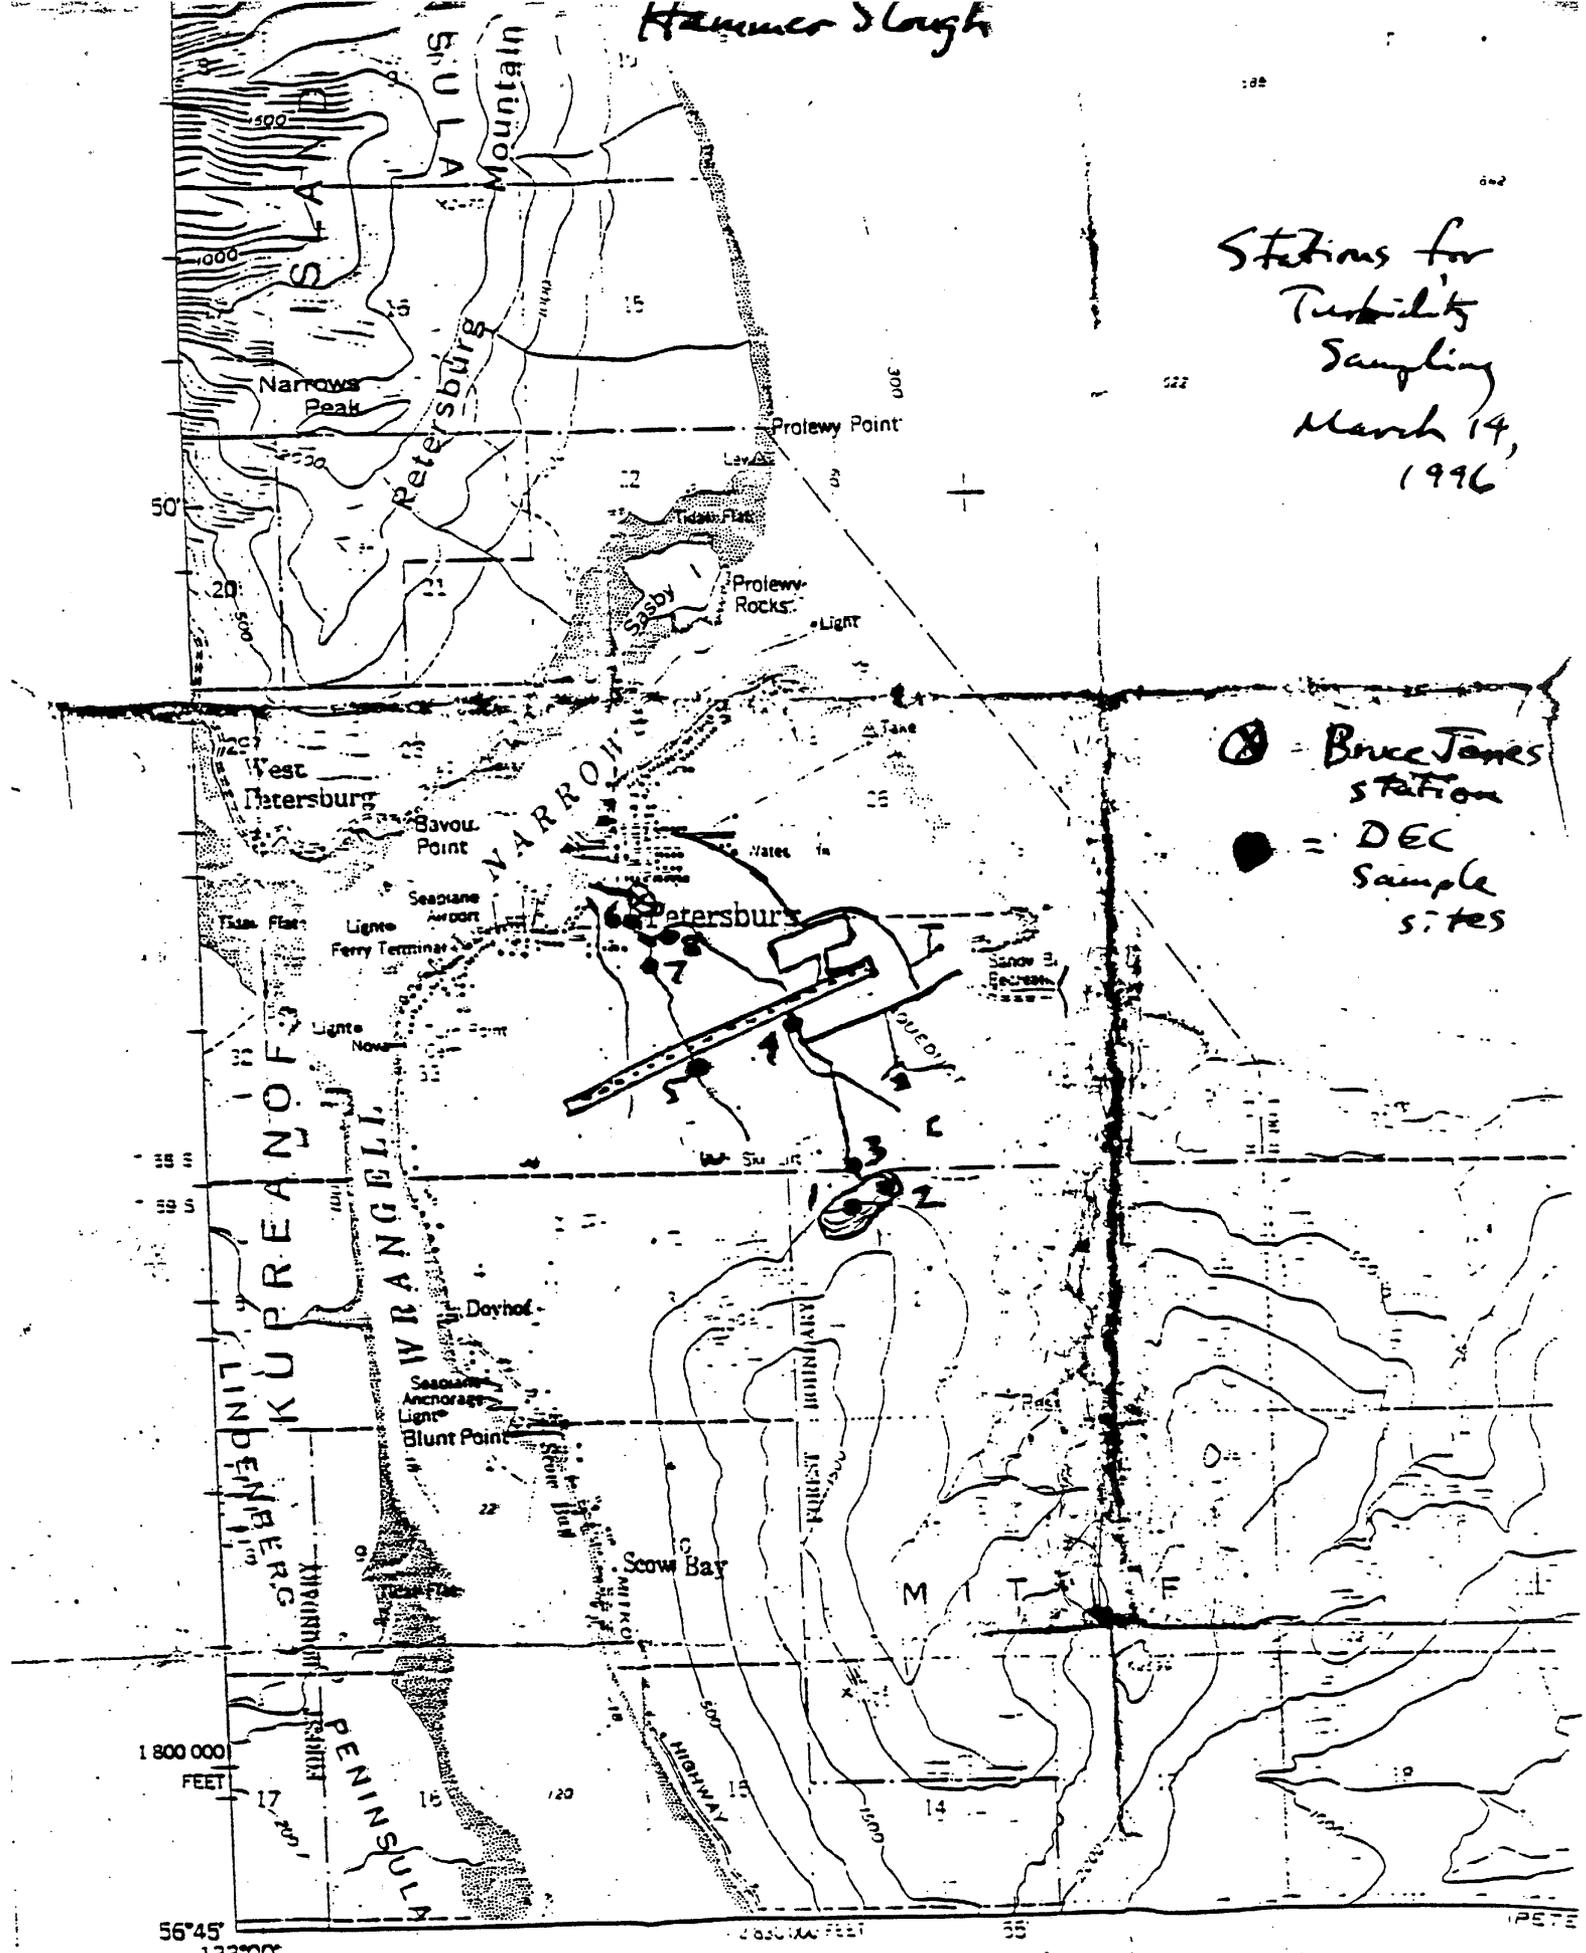
Stations for  
Turbidity  
Sampling  
March 14,  
1996

\* (Station 1) State side of rock pit, ditch runoff adjacent to pile of fine material and face of pit:

242 NTU, 237 NTU

\*(Station 2) Sheet flow drainage from City side of quarry upland from flow into sump area:

43.2 NTU, 35.6 NTU

\*(Station 3) Directly below gravel pit sump area:

121 NTU, 106 NTU

\*(Station 4) "Beaver Pond" location on uphill side of airport runway:

55.9 NTU, 66.2 NTU

\*(Station 5) Reference/control location (called middle West Fork) on uphill side of airport runway:

28.5 NTU, 35 NTU

\*(Station 6) Mainstem of Hammer Slough 200 feet below City Shop:

65.7, 62.9 NTUs

\*(Station 7) Main "control" fork entering Slough just above City Shop:

27.4, 28.2 NTUs

\*(Station 8) Mouth of main culvert discharging to Slough at City Shop location:

86.4, 92.4 NTUs

\*Small feeder rivulet entering Hammer Slough, draining natural blue clay deposit across from Leo's office:

225 NTU, 205 NTU
