**Waterbody Inspection and Monitoring Report**

**Waterbody / Watershed:** Hammer Slough Date & Time: **March 14, 1996 . 9:00 am through 4:00 pm.**

## DETAILED REPORT OF MONITORING DATA AND OBSERVATIONS OF HAMMER SLOUGH WATER QUALITY

# Hammer Slough

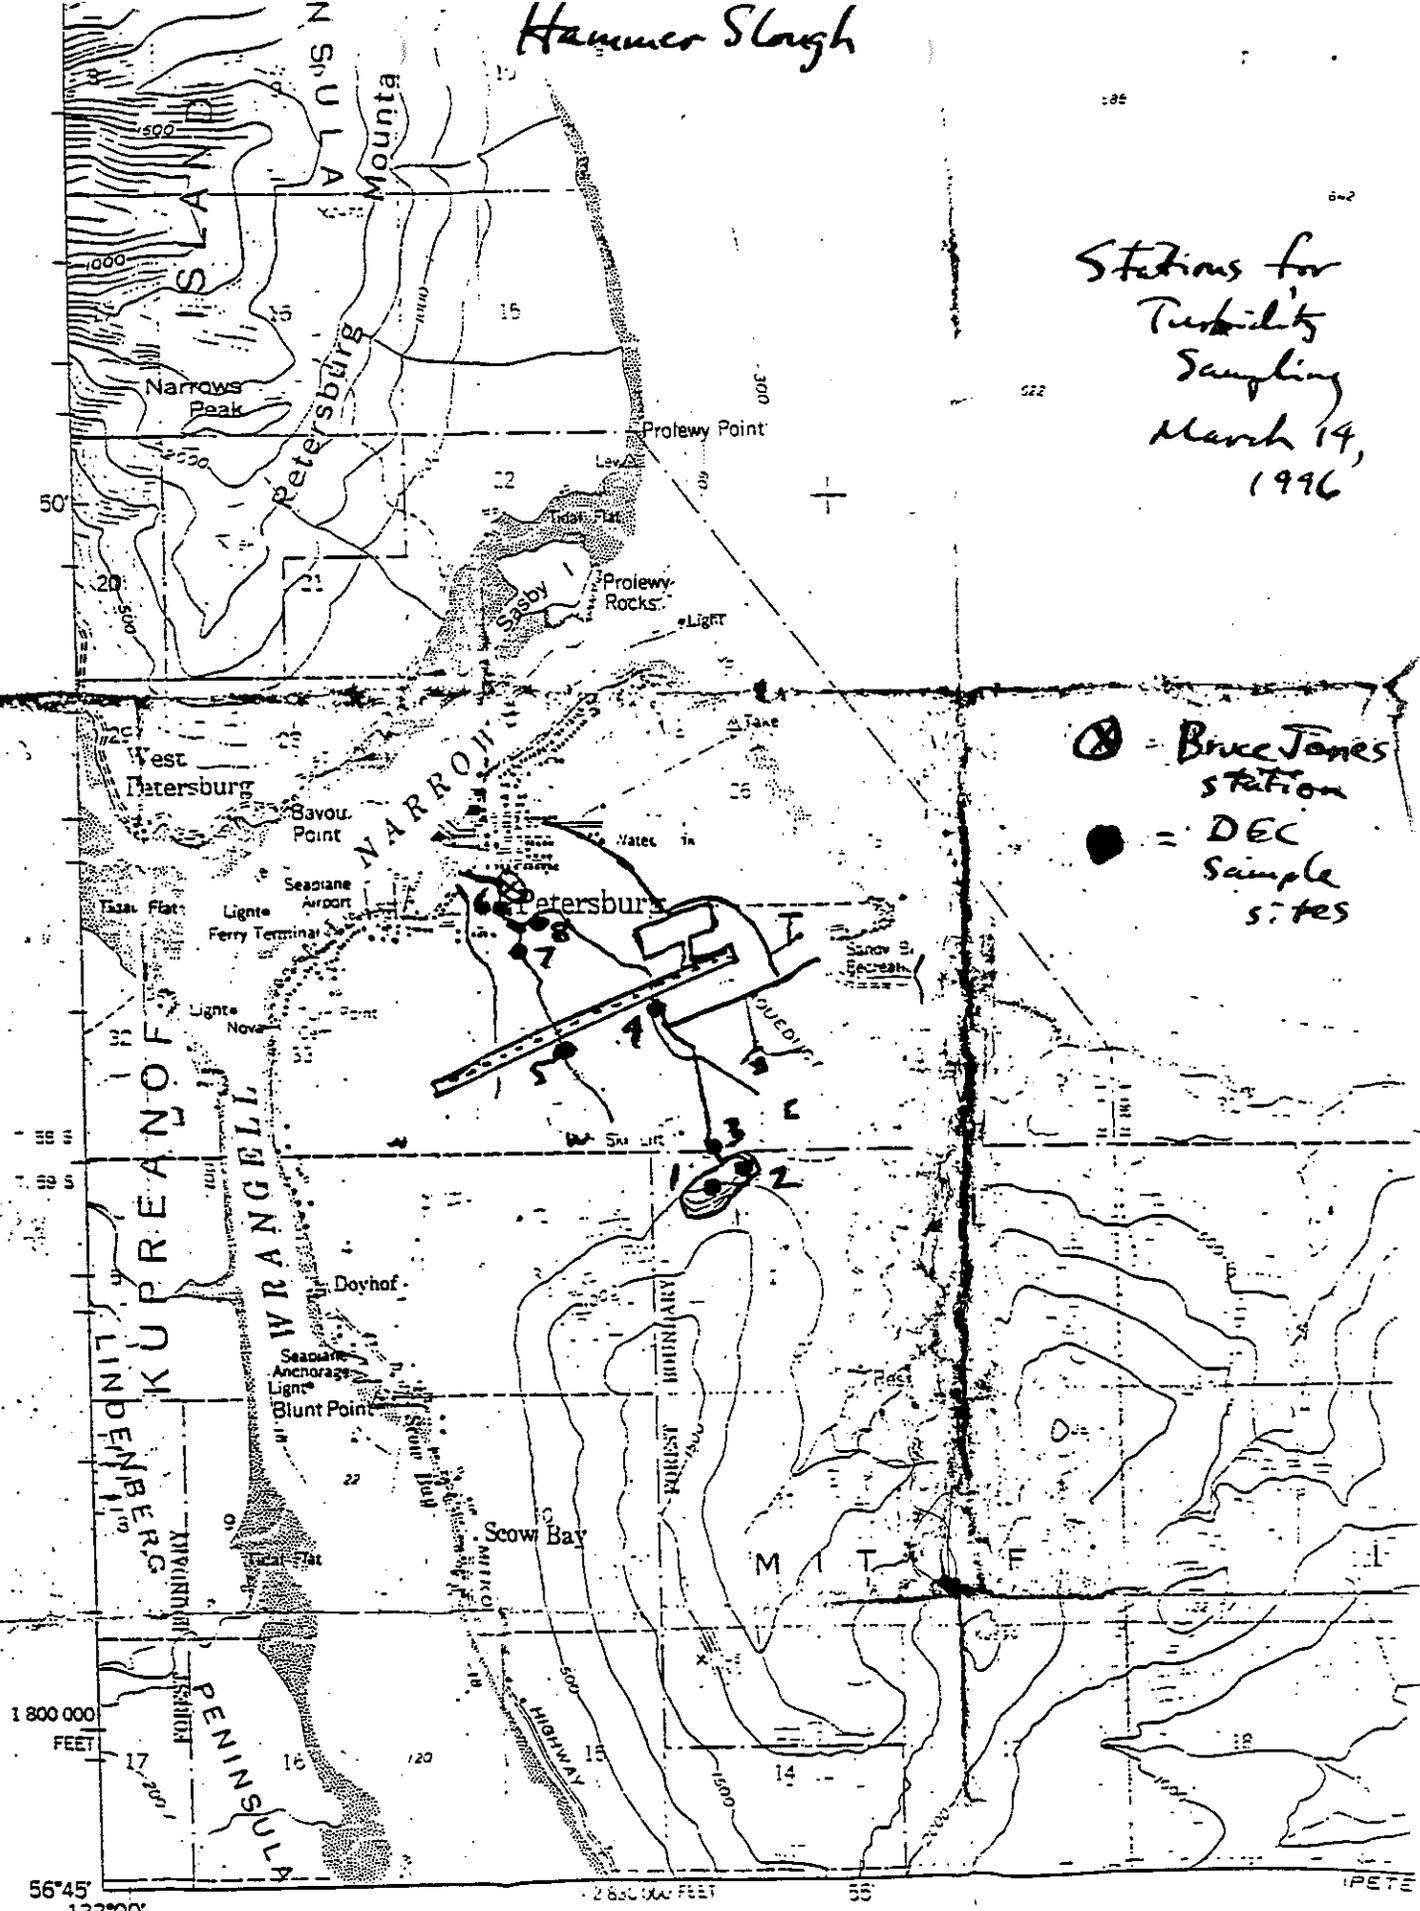
Stations for  
Turbidity  
Sampling  
March 14,  
1996

Turbidity measurements taken in afternoon of March 14. Results are below, by location.

Brian Lynch report gives good overview of site observations at this location. Results of duplicate turbidity measurements (Hach 2100 Turbidimeter) taken at several locations at this site are as follows:

\*(Station 1) State side of rock pit, ditch runoff adjacent to pile of fine material and face of pit:

242 NTU, 237 NTU

\*(Station 2) Sheet flow drainage from City side of quarry upland from flow into sump area:

43.2 NTU, 35.6 NTU

\*(Station 3) Directly below gravel pit sump area:

121 NTU, 106 NTU

\*(Station 4) "Beaver Pond" location on uphill side of airport runway:

55.9 NTU, 66.2 NTU

\*(Station 5) Reference/control location (called middle West Fork) on uphill side of airport runway:

28.5 NTU, 35 NTU

\*(Station 6) Mainstem of Hammer Slough 200 feet below City Shop:

65.7, 62.9 NTUs

\*(Station 7) Main "control" fork entering Slough just above City Shop:

27.4, 28.2 NTUs

\*(Station 8) Mouth of main culvert discharging to Slough at City Shop location:

86.4, 92.4 NTUs

Bruce Jones data for turbidity, color, temperature, settleable solids, and TSS collected during February 1996 are attached. Station noted on Figure 1.

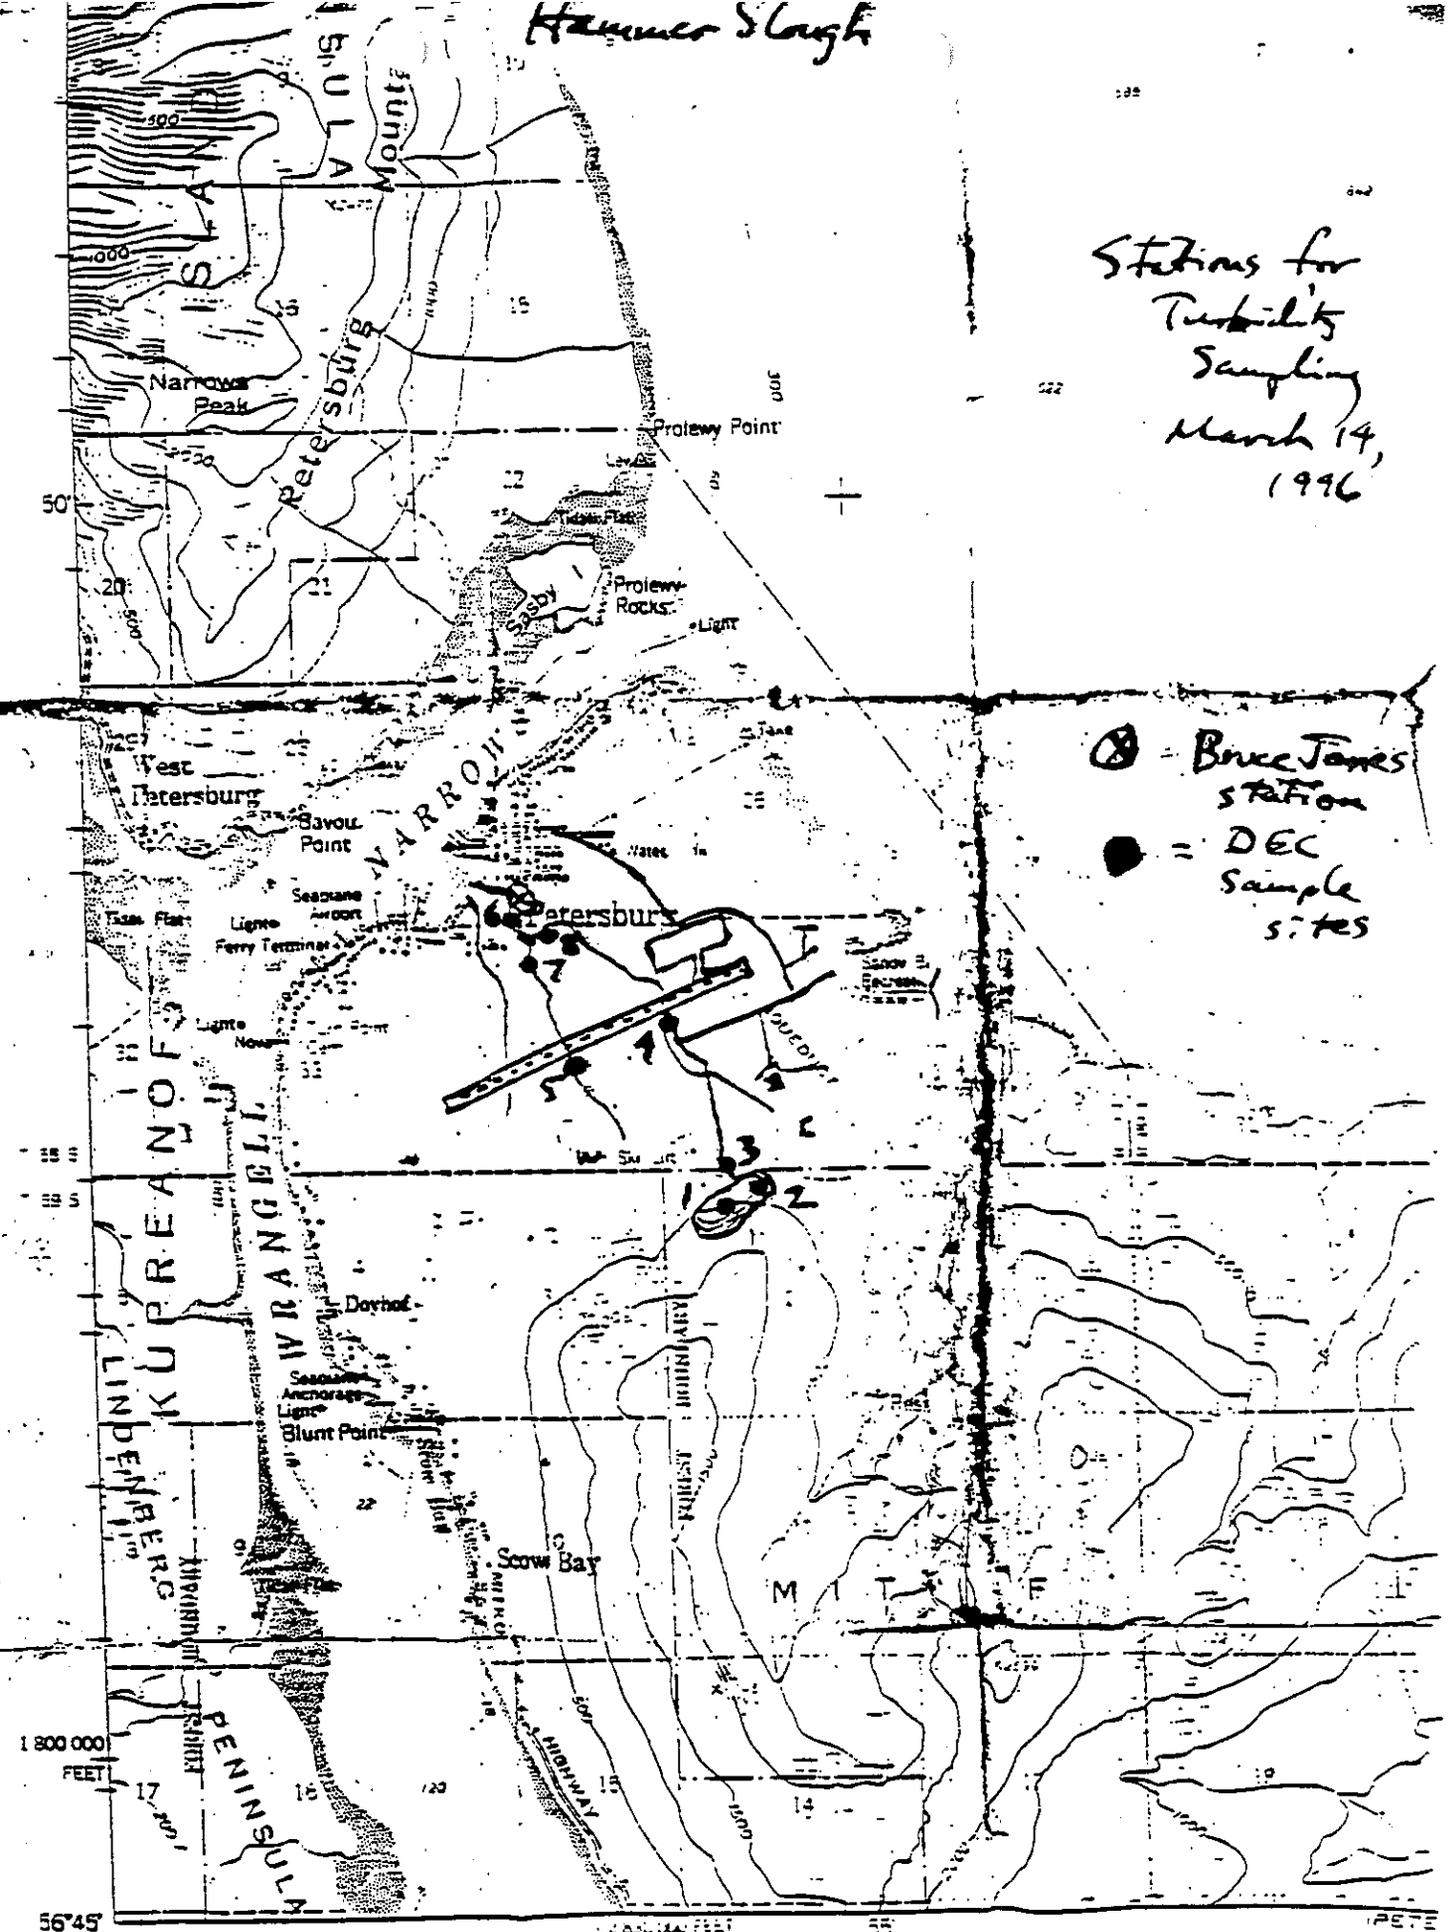
Stations for  
Turbidity  
Sampling  
March 14,  
1996

Bruce Jones data for turbidity, color, temperature, settleable solids, and TSS collected during February 1996 are attached. Station noted on Figure 1.
