REPORT OF INACTIVE MINE HAZARDS

MILLS CREEK MINE

3 June, 1991

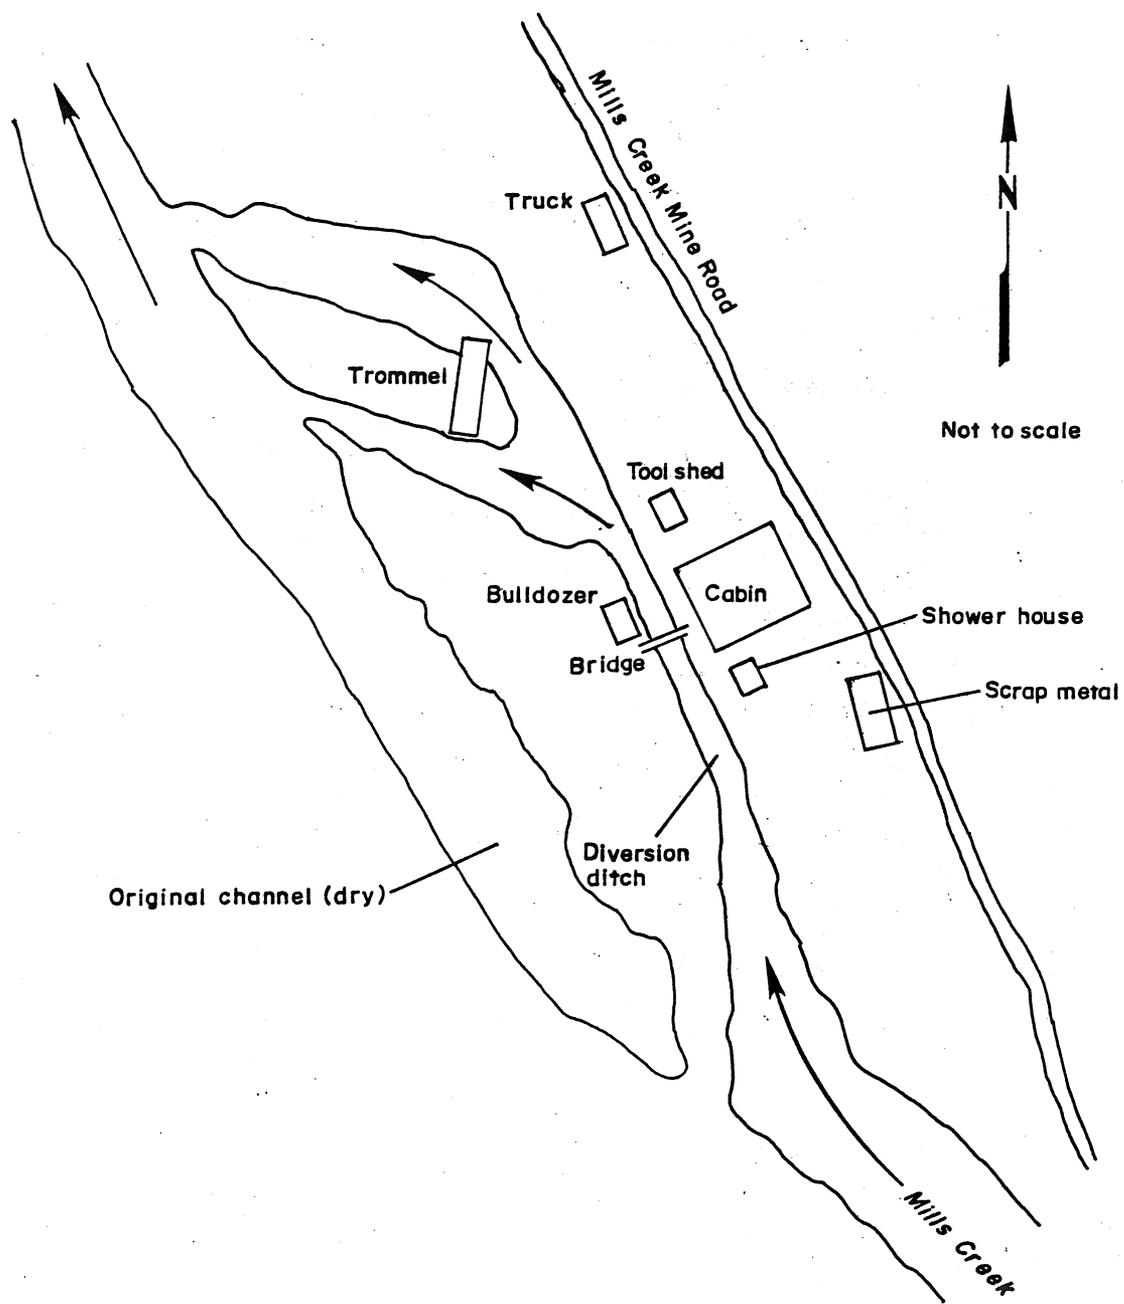
Access to the mine is by an improved gravel road that leads 2 and 1/2 miles from the Seward Highway. The mine road fords Canyon Creek within a 1/4 mile of the highway. This crossing is not passable except when the water level is very low during the late summer. Thus, the mine is isolated for most of the year. A nearby foot bridge allows hikers to cross the creek easily, though. See figure 2.

Figure 2.- Sketch map showing the main features of the Mills Creek Mine.

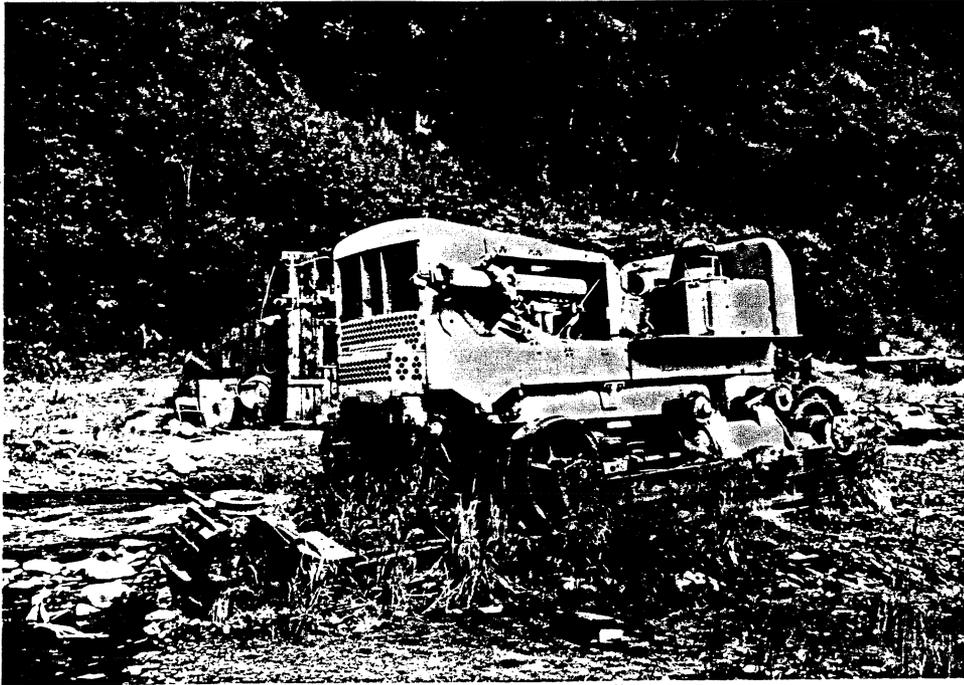
Equipment at the site includes a wrecked, late-model, pickup truck; a bulldozer with track missing; and a large skid mounted trommel. In addition, several old refrigerators, large diesel engines, and various pieces of scrap steel litter the site. Most of the metal pieces are big, heavy, and have many sharp edges. See figures 3 and 4.

Figure 3.- Derelict bulldozer at the Mills Creek Mine.

2. The scrap lumber could be collected and disposed of by burning or burying. The smaller pieces of scrap metal could be buried or recycled. The larger pieces of equipment which will have no future use, such as the abandoned pickup truck, could also be salvaged or recycled.

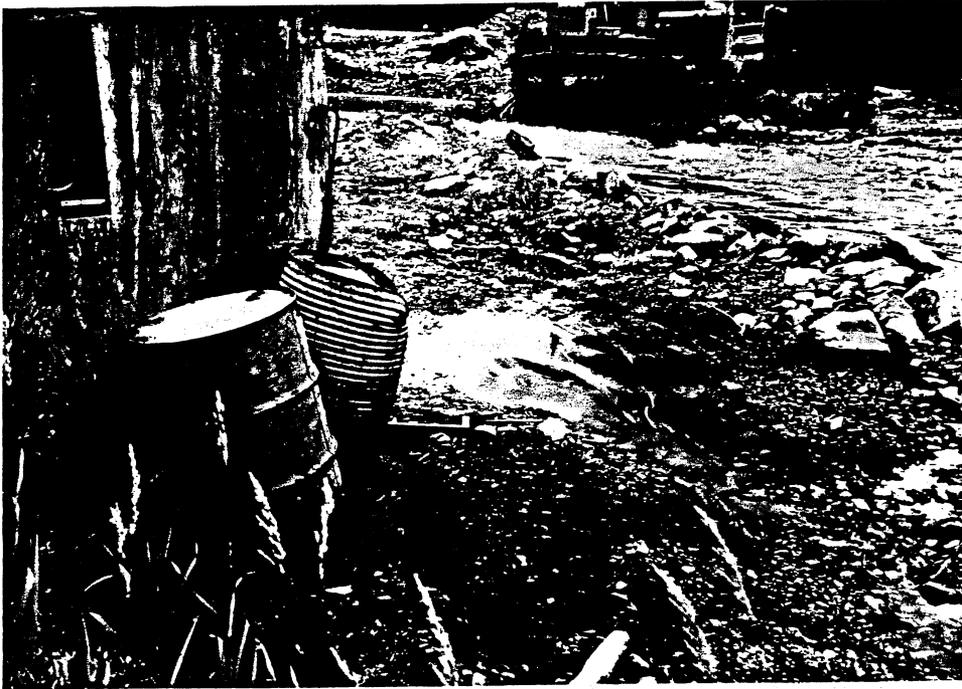
Petroleum products from 2 barrels have saturated the ground in and around the tool shed. One barrel contains engine oil and the other hydraulic fluid. The ground around the barrels and the shed are wet and discolored to a very dark grey-brown color. Puddles of water next to the shed had an oil sheen on them. The shed and barrels are approximately 10 feet from the diversion ditch. See figure 5.

Figure 5.- Barrels of petroleum products which have leaked onto the ground near the diversion ditch.

4. The petroleum products in the barrels by the tool shed could be transferred to leak proof barrels if they are expected to be used in the near future. If not, the petroleum products could be recycled and the barrels properly disposed of in a land fill. The contaminated soil in and around the tool shed could be cleaned up by incineration or it could be removed and transported to an approved hazardous waste disposal site.
