RED DEVIL MINE
AKD-980495618
CERCLA Site Inspection Report

September, 1987

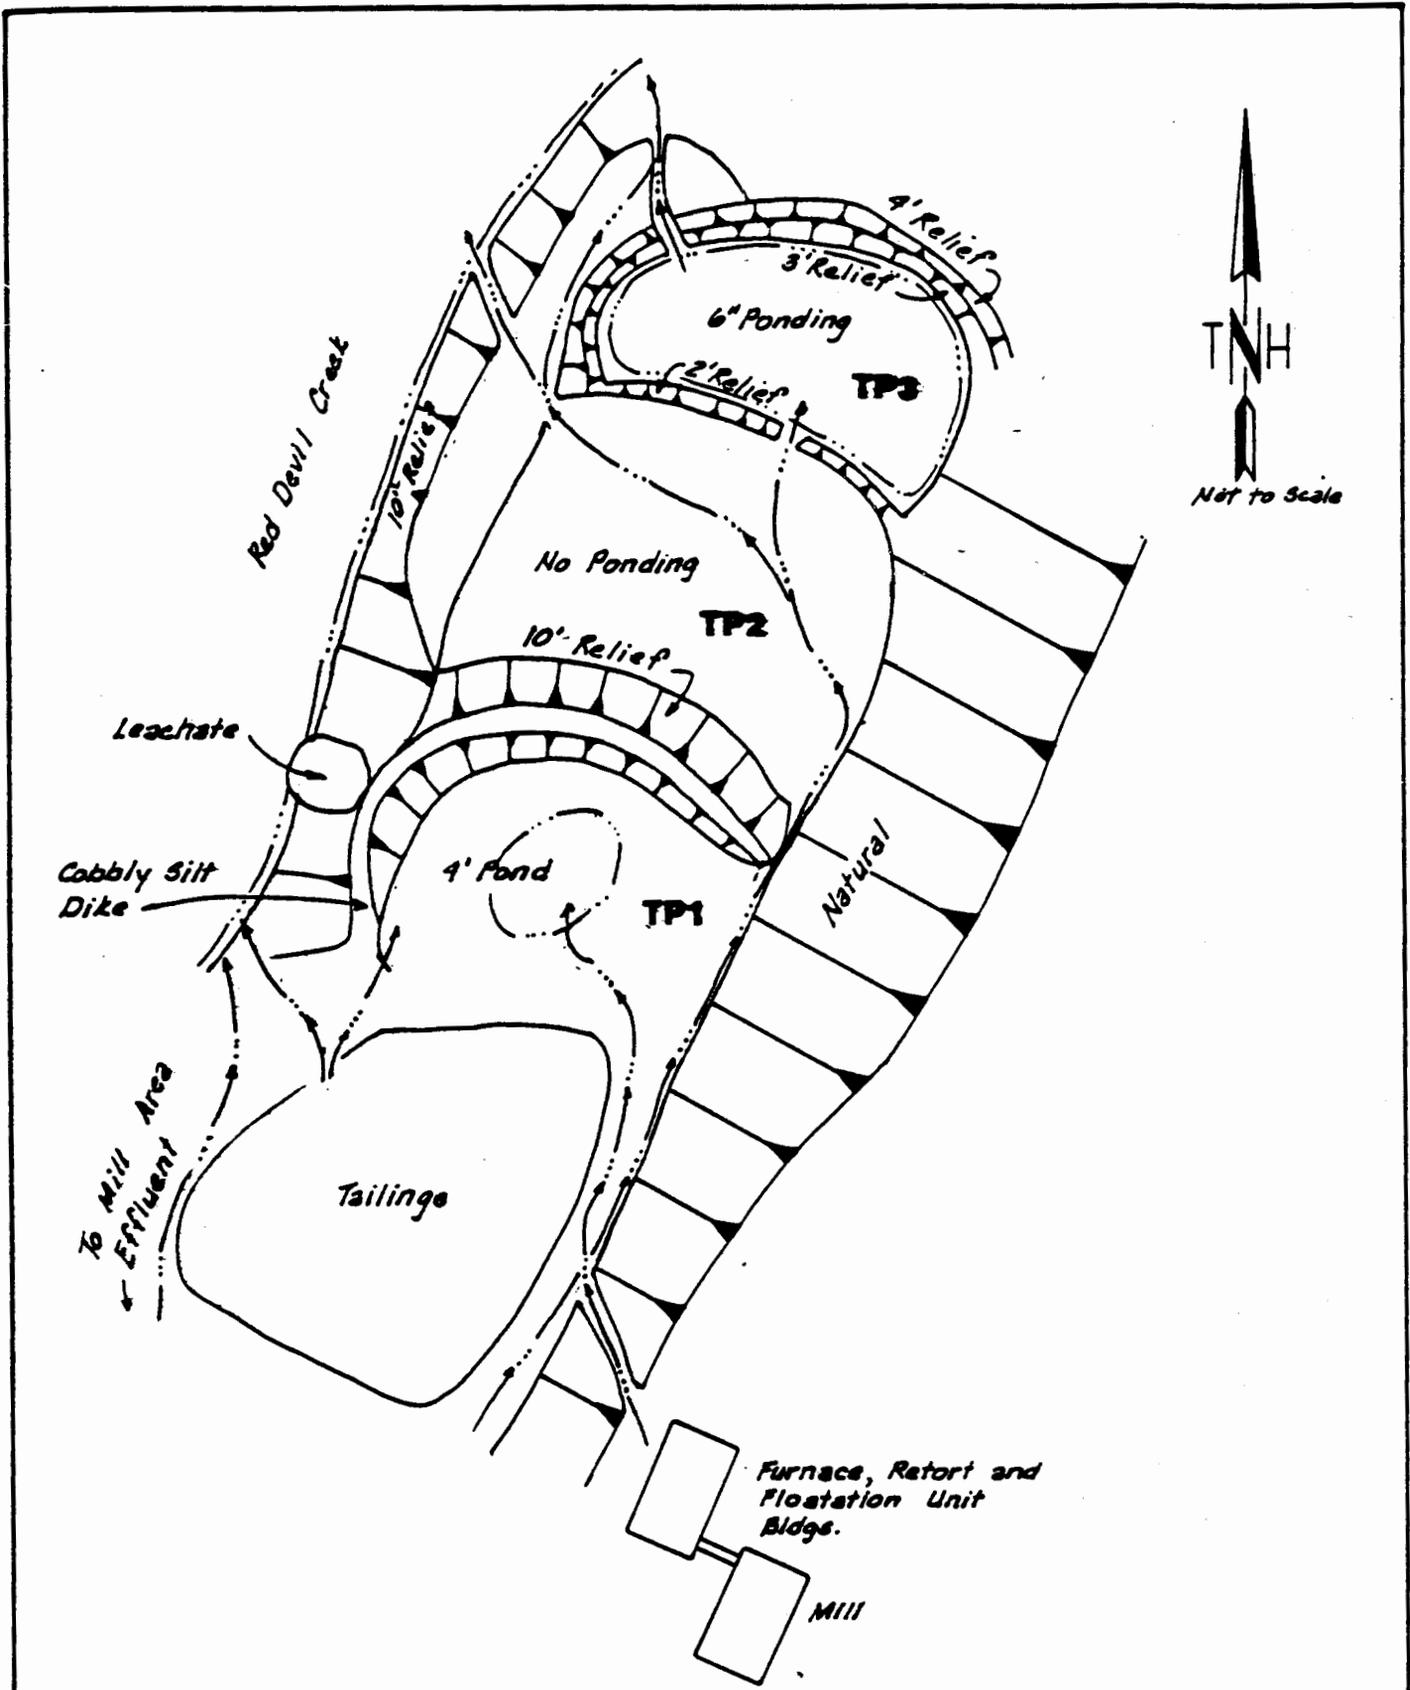
FIGURE
6

ALASKA HAZARDOUS WASTE PROGRAM
RED DEVIL MINE
SETTLING PONDS

approximately one foot in depth drain toward TP1 or toward Red Devil Creek. During periods of high water, Red Devil Creek rises to touch the base of the settling pond dikes. The diking material consists of 6 inch cobbles in a silt matrix. The diking is unsound, leaking and in danger of collapse.

There is standing water in TP1. Settled solids are evident over the entire surface of TP1. Some leaching has occurred at the base or toe of the dike. Overflow in TP1 has cut a one to three foot deep erosional gully in the northeast portion of the dike allowing water to flow into TP2.

TP2 no longer contains water. Water flows directly into TP3 from the north side of TP2. Two branches of erosional gullies approximately one foot deep allow water to exit TP2 on the northwest side to a bench approximately six feet below the pond and then directly to Red Devil Creek approximately ten feet further below.

Water in TP3 is approximately six-inches deep. Water exits the TP3 dike on the northwest side, flows onto a bench and thence into Red Devil Creek.
