CITY OF ATKA

**FEBRUARY 2008**

**VILLAGE SAFE WATER  
OUTFALL INSPECTION REPORT**

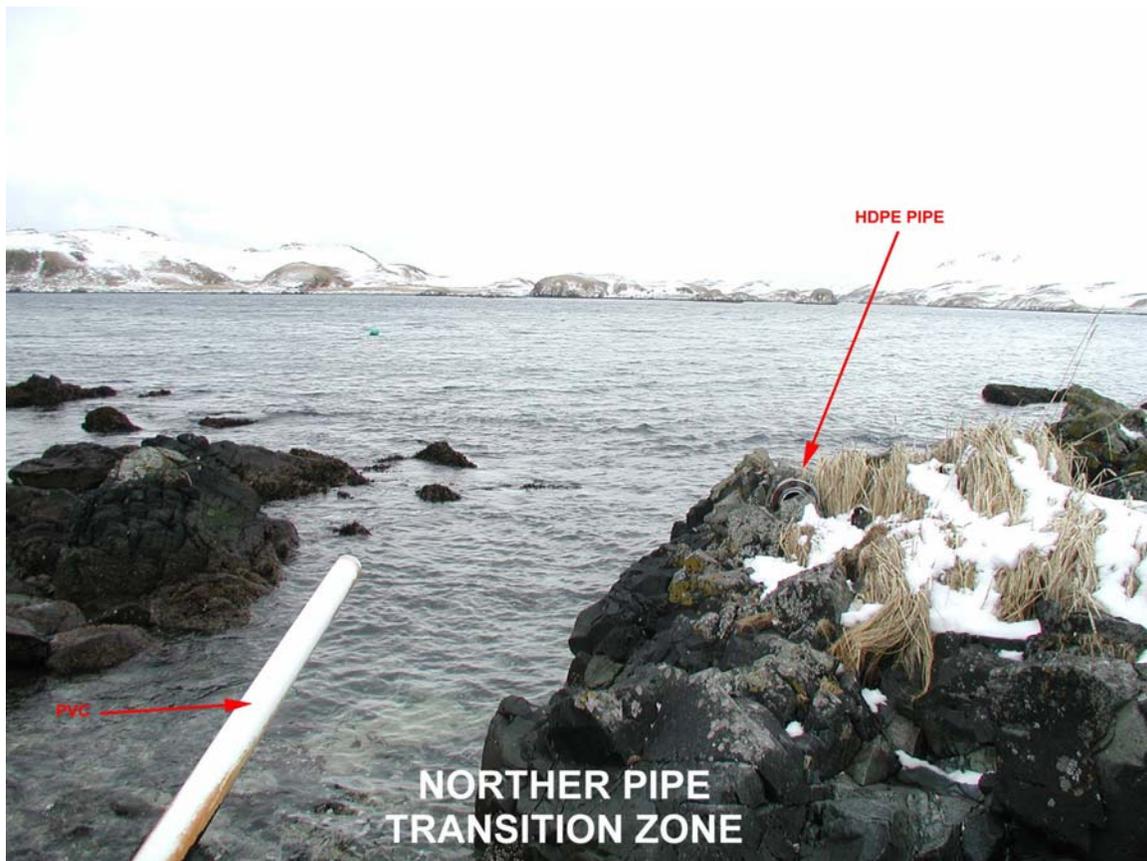
The northern pipe is a HDPE pipe that is disconnected from the PVC supply side in the inter-tidal zone.

From the water entry to the terminus of the pipeline divers estimate approximately 300 feet of pipe before terminating in -27 feet MLLW. Divers measured 240 feet of outfall line to -4 feet of water where sonar signals could no longer be received. The construction of the pipeline is HDPE pipe that is fused or welded in 40 foot sections that are anchored with concrete blocks at regular intervals.

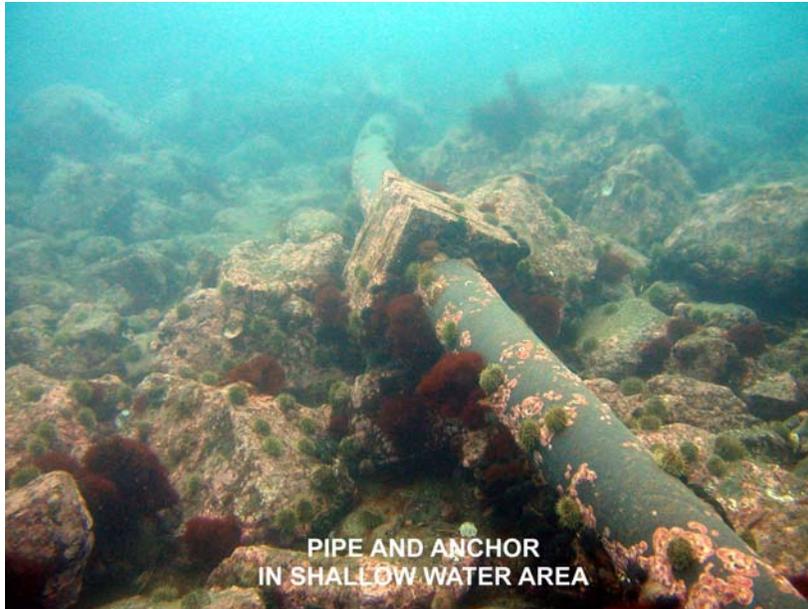
The shallow water section is very rocky with evidence that this is a high energy zone. The pipeline snakes through this area, before making a slight bend to the north, straightening and terminating on a mixed mud, small cobble bottom. There are a few fairly steep transitions as the pipeline progresses toward deeper water.

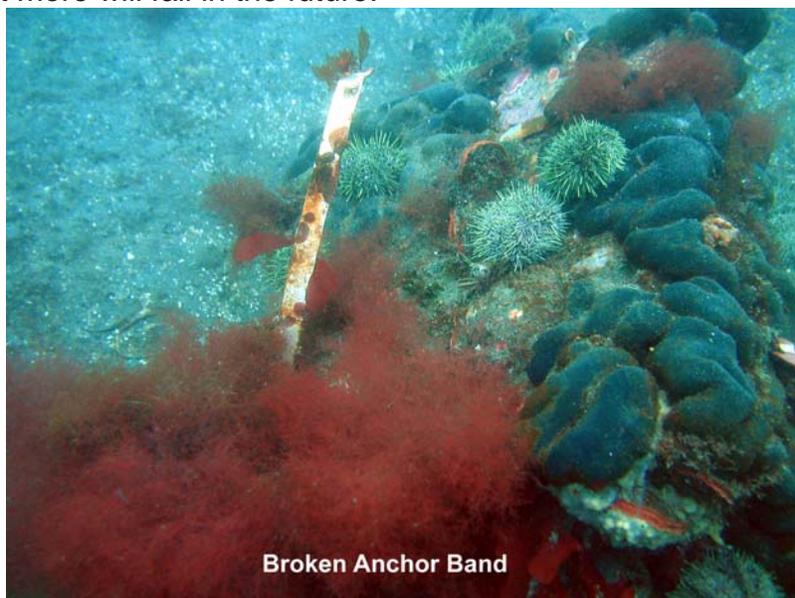
The outfall line is anchored with concrete saddle blocks at regular intervals. The amount of anchorage on the line appears to be adequate for keeping the line from floating and restricting movement, however the anchor construction is not the best for a high energy salt water environment. Anchorage consists of 2 piece concrete blocks which are banded with 2 stainless steel bands. Some of these bands are failing from corrosion and given the saltwater environment more will fail in the future.

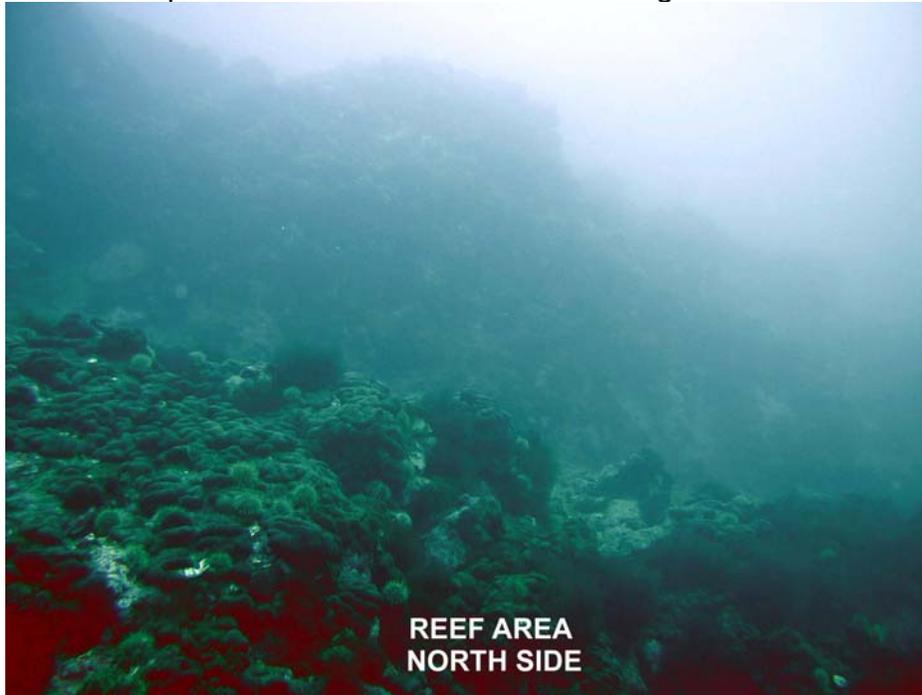
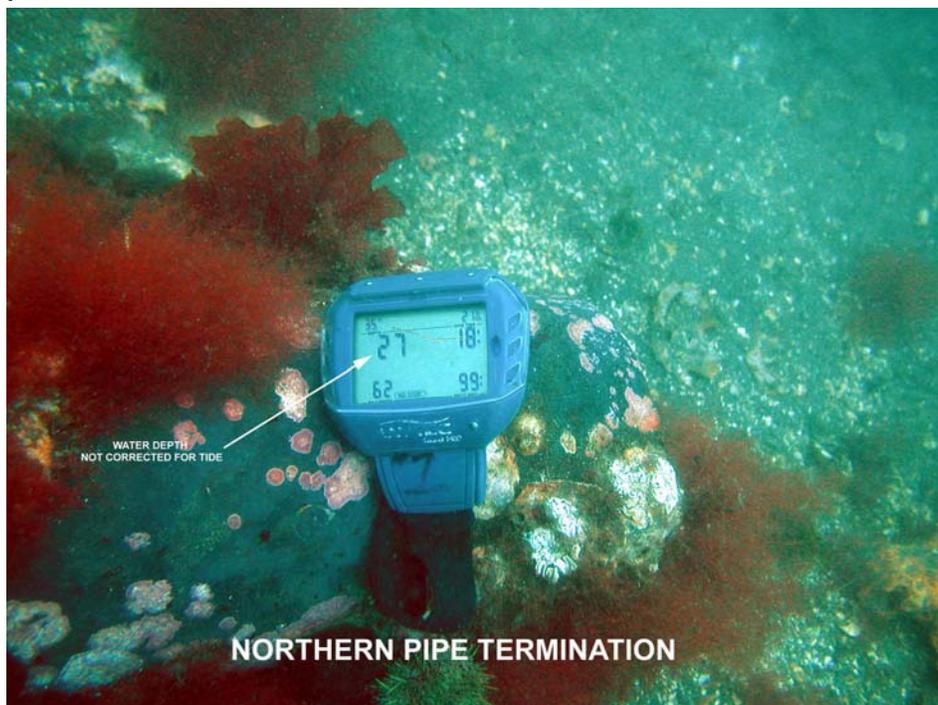
Past -14 feet the bottom becomes a mix of small cobble and mud which slopes in a southeast direction to deeper water. Just to the north however there is a large reef which rises dramatically 10 to 15 feet from the mud bottom. This reef will have an impact on currents and water exchange in the area.

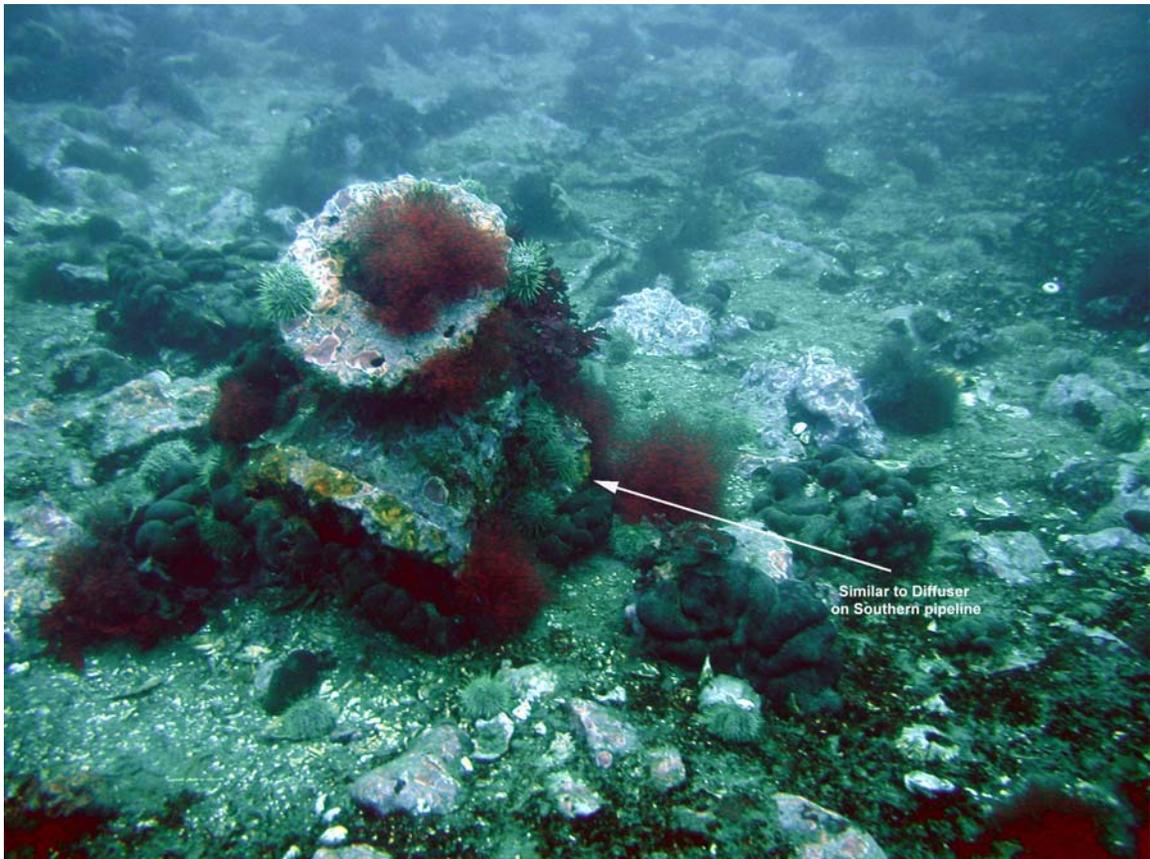
The outfall line has no actual diffuser, just the end of the pipe lying on the bottom in -26 feet MLLW. One 40 foot section of pipe was discovered to

southeast of the terminus and divers believe that this was once attached to the outfall line. Divers also discovered pipe a fitting which is similar to the diffuser used on the southern pipeline in -50 feet of water.

With the exception of the missing end the pipeline is good condition and appears to have no major deflection or damage to the pipe. The outfall's location and the bottom substrate in the shallow water area would make burial and trenching in the area difficult at best if not impossible.

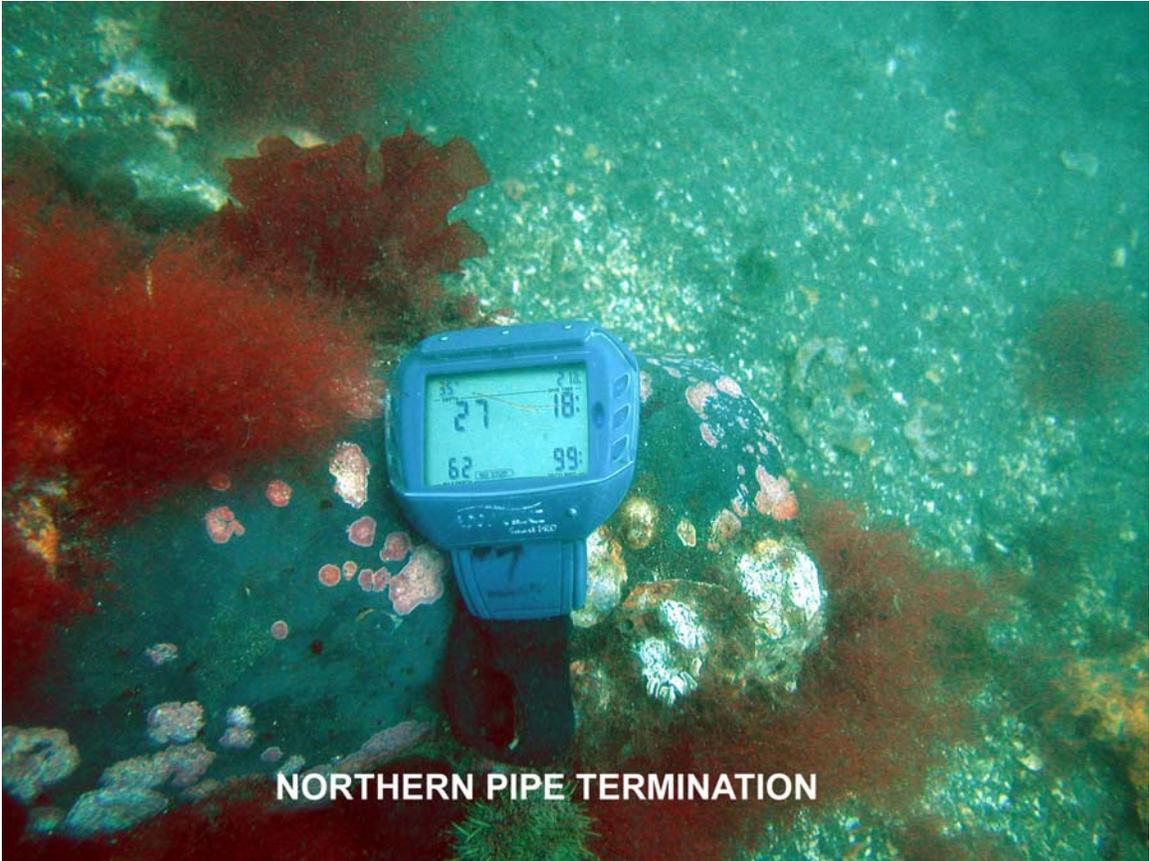
**NORTHERN PIPE TERMINATION**

The northern pipe is a HDPE pipe that is disconnected from the PVC supply side in the inter-tidal zone. The line extends approximately 330 feet in an easterly direction before terminating in -26 feet MLLW. The end appears to be sheared clean which could indicate one of the following:

- A failed weld
- Cut by vessel
- Detached diffuser

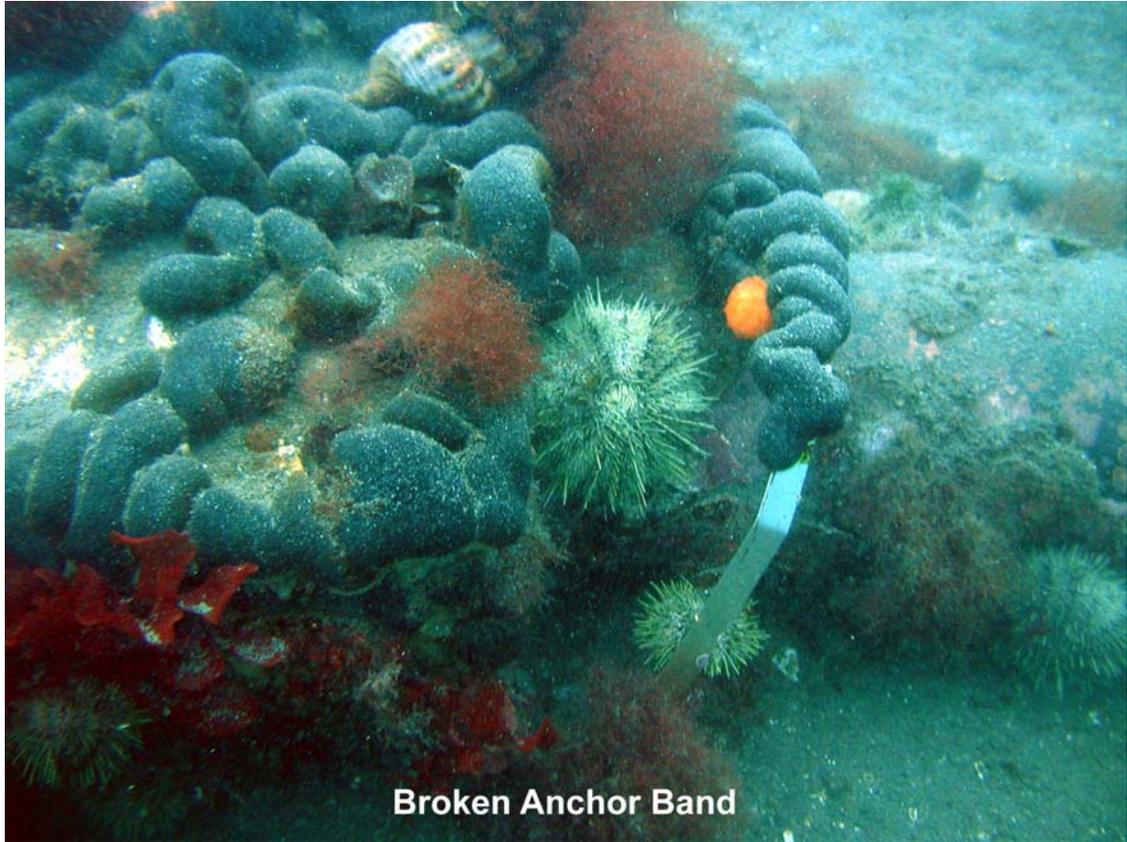
**Broken Anchor Band**

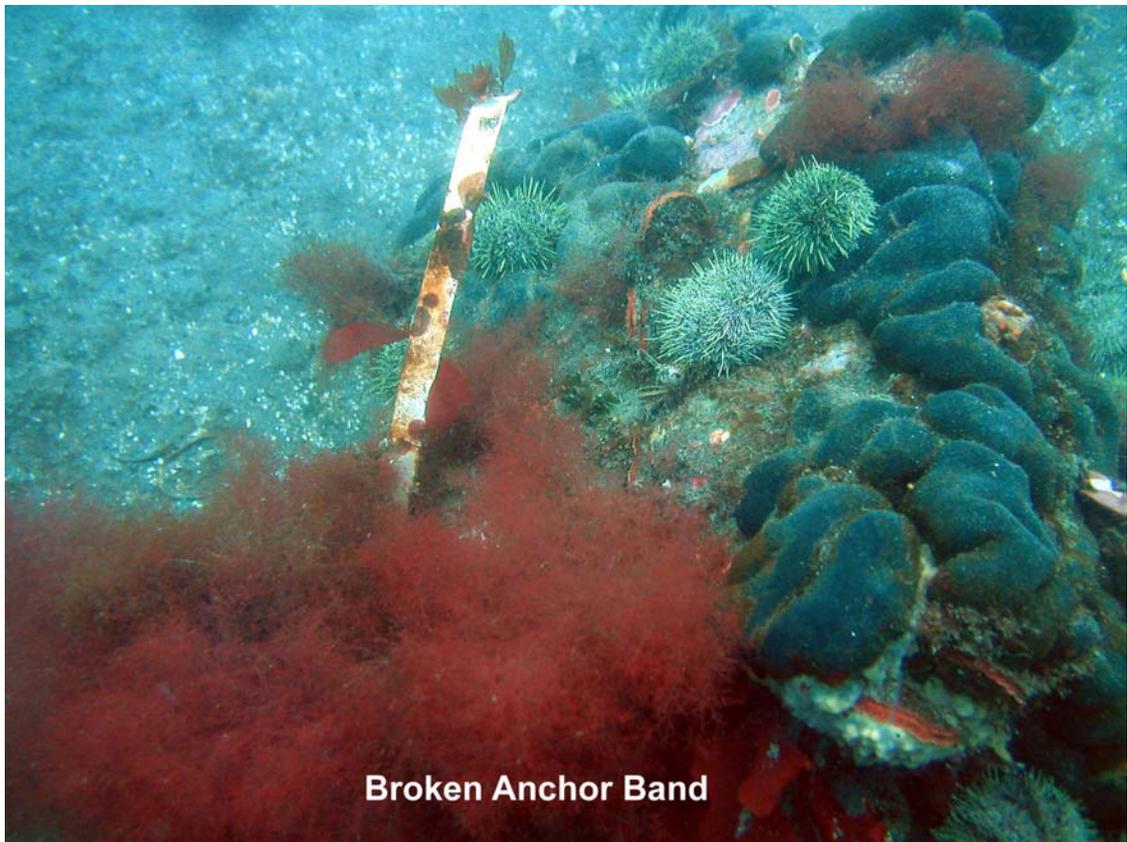
**Broken Anchor Band**

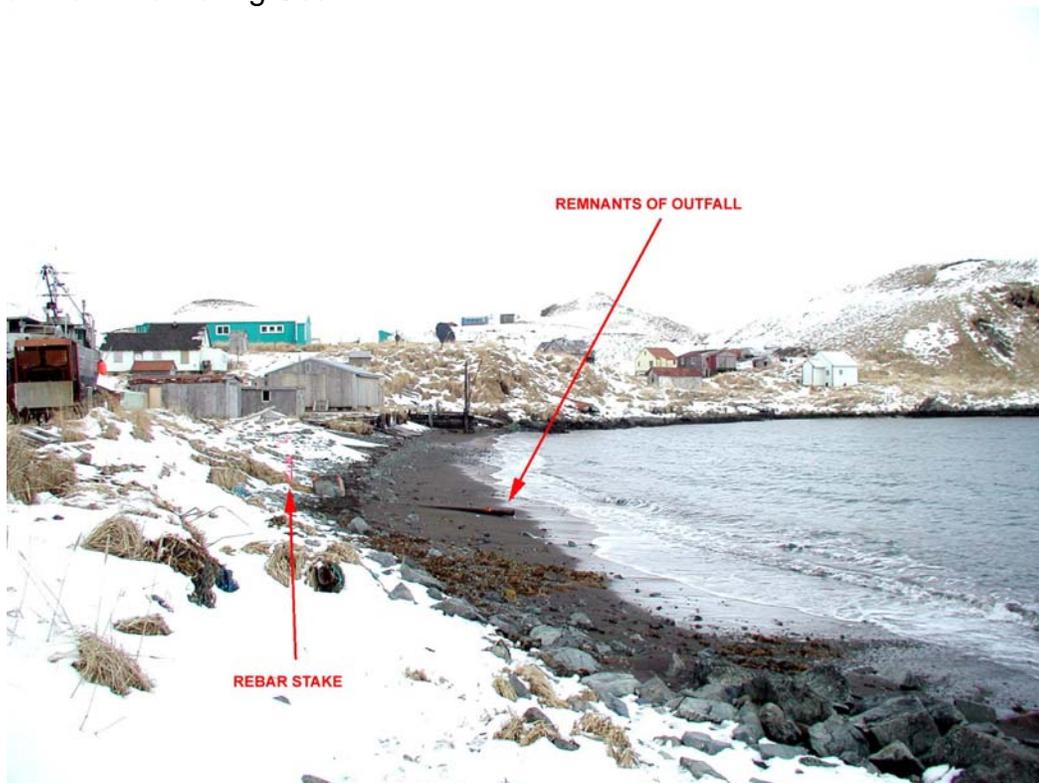
The only visible remains of the southern pipeline are the cast iron pipe just above the water line. This area is a high energy zone exposed to wind and wave action from the Bering Sea.

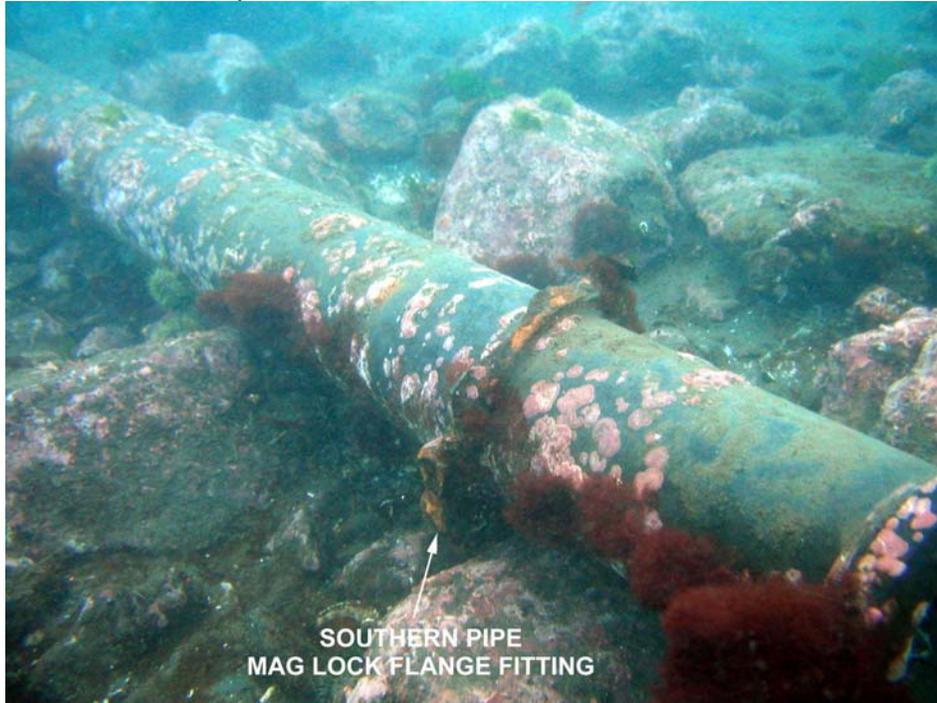
Divers were able to locate the HDPE section of the outfall line 80 feet to the south and 160 feet to the east of the cast iron pipe in -7 feet MLLW. At the shore side end the flanged end appears to have the remains of a Mag-Lock fitting with its counterpart located a few feet away. This discovery with the broken pieces of cast iron pipe observed between the onshore pipe and this remnant would infer that the previous installation used cast iron water pipe with Mag-lock

fittings in the shallow water transition zone. The bottom in front of where cast iron pipe daylighted on the shoreline is mostly coarse sand however the area where the outfall was located is rocky inferring that the outfall became separated and was washed to the present location.

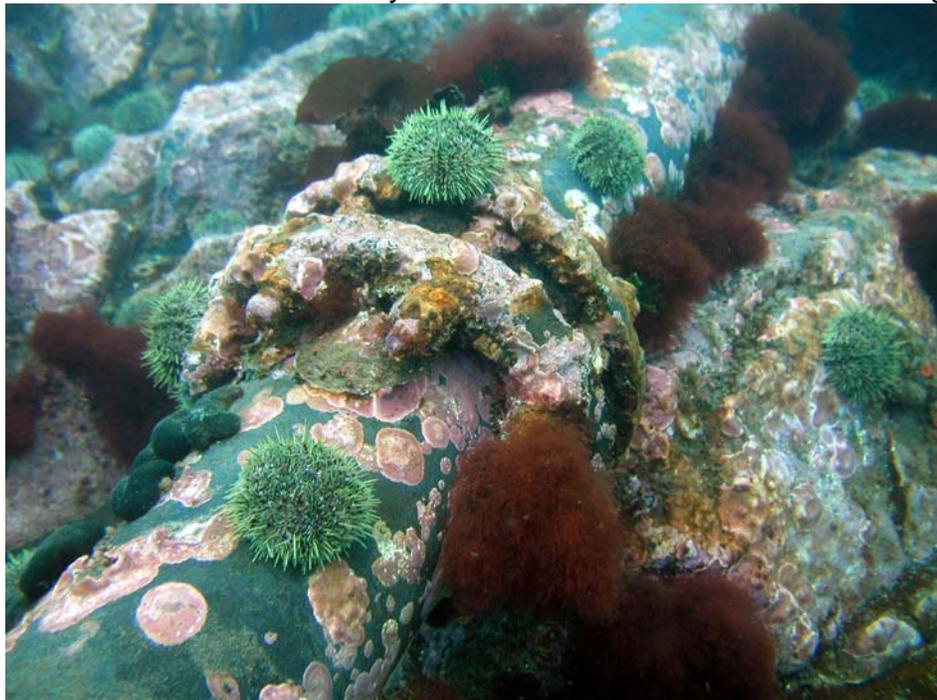
The outfall is HDPE construction with flanged connections at regular intervals. The connections are very corroded and encrusted with marine growth.

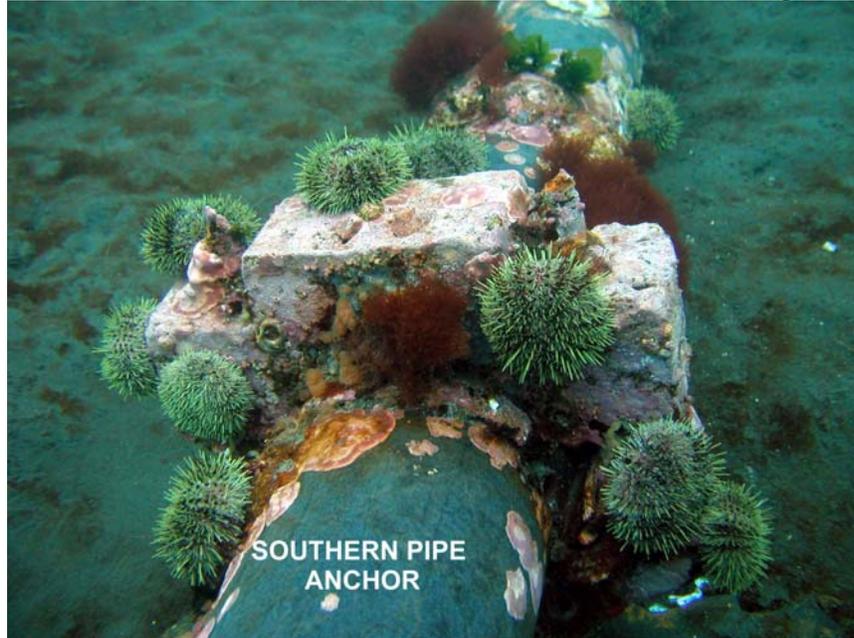
The outfall line is anchored with very small concrete narrow two piece saddle anchors secured with two bolts, spaced approximately 40 feet to 60 feet apart. The anchor bolts are corroded and encrusted with marine growth.

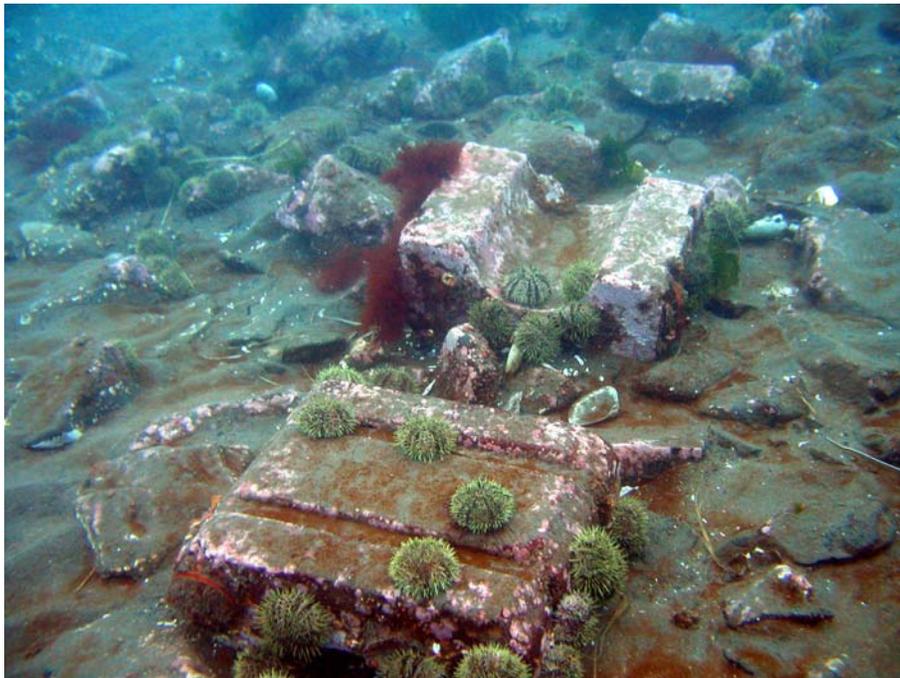
Divers also observed sections of large saddle anchors which had separated and were lying in the general vicinity of the line. These anchors appear to have been banded together in a similar manner as the anchors on the north outfall line.

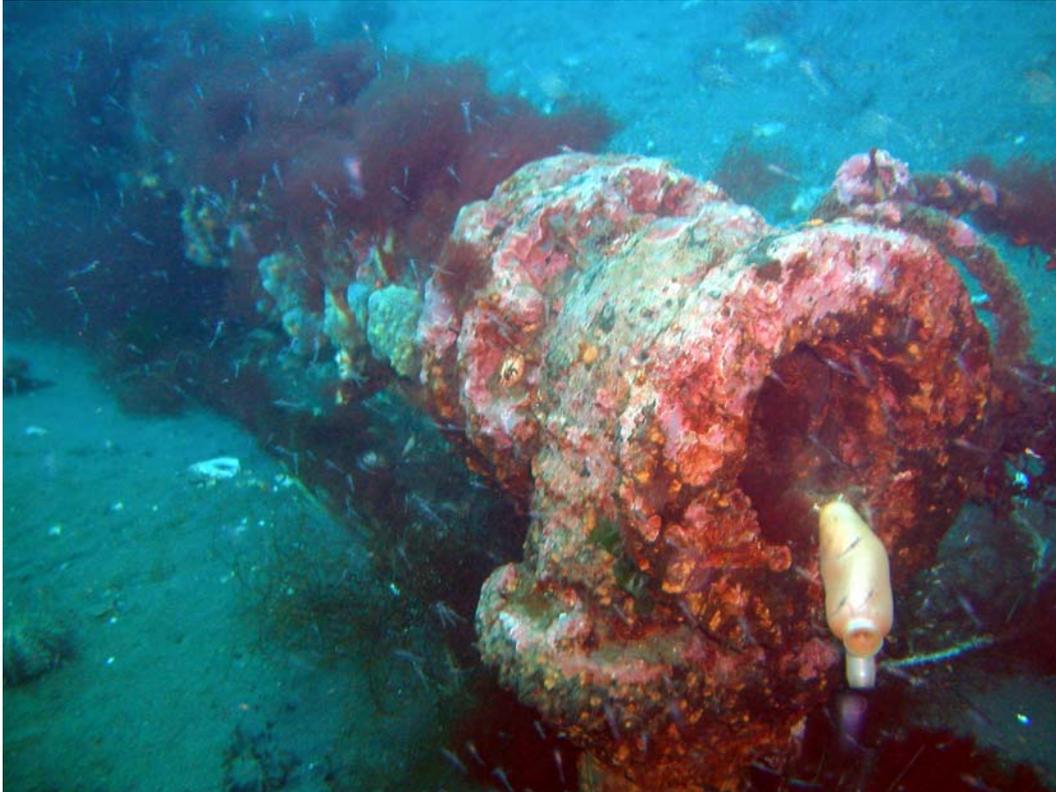
The outfall line extends in an easterly direction for almost 240 feet before heading south for 120 feet and becoming buried by the soft sediment in the area. The majority of the bottom is a soft substrate mixed with small cobble which gives way to a soft silt / mud bottom. The pipeline reemerges from the sediment and travels in a northeast and then a northerly direction before once again heading south and terminating in -32 feet MLLW. The terminus has a pipe fitting that is believed to be the remains of a diffuser.

The present layout of the pipe, (roughly S shape) would indicate that at some time the line was fouled by an anchor or some other object. Total pipe length is estimated at 640 feet with no major structural damage to the pipe. There is significant marine growth and sediment in the shallow water end of the pipe.

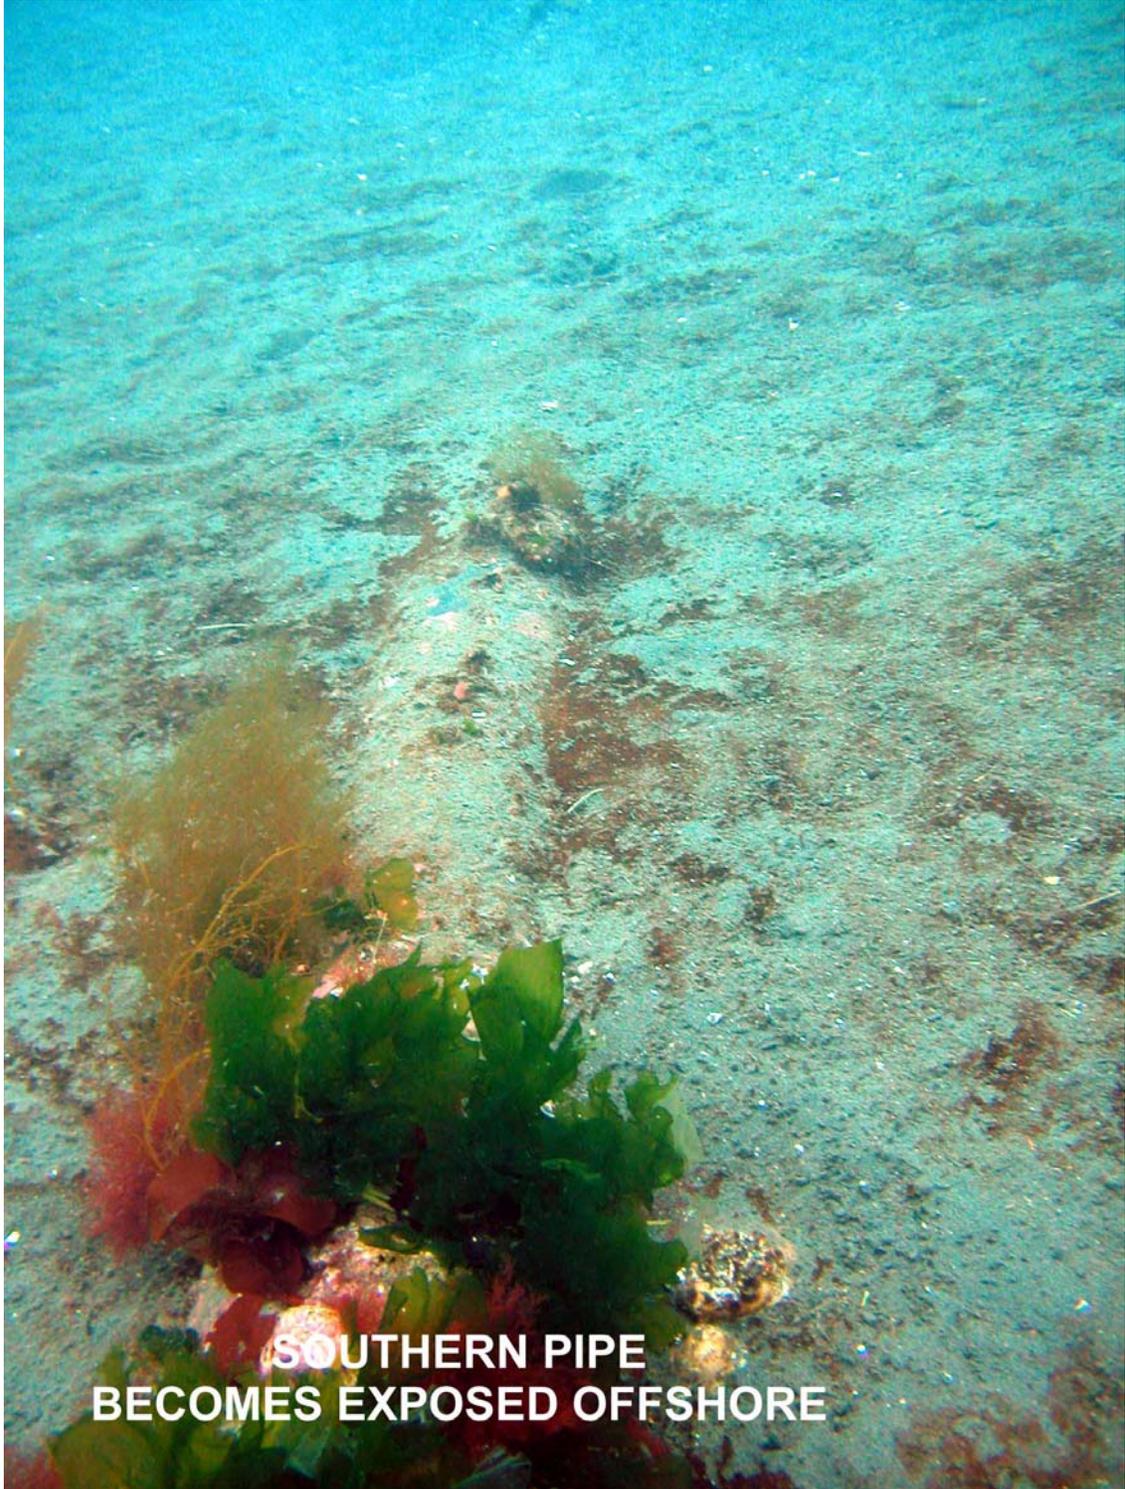
**SOUTHERN PIPE  
BECOMES EXPOSED OFFSHORE**
