# **DESIGN SUMMARY REPORT**

## **ATKA ROADS PROJECT ATKA, ALASKA**

Prepared By  
Eric Zeimer  
Department of the Interior  
Bureau of Indian Affairs  
Branch of Transportation  
Juneau, Alaska  
December 2005

# PRELIMINARY ENGINEERING REPORT ATKA ROADS PROJECT

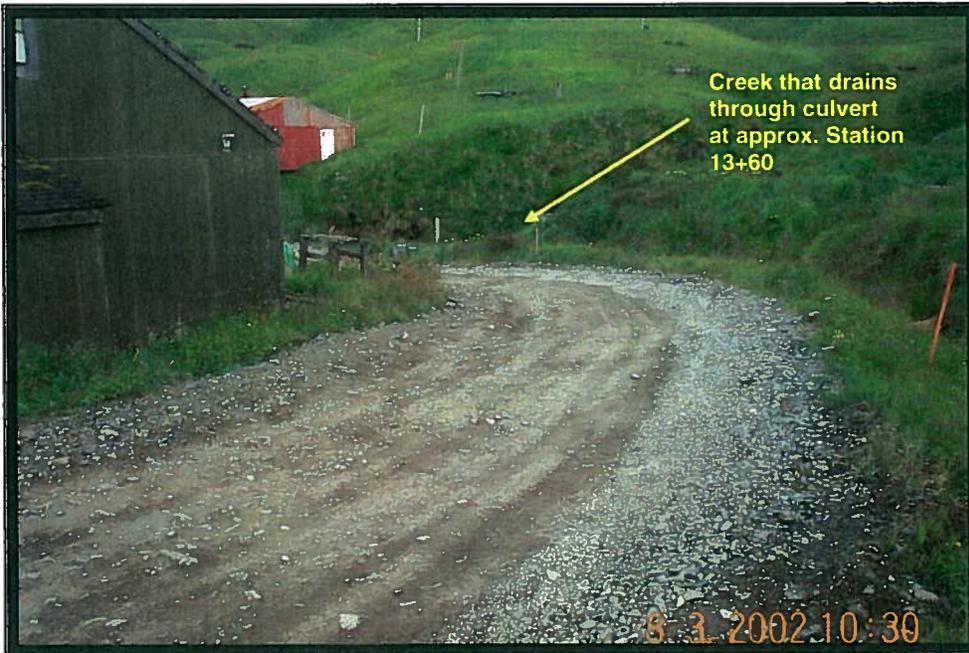
P1 – Looking upstation at Atxax Way from approximate Station 15+25.

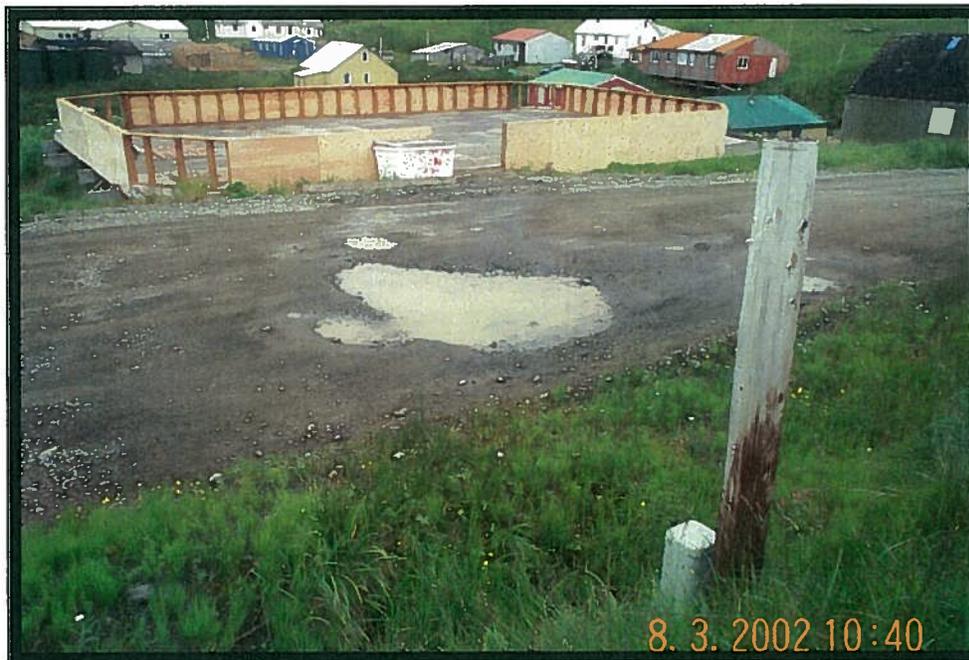
P2 – Wet area at approximate Station 16+10. Residents report that in years preceding the photo, the area was wet or icy all year long. We observed dry conditions in July 2003

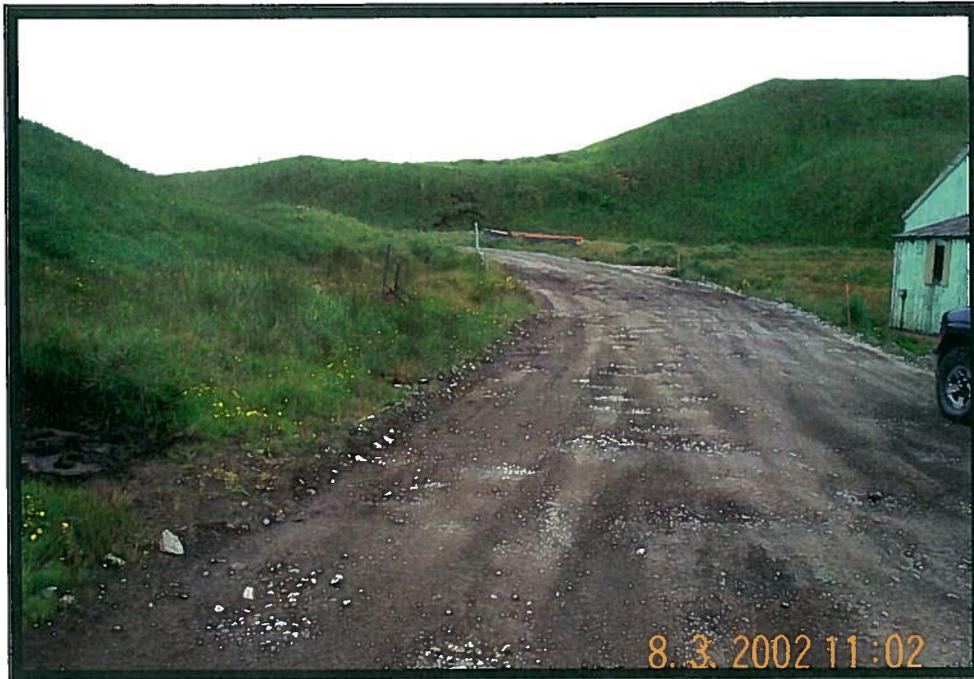
As discussed above, an abundance of potholes was observed along the relatively flat grade between approximate Stations 16+00 and 17+25. In our opinion, the lack of a ditch adequate to drain the large adjacent slope is the primary cause of the exceptionally poor road surface in this area. The flat road grade contributes by allowing water to pond along the edge of the road for prolonged periods, saturating the moisture-sensitive roadbed materials. Along steeper sections, the steep grade allows water to more easily flow despite obstructions, etc. A well maintained, 2-foot-deep ditch draining to the creek at approximate Station 13+60 would likely reduce roadbed instability to an acceptable level. However, the 15-foot-wide ROW will make such a ditch unlikely. As shown on photo P1, superelevation of the curve between approximate Stations 14+00 and 15+30 will direct water toward the right edge of road and the adjacent house. Currently a berm along the edge of road acts

P3 – Looking downstation from approximate Station 16+25. Note numerous potholes.

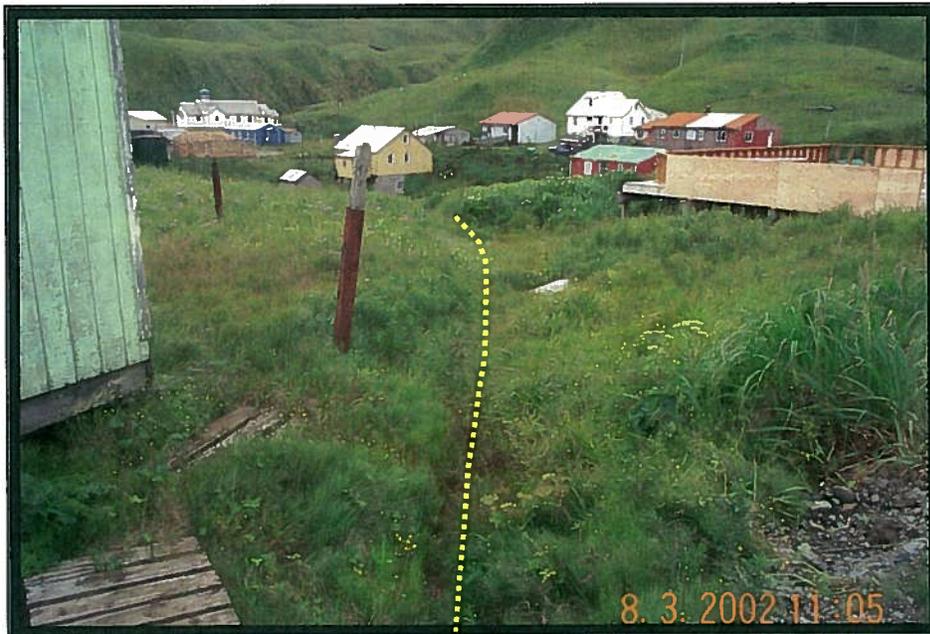
P4 – Looking southwest at existing drainage, approximate Station 16+75, right. This would be a good place to discharge a culvert.

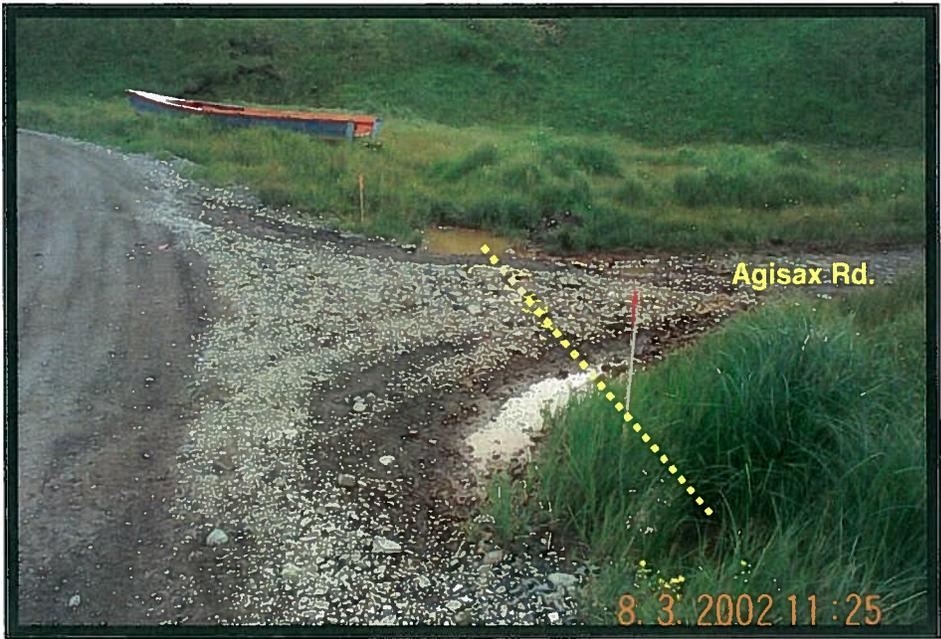
*P5 – Looking downstation along right edge of existing roadway from approximate Station 17+30. A culvert is needed to drain water along right side of road, beneath intersection with Agisax Rd.*

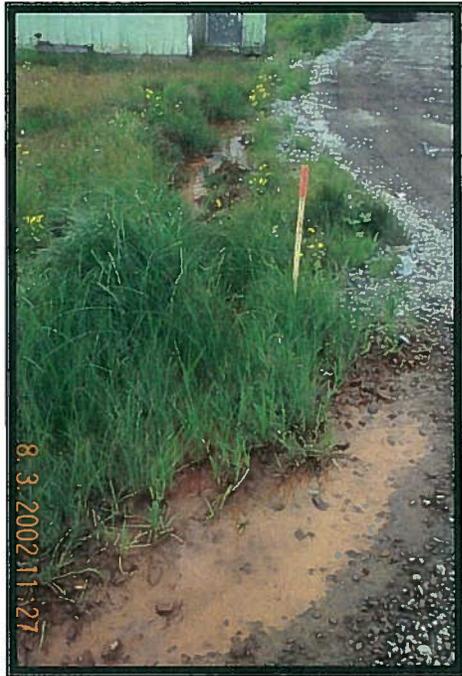
*P6 -- Looking upstation from approximate Station 17+50. Culvert discussed in P21 would discharge into existing drainage on this photo, which drains into existing drainage shown on P4.*

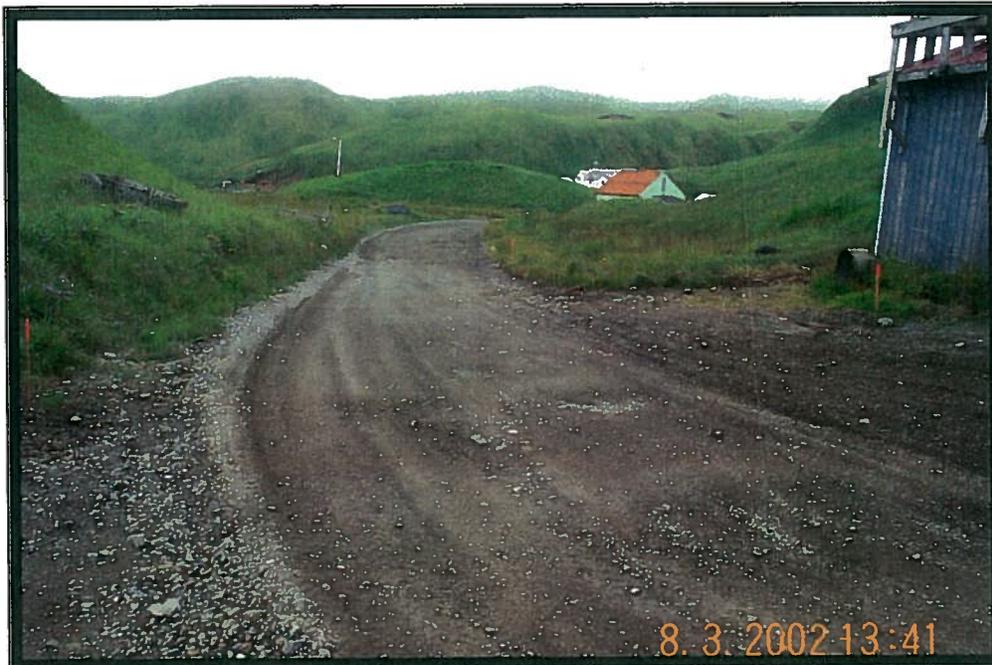
*P7 – Looking upstation from approximate Station 20+00.*

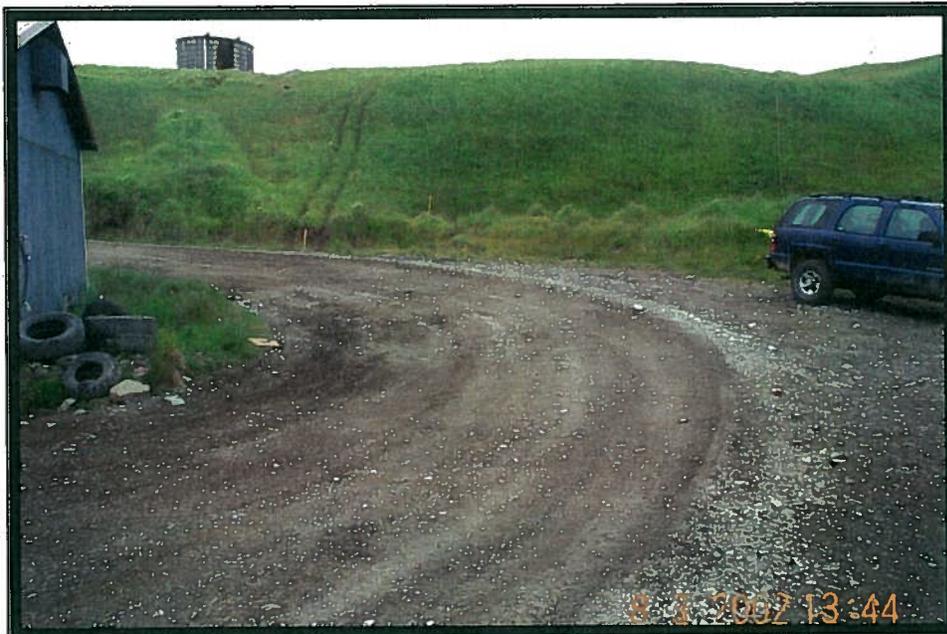
*P8 – Looking upstation from approximate Station 19+75. Shop is on left, parking area on right.*

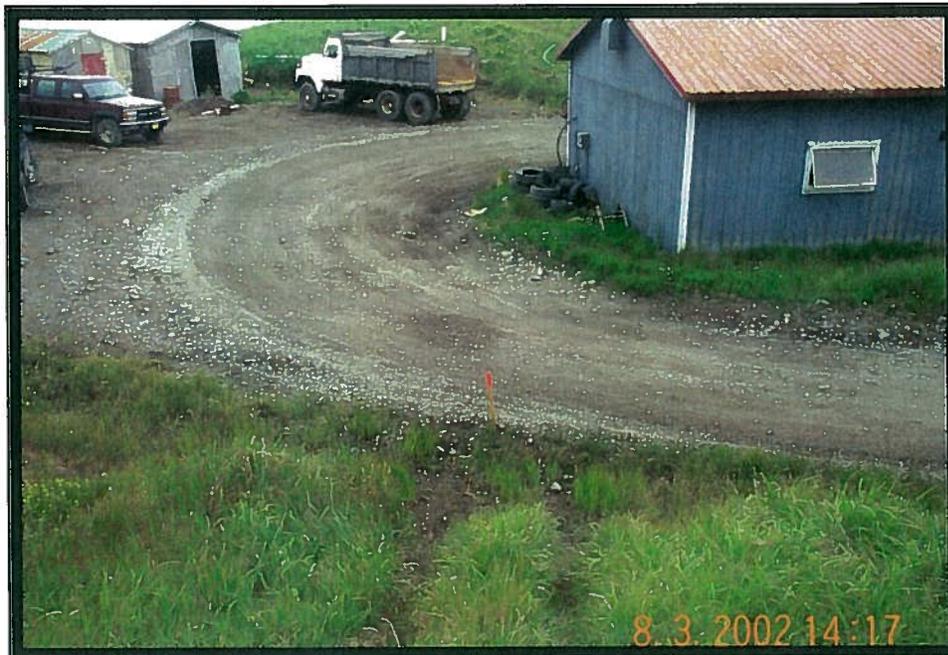
*P9 – Looking upstation at curve, from approximate Station 20+75, right. Shop is on right side of photo, sheds and parking area on left.*

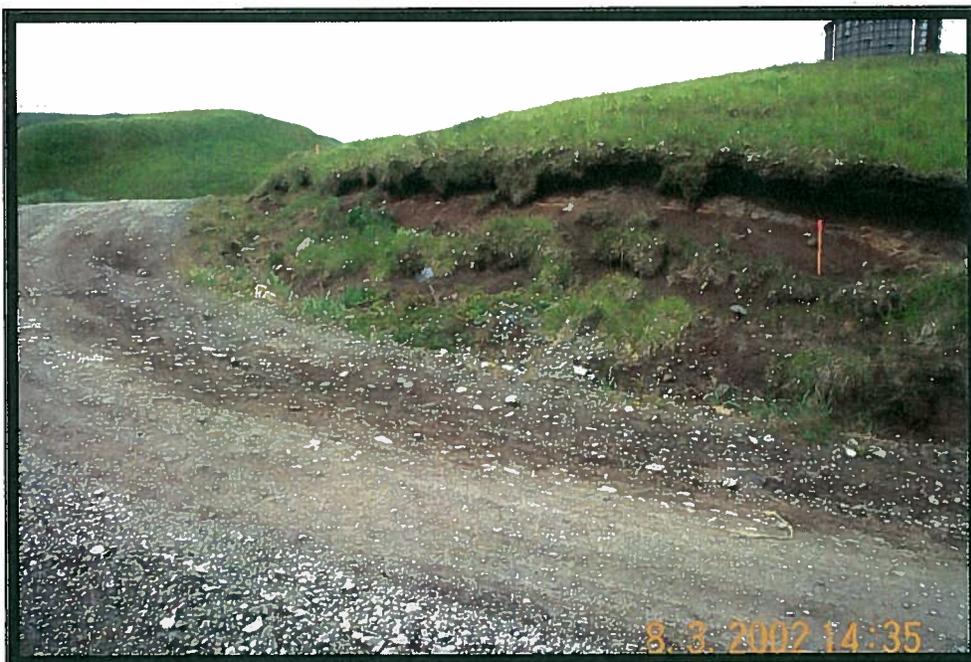
*P10 – Portion of existing, slumping cut slope that extends between approximate Stations 21+50 and 24+50, right.*

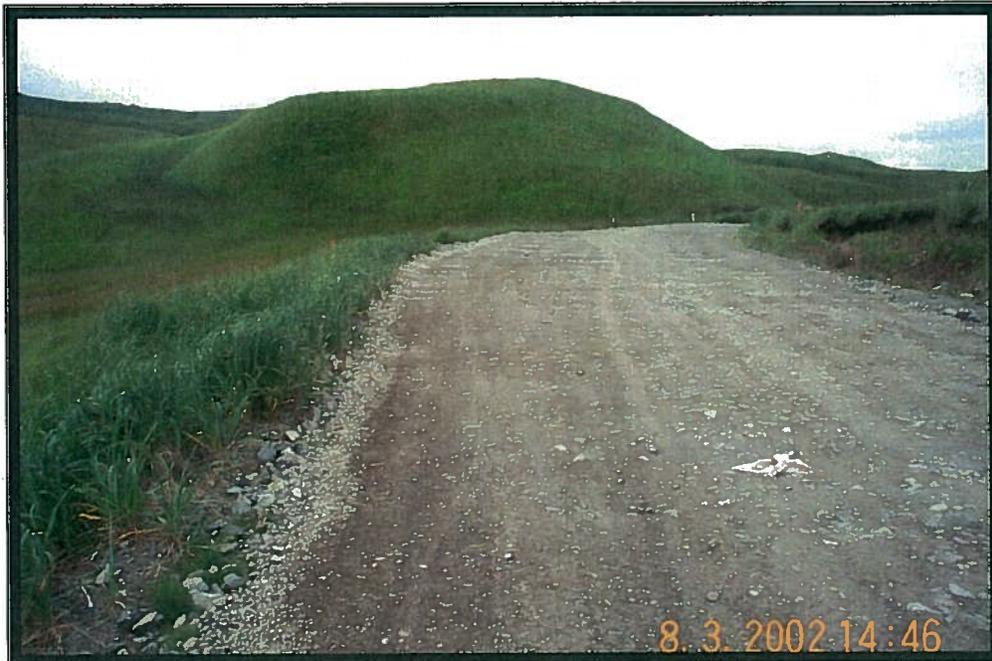
This segment of Atxax Way begins on a relatively short tangent that extends to approximate Station 24+25. The average grade along the tangent is only about 1%. Between Stations 23+25 and 24+25, the road widens from approximately 21 feet to 28 feet. This section of roadway was the most badly potholed of any we observed as shown on photo P11.

*P11 – Looking downstation at most badly potholed section of Atxax Way, approximate Stations 23+25 to 24+25.*

A good ditch draining upstation along the right side of Atxax Way from its intersection with the non-project road at approximate Station 25+00 is badly needed. As noted above, the most badly potholed portion of Atxax Way occurs between Stations 23+25 and 24+25. In our opinion, the poor road conditions are primarily due to poor drainage of surface water from the righthand side of the road. This, in turn, is partially due to the flat longitudinal grade, which allows water to pond on and beside the side of the road, saturating the roadbed. As discussed above, narrowing of the ROW at approximate Station 21+42 may prevent extension of the ditch further upstation. Instead, one or more culverts to pass the water beneath the road may be installed. To reduce the volume flowing down the steeper portions of the ditch, additional culverts could be installed between approximate Stations 24+50 and 22+00. Note, however, that discharging culverts onto the steep slope along the left side could result in excessive erosion unless erosion control measures are properly installed and maintained (off of the ROW).

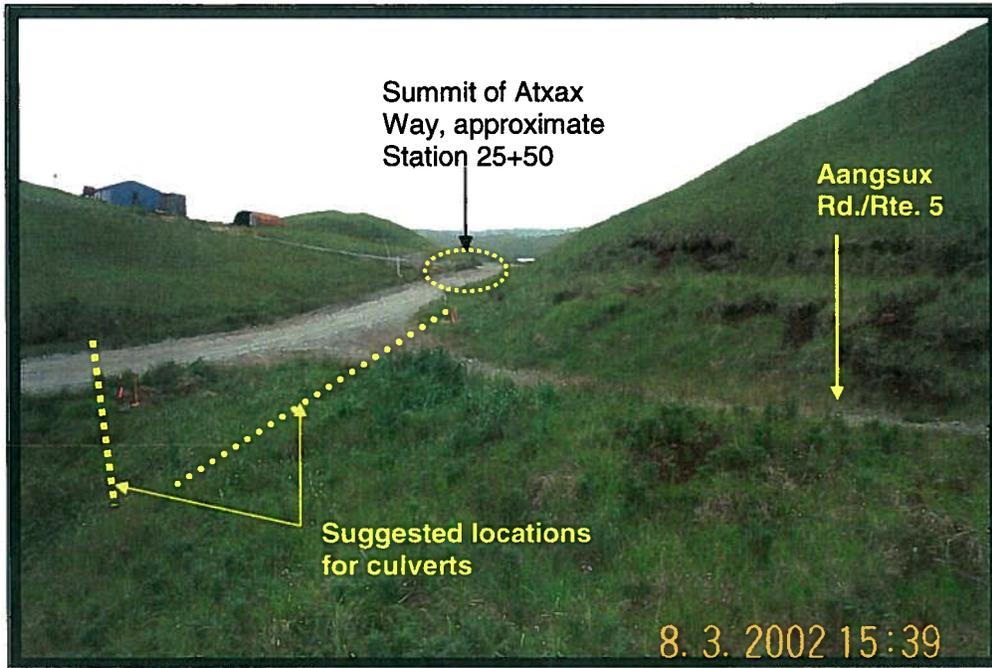
P12 – Looking south at summit area of Atxax Way.

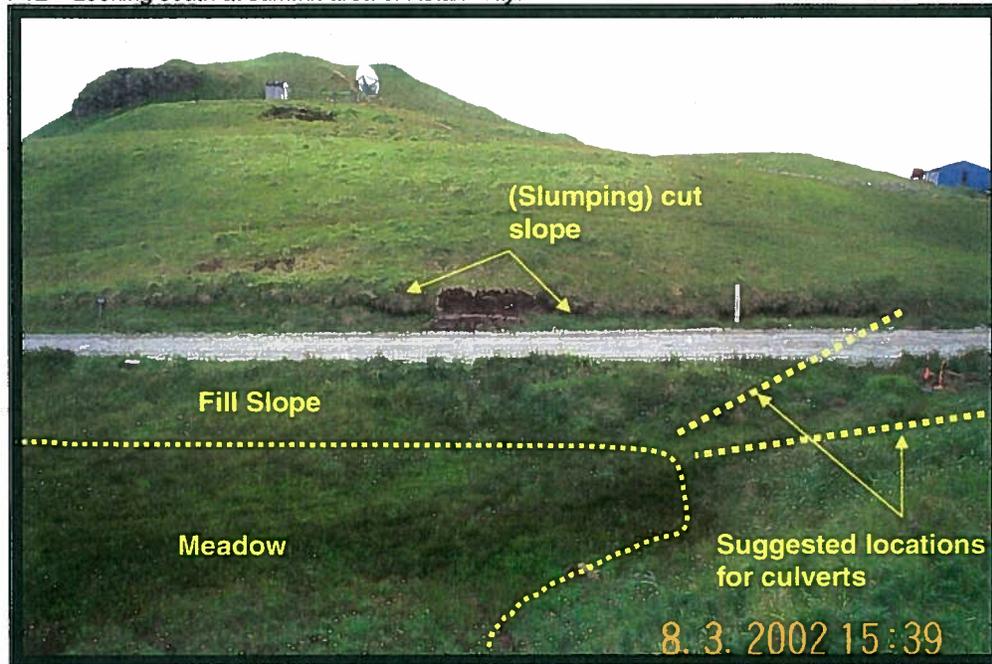
P13 – Looking east across Atxax Way at section between approximate Stations 27+25 and 28+25.

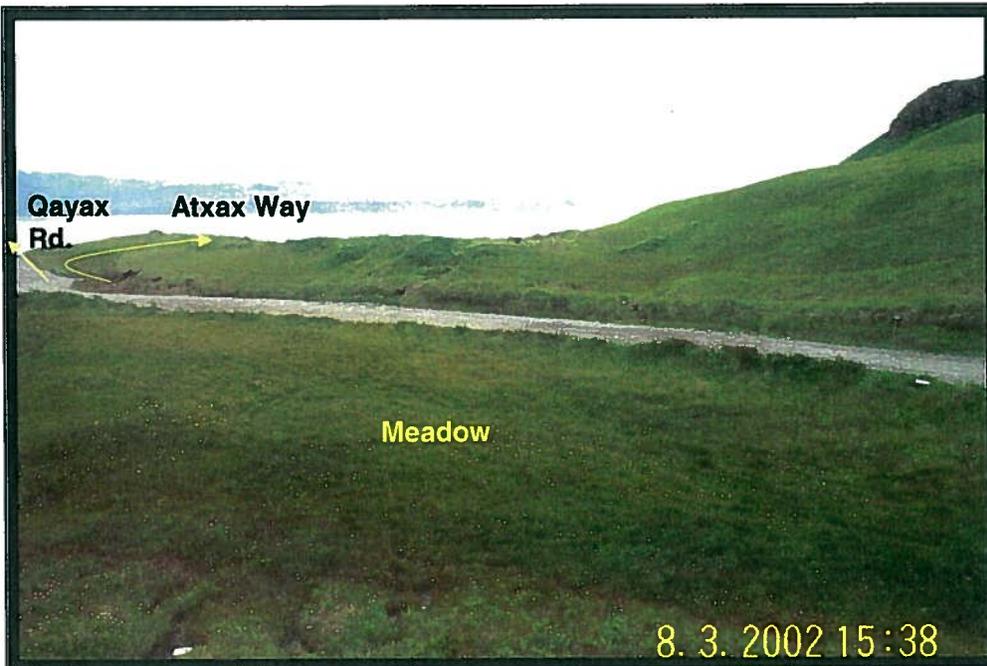
P14 – Looking Northeast across Atxax Way at section between approximate Stations 28+15 and 31+00.

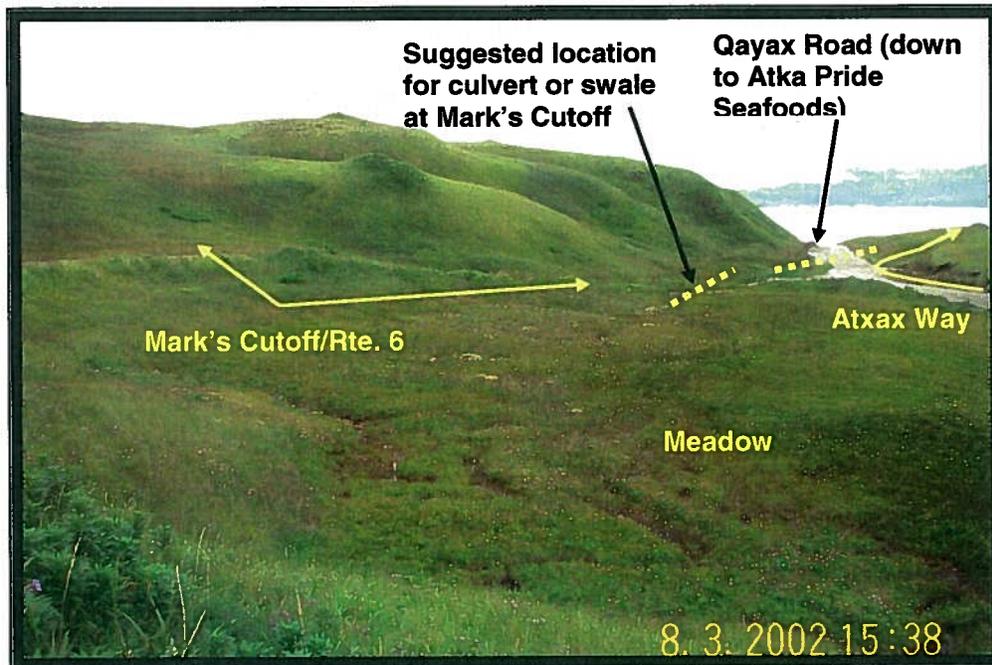
P15 – Looking north across meadow. Curve on Atxax Way shown on right side is at approximate Station 30+50.

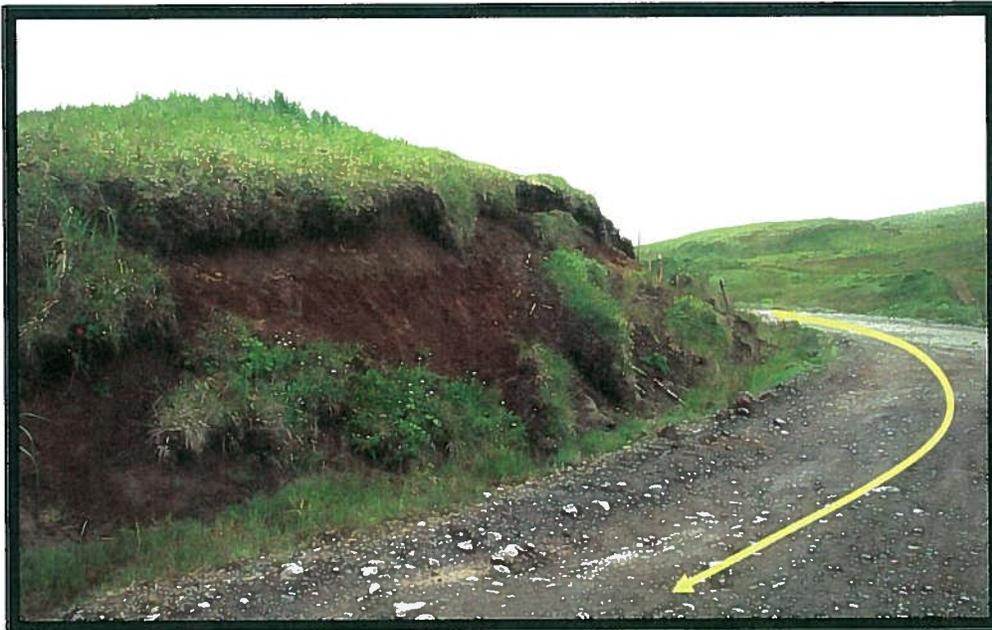
-06. The generalized subsurface conditions indicated by our explorations and observations consist of 3.4 to 5.0 feet of medium stiff to stiff, dark brown to reddish brown to black, silt, sandy silt, and silty sand with occasional layers of roots, overlying 0.2 to 1.3 feet of weathered rock that grades to sounder rock. Weathered rock retrieved from our explorations consisted of dense to very dense light brown to gray, silty, sandy gravel to coarse sand and angular gravel. Refusal on sounder bedrock was encountered at 3.7 to 6.3 feet. Although coring of rock was not completed, our observations indicate that they anticipated excavations could be completed by ripping with a large dozer. Although the cuts average 32 degrees from horizontal, it should be noted that such unprotected cuts are subjected to weathering and subsequent erosion and slumping of the vegetative mat, as shown on photos P16 through P19.

*P16 – Looking upstation (southwest) at existing cut slope along right side at intersection of Atxax Way and Qayax Road This cut hinders sight distance. This cut is representative of the conditions observed along cuts throughout Atka: difficult revegetation, erosion, and slumping of vegetative mat.*

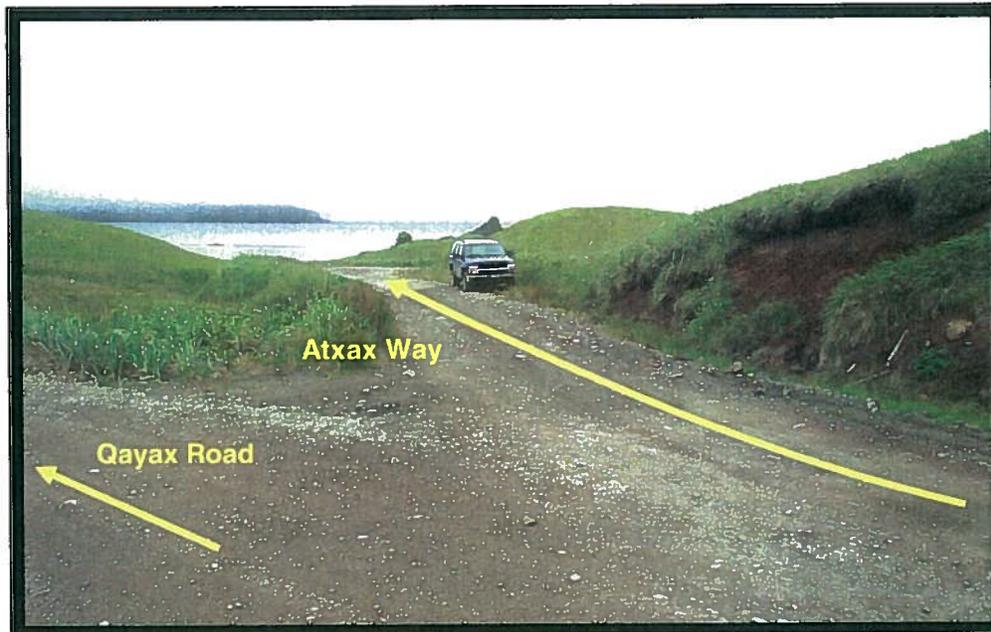
P17 – Looking downstation along Atxax Way from intersection with Qayax Road (approximate Station 30+50).

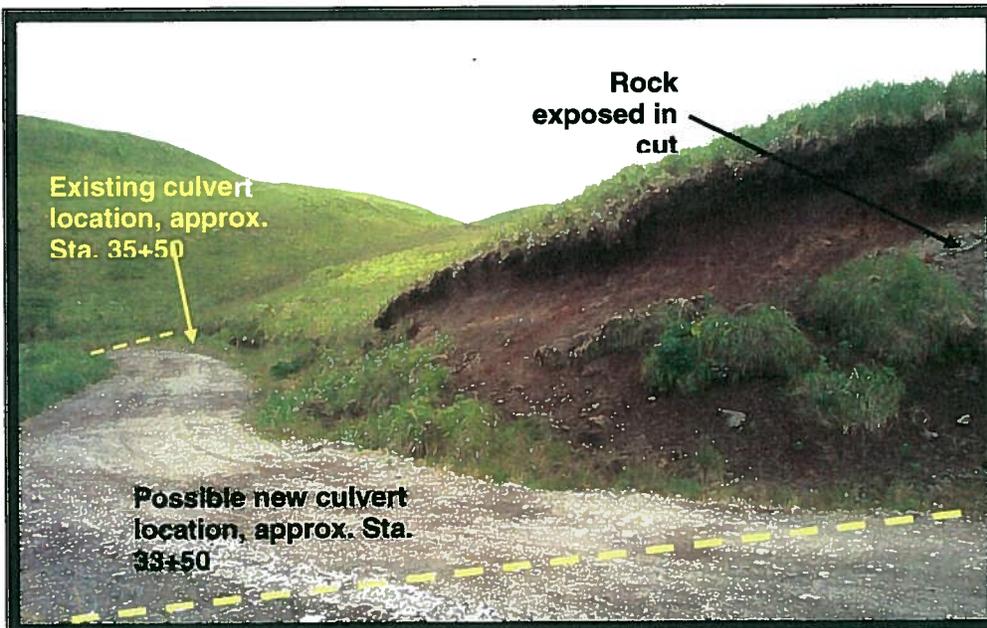
As shown on photos P18 and P21, an existing culvert beneath the road near Station 35+50 should be replaced (36-inch-diameter). Downstation ditch flow between the culverts at Stations 33+50 and 35+50 should also be diverted through this culvert. In our opinion, no new channel should be constructed at the culvert outlet – the culvert should discharge into an existing, natural drainage system that flows through the adjacent meadow (see photo P21).

P18 – Looking downstation along Atxax Way from approximate Station 33+50. Note evidence of ongoing slumping of cut.

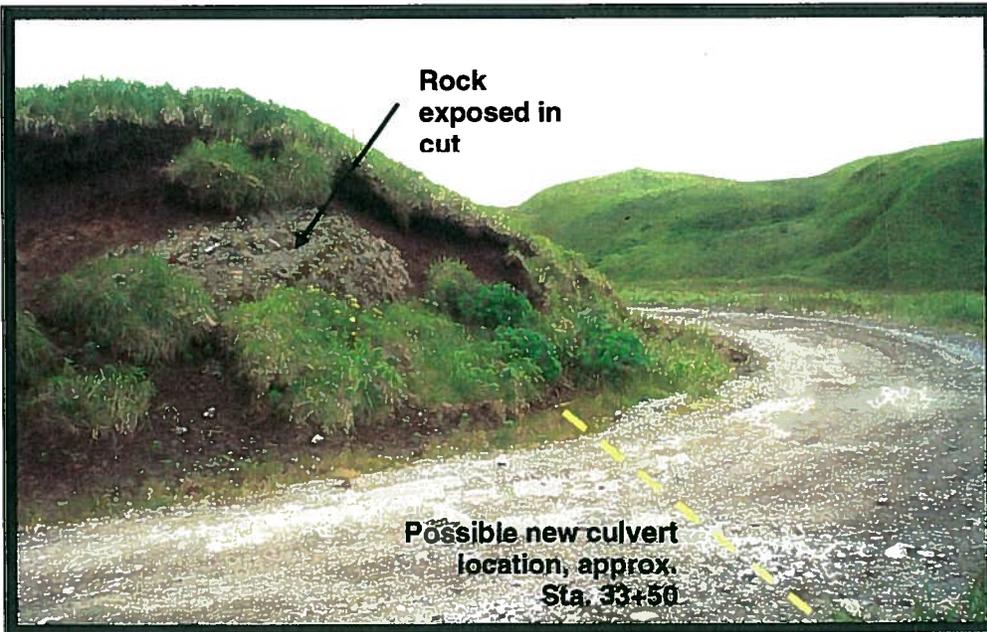
P19 – Looking upstation along Atxax Way from approximate Station 33+50.

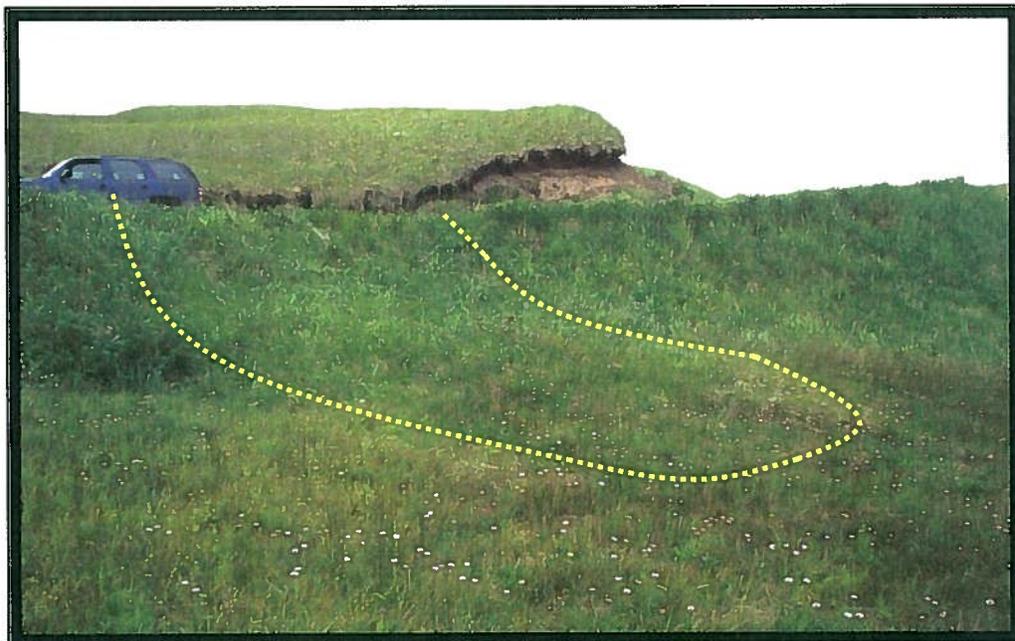
As shown on photo P20, we observed surface features such as a head scarp and toe bulge that indicate past instability on this slope. Due to the high seismicity of the region and the liquefiable soils encountered in our boring, it is possible that this slide was triggered by an earthquake.

P20 – Looking upslope at Atxax Way at approximate Station 34+75. We observed evidence of previous slope instability along approximate line shown. Based on soils encountered in hand boring HB-02-07, it is our opinion that slump may have been caused by liquefaction during an earthquake.

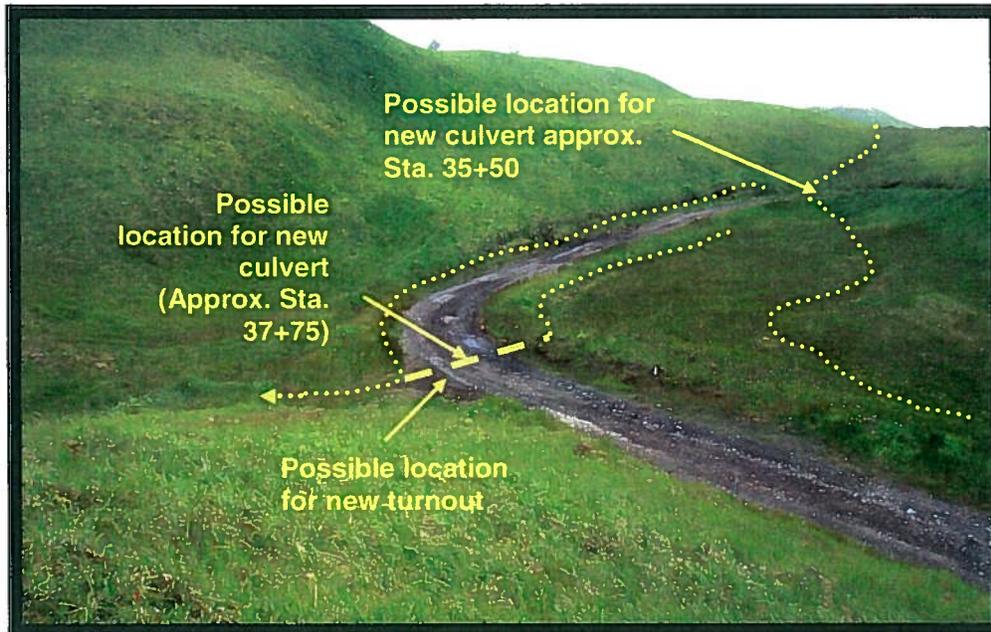
As shown on photos P21 through P23, water discharged by the proposed culverts at approximate Stations 33+50 and 35+50 and runoff from the meadow and surrounding slopes would flow in existing, natural drainages toward the left edge of road at approximate Station 41+50. Due to the large drainage area, we expect that a large culvert (36- to 48-inch-diameter) will be required to drain the combined flow to the beach at Station 41+50 (this culvert would replace an existing culvert constructed of 55-gallon drums). Existing culvert outlets in the vicinity are probably difficult to find because storms bury them with sand and debris. Therefore, we expect that special outlet protection of this culvert will be required.

P21 – Frame 1 of 2 frame panorama of section of Atxax Way between approximate Stations 34+00 and 39+00 showing possible surface water drainage improvements. This frame is looking southwest.

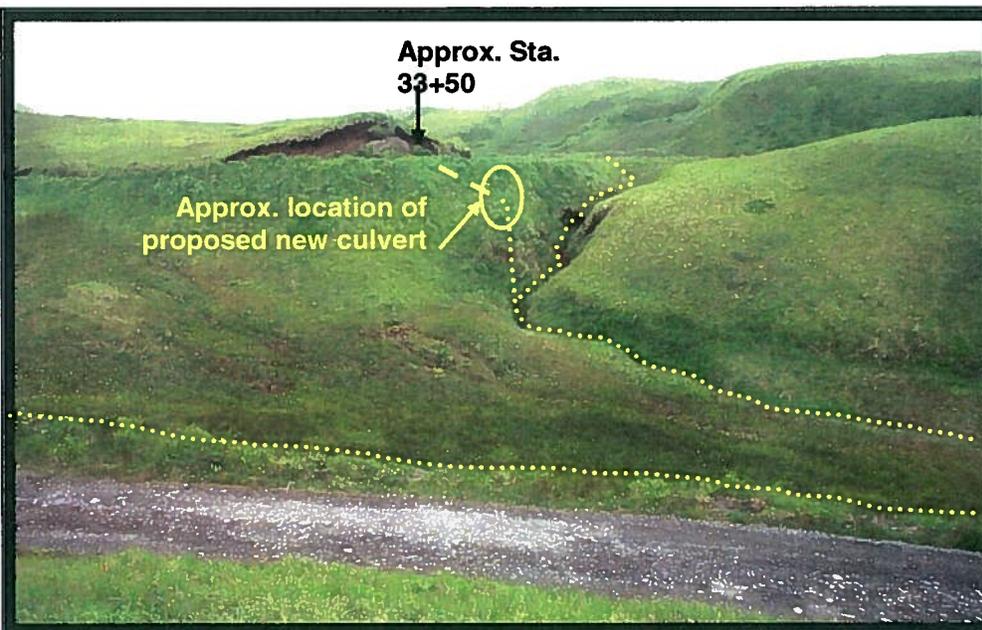
P22 – Frame 2 of 2 frame panorama of Atxax Way showing possible surface water drainage improvements.

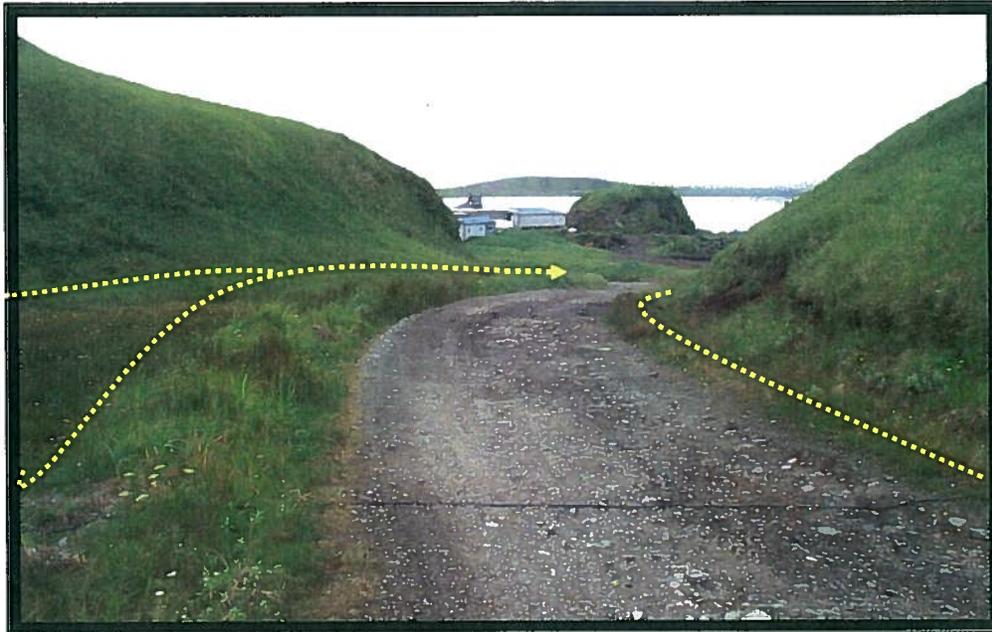
*P23 – Looking downstation along Atxax Way from approximate Station 38+50. Lines on left schematically show natural drainage from meadow converging for discharge by culvert at approximate Station 41+50. Line on right shows proposed ditch that would be diverted to beach near Station 41+50.*

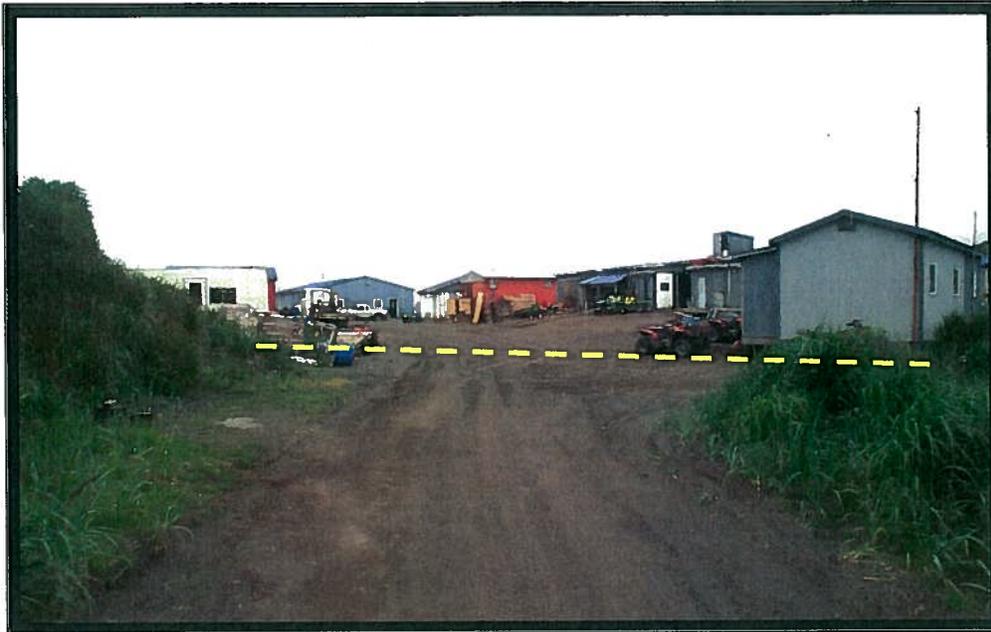
As discussed in the previous section, a badly deteriorated culvert constructed of 55-gallon drums passes beneath the road at approximate Station 41+50 and will likely be replaced. As shown on photo P25, a pair of approximate 8-inch-diameter plastic pipes drain beneath the road at approximate Stations 43+45. We expect that the existing pipes will continue to

*P25 – Looking downstation along Atxax Way through Atka Pride Seafoods. Dashed line shows approximate location of twin plastic culverts*

function without replacement, although maintenance to clear the pipes is recommended.

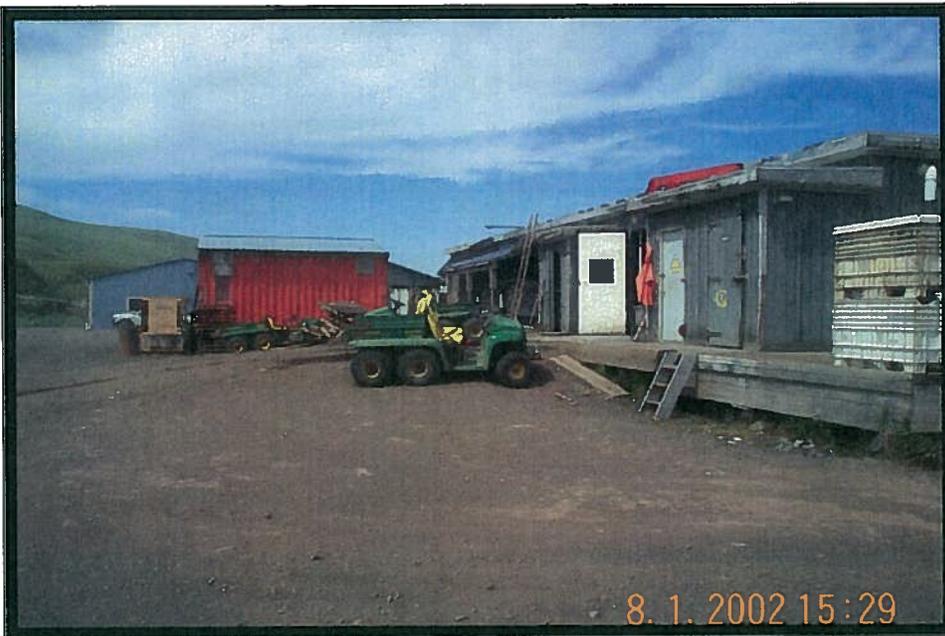
*P26 – Looking downstation at portion of Atka Pride Seafoods operations on right side of road.*

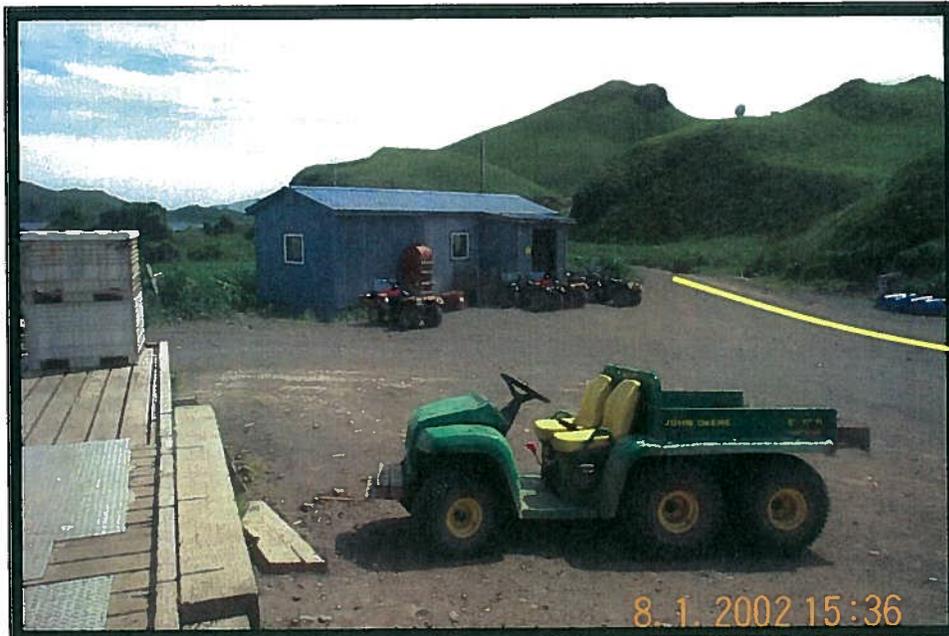
*P27 – Looking upstation at Atxax Way from right side of road. Blue building is Atka Pride Seafoods office which is located at about Station 43+40. Yellow line indicates approximate location of Atxax Way centerline.*

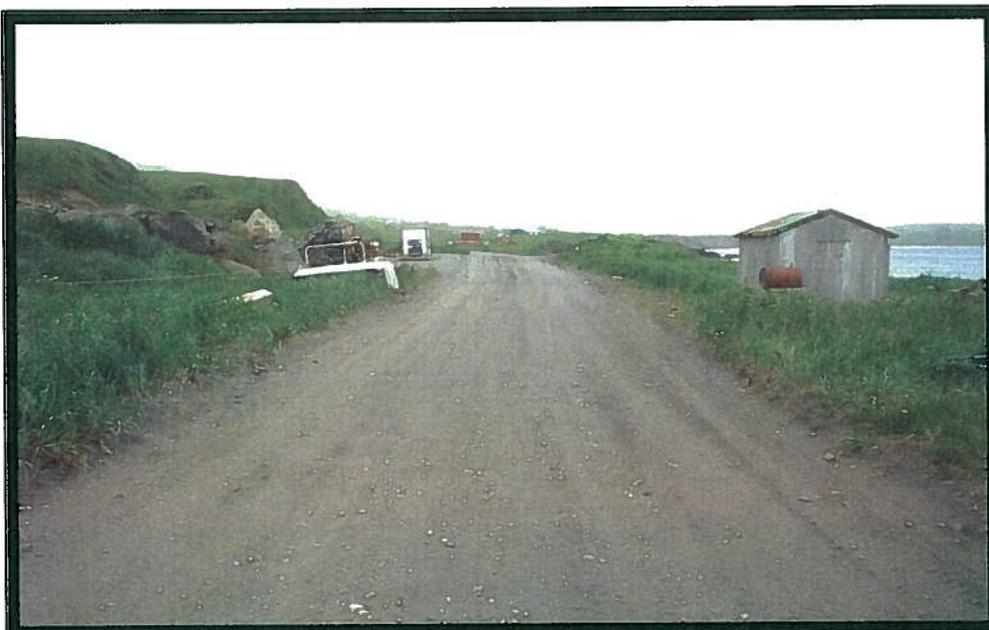
*P28 – Looking downstation on Atxax Way (Rt. 1) from approximate Station 47+00. This segment of road seemed plenty wide and could accommodate 3- to 4-foot grade increase (including crowning roadway) to facilitate drainage.*

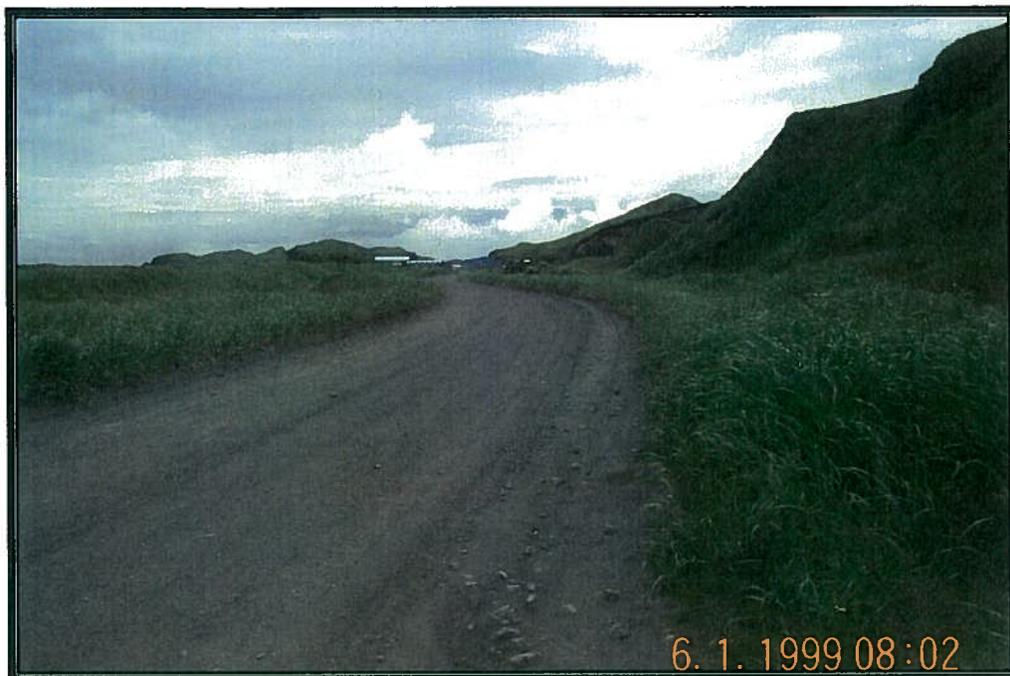
*P29 -- Looking upstation from approximate Station 55+00. Atka Pride Seafoods visible in background. Date/time shown is not correct.*

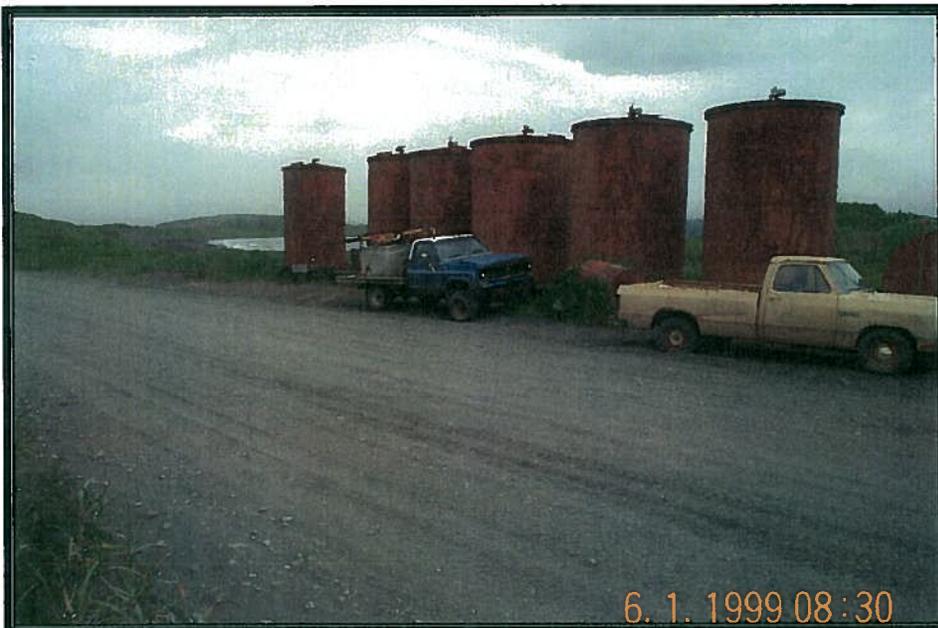
*P30 -- Existing fuel tank farm along the right side of Atxax Way and approximate Station 56+00. Date/time shown are not correct.*

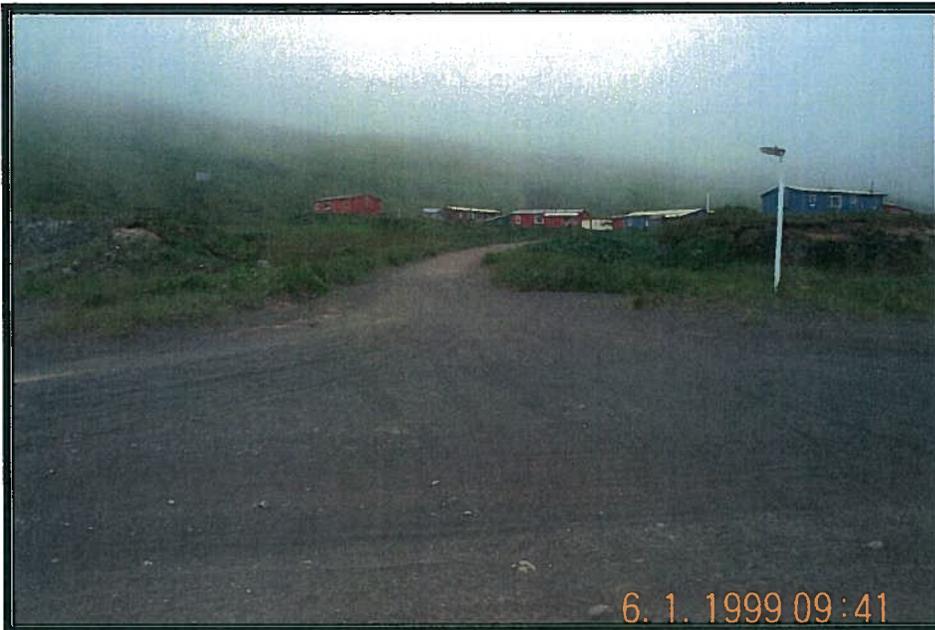
*P31 -- Looking left (west) from approximate Station 69+35. Chavichax Lane and New Atka Subdivision. Date/time shown is not correct.*

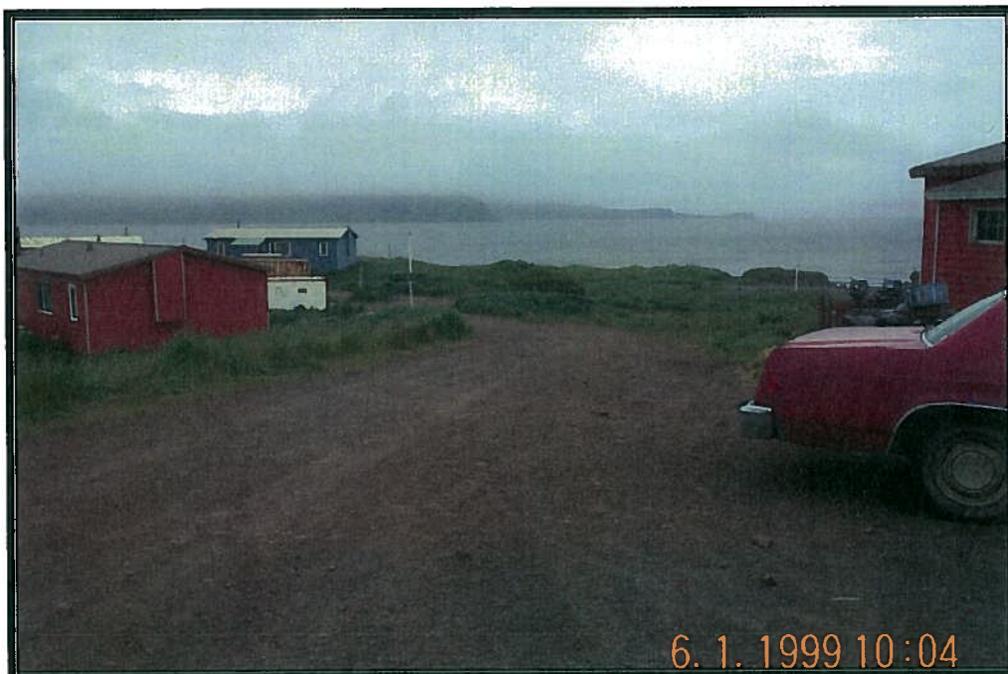
*P32 -- Looking upstation along Chagix Road from end of alignment. Note that date/time are incorrect.*
