STATE OF ALASKA

DEPARTMENT OF ENVIRONMENTAL CONSERVATION DIVISION OF SPILL PREVENTION AND RESPONSE CONTAMINATED SITES PROGRAM

Re: Decision Document; McCully Truck Rollover 32.1 Taylor Hwy.
Cleanup Complete Determination

32 Mile Taylor Highway
Diesel Tanker Spill Site

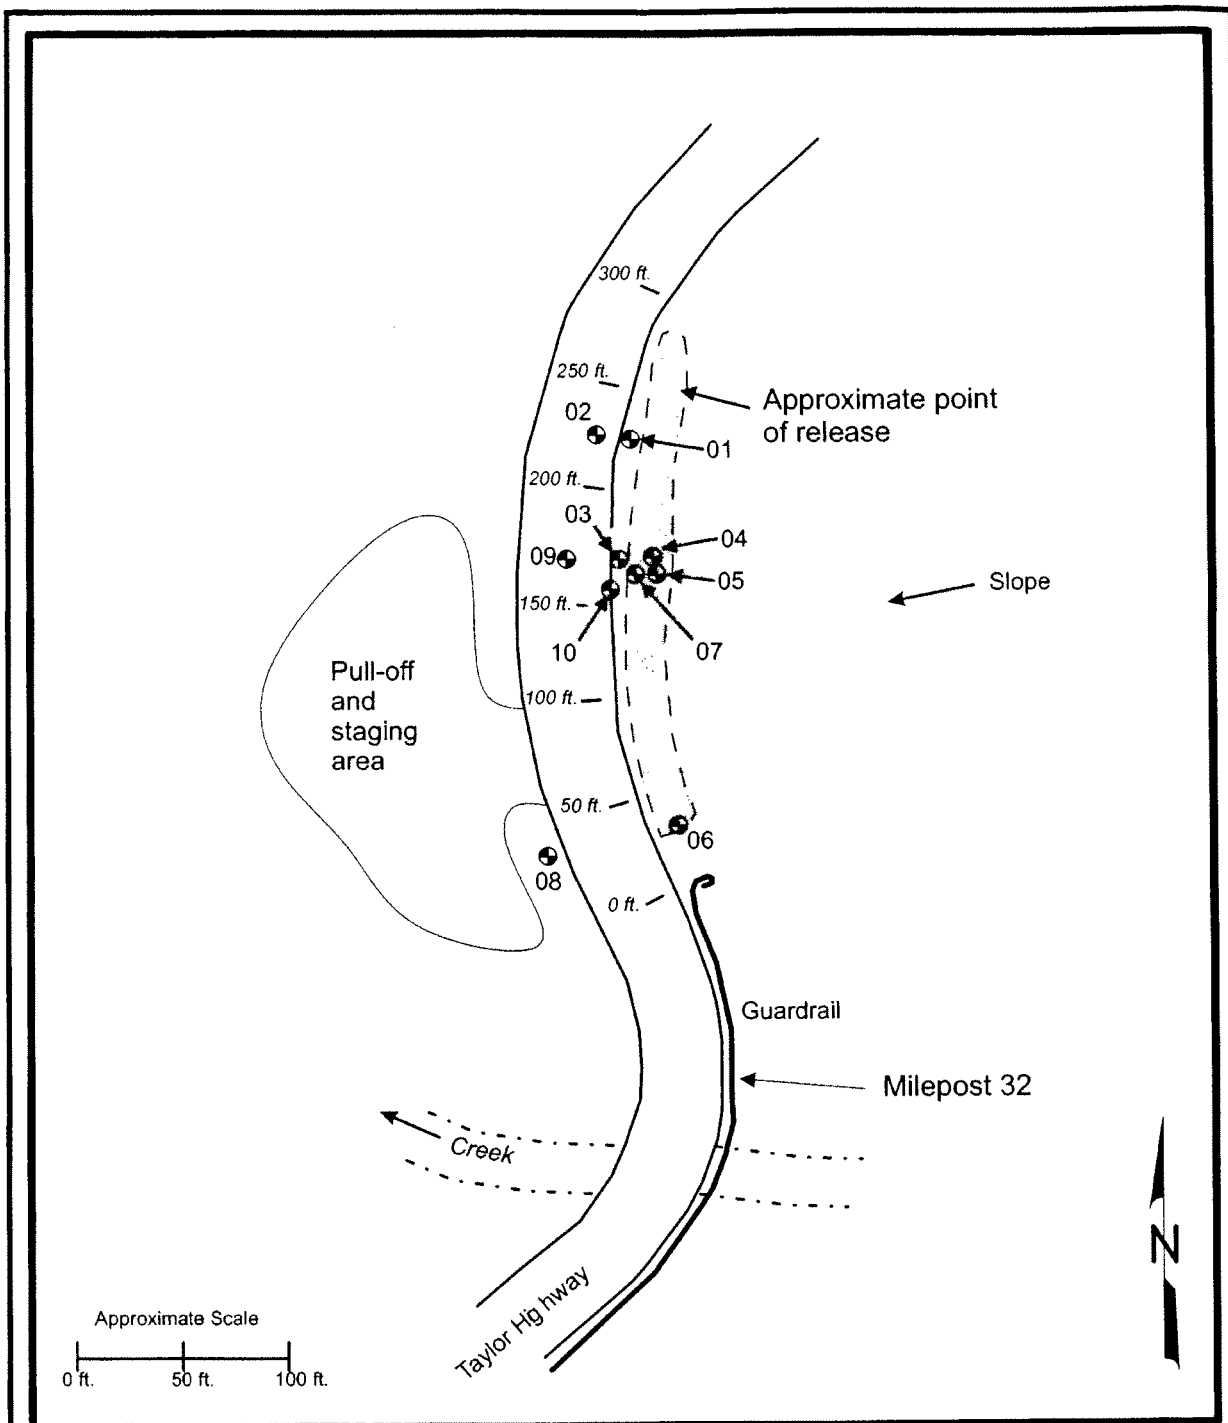
Figure 2

Shannon & Wilson conducted another site visit in May 2009. The underflow dam at the end of the spill site had been partially washed out in the early spring of 2009 and was repaired. The ditch where the original spill took place did not retain any water but the dam had retained some water approximately one foot deep. Surface water samples were taken from behind the dam and from the creek. No sheen was detected behind the dam or on the creek. Analytical results showed no BTEX or PAH analytes were detected above their PQLs in either location and TAH/TAqH water quality criteria were not exceeded. The contaminated surface soils had previously been removed to a depth of 2 to 4 feet and backfilled with clean material. Based on this information, Shannon & Wilson determined that contamination above cleanup levels at the site is limited to subsurface soils in the location of the original release.

Shaded drawing area indicates approximate subsurface area of contamination remaining at site.
