**Department of Environmental
Conservation**

Re: Decision Document: Wrangell Sawmill
Cleanup Complete Determination

Wrangell Sawmill
7 Mile Zimovia Highway
Wrangell, Alaska 99929

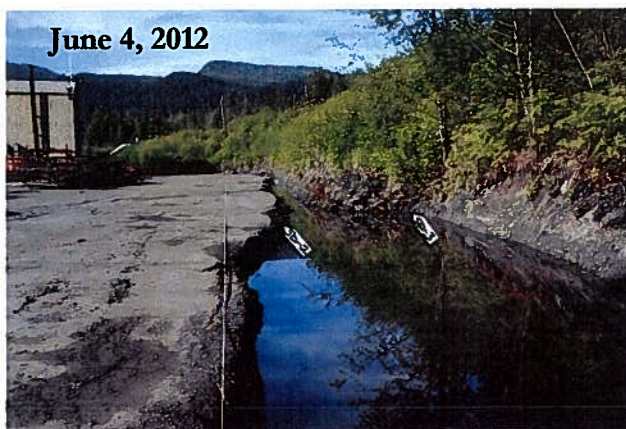
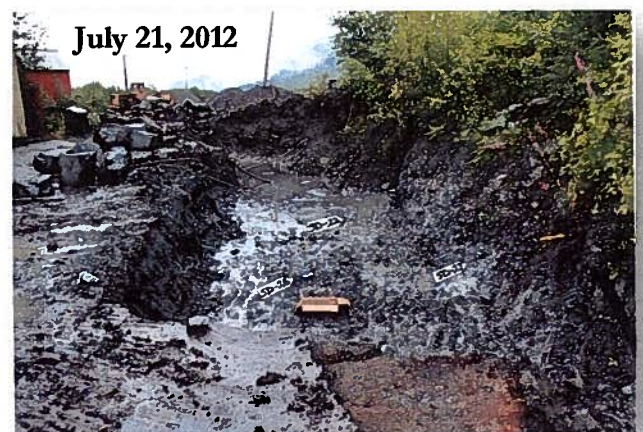
Area #4- Shop Ditch Line and Sump: By 6/4/12 contaminated soil and sediments had been removed from the entire 254' ditch line and the sump sediment deposits were excavated to approximately 2' depth. Confirmation samples throughout the sump and ditch line showed low levels of DRO and RRO, 28-1,400 mg/kg and 110- 1,300 mg/kg, respectively.

The excavations to the evaporation pond behind the maintenance shop exposed high RRO contaminated soil, 10,000- 14,000 mg/kg. The upper end of the ponded area had been excavated to 4' depths and by 7/1/12, confirmation samples all met DRO and RRO cleanup criteria. The excavations, however for the lower end of the pond ended with a 20' x 70' x 4' area that eventually reached a clean clay layer and cleanup criteria by 7/21/12. Laboratory analyses for DRO, RRO, RCRA-8 metals, and SVOCs met DEC cleanup levels. A total of 400 c.y. of contaminated soils were removed and stockpiled.

Figure 3: The Shop Drainage Ditch and Shop site

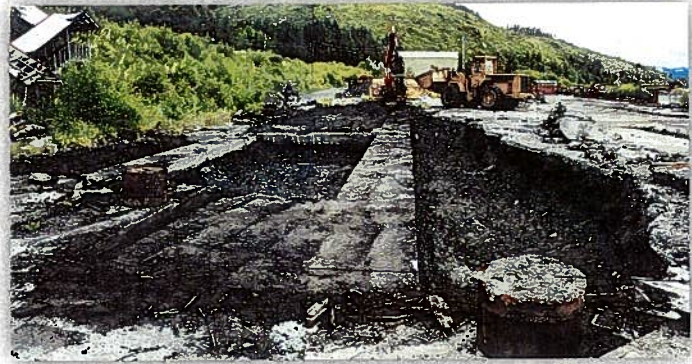
Figure 6: Looking south along the former green chain line area on 6/29/12. Excavations exposed 4'-wide foundations which later were discovered to be the former hydraulic-powered 'action pack'

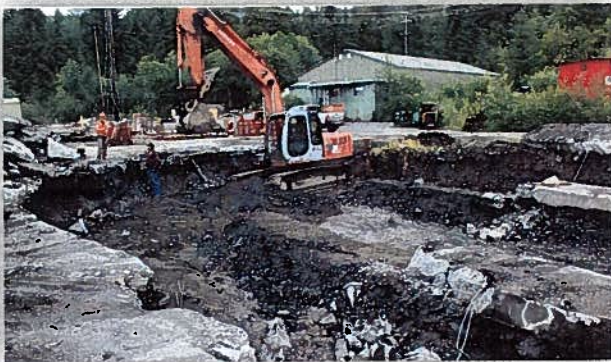
Figure 7: View on 7/20/12- looking toward the north end of the green chain/ sorter line after the former 'action pack' foundation had been removed for continued excavation of contaminated soil

7/20/12 and removed the middle portion of the foundation structure and an additional 25' of the concrete foundation's north end. On 8/20/12, two areas of contaminated soil were removed in the north end-- the northwest corner and embankment and north of the sorter foundation. Confirmation samples found the bottom northwest corner met cleanup criteria, however the embankment still had RRO levels of 9,700 mg/kg. The last two excavations of 2012 took place on 9/15 and 10/25/2012. The 9/15/12 excavation removed an additional 2'-3' of contaminated soil just north of the sorter foundation. RRO levels along the southwest corner were above cleanup criteria. The northwest embankment, required the removal of a 5' x 20' x 3'

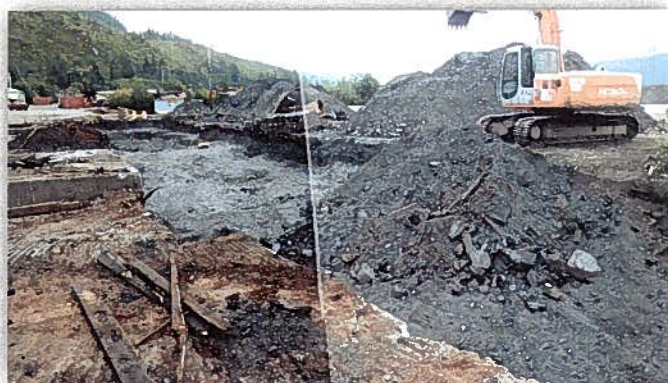
Area #10-The Cherry Pickers: The former cherry picker consisted of four hydraulically operated cranes on concrete blocks that removed and sorted sawed lumber from a long chain grate that came out of the sawmill building. After black stained soil and gravels were noticed, SMS hand-dug shallow excavations that confirmed the presence of petroleum contaminated soil. DEC included the Cherry Picker Site in the September letter based on this new found contaminated area.

Figure 9: View on 8/21/12 looking toward the south-end of the former cherry picker line.

The series of excavations began on 8/20/12, starting at the south-end of the former cherry picker line that opened up an area approximately 2'x4'x50'. A characterization sample taken at a 1' depth had a high DRO level of 26,000 mg/kg thus prompting the continued excavation activities. By the time excavations reached the north end, a 188'-long excavation had been overseen by SMS. Confirmation samples showed that four areas

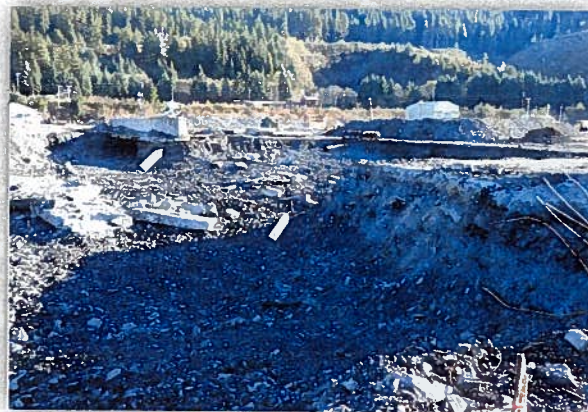
Area #12- Log Barker Area: The former barker area is located along the northwest corner of the mill site facility. All operating equipment had been removed by 2012 leaving only the two earth-filled log loading ramps. The 9/14/2012 exploratory excavations found contaminated soil within 1' bgs of the surface. A characterization sample taken 2.5' bgs had DRO/RRO levels of 10,000 mg/kg and 17,000 mg/kg located under the south log conveyor. Excavations extended eastward to 9'-depths and 143' of the original starting point. DRO/RRO cleanup criteria were met along the north

Figure 13: The 10/24/12 view of the log barker area. Arrow in the back shows the log kickout structure and lower arrow indicates the point of origin.

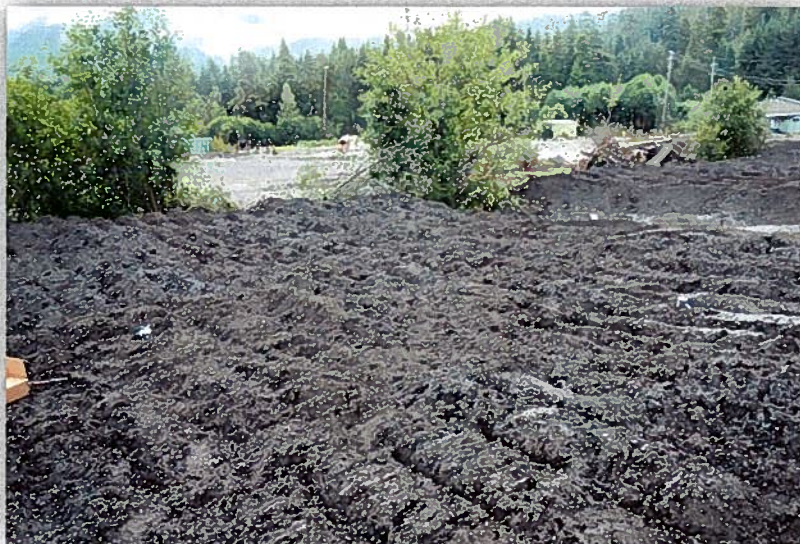
Figure 16: July 23 view showing the northeast corner of Biocell #3, where B3-5 and B3-6 were taken to determine current conditions

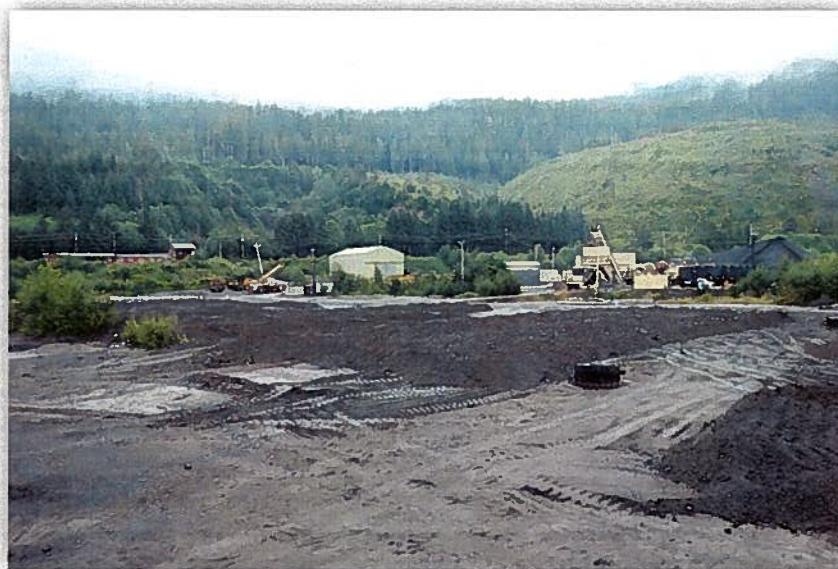
tilled by Silver Bay Logging staff at least three times from June – August 2013. SMS inspected the biocells multiple times throughout the summer and took three analytical samples from Biocell #1 at 8”-10” depths. Again, all samples were below cleanup criteria. By September 2013, the biocell layout had increased from four to five cells with a soil thickness ranging from 24”-32”. Confirmation sampling for the 5 biocells took place on 9/17-18/2013. A total of 111 samples were collected. The following tables, figures and digital images present the sampling results, data on volumes, and the locations and configuration of the cells. The final mean soil concentrations at the 95th upper confidence limit (UCL) are listed in Table 2. The final concentrations met the DRO (8,250 mg/kg) and RRO (8,300 mg/kg) cleanup levels for the site.

Figure 17: July 23 view showing 4 of the 5 Biocells that have been turned and tilled
