Department of Environmental
Conservation

DIVISION OF SPILL PREVENTION & RESPONSE
Contaminated Sites Program

Re: Decision Document: HIPAS Observatory
Cleanup Complete Determination – Institutional Controls

Site Name and Location:
HIPAS Observatory
7795 Chena Hot Springs Road
Two Rivers, Alaska 99712
Section 36, T1N, R4E, Fairbanks Meridian

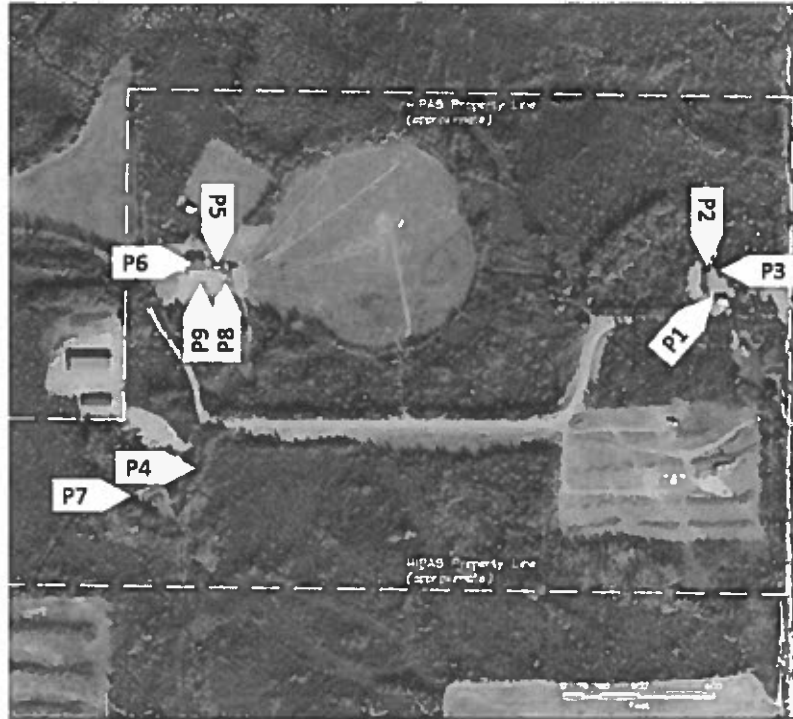
3) Source areas of Petroleum Contamination at the HIPAS Observatory Site

- P1 LIDAR Garage AST, Leader and Drum
-Clean closure achieved for this site.
-See Figure 05c for details.
- P2 LIDAR Heating Oil Tank
-Clean closure achieved for this site.
-See Figure 05a for details.

- P3 LIDAR Abandoned Transformer
-Clean closure achieved for this site.
-See Figure 05b for details.
- P4 Boneyard Transformer Shed
-Clean closure achieved for this site.
-See Figure 06b for details.

- P5 Generator Diesel AST
-Clean closure achieved for this site.
-See Figure 06a for details.
- P6 Generator Pedestal and Floor
-Clean closure achieved for this site.
-See Figure 07 for details.

- P7 Boneyard Hydraulic Station
-Clean closure achieved for this site.
-See Figure 06a for details.
- P8 Parts Generator Surface Stan
-Clean closure achieved for this site.
-See Figure 08b for details.

- P9 Heavy Equipment Surface Stan
-Clean closure achieved for this site.
-See Figure 08c for details.

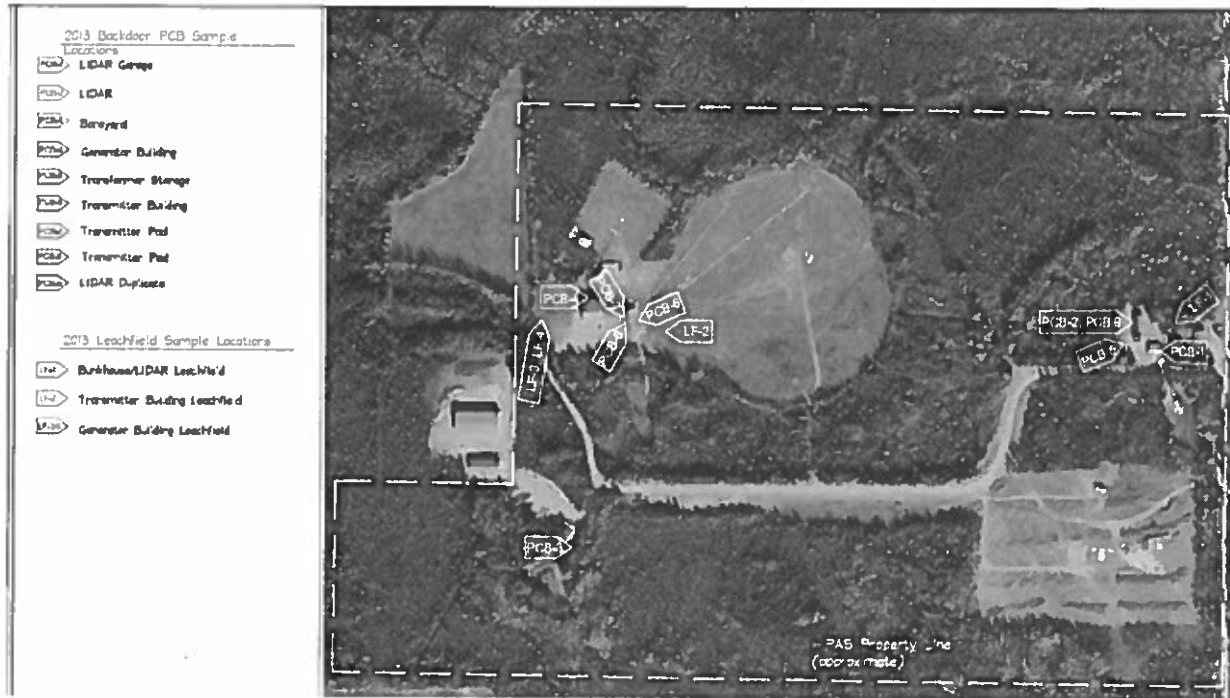
4) Areas investigated for PCB Contamination at the HIPAS Observatory Site

PCBs were detected in transformers and on building materials where dielectric oil had leaked. These materials were removed for off-site non-hazardous waste disposal. At the request of ADEC, additional soil sampling for PCBs was conducted at leach fields of decommissioned septic tanks, located at the Bunkhouse, the LIDAR Building, the Generator Building, and Transmitter Building. No evidence of PCB contamination was found through field screening or laboratory analysis.

Additional PCB sampling was also conducted at areas where doorways were located in former buildings known to house electrical transformers, the transformer pad area, and in locations where electrical equipment was staged prior to off-site disposal. ADEC requested sampling at doorways based on PCB contamination patterns observed at other radar and communication facilities across Alaska. Five doorway locations were identified at the former LIDAR Building, the LIDAR Garage, the Generator Building, the Transmitter Building, and the trailers located within the Boneyard Area. Soil was hand excavated from three locations and mixed to form a composite sample at each location; similar samples were collected at the transmitter pad and at the electrical equipment staging area. Laboratory analysis indicated that PCBs were not detected in any of the composite soil samples collected.

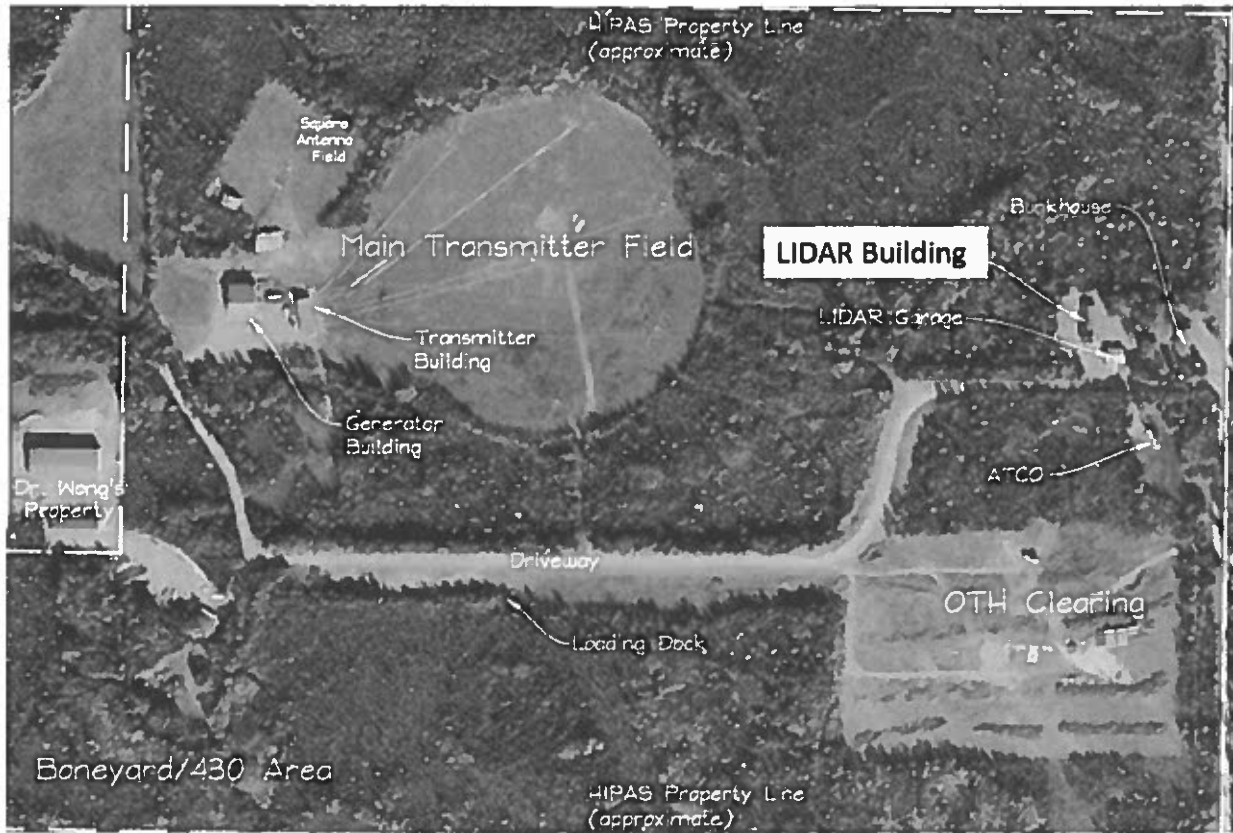
5) HIPAS Lidar Building where Mercury Contamination was located

The LIDAR Building contained a 2.7 meter diameter liquid mercury reflecting surface telescope. The liquid mercury telescope was isolated in a separate room from a second floor mezzanine (referred to as the LIDAR Tower), which contained mercury monitoring and other laser control equipment. After removal of the liquid mercury and mercury-containing building materials as hazardous waste, the Lidar Tower was disposed of as demolition waste after Toxicity Characteristic Leaching Procedure (TCLP) testing indicated that this portion of building was non-hazardous waste. The concrete slab foundation of the LIDAR Tower was removed and soils beneath were found to contain mercury above the soil cleanup level along former seams and cracks in the slab. Approximately 10 cu yds of soil and demolition dust and debris were removed, using mercury headspace field screening to guide soil removal activities. Confirmation sampling within the footprint of former building indicated mercury remained in soils, but below the soil cleanup level. Mercury was not detected in confirmation samples collected exterior to the building footprint.

At the request of ADEC, additional surface soil sampling for mercury was conducted around the former LIDAR Tower building footprint, and soil gas sampling for mercury was conducted within the building footprint. Mercury was not detected in any of the soil samples, except for one sample which was below the soil cleanup level. Field screening at soil gas sample locations indicated mercury was not detected within the former building footprint, and laboratory analysis of confirmation samples verified that mercury was not detected at a Limit of Quantification (LOQ) of 0.0024 mg/m³. This LOQ was below
