Department of Environmental Conservation

DIVISION OF SPILL PREVENTION & RESPONSE
Contaminated Sites Program

November 12, 2014

Re: Institutional Control Inspection – Stabilization Caps
Upper and Lower Cyanide Process Tailings Sites
Mexican Mine (Treadwell Mine Complex)
Hazard ID #405

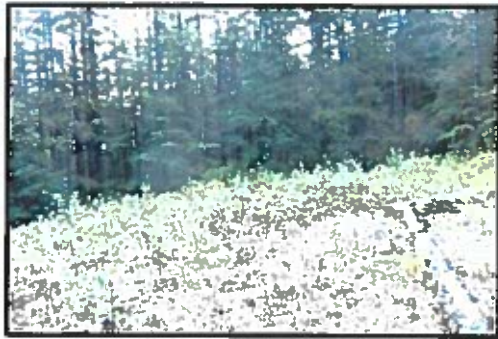
The upper tailings cap is intact with thicker vegetation than observed during the spring 2014 inspection. There is a shot-rock utility road running through the upper tailings pile. The log abutment that prohibits vehicle traffic remains in place and effective (photo 1 & 2).

Photo 1: upper tailings abutment

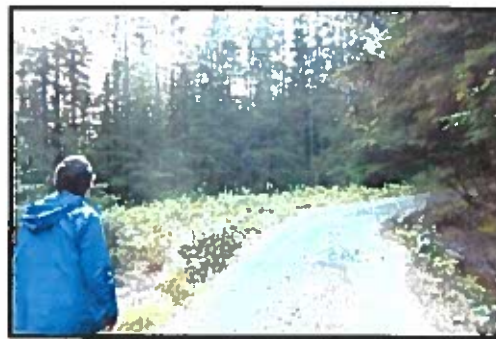
Photo 2: upper tailings road

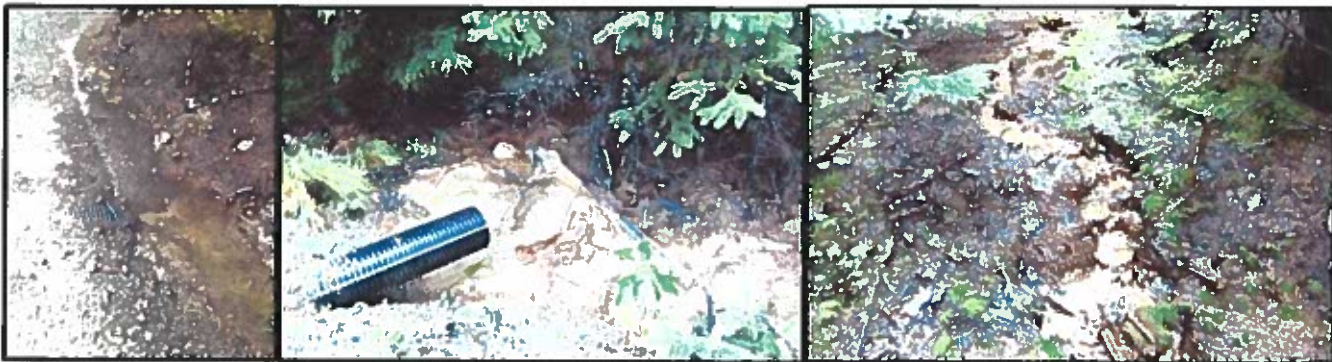
Photo 3: culvert input

In 2013 at the request of AJT Properties, NORTECH was retained to collect samples from the stream south of the tailings piles and to collect a sample of the sediment precipitating from the upper tailings pile. This sampling was not required by ADEC, but was intended to provide additional data to the historic body of data which exists. In the sampling report dated June 20, 2014, it mentions a poorly defined intermittent ephemeral drainage along the eastern edge of the upper tailings pile. This drainage is diverted from one side of the road and routed under the road and the tailings cap (photo 3). It exits downslope of the eastern side of the upper tailings (photo 4).

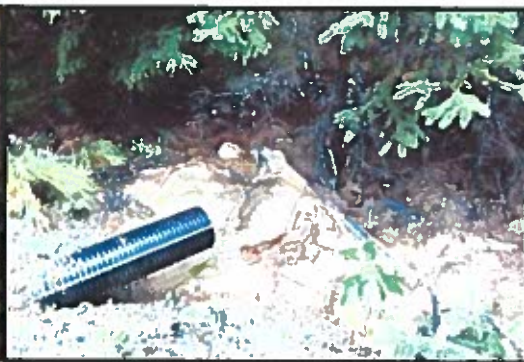
During this site inspection stressed vegetation and discolored water were observed throughout the route of the intermittent drainage that exits the downgradient toe of the tailings pile and extends all the way to the lower road (photos 4 & 5). This appears to be due to runoff from the road/hillside being routed through the tailings, thereby transporting some of the heavy metal-laden silt from the pile itself downslope.

Photo 4: culvert output

Please provide DEC with a plan to remedy this situation, which may consist of rerouting the drainage so that it no longer runs directly through the tailings pile but rather is routed along the road itself.

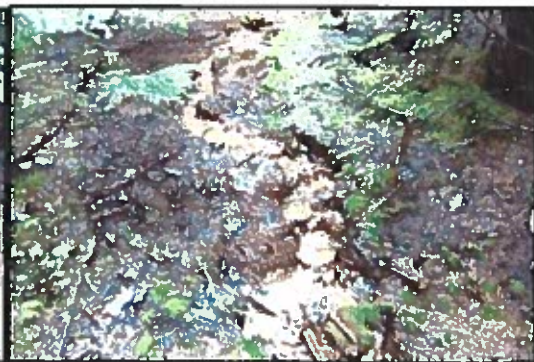
Photo 5: below culvert output

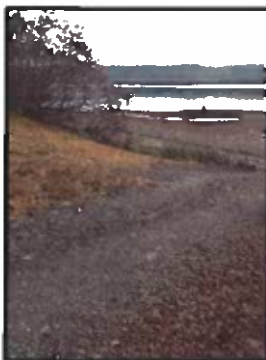
Photo 6: road to the beach

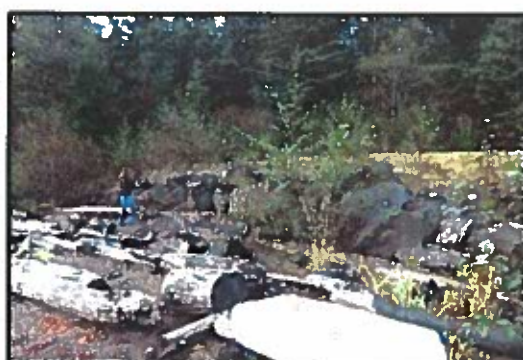
The lower site tailings cap remains intact with intermittent vegetation growing on the surface. The channel side of the tailings pile is contained with a sloped armor rock wall 4' high and 225' long (photo 7). There is a shot-rock utility road running through the capped pile that is used occasionally by the Alaska Canopy Adventures zipline business to transport customers and supplies to their lodge during certain periods of tidal fluctuations (photo 6 & 8). Normally the customers disembark from the boat directly in front of the lodge, but the road condition may signify vehicle usage more than occasional since there is no vegetation growth on this part of the cap.

Photo 7: sloped armor rock wall of lower tailings cap

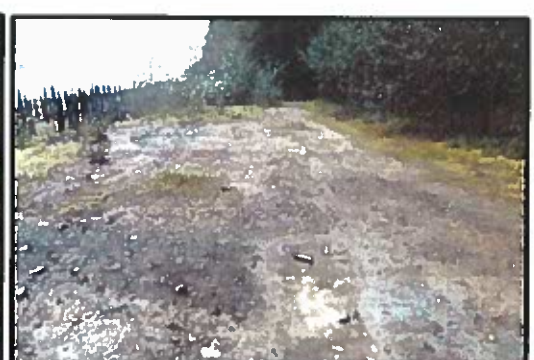
Photo 8: road across the cap

ADEC finds that the soil cap and long term maintenance plan on the upper and lower tailings sites can continue to provide an effective site control remedy with maintenance and modifications as needed and observed. However, in advance of the next tourism season, please provide DEC with a plan to remedy the offsite migration of metals-laden leachate which is causing distressed vegetation throughout its path. This may consist of rerouting the drainage and diversion culvert away from the upper tailings cap so that runoff no longer flows through the tailings pile but rather is routed along the road itself. In addition, please provide specifics about the frequency of the road usage at the lower tailings cap.
