Department of Environmental Conservation

DIVISION OF SPILL PREVENTION AND RESPONSE
Contaminated Sites Program

Re: Decision Documents - Cleanup Complete for *Tazlina Copper Valley School Site*, Hazard ID 25429; and
Cleanup Complete with Institutional Controls for *Tazlina River Dumpsite*, Hazard ID 26337.

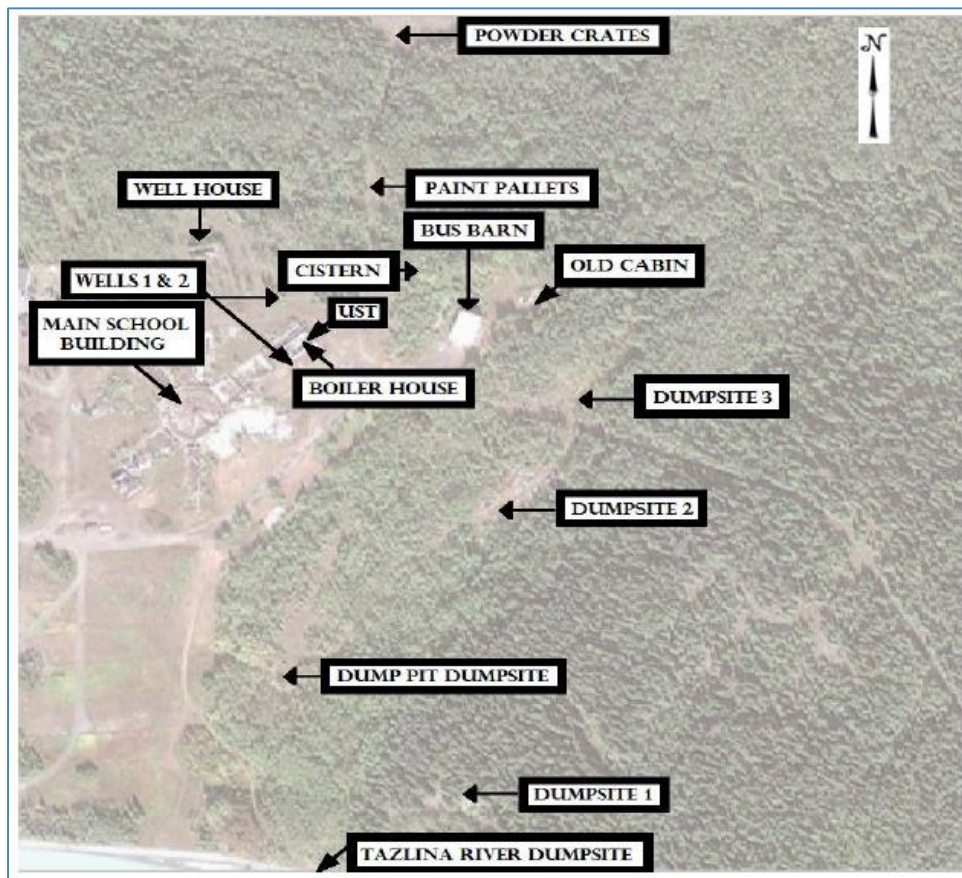
Detailed figure of building locations and hazard locations on former school property.

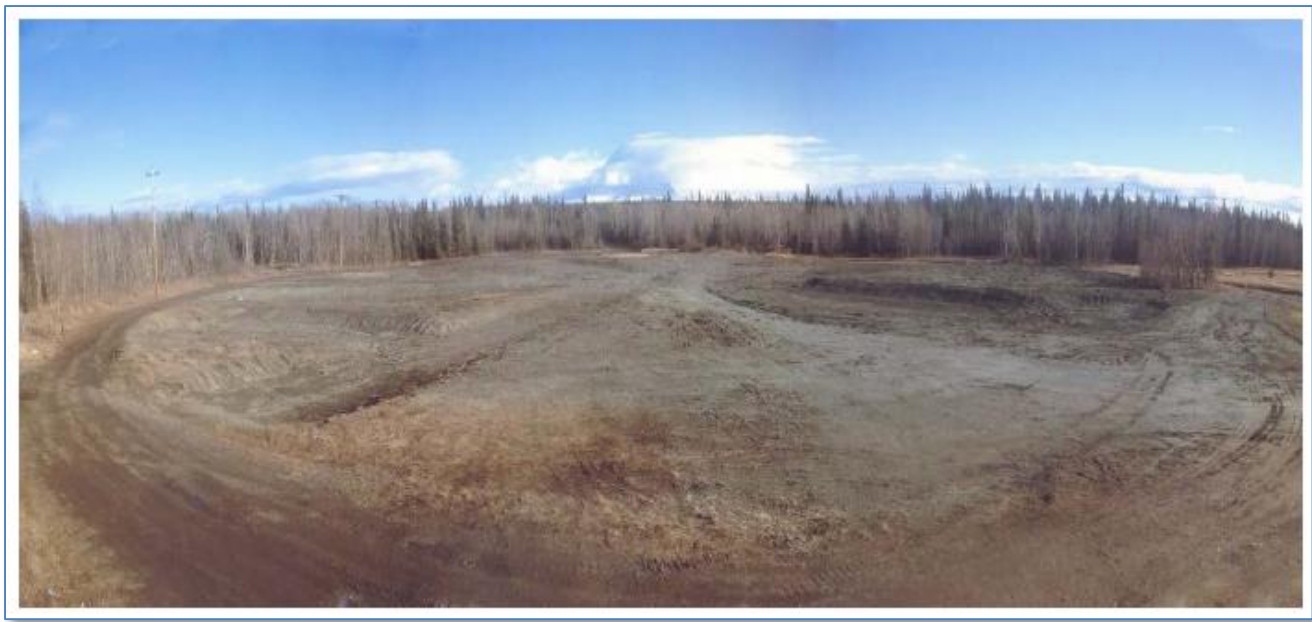
Final picture of school property following cleanup activities.

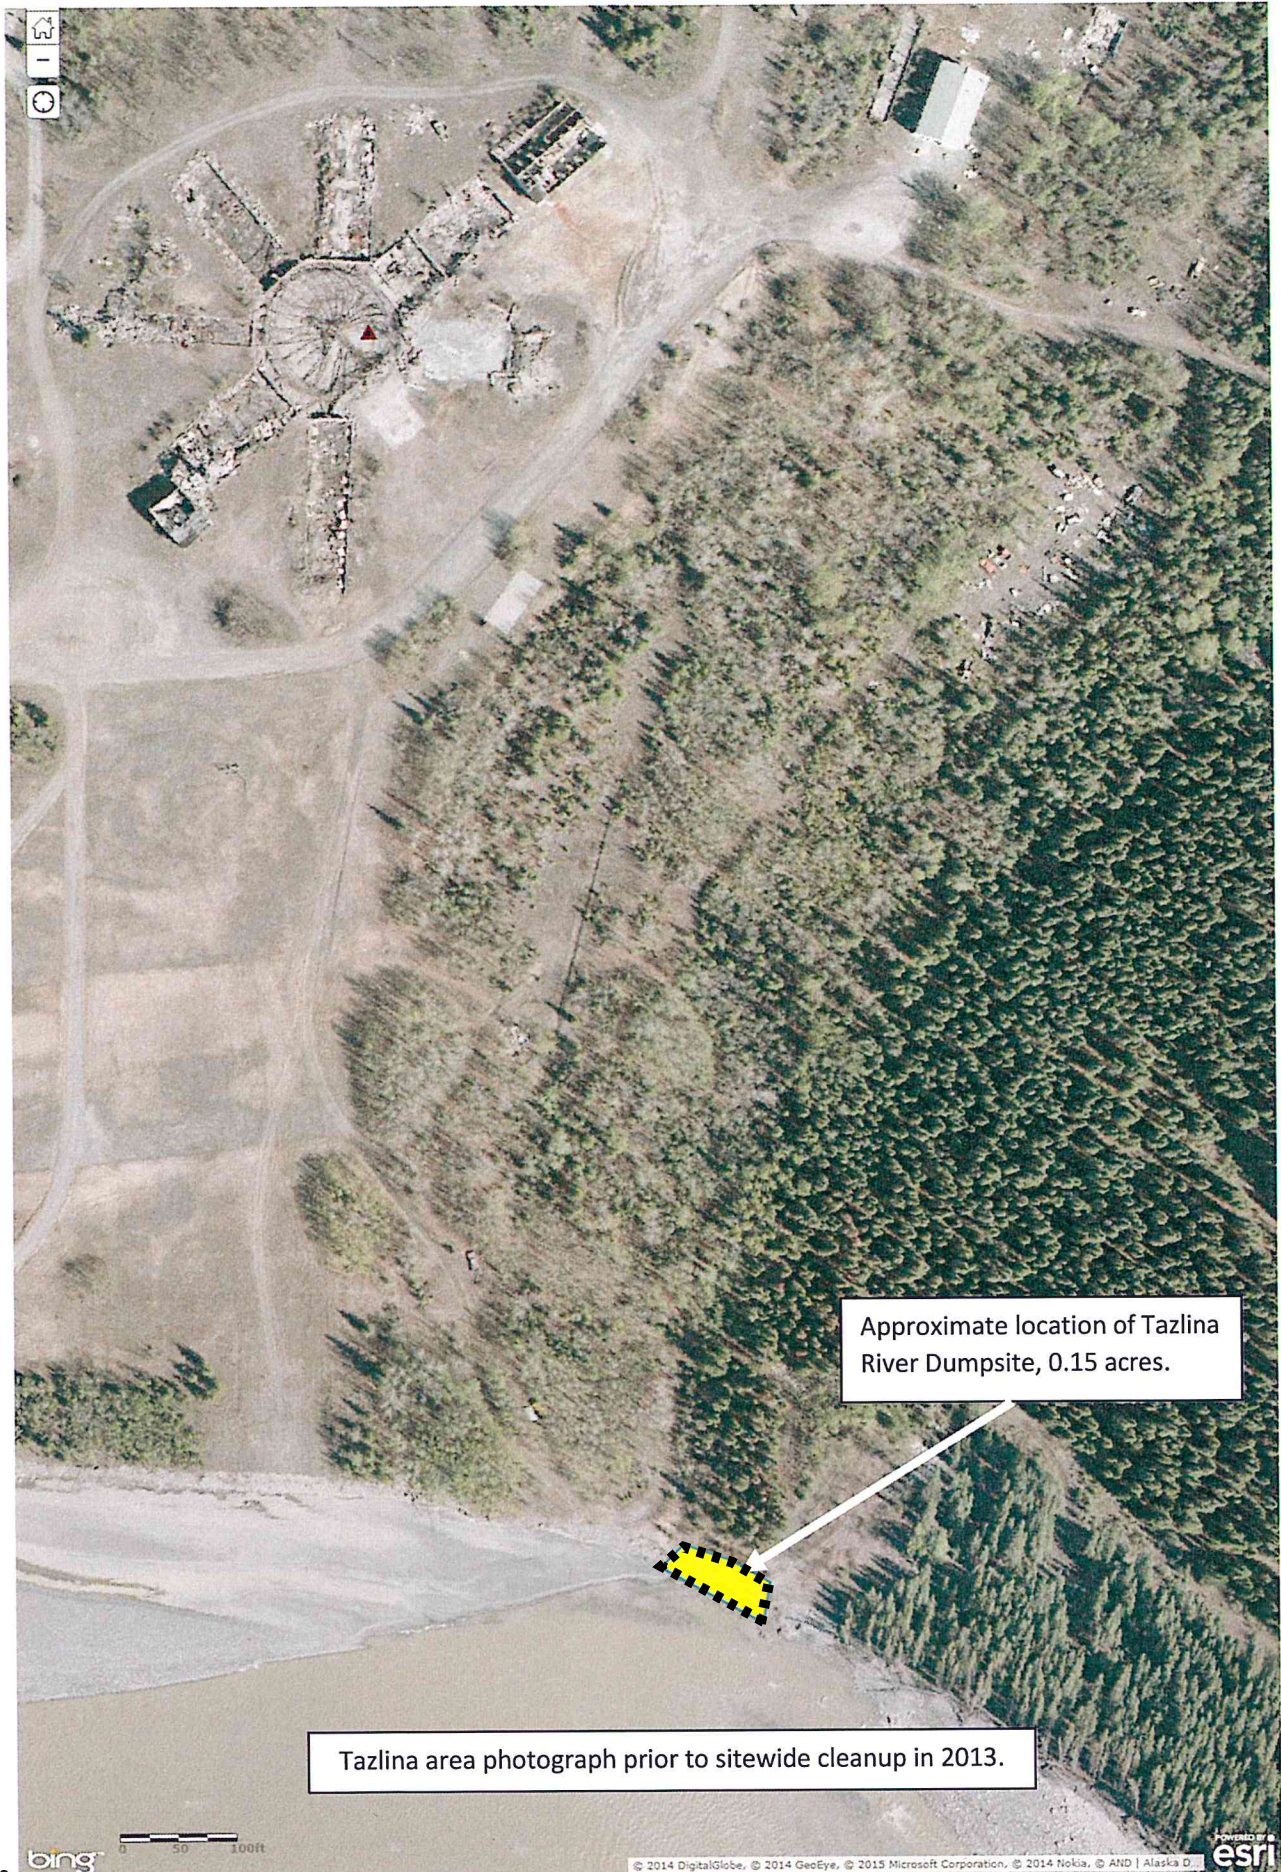
Attached is a decision document for the two sites that includes two figures. In Figure 1, the approximate location of the former Copper Valley School Site is outlined in a dashed line (for reference, the location of the former burned school is identified by a dashed circle), and the Tazlina River Dumpsite location is depicted with a solid circle. The second Figure 2 is an aerial photograph showing the former burned school wreckage that has since been removed, and the approximate outline of the Tazlina River Dumpsite in which elevated lead concentrations were detected.

Approximate location of Tazlina River Dumpsite, 0.15 acres.

Tazlina area photograph prior to sitewide cleanup in 2013.
