File No: 2407.38.001

Re: Summary of Determinations: FAA Bethel Flight Service Station- AST 19-D-5, B302 Injection Well, and B300 Injection Well

FAA Bethel Flight Service Station
Shop Buildings 300 and 302
Bethel, AK 99559

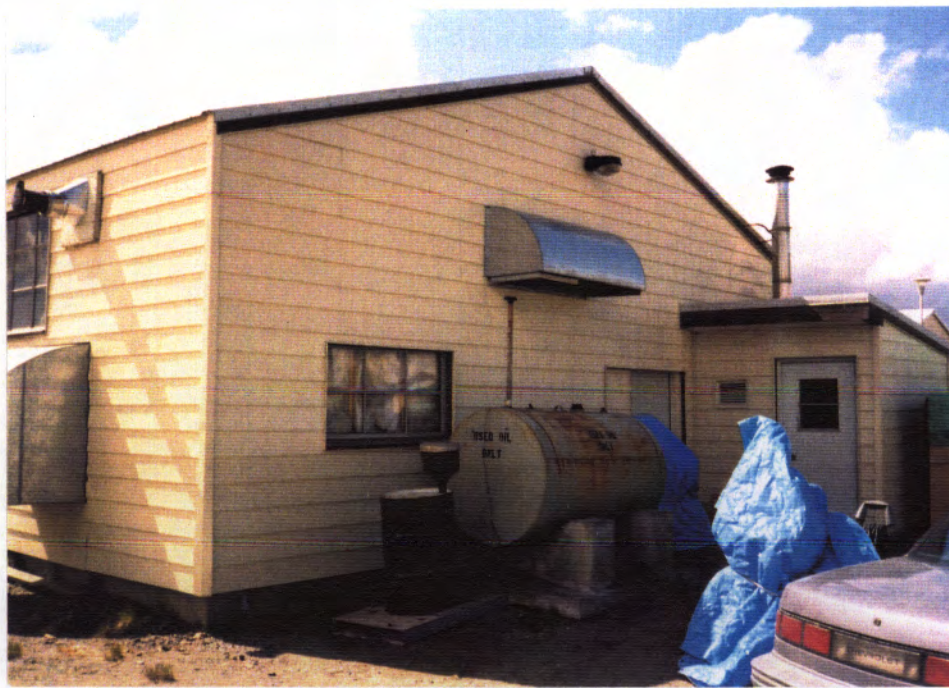
AST 19-D-5 was a 500-gallon, welded-steel tank located north of shop Building 300 at the Bethel FAA Station in Bethel, Alaska. According to FAA records, the tank was installed in 1968 and stored waste oil generated by engine maintenance. On August 10, 1994, Harding Lawson Associates (HLA) removed AST 19-D-5. Petroleum stains were evident on the ground surface beneath the former tank location. The petroleum release was reported to the DEC on August 11, 1994 (DEC Spill No. 94-2601-220-04).

ABOVEGROUND STORAGE TANK (AST) 19-D-5 AT THE SHOP BUILDING 300, VIEWING SOUTHWEST.

Approximately 16 cubic yards of potentially petroleum-affected soil was excavated from the AST 19-D-5 area and temporarily stockpiled on a 20-mil impermeable liner at the FAA's RCAG facility temporary soil storage area in 1994. Two samples were taken from the limits of the excavation - 19-D-5-S11 and 19-D-5-S12, and were analyzed for Arsenic (EPA 7060), Cadmium and Chromium

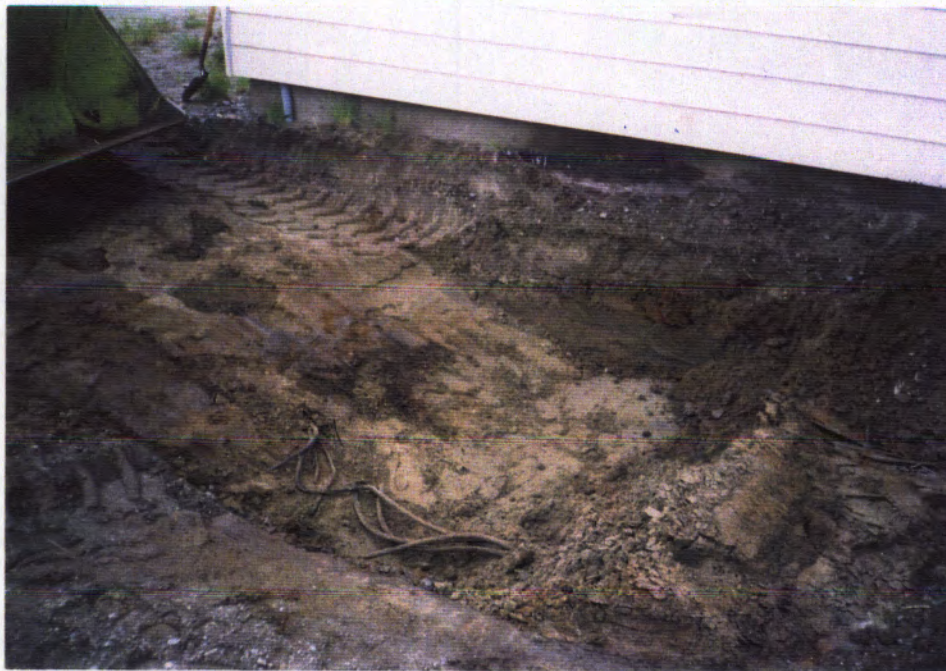
EXCAVATION BELOW FORMER LOCATION OF AST 19-D-5, VIEWING SOUTH.

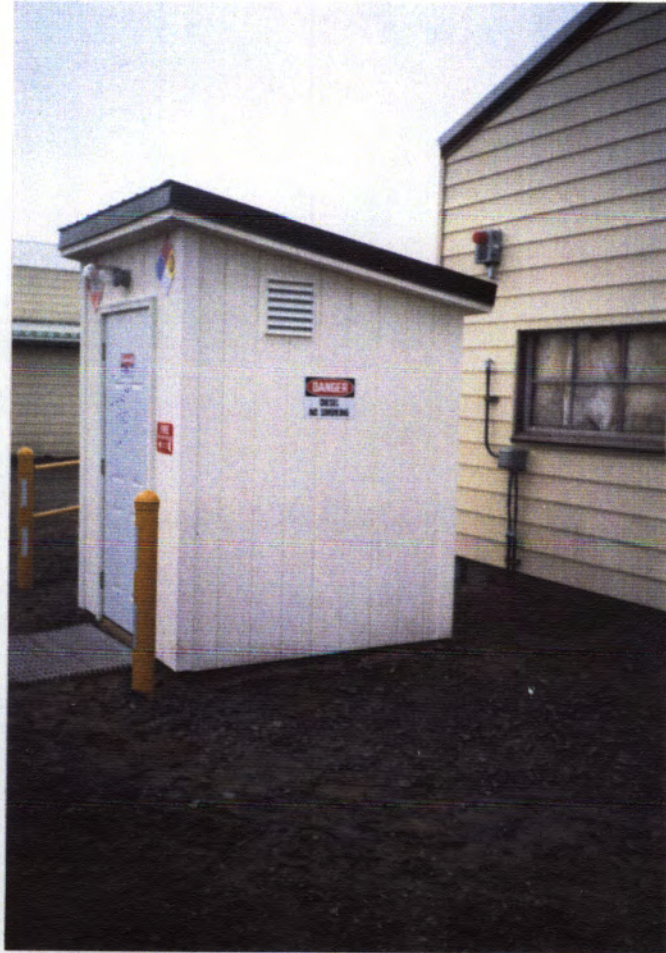
8

ABOVEGROUND STORAGE TANK (AST) 19-D-5 SITE AFTER EXCAVATION HAD BEEN BACKFILLED AND A VEHICLE FUEL DISPENSER SHED RELATED TO UNDERGROUND STORAGE TANK 19-D-104 CONSTRUCTED, VIEWING SOUTHEAST.

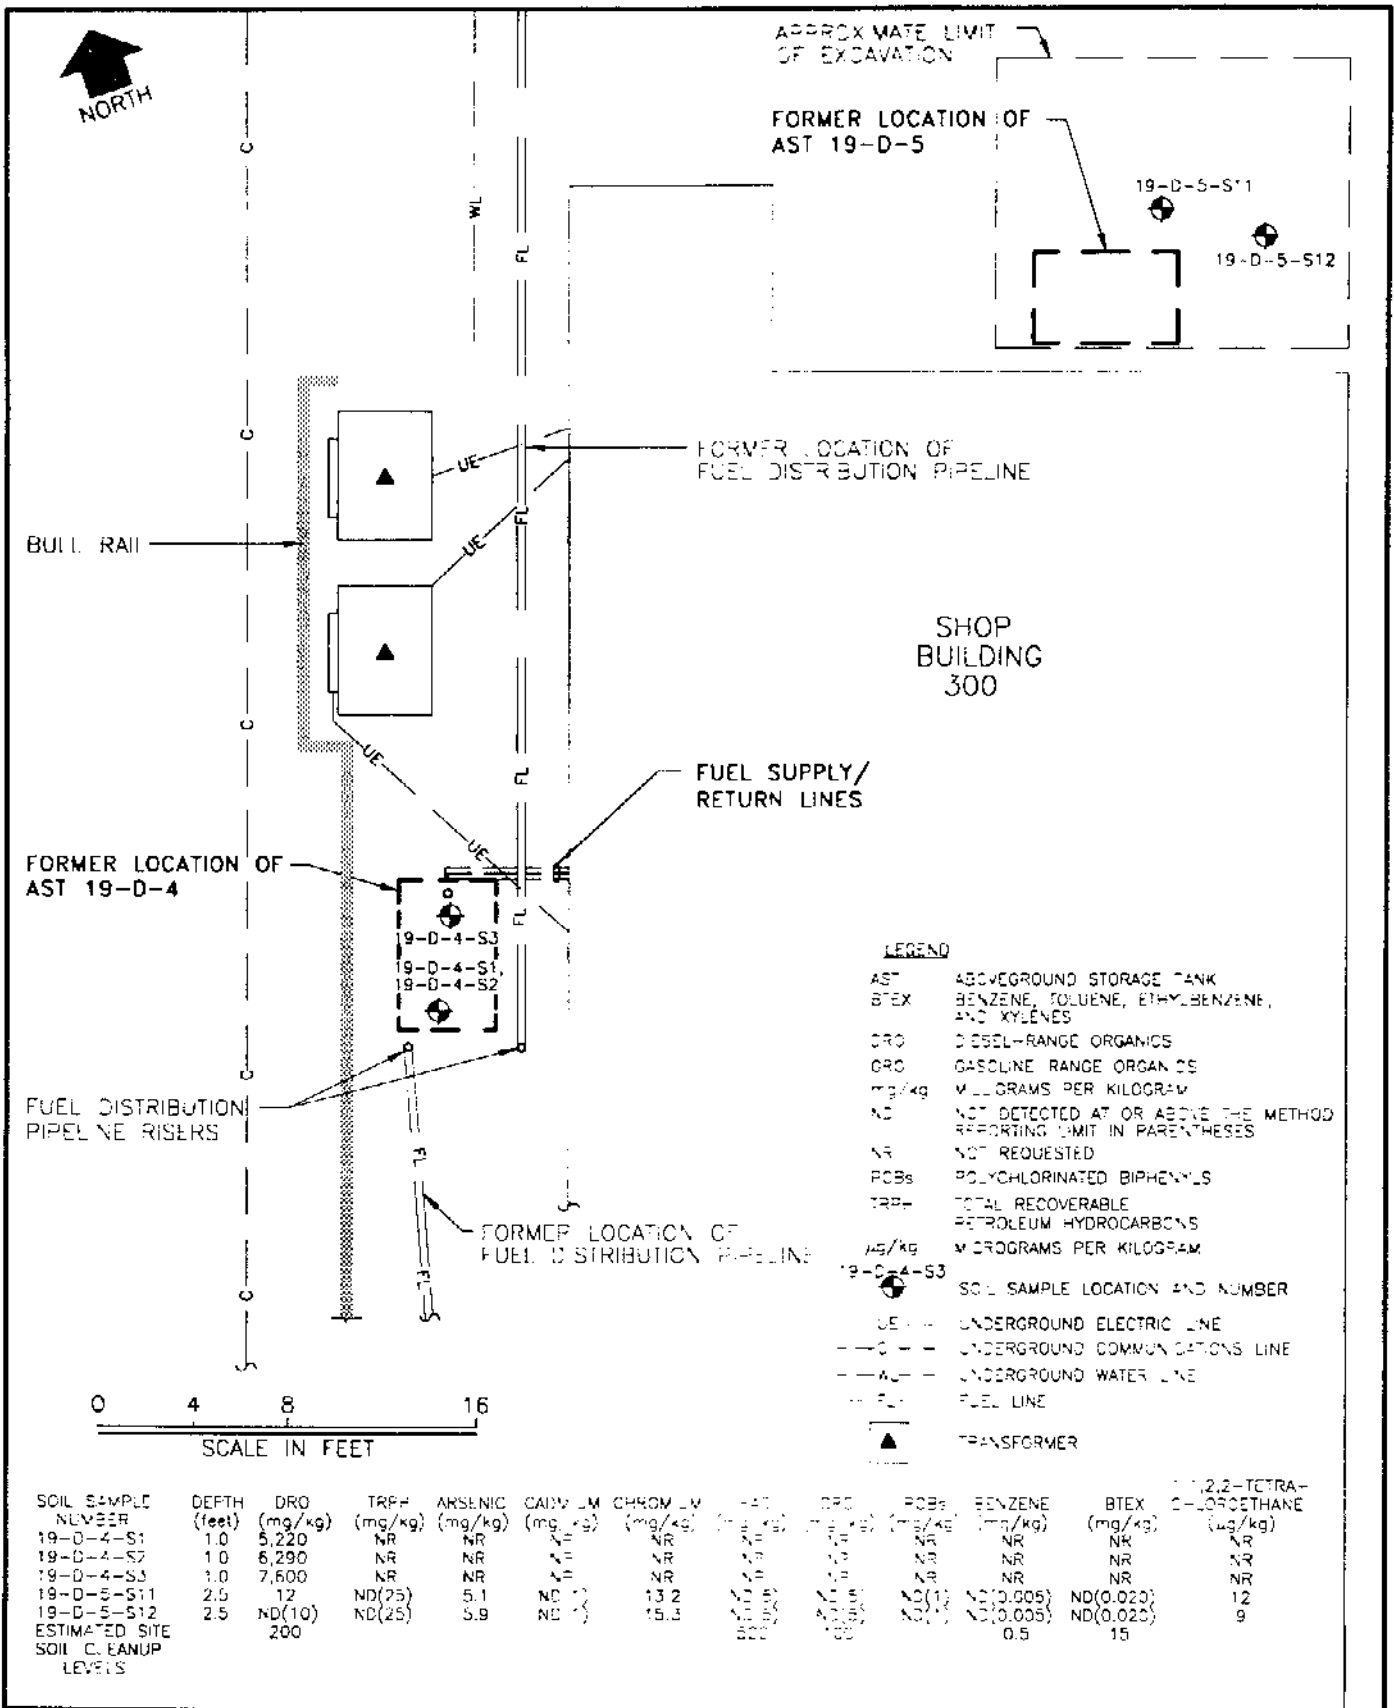
23

ASTs 19-D-4 and 19-D-5 Sample Locations and Selected Results
Decommissioning Assessment Report
Bethel AST Improvements
Bethel, Alaska

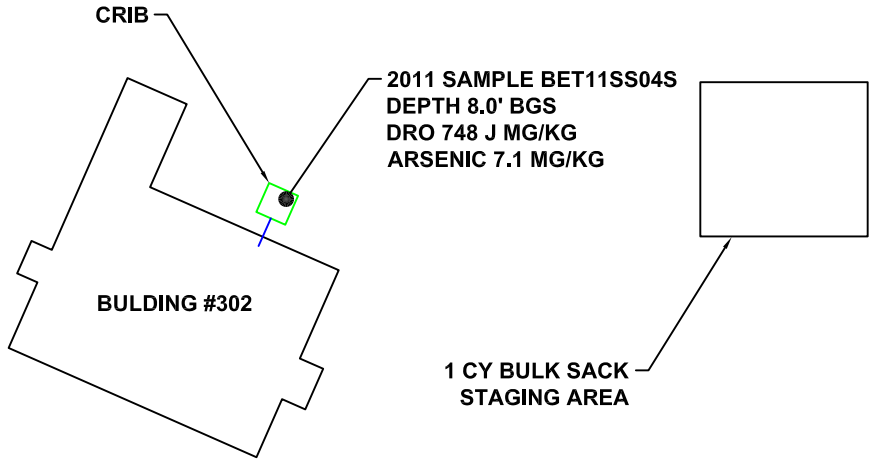
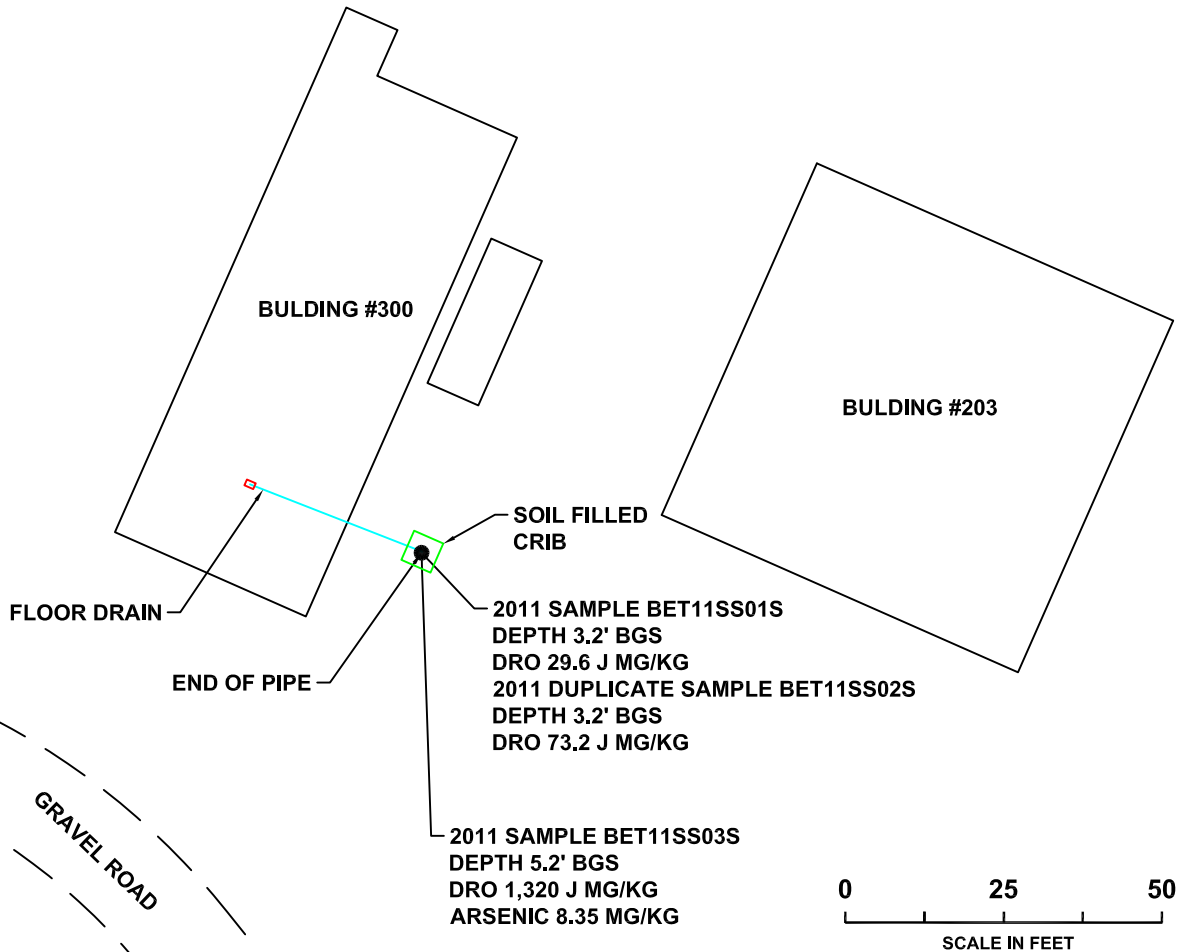
4-2

With the exception of Sample BET12SS004M, all soil samples had concentrations of DRO less than the applicable cleanup level. Sample BET12SS004M, collected from 9.0 feet bgs from the floor of the Building 302 excavation had a DRO concentration of 270 mg/kg, which exceeds the DRO soil cleanup level of 250 mg/kg. The remaining confirmation samples collected from both excavations had concentrations of DRO ranging from non-detect to 216 mg/kg.

BET12SS002S
 DEPTH 10.5 'BGS
 DRO 18.3 J MG/KG

BET12SS003S
 DEPTH 9.5 'BGS
 DRO 71.6 MG/KG

BETHEL BUILDING 300 EXCAVATION AREA AND 2012 DRO RESULTS

In 2012, remediation was performed at the Shop Building 300 and Building 302. The wooden timbers associated with the wooden leaching cribs at each building were excavated and properly disposed, and approximately 35 and 24 cubic yards (CY) of DRO-contaminated soil from the Building 300 and Building 302 end points, respectively, was removed and disposed of. Confirmation soil samples were collected from the locations with the highest field screening results. 11-12 Soil samples were collected for confirmation of excavation completion and analyzed for DRO by Alaska Method (AK) 102, arsenic by SW6020, VOCs by SW8260B, and SVOCs by SW8270. Groundwater was not encountered in the excavations.

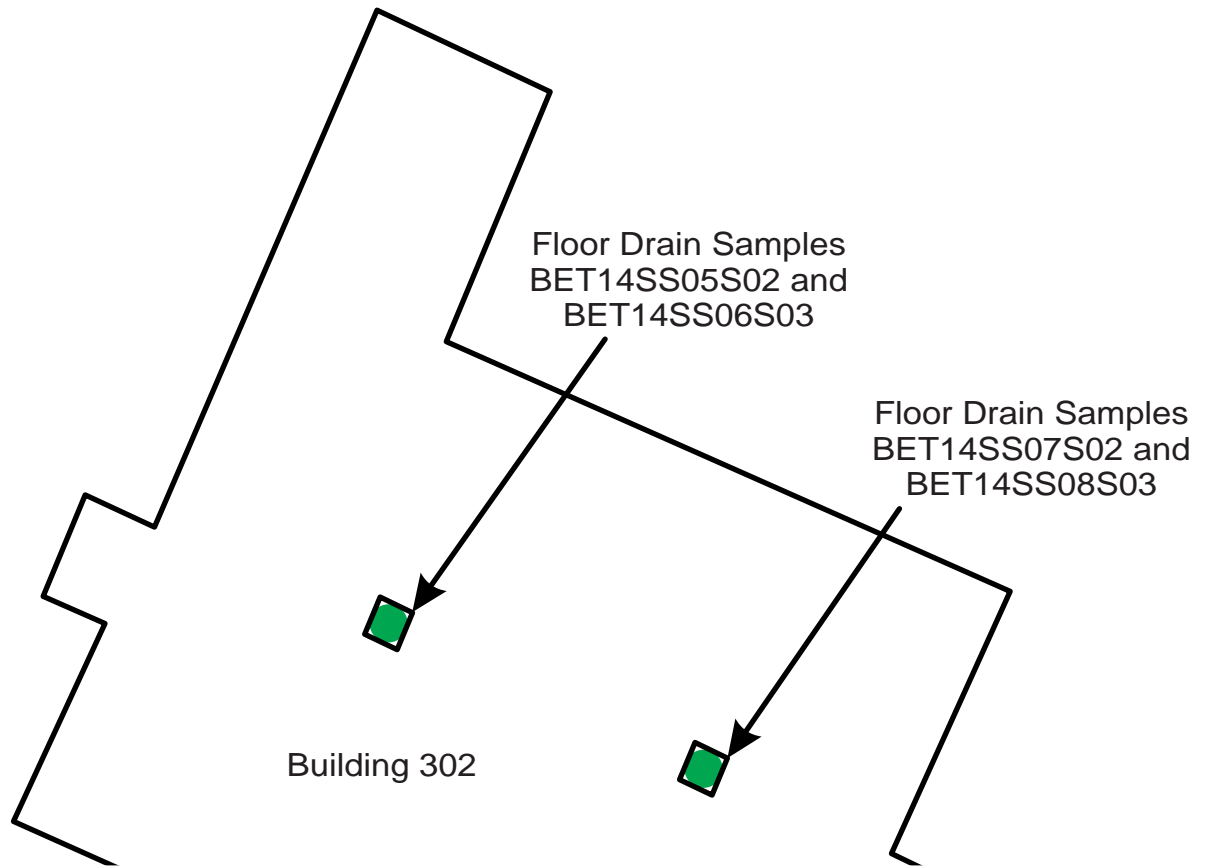
BUILDING 302 FLOOR DRAIN SAMPLE LOCATIONS

Building 302 was demolished in 2014. The two floor drains that were present in building 302 which discharged to the septic crib (decommissioned in 2012) were also removed. To determine if liquids from shop operations impacted the underlying ground, soil samples were collected from approximately 6 and 18 inches beneath each of floor sump, respectively. Soil samples were analyzed for: GRO by State of AK 101, DRO by AK 102, RRO by AK 103, Volatile Organic Compounds (VOCs) by EPA Method 8260B, Semi-Volatile Organic Compounds (SVOCs) by EPA Method 8270C, and arsenic, cadmium, chromium, and lead by EPA Methods 6020. Analytical results for soil samples collected beneath the floor sumps indicated that arsenic is the only analyte that exceeds DEC Method 2 Soil Cleanup levels. These concentrations of arsenic are typical for the region and are attributable to naturally-occurring, background levels, which were sampled in 2012. Therefore, the Building 302 floor drains, the drain pipe, the decommissioned crib, and all associated contamination, has been removed.

Floor Drain Samples
BET14SS05S02 and
BET14SS06S03

Floor Drain Samples
BET14SS07S02 and
BET14SS08S03

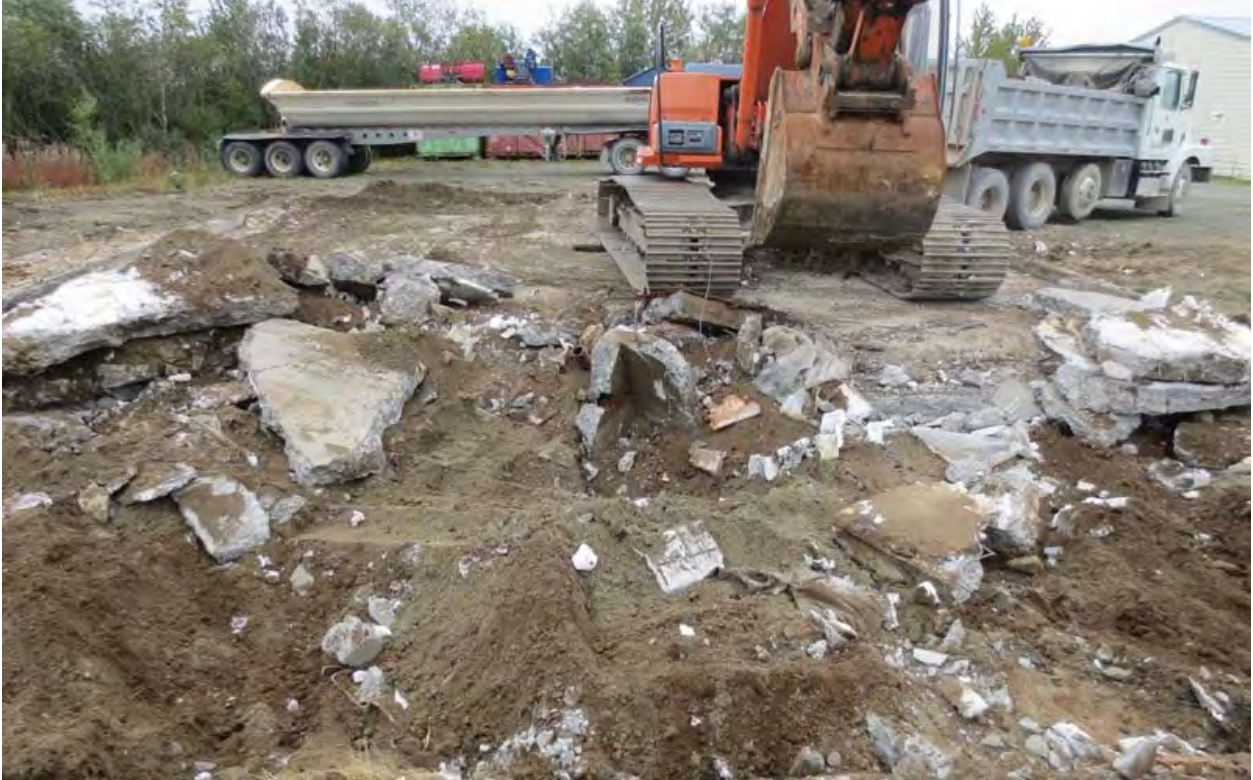
Photo 9: Concrete pad prior to its demolition; facing southeast (September 2, 2014).

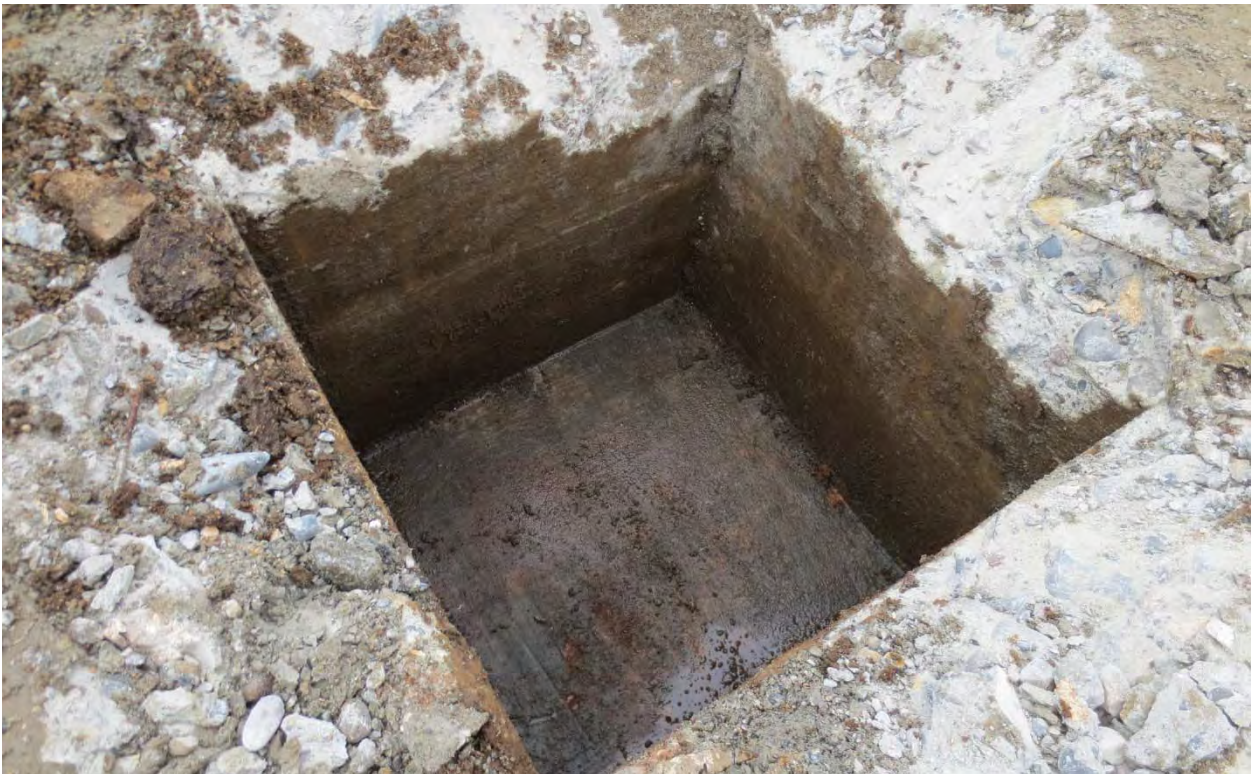
Photo 10: One of two sumps that formerly discharged to a decommissioned septic crib (September 2, 2014).
