Department of Environmental  
Conservation

DIVISION OF SPILL PREVENTION AND RESPONSE  
Contaminated Sites Program

Re: Decision Document: Deshka River Lodge  
Cleanup Complete Determination

Deshka River Lodge  
Lot 1, USS 3943 and ASLS 72-78  
Section 26, T19N, R6W, S.M.  
Talkeetna Recording District,  
Willow, Alaska

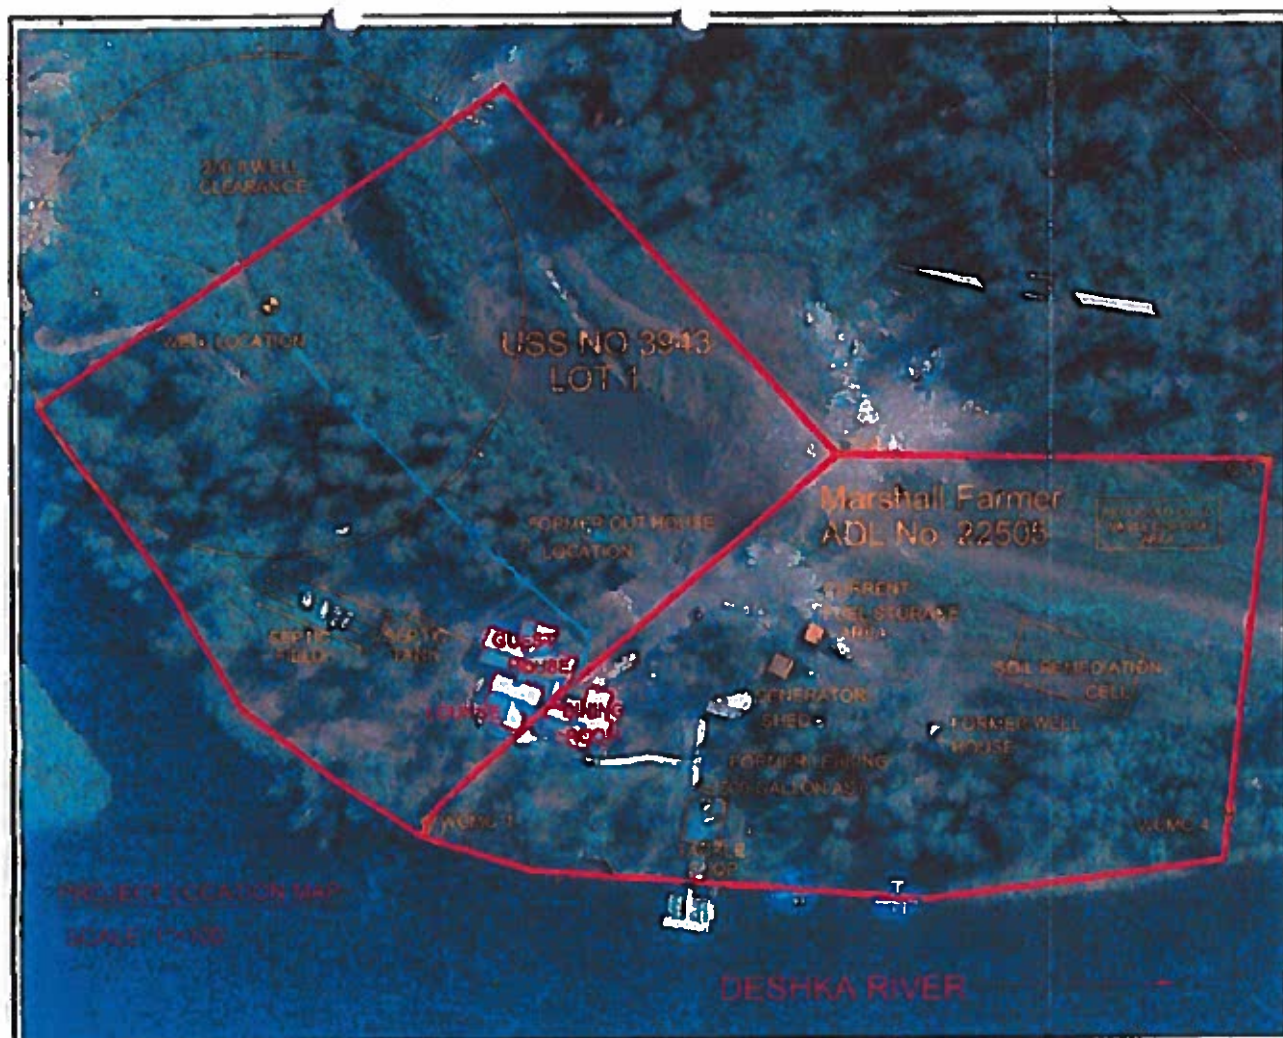
1. Tackle shop: The gasoline aboveground storage tank (AST) behind the tackle shop had soils contaminated with volatile petroleum hydrocarbons (VPH) at 9,350 ppm, benzene at 441 ppm, and total benzene, toluene, ethylbenzene, and xylene (BTEX) at 5061 ppm.

2. Main lodge buildings: The storage area below the guest rooms had ten 5-gallon buckets containing waste oil. There was evidence of leakage and staining on the wood board overlying the dirt floor.

3. Main lodge buildings: The soil in the area near the 500-gallon underground storage tank (UST) for heating oil had 132 ppm extractable petroleum hydrocarbons (EPH) which exceeded ADEC cleanup levels.

4. Dump site: The dump site nearest the pond contained 55-gallon drums of gasoline.
5. Pond burial site (potential buried materials identified during interview): Fuel drums and tanks were burned in a fire in 1991. There may be fuel and DDT contamination at the pond burial site.

6. Tank farm: Diesel fuel contamination was identified within the containment berm.
7. Heavy equipment: There was olfactory and visual evidence of the presence of hydraulic fluid and fuel near the CASE 450 bulldozer.

Figure 2: Site map of the Deshka River Lodge including locations of both present and historical buildings and facilities. Figure copied from DWWW Facility Summary Report, Deshka River Lodge, dated Friday, May 17, 2002.

1. GRO contaminated soil near the AST at the tackle shop was excavated and placed in a treatment cell in 2001, and the treatment cell had been successfully remediated in 2004 according to RSE.
2. Reportedly, there had been 5-gallon buckets of waste oil in the main lodge storage area below the guest rooms. These have presumably been properly disposed of.
3. The pond dump site was found by GE<sup>2</sup>T to be free of petroleum hydrocarbons, metals, VOCs, PCB, or pesticide contamination in 1999.
