Re: DEC Decision Document – FAA Station – Fairbanks International Airport, Alaska

Decision Document FAA Station – Fairbanks International Airport, Alaska September 4, 2015

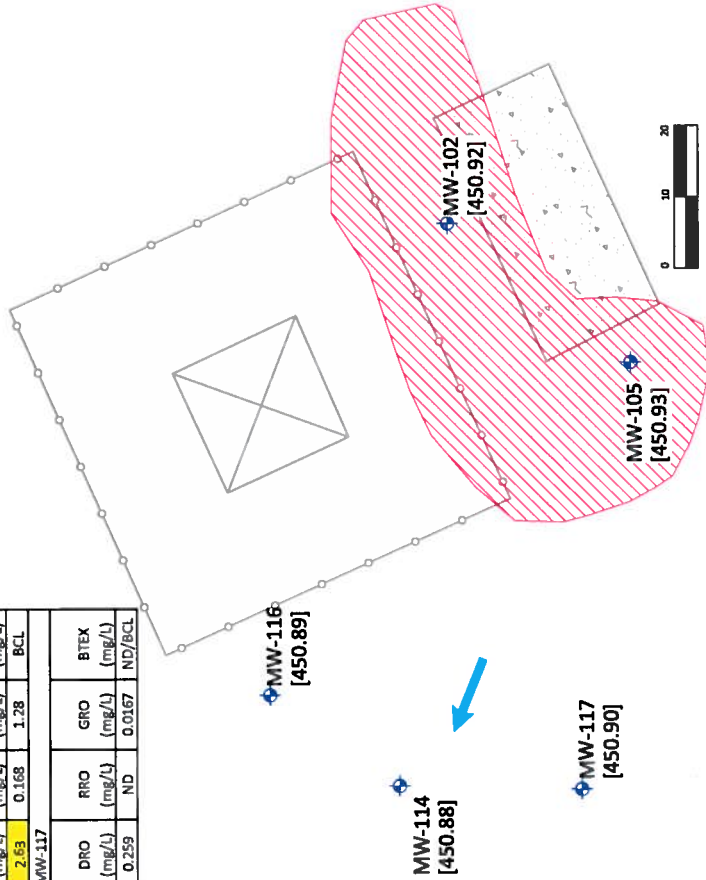
**Chena NDB - Former EG Building, Former UST-
 2011 Groundwater Data**

Further action is required at this site. DRO contamination in the soil remains above the Method 2, under 40 inch zone, Ingestion and Migration to Groundwater cleanup levels. HRC results for the Chena NDB AOC indicate that concentrations of xylenes, GRO aromatics, ethylbenzene, 1,2,4-trimethylbenzene, and 1,3,5-trimethylbenzene pose unacceptable risk via the migration to indoor air vapor inhalation pathway under a residential land use scenario. HRC results also indicate that compounds or hydrocarbon fractions pose unacceptable risk under current site conditions via the groundwater ingestion pathway.

Groundwater contamination has not been completely delineated at this site. DEC recommends that an alternative point of compliance, per 18 AAC 75.345(g), be established at this site on the property at the downgradient edge of the groundwater plume. This could be achieved with the recommended action of installing additional monitoring wells at the fence line. Continued groundwater monitoring and free product removal should be conducted to determine if groundwater contamination is migrating off property and to demonstrate concentration trends.

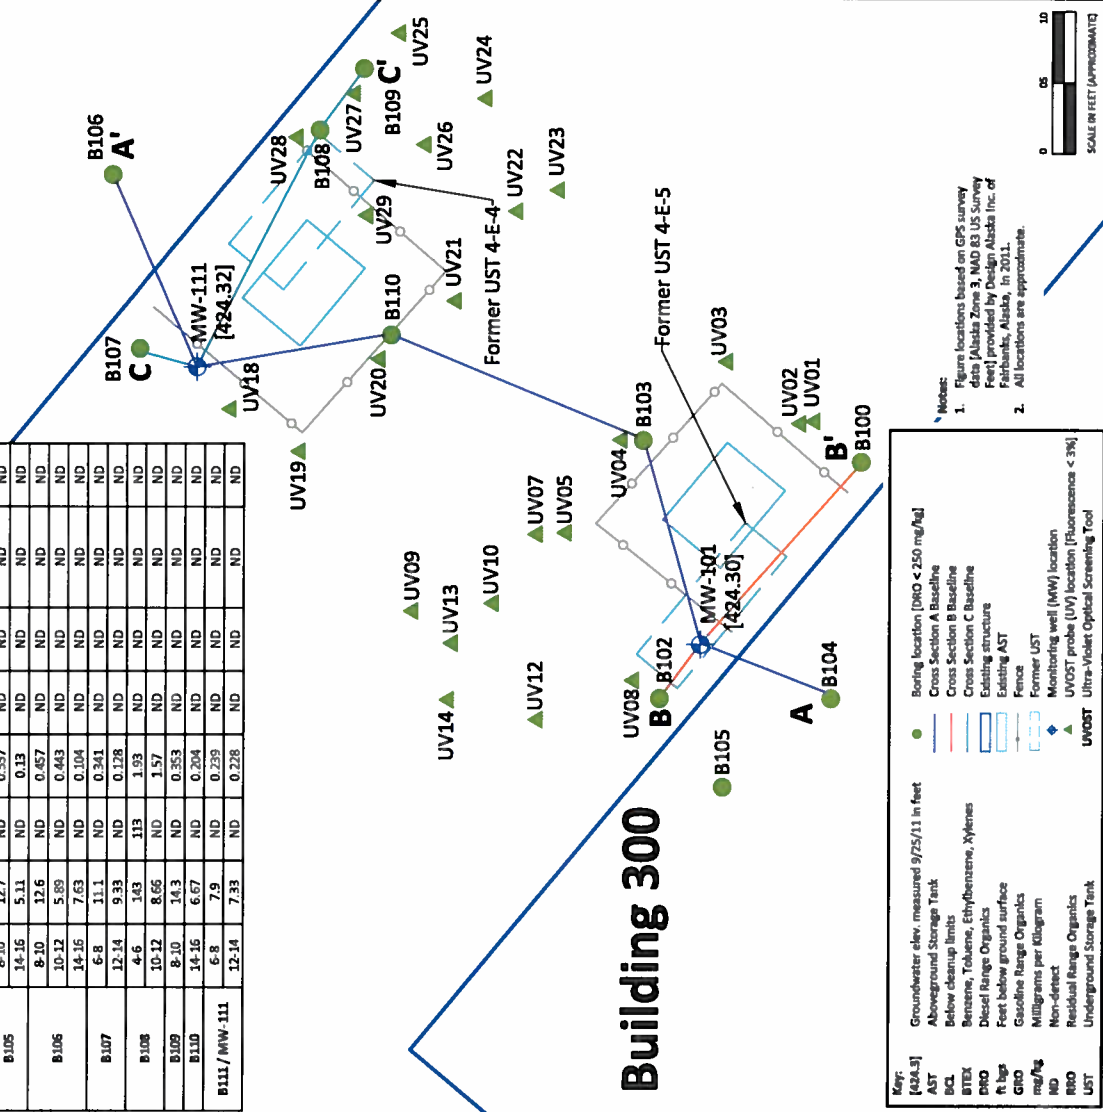
Hydrocarbon Risk Calculator Report Fairbanks FAA Station, Alaska Buildings 207 and 300, Former USTs 4-E-4 and 4-E-5 - 2011 Soil Data

During the 1995 decommissioning of UST 4-E-4 from the Building 300 (B300) area, approximately 36 cubic yards (cy) of contaminated soil were identified and removed. One sample collected from 3.5 feet bgs at the excavation sidewall near the B300 foundation exceeded cleanup levels for DRO at 3,900 mg/kg. Another sample, taken from 8.5 feet bgs at the excavation bottom, did not exceed DEC cleanup levels.

Former UST 4-E-5 (Building 207) was decommissioned in 1996. Approximately 35 cy of potentially impacted soil was excavated, temporarily stockpiled on-site, and later thermally treated at Organic Incineration Technology, Inc. (OIT) facility near North Pole, AK. Due to the close proximity of the building foundation to the remaining contaminated soil, and the apparent shallow depth of contamination, no further excavation was conducted. A soil sample collected from a depth of 4 feet bgs from the west sidewall adjacent to the building foundation was reported to contain 5,300 mg/kg DRO.

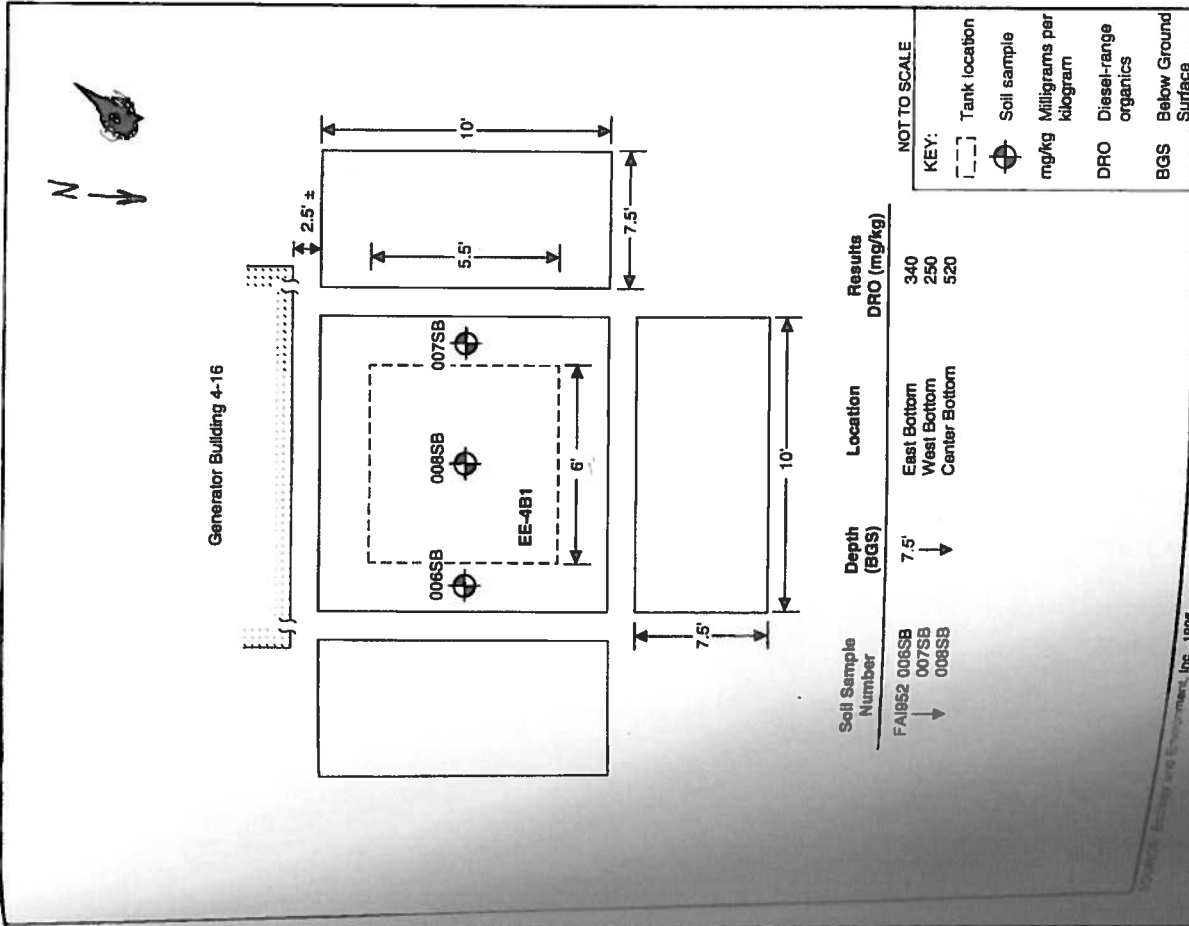
CONFIRMATION SAMPLE LOCATION AT EXCAVATION FOR UST EE-4B1
 FAIRBANKS INTERNATIONAL AIRPORT ASR-8 GENERATOR BUILDING
 FAIRBANKS, ALASKA

showed DRO contamination at levels ranging from 250 mg/kg to 520 mg/kg. A concrete hold-down pad was located below that depth so additional soil removal was infeasible. A new 500 gallon tank was installed in the same excavation. Neither groundwater nor permafrost were encountered during the removal.

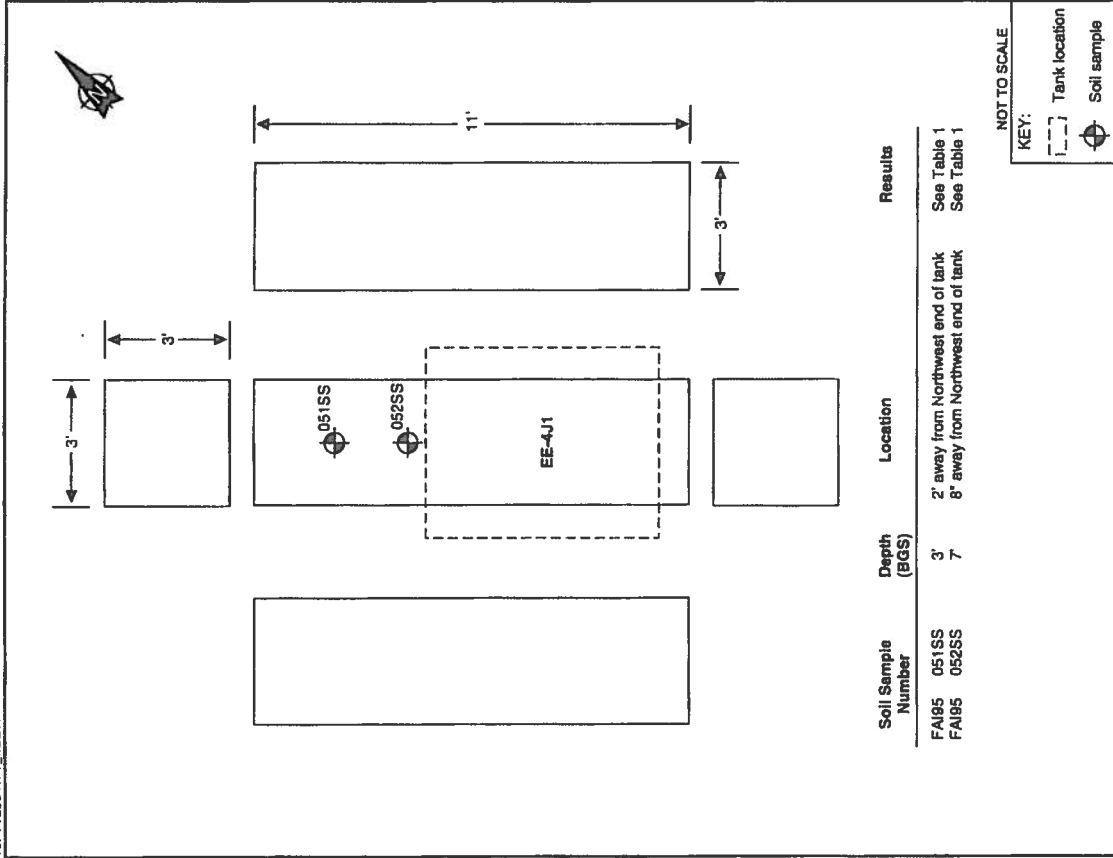
Figure 4 CONFIRMATORY SAMPLE LOCATIONS AT THE EXCAVATION FOR UST EE-4J1 FAIRBANKS INTERNATIONAL AIRPORT FAA VORTAC FACILITY FAIRBANKS, ALASKA

UST 4-J-1 was decommissioned in 1995. The tank was abandoned in place because of its proximity to utility and building foundations. The final excavation dimensions were approximately 8' long, 3.5' wide, and 3-5' deep. Frozen soil was not encountered during the excavation. During the excavation, contamination was discovered under the supply and return lines. Approximately 0.25 cubic yards of contaminated soil in this area was removed and thermally treated. Two samples were collected, one at the north end of the tank at 7 feet bgs, and one directly below the supply and return lines at 3 feet bgs. The sample collected below the supply and return lines had a DRO concentration of 2,600 mg/kg and an ethylbenzene concentration of 9.6 mg/kg, both of which exceed the method two migration to groundwater cleanup levels. In addition, the method detection limit for benzene in this sample (0.88 mg/kg) was greater than the migration to groundwater cleanup level. The decommissioning report stated that, given the 200' bgs depth to groundwater, the small mass of remaining contamination will not migrate to groundwater.
