**Department of Environmental  
Conservation**

Division of Spill Prevention and Response  
Contaminated Sites Program

Re: FAA Tanana Station – Summary of Evaluations and Determinations

### Comprehensive Site Status Summary for All FAA Tanana Station Areas of Concern

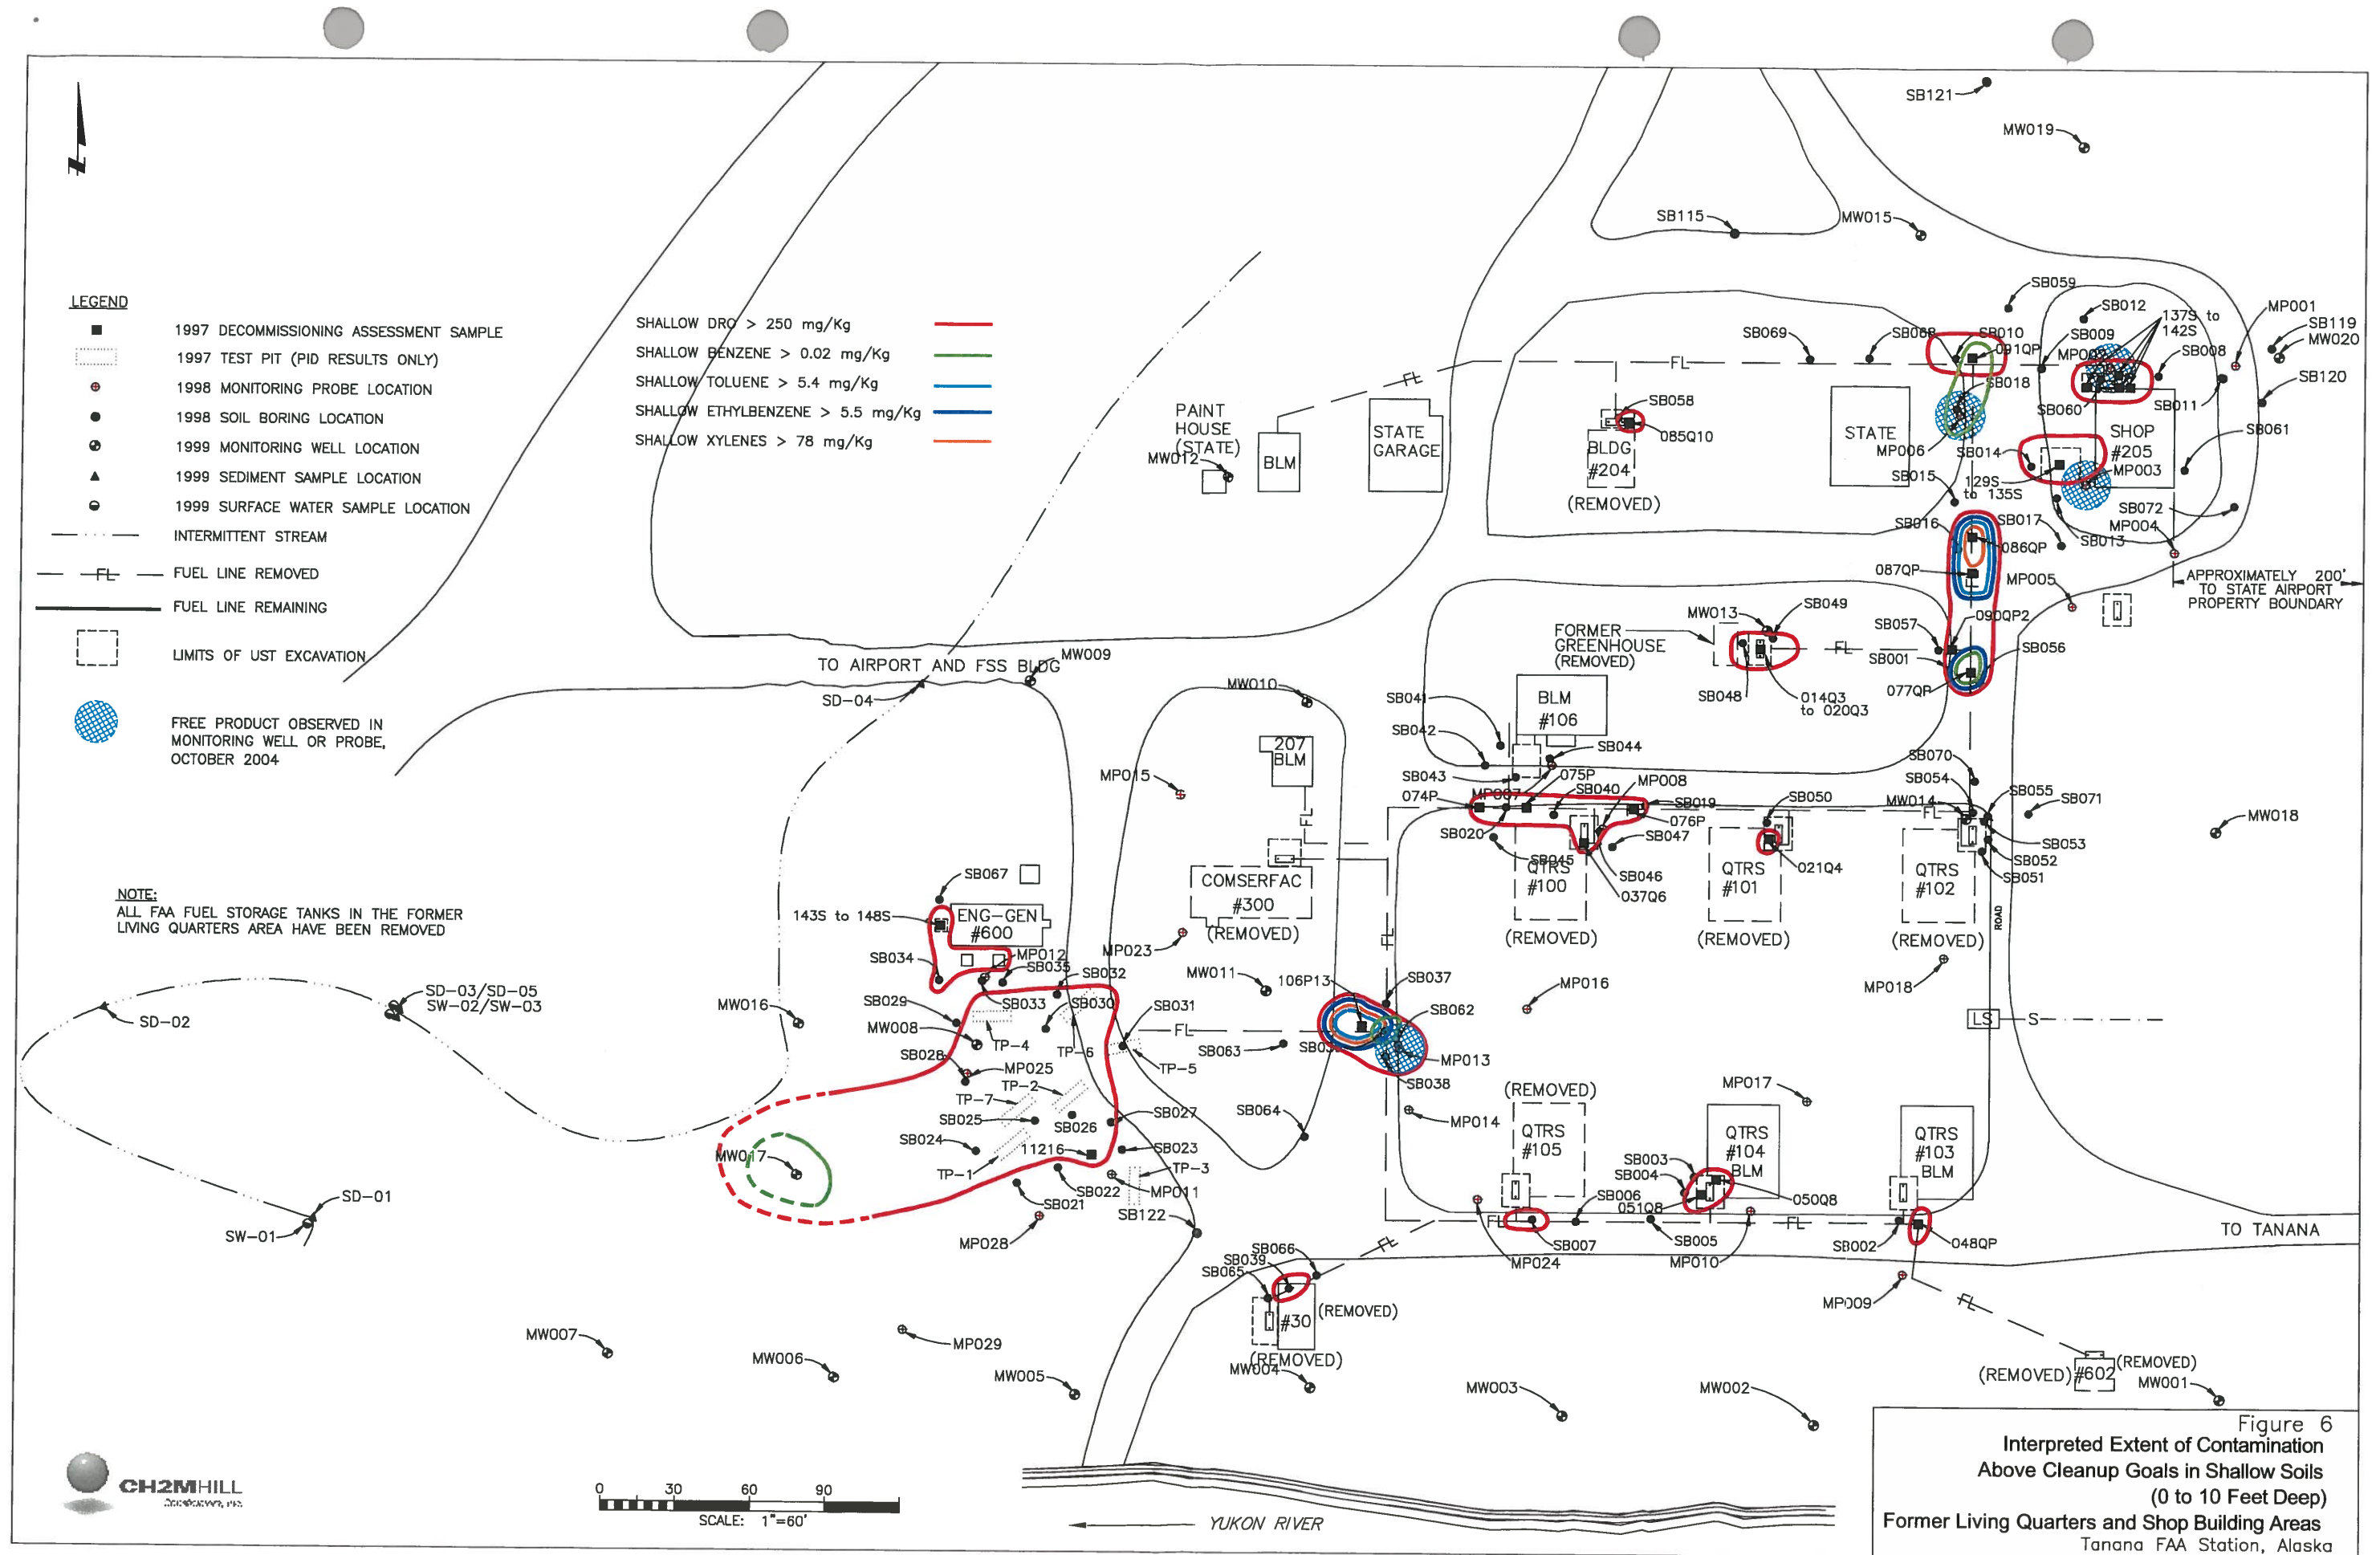
Figure 6  
Interpreted Extent of Contamination  
Above Cleanup Goals in Shallow Soils  
(0 to 10 Feet Deep)  
Former Living Quarters and Shop Building Areas  
Tanana FAA Station, Alaska

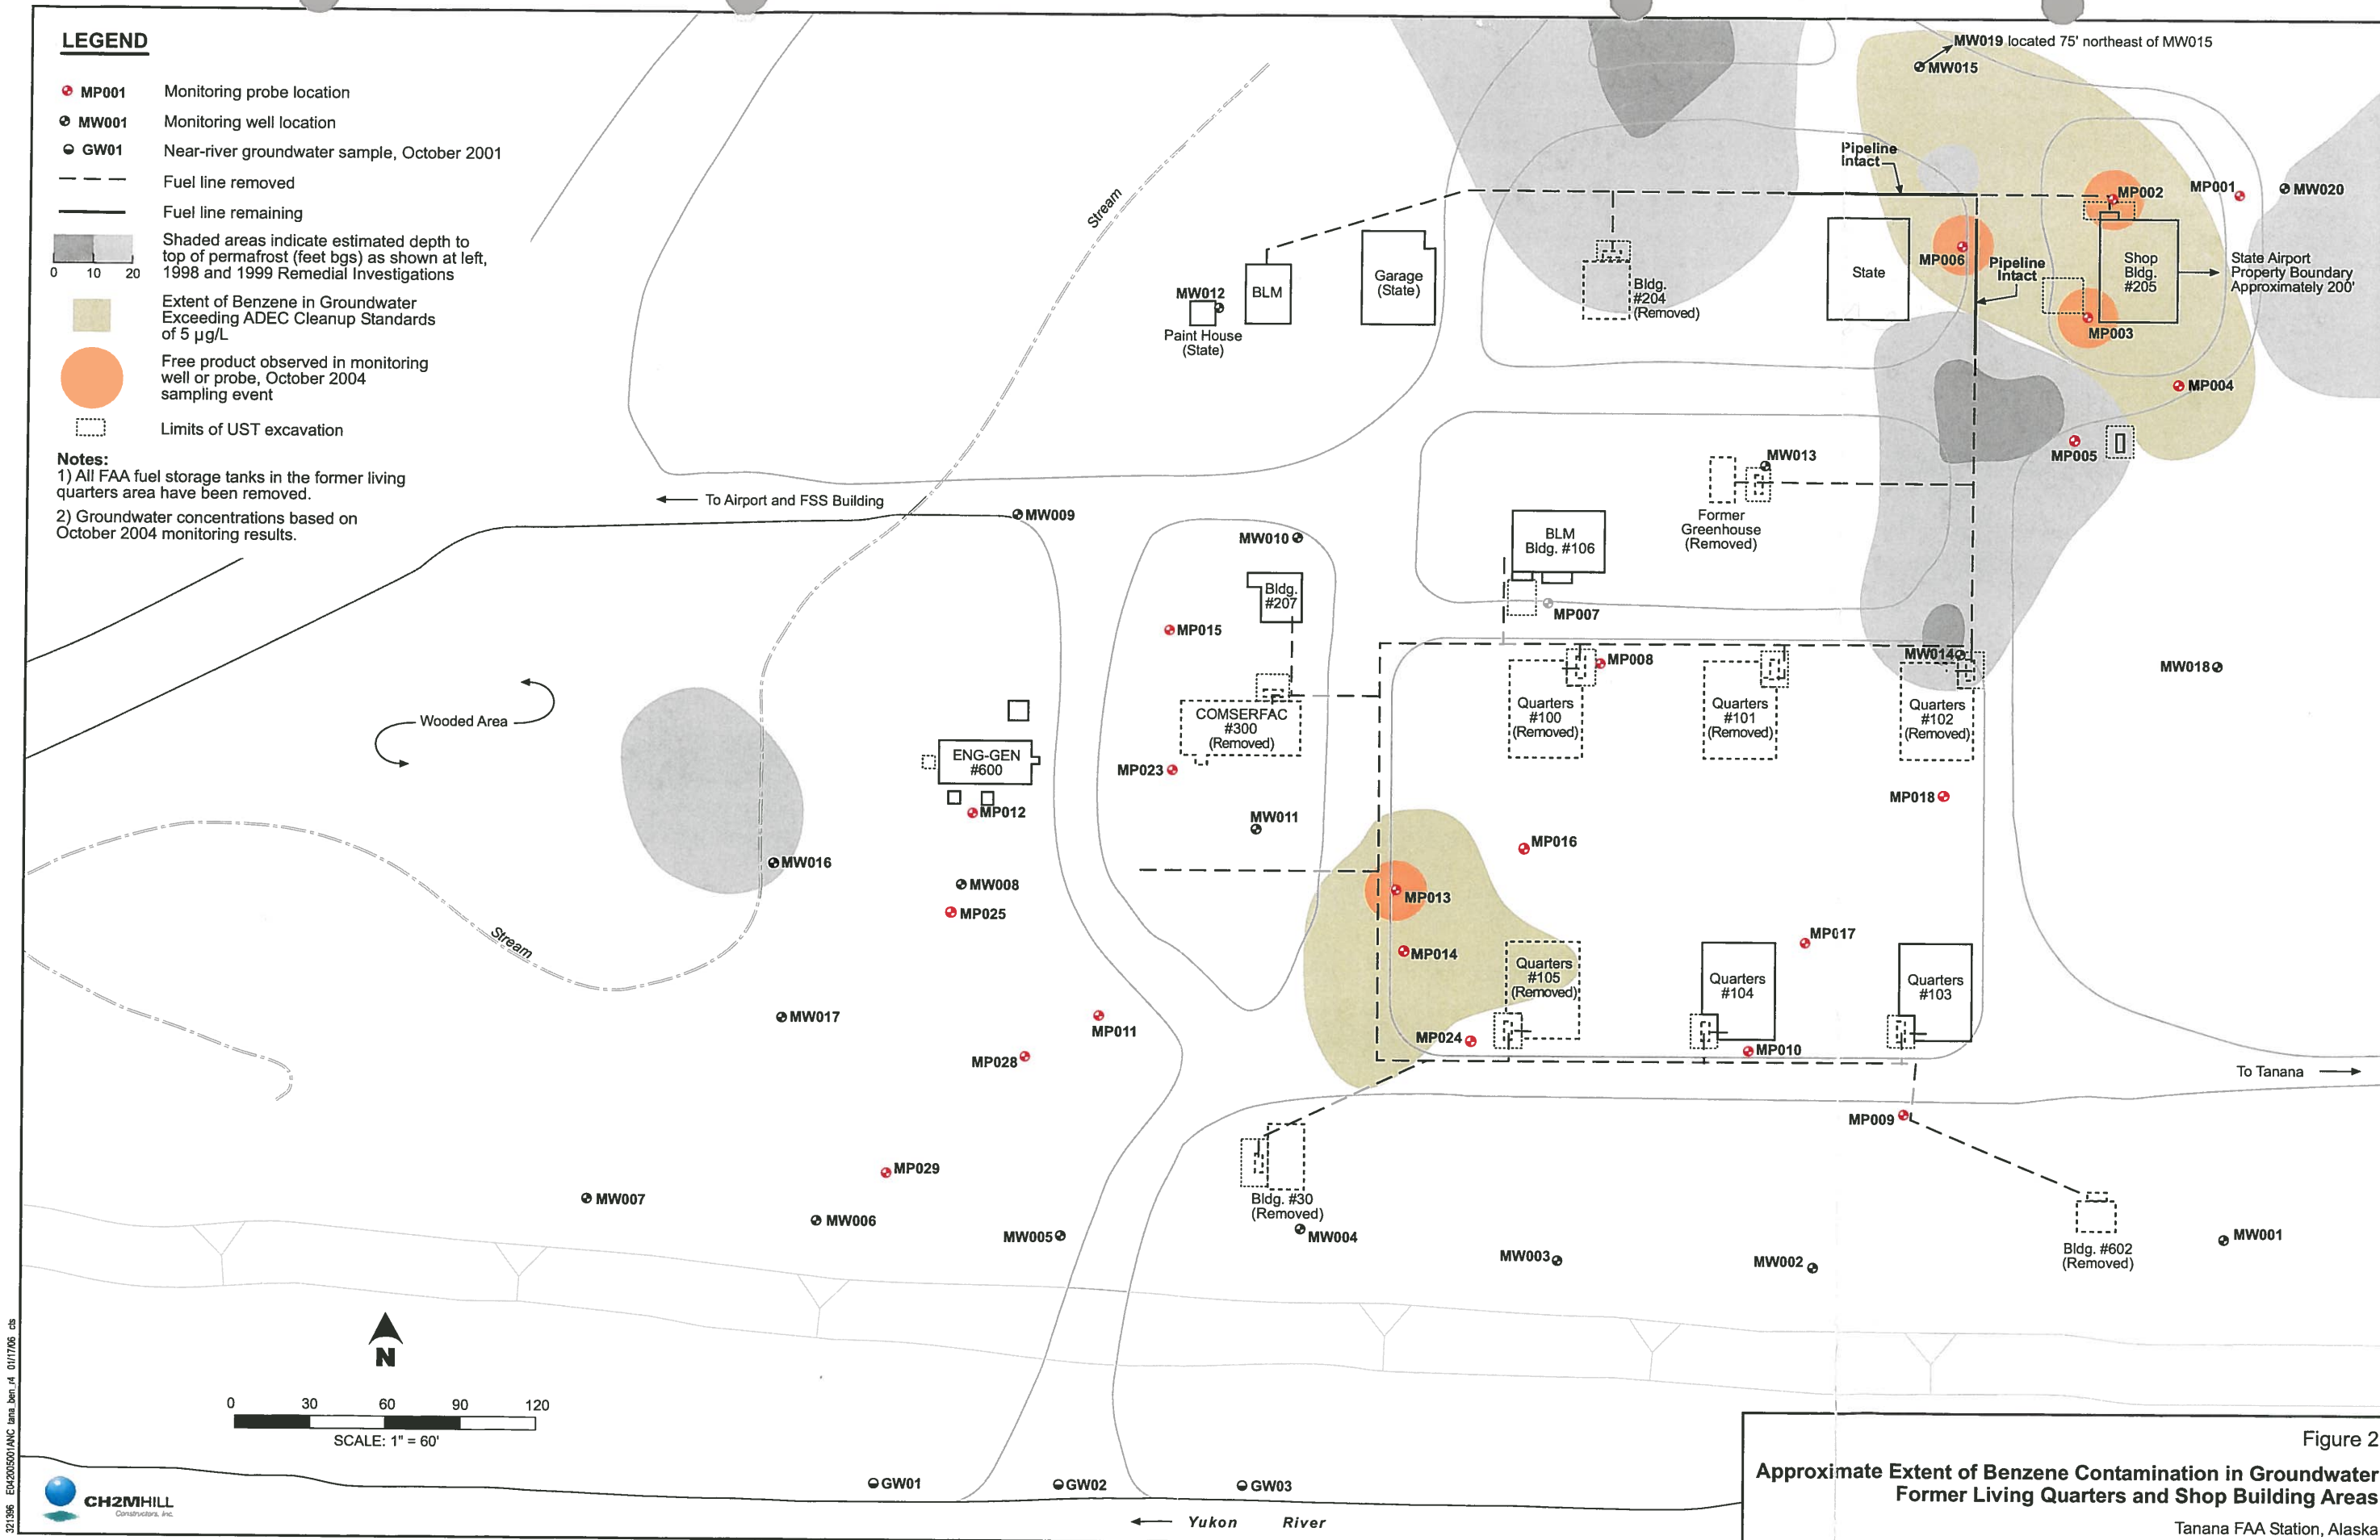
Figure 2  
 Approximate Extent of Benzene Contamination in Groundwater  
 Former Living Quarters and Shop Building Areas  
 Tanana FAA Station, Alaska

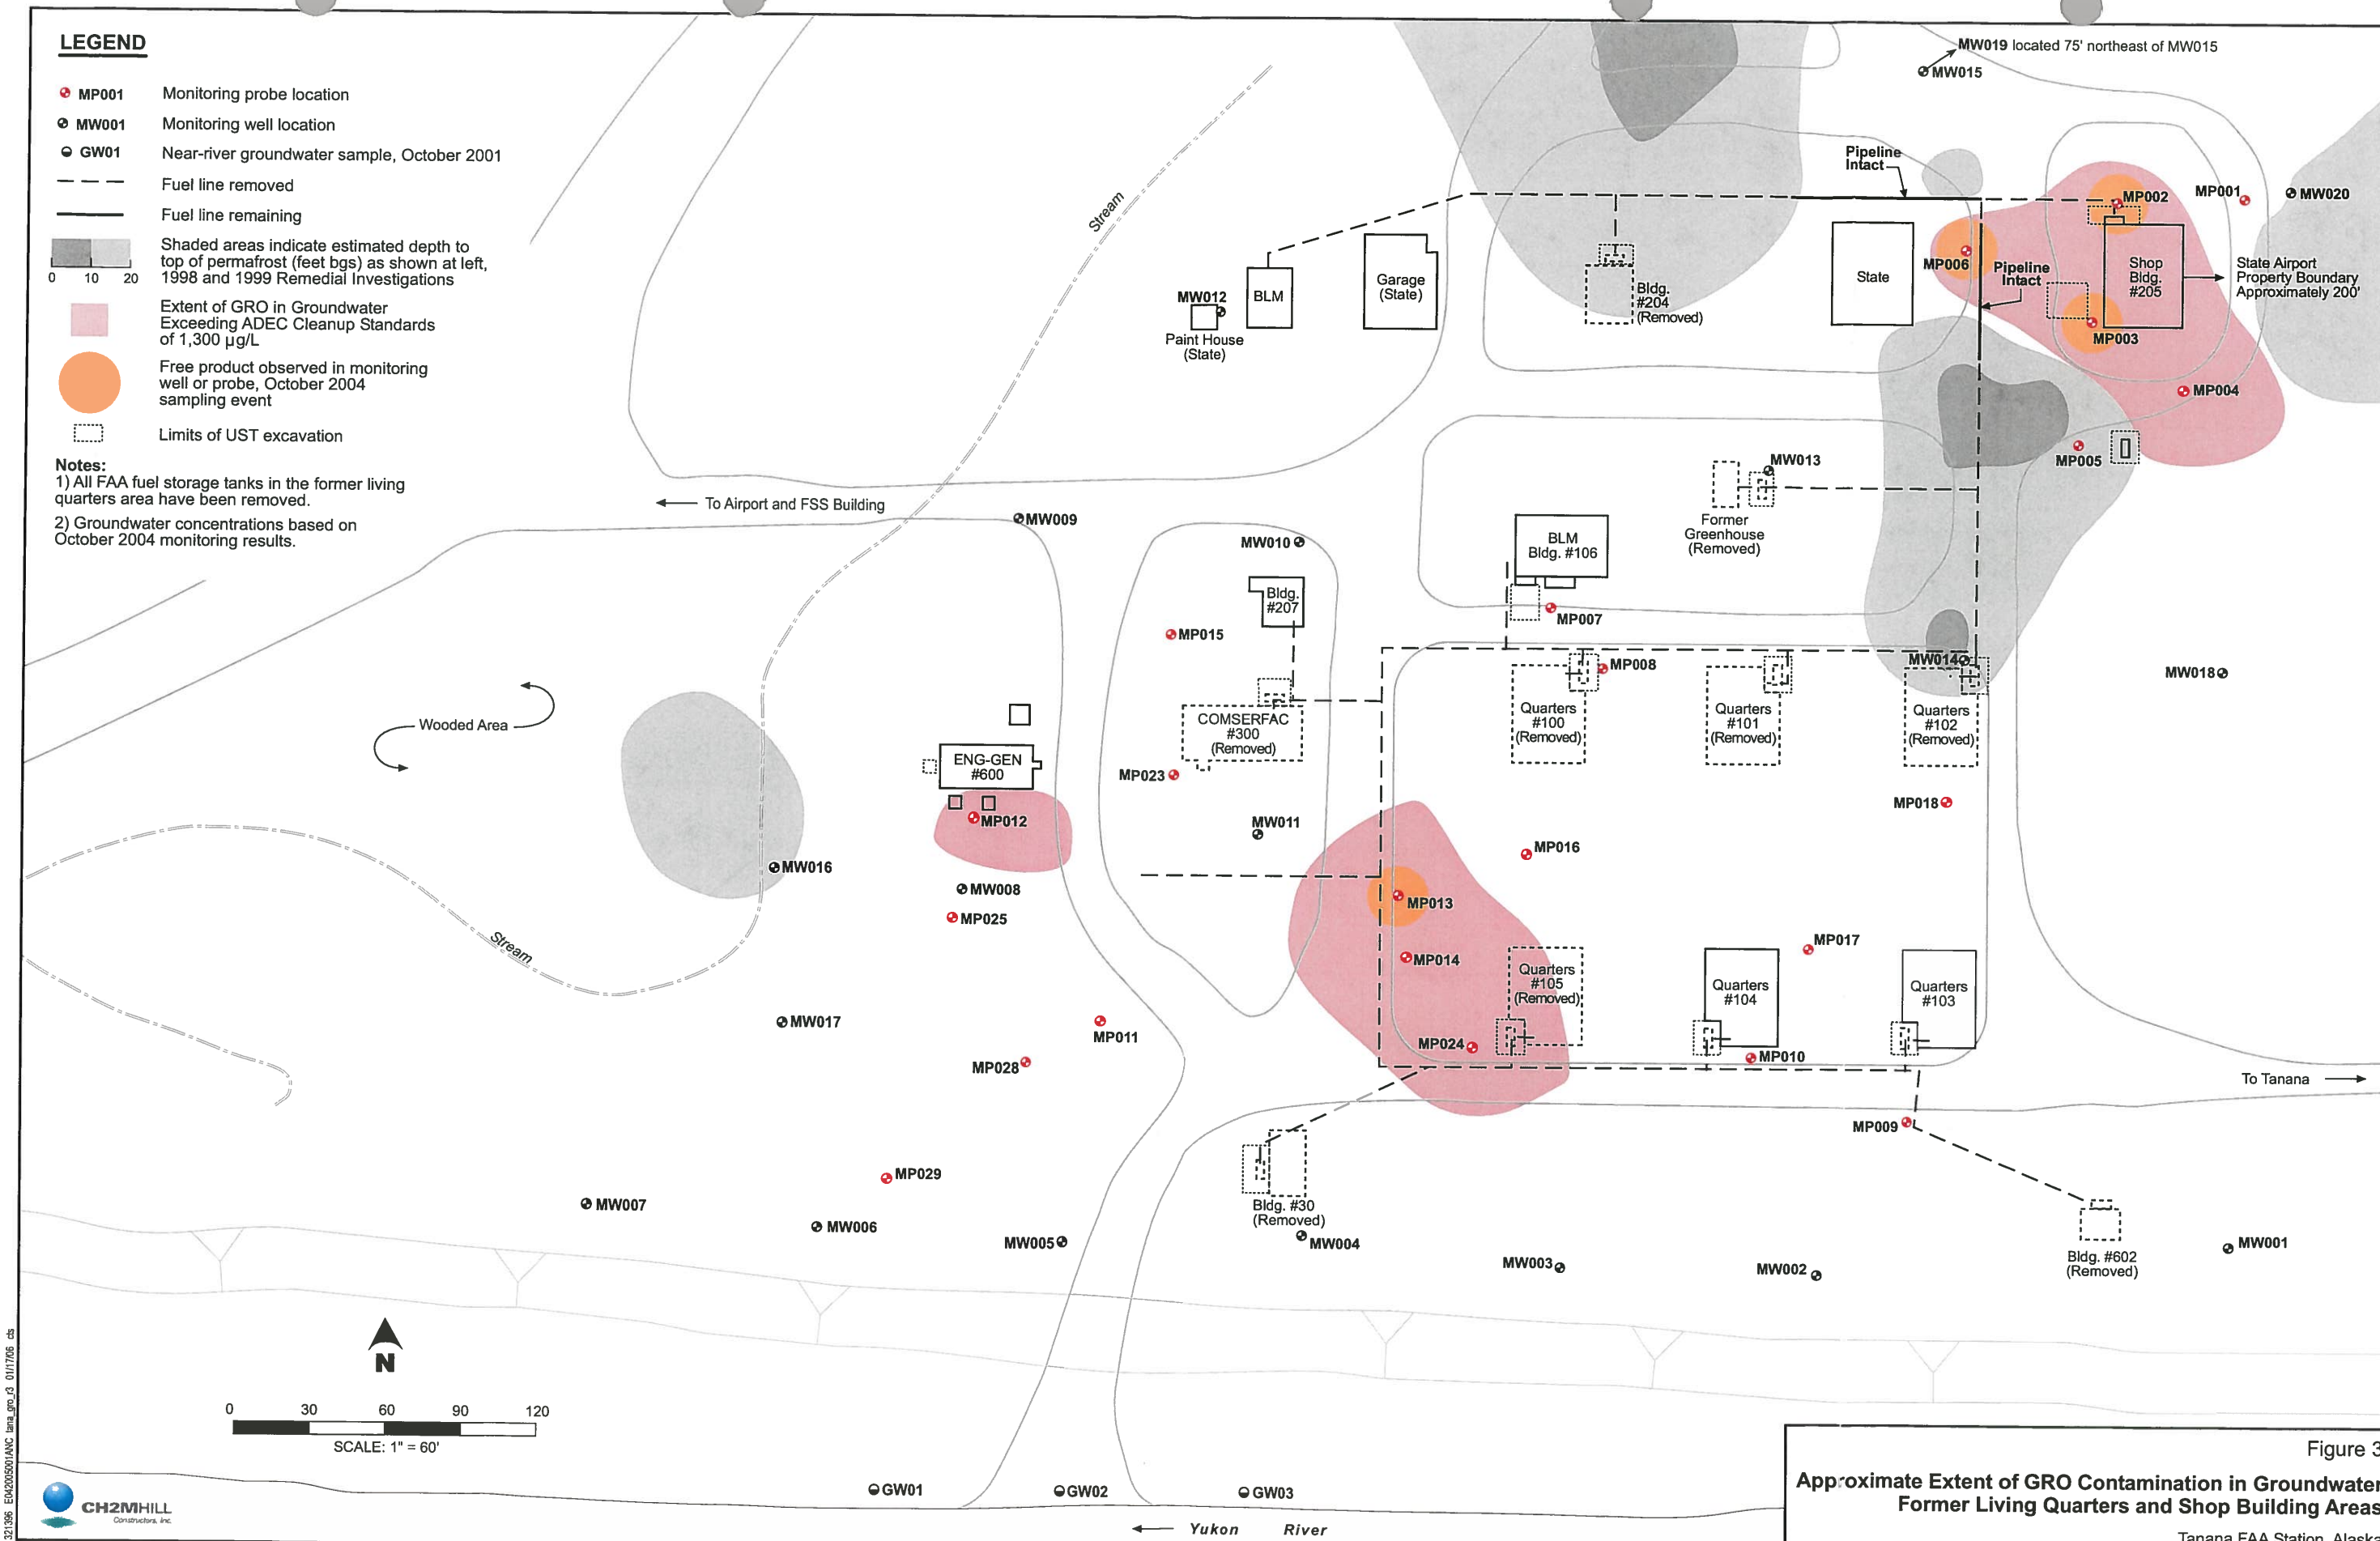
Figure 3  
 Approximate Extent of GRO Contamination in Groundwater  
 Former Living Quarters and Shop Building Areas  
 Tanana FAA Station, Alaska

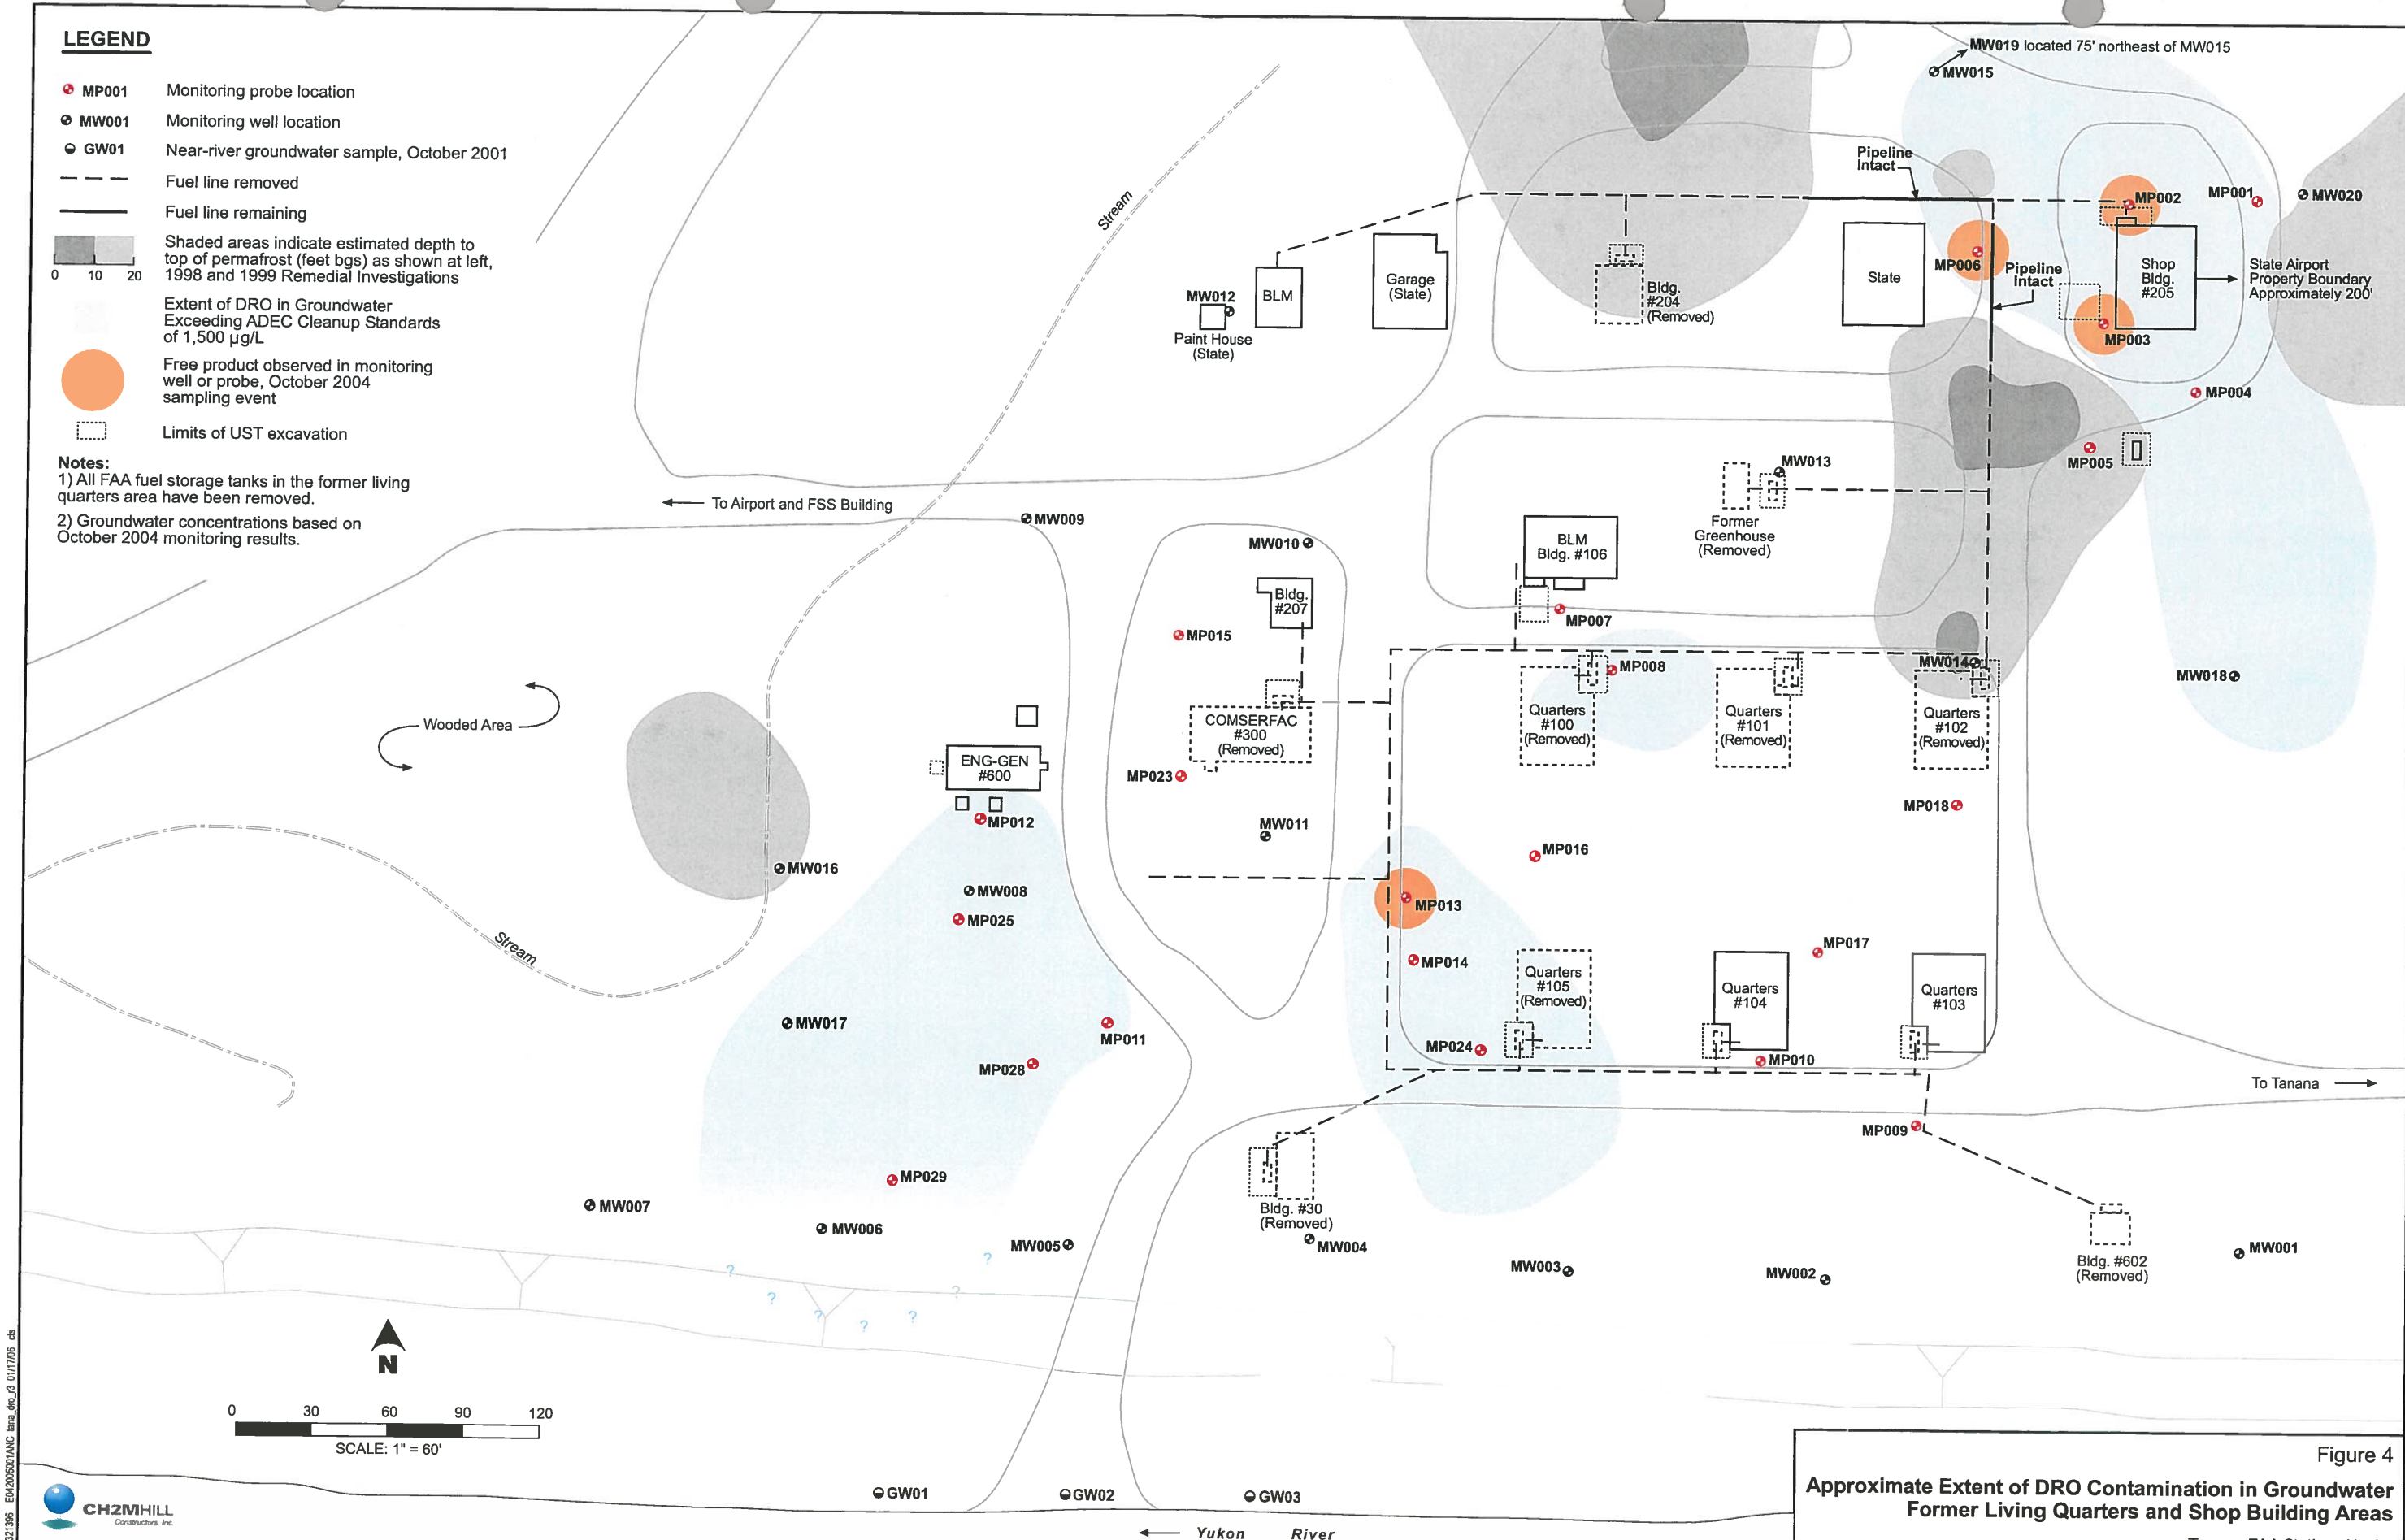
Figure 4  
Approximate Extent of DRO Contamination in Groundwater  
Former Living Quarters and Shop Building Areas  
Tanana FAA Station, Alaska

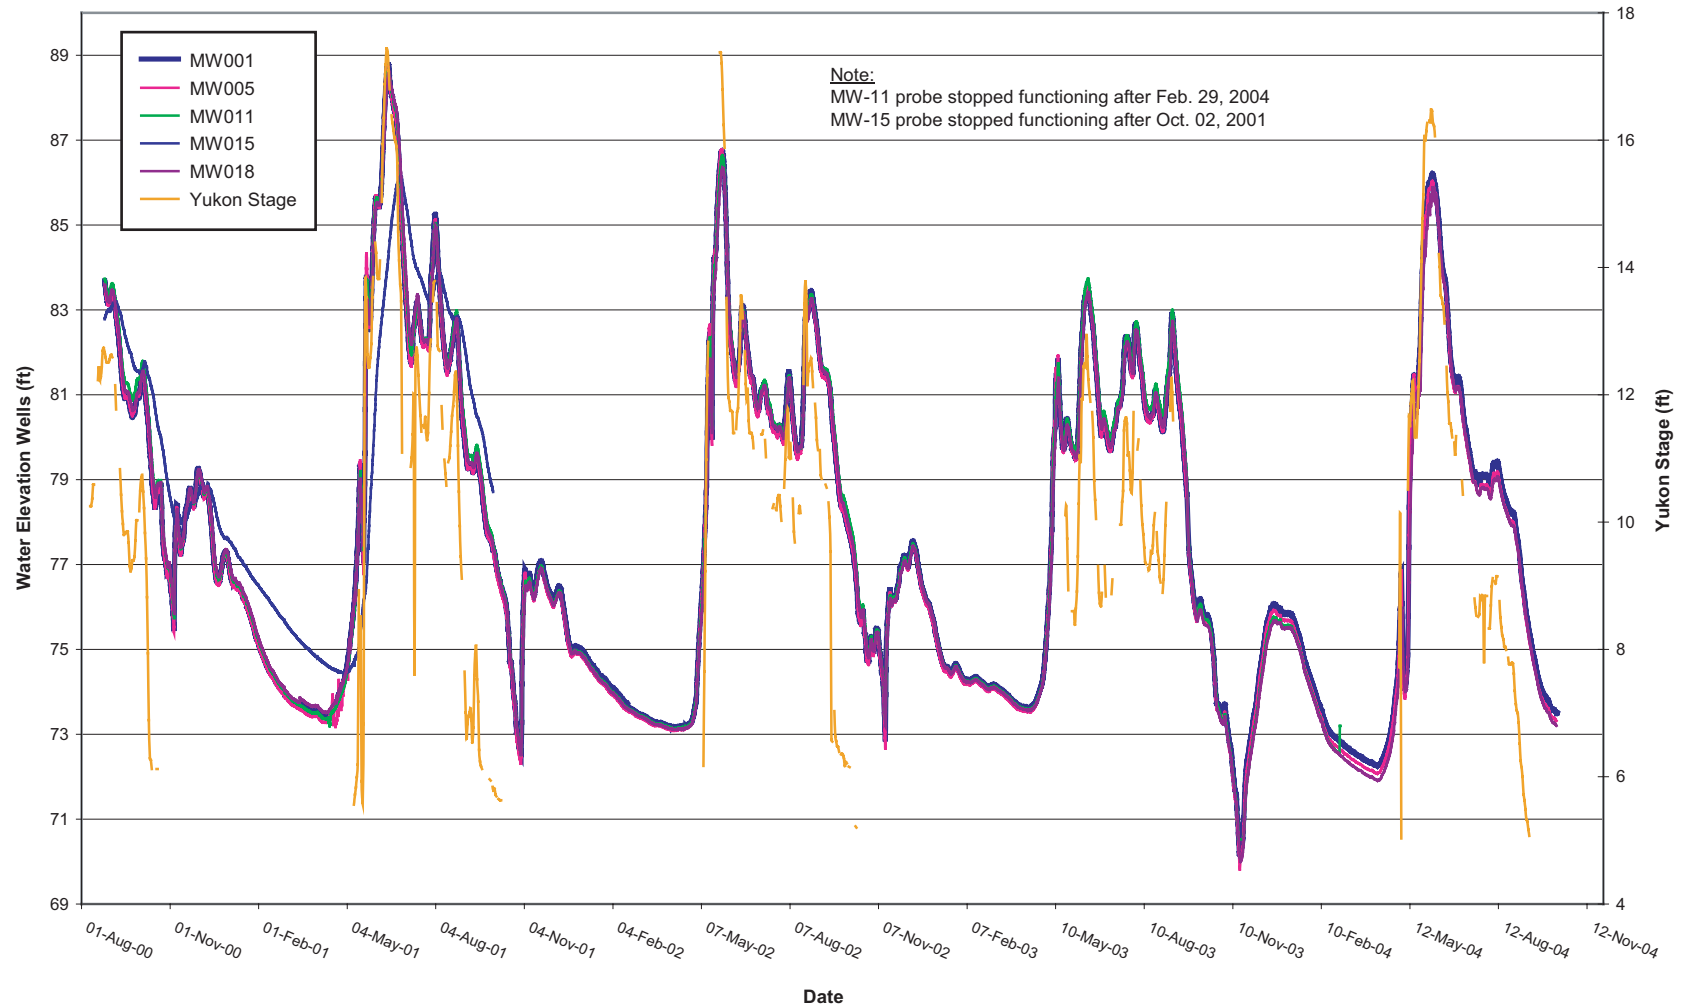
Figure 12-6  
**Continuous Water Level Monitoring Results**  
 Tanana FAA Station, Alaska
