## DEPT. OF ENVIRONMENTAL CONSERVATION

### DIVISION OF SPILL PREVENTION AND RESPONSE CONTAMINATED SITES PROGRAM

Re: Decision Document; Mountain Market (formerly K&J Auto)  
Corrective Action Complete Determination

Mountain Market (formerly K&J Auto)  
Mountain Corporation  
Corner of Haines Hwy and Third Ave

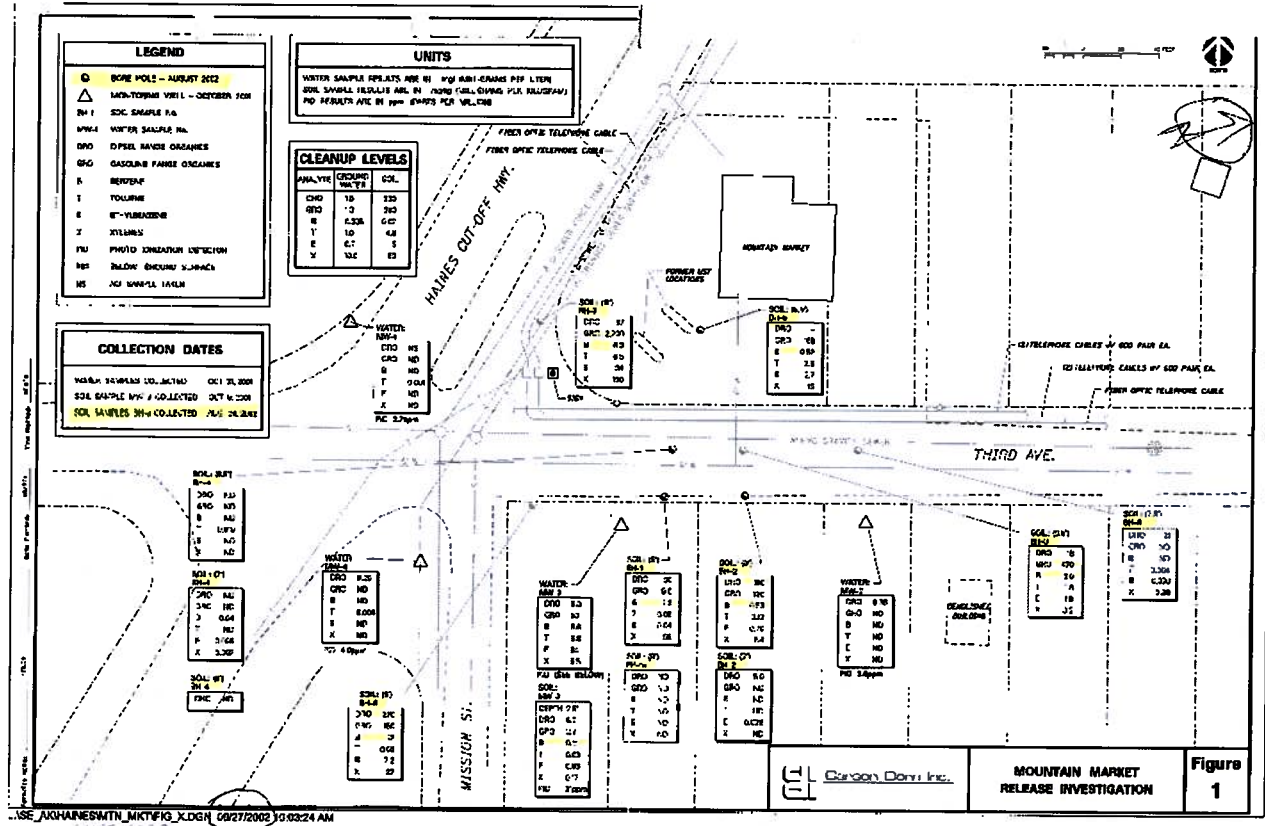
**Attachment B: Figure I, 2002 CDI Report**

In 2001, Carson Dorn Inc (CDI) collected subsurface soil samples from borings on the Mountain Market property, on the Third Avenue roadbed and on Lot 11, Block D, Mission Street Subdivision, an undeveloped property owned by Mike Ward (Ward Property). In the subsequent 2002 Report by CDI, the highest levels detected in soil samples were 2200 mg/kg GRO, 270 mg/kg DRO, 12 mg/kg benzene, 34 mg/kg ethylbenzene, 6.5 mg/kg toluene, and 130 mg/kg total xylenes at a depth of?. Soil contamination was greatest in the southeast corner on the Mountain Market site and on the boundary line between the Ward Property and the Third Avenue right of way (ROW). Figure 1 from the 2002 CDI Report displaying the layout of borings and monitor wells with the associated data is included in this letter as Attachment B.

In 2001, Carson Dorn Inc (CDI) installed four temporary monitor wells to investigate the migration of petroleum contamination in the shallow soils to off-site properties. Soil boring and well locations with data from the subsequent 2002 CDI Report are displayed in Figure 1 as Attachment B to this letter. Well MW-2 and MW-3 were installed on the Ward Property and two other wells were installed in the ditches along the Haines Highway Cutoff and Mission Street ROWs. The highest levels of COCs detected were from MW-3 on the Ward Property (Table 3). Samples from all other wells met the applicable criteria.

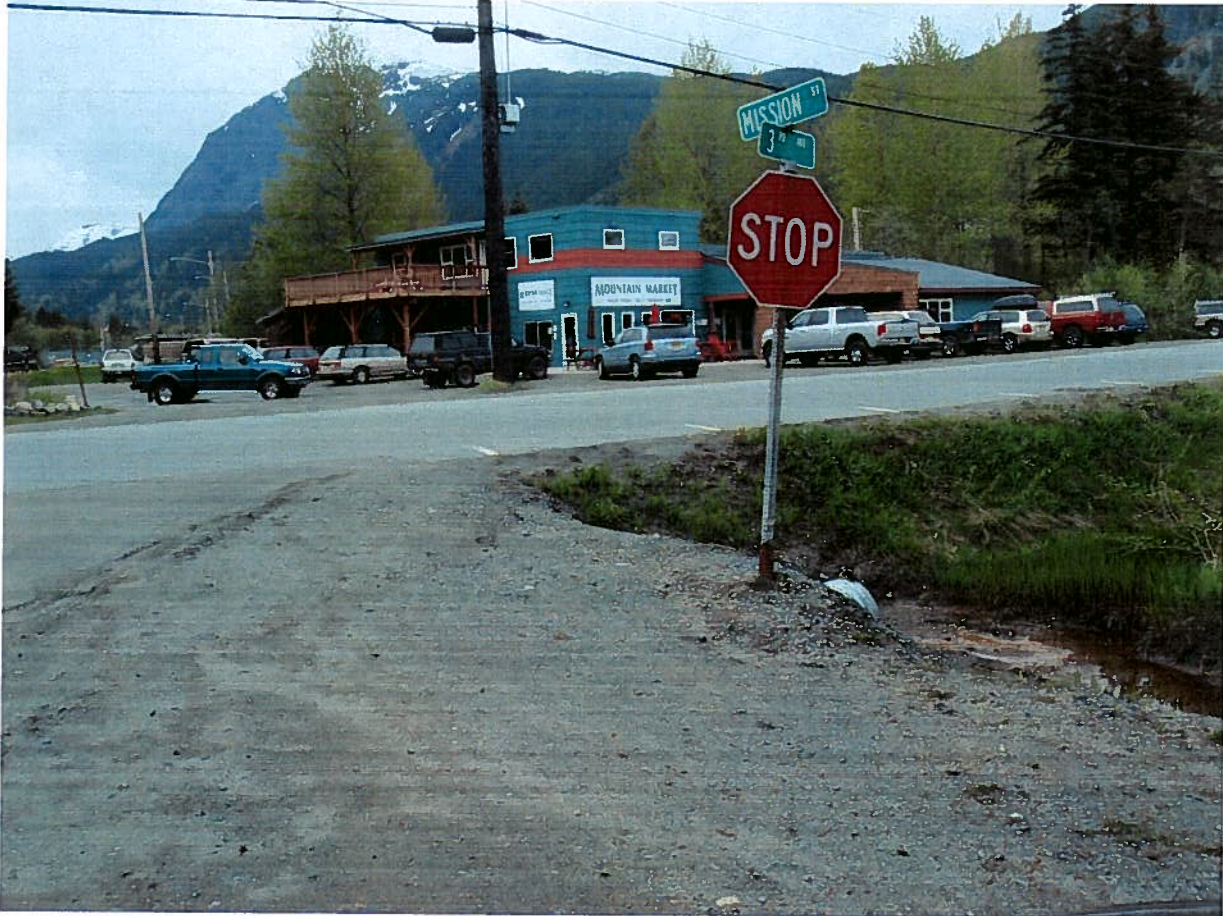
**Attachment C: Mountain Market at Mission and 3<sup>rd</sup> May 2012**

Site Photograph May 2012, Mountain Market at Mission and 3rd
