Department of Environmental Conservation

Division of Spill Prevention and Response Contaminated Sites Program

Re: Decision Document: Lonely AFS Dewline - Beach Diesel SS003 (Tanks and Pumphouse), Cleanup Complete Determination

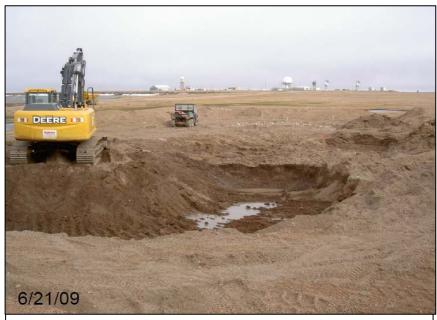
Initial excavation of Beach Diesel Tank northern area was advanced to the frost line at approximately 2.5 feet below grade (2009 photo courtesy of BEM).

During the 2009 field season, approximately 356 CY of petroleum-contaminated soil excavated from the southern excavation area and the northern excavation area of SS003 Beach Diesel Tanks was placed at the SS005 landspread area. This soil was spread in the eastern portion of the area approximately 0.5 feet thick using a loader and bulldozer. The soil was re-spread multiple times with heavy equipment during the field season to enhance the natural attenuation process. No additional soil was placed in the southwest portion where landspreading was conducted in 2008. Sampling conducted in 2009 confirmed that soil contained in the landspreading area was below DEC Method 2 cleanup criteria (the 2008 Decision Document required Method 1 cleanup levels for the SS003 site but allowed for Method 2 cleanup levels when soil was transferred inland to the SS005 location where it would be landspread and no longer pose a risk to surface water). All samples in the south excavation were below DD cleanup levels. One sample in the north excavation exceeded DD cleanup levels and contained GRO at a concentration of 120 mg/Kg, and DRO at a concentration of 3, 100 mg/Kg, All other samples were below DD cleanup levels and the location has since eroded making the pathway incomplete.

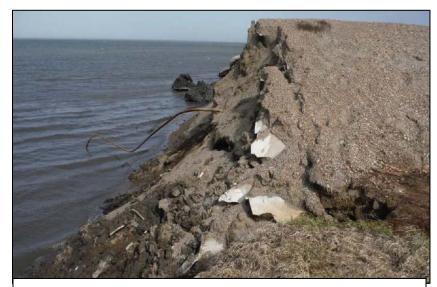
By 2014 the Beach Diesel Tank area was completely eroded. During the 2014 field season, a pipe of 3-inch diameter was identified protruding from the eroded side of the berm and into the ocean. This 100-foot length of piping was removed and cut up for recycling. Styrofoam that was identified beneath a berm layer was also falling into the ocean as the berm eroded. This material could not be removed during the 2014 field season and was subsequently collected from the beach and lagoon area during the 2015 field activities. Based upon the completion of the beach debris

Pipe protruding from berm at beach showing Styrofoam beneath surface of berm (2014 photo courtesy of BEM).

cleanup efforts and the fact that the entire gravel pad associated with the former beach tank area has eroded into the ocean, the demolition efforts are deemed complete for the Beach Diesel Tank Soil Berm. At this time, the entire site has eroded into the ocean.
