Re: **Decision Document: Residence - Jelinek Place  
Cleanup Complete determination**

Residence - Jelinek Place  
161 Jelinek Place  
Anchorage, Alaska 99504

File No.: 2100.38.052  
Hazard ID.: 3156

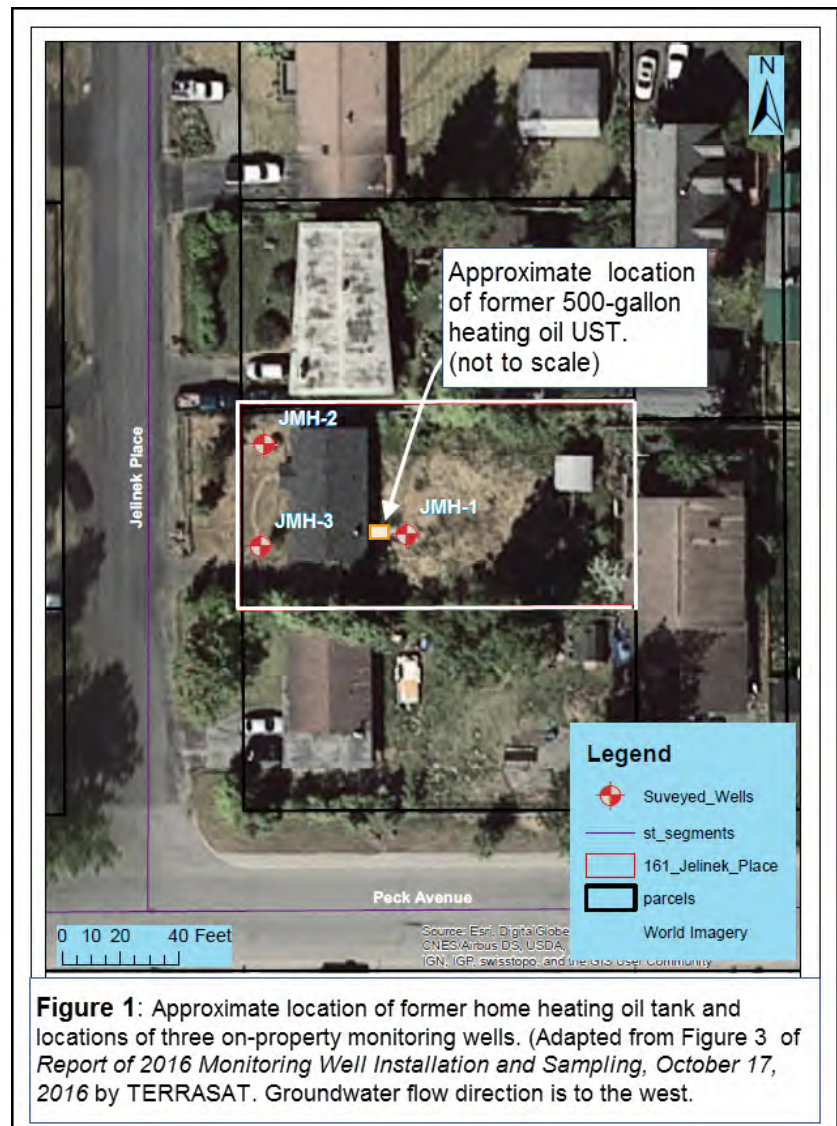
After a lengthy hiatus, site work resumed in September 2016 with the installation of three borings completed as monitoring wells at the locations shown on **Figure 1**. Following completion of site work and monitoring in January 2017, no soil or groundwater samples exceeded cleanup levels for any petroleum hydrocarbon compounds.

Site work resumed in September 2016 after ADEC notified the property owner of his status as a potentially responsible party. Work included the installation of three borings completed as monitoring wells at the locations shown on **Figure 1**. Soil and groundwater samples were collected on September 7, 2016 and analyzed for RRO, DRO and BTEX. Boring JMH-1, shown on **Figure 3** below, was placed as close as possible to the location of the most highly contaminated sample collected at 12.5 ft bgs in October 2000.

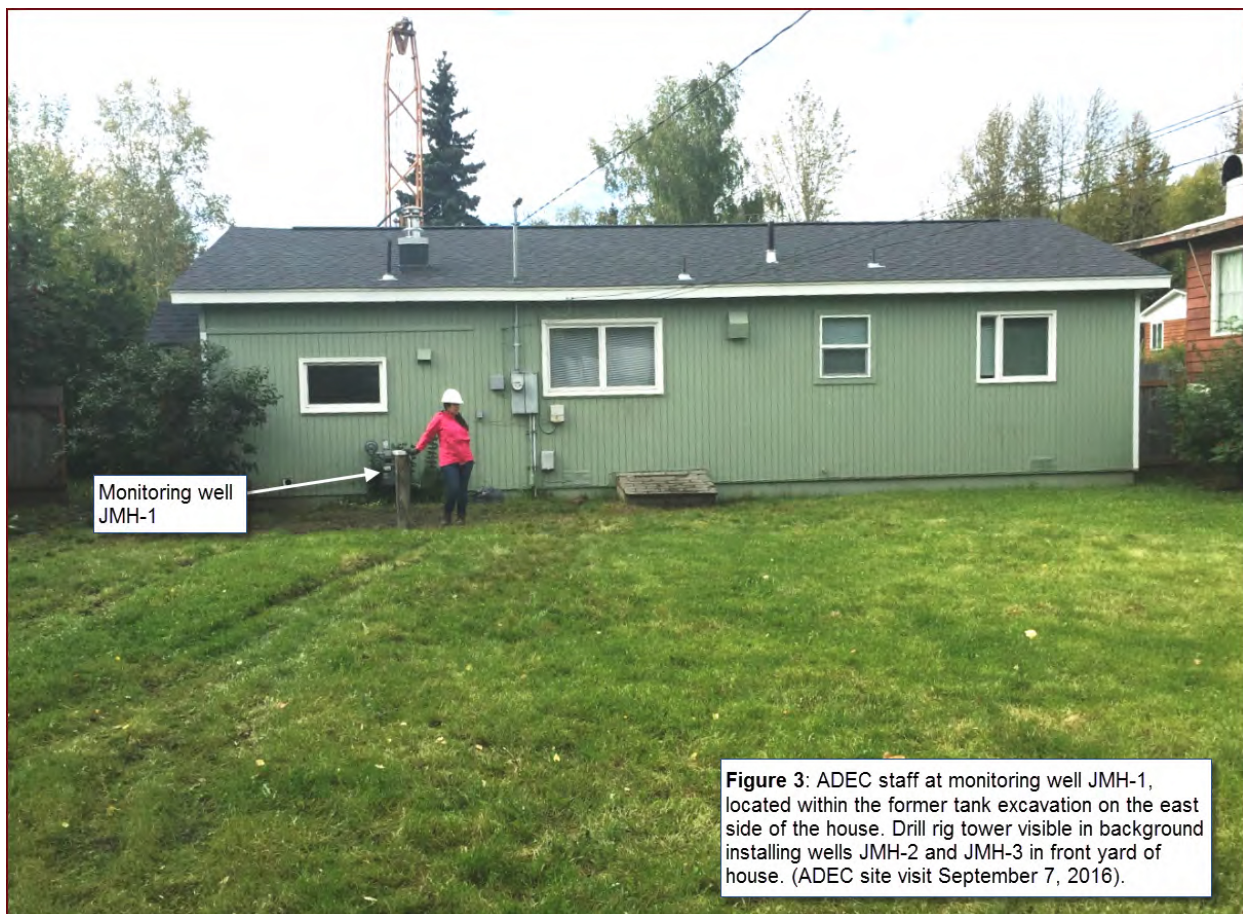
**Figure 3:** ADEC staff at monitoring well JMH-1, located within the former tank excavation on the east side of the house. Drill rig tower visible in background installing wells JMH-2 and JMH-3 in front yard of house. (ADEC site visit September 7, 2016).

Contaminants detected in soil in JMH-1 were DRO at 9 mg/Kg and RRO at 27.2 mg/kg at 11 ft bgs, over two orders of magnitude below the applicable migration to groundwater cleanup levels, with no other contaminants detected. Groundwater analytical results were non-detect for all compounds.

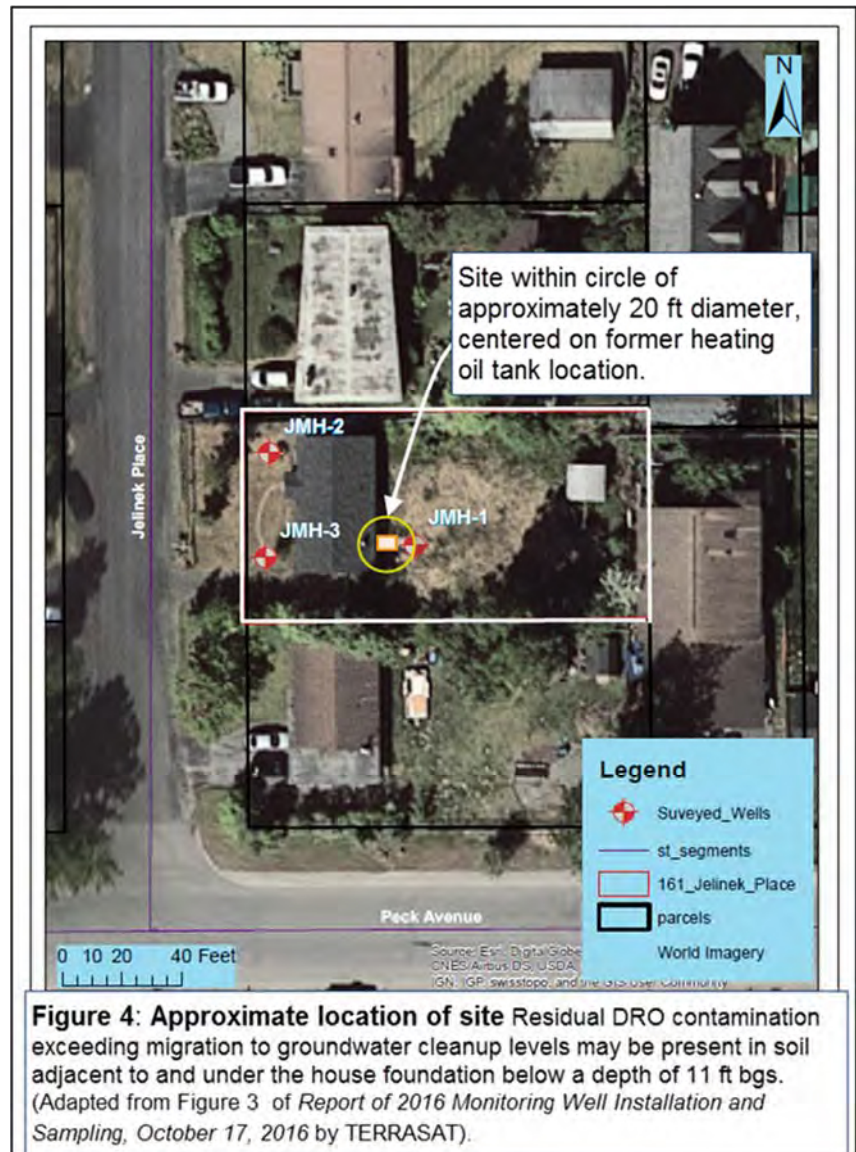
The approximate area of the site is shown on **Figure 4**.

1. Any proposal to transport soil or groundwater off-site requires ADEC approval in accordance with 18 AAC 75.325(i). A "site" as defined by 18 AAC 75.990 (115) means an area that is contaminated, including areas contaminated by the migration of hazardous substances from a source area, regardless of property ownership. The approximate location of the site is shown on **Figure 4**.
