Department of Environmental Conservation

DIVISION OF SPILL PREVENTION AND RESPONSE
Contaminated Sites Program

Re: Decision Document: **Residence – 629 Tazlina Terrace**
Cleanup Complete Determination

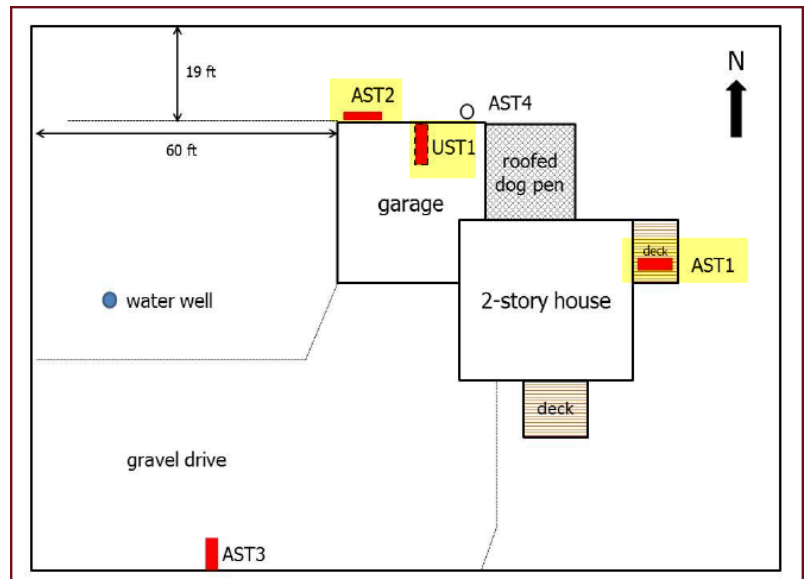
Contamination associated with three heating oil storage tanks was identified in August 2012 at this one-acre residential property, with the most extensive release originating from the damaged fill pipe of a 1,000-gallon underground storage tank (UST), designated UST1 in **Figure 1** below. Surface spills were associated with two aboveground tanks (ASTs) including AST1 with a capacity of 500 gallons, and AST2 with a capacity of 290 gallons. Contaminated soil at the AST locations was excavated with confirmation samples collected at excavation limits demonstrating that the remaining soil met site-specific cleanup levels. The AST releases did not extend to groundwater.

Soil associated with surface releases from two ASTs (“AST1” and “AST2”) and subsurface releases from a damaged fill pipe on an underground heating oil tank (“UST1”) was contaminated above the 18 AAC 75.341 Tables B1 and B2 migration to groundwater cleanup levels by GRO, DRO, benzene and total xylenes. (See tank locations, **Figure 1** above).

Contamination at the locations of UST1 and AST2 was comingled and removal of accessible soil, that is soil that could be removed without compromising the garage structure, comprised a single excavation. Approximately 203 tons of contaminated soil were excavated to a maximum depth of 17.5 feet from the UST1 location and to a maximum depth of 6.5 ft at the AST2 location, with confirmation samples demonstrating that applicable cleanup levels were met at the AST2 location at that depth.

Contaminant characterization and cleanup of the AST1, AST2 and UST1 took place in August and September 2012. A total of 218 tons of petroleum hydrocarbon-contaminated soil was excavated from the three tank locations and transported to Alaska Soil Recycling for treatment. Approximately 15 tons of soil was excavated from the AST1 location to a depth of approximately 4 feet below ground surface (bgs) with confirmation samples demonstrating that applicable cleanup levels (migration to groundwater) were met and that contamination did not extend to groundwater.

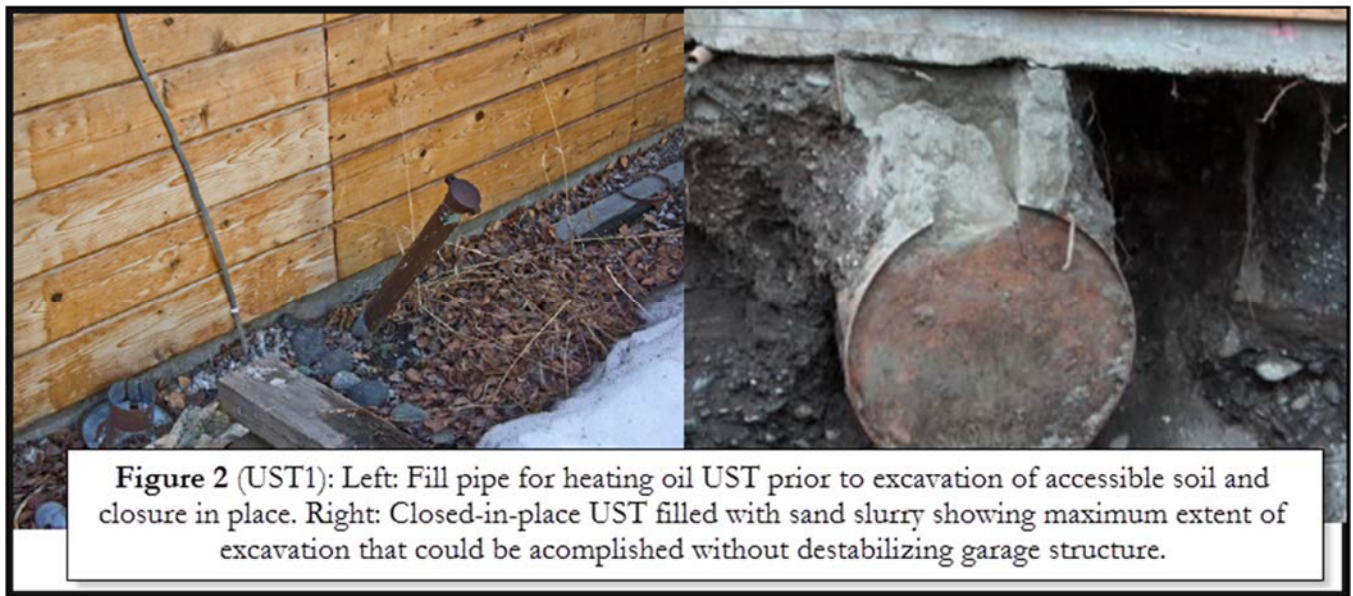
The residence on the property has an attached garage that was built over UST1, with the fill and vent pipes formerly extending outside of the foundation perimeter (See **Figure 2**). UST1 was filled with slurry and closed in place as removal of the tank would have jeopardized the garage structure. **Figure 3** shows the approximate location of UST1 following backfilling and grading. Soil contamination exceeding applicable site cleanup standards remains beneath and adjacent to closed-in-place UST1.

Contamination at the UST1 location resulted from fuel released at the damaged connection between the tank and the fill pipe. The fill pipe was observed to be corroded and disconnected from the tank. Virtually all of UST1 is beneath the garage slab, with the top of the tank approximately 18 inches beneath the slab as shown on **Figure 2**. The vent and fill pipes originally extended beyond the garage perimeter to the north and were cut off at the time the tank was closed in place and filled with slurry, during August and September 2012 work. The contents of UST1, consisting of 360 gallons of heating oil and water, were pumped out and disposed of prior to tank closure. Samples were collected adjacent to the side of and beneath the north end of the tank, at depths of three and six feet below the ground surface and respectively contained DRO concentrations of 3,710 mg/kg and 5,440 mg/kg. These soils were collected just inside the garage perimeter and are presumed to represent the most highly contaminated soil remaining at the site. GRO was presumed to exceed the 300 mg/kg migration to groundwater cleanup level as per footnote 1. BTEX and RRO levels did not exceed cleanup levels.

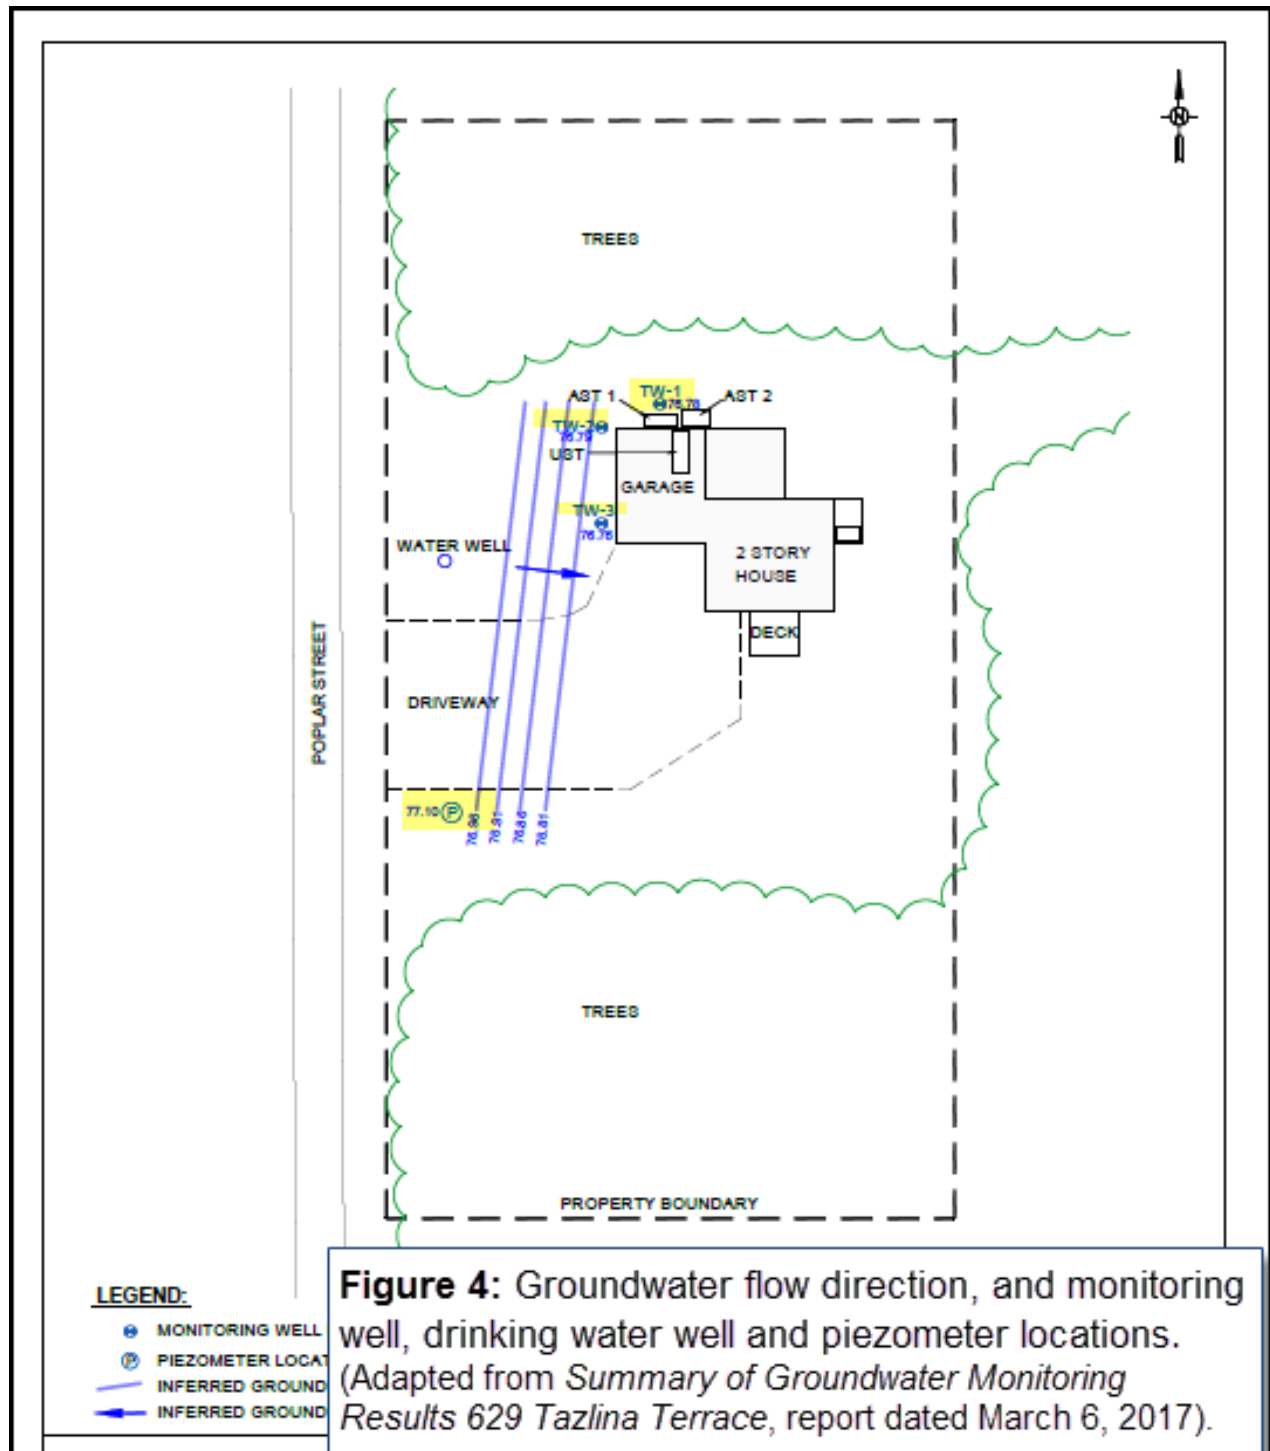
ADEC's March 13, 2014 review letter for the report of the work described above required additional characterization of soil contamination and an investigation of the migration to groundwater pathway to determine whether groundwater, present at about 22 feet bgs, was impacted by the releases. Groundwater flow direction over all monitoring events was to the east as shown on **Figure 4**.

Based on the elevated benzene level in soil at the groundwater interface, and the area use of the potentially impacted aquifer, ADEC required long-term groundwater monitoring comprised of a minimum of four quarterly monitoring events with groundwater levels measured to confirm that groundwater flow direction was away from the on-property drinking water well or other area wells. Consultant Hobbit Environmental undertook the last three of the four quarterly monitoring events and reported the results in a letter report with subject line *Summary of Groundwater Monitoring Results, 629 Tazlina Terrace, Copperville, Alaska*, dated March 6, 2017. The report was received by ADEC on March 23, 2017 with a letter by First National Bank counsel requesting a cleanup complete determination. The report findings confirmed that the water well on the property was upgradient with respect to groundwater flow direction during all four monitoring events.

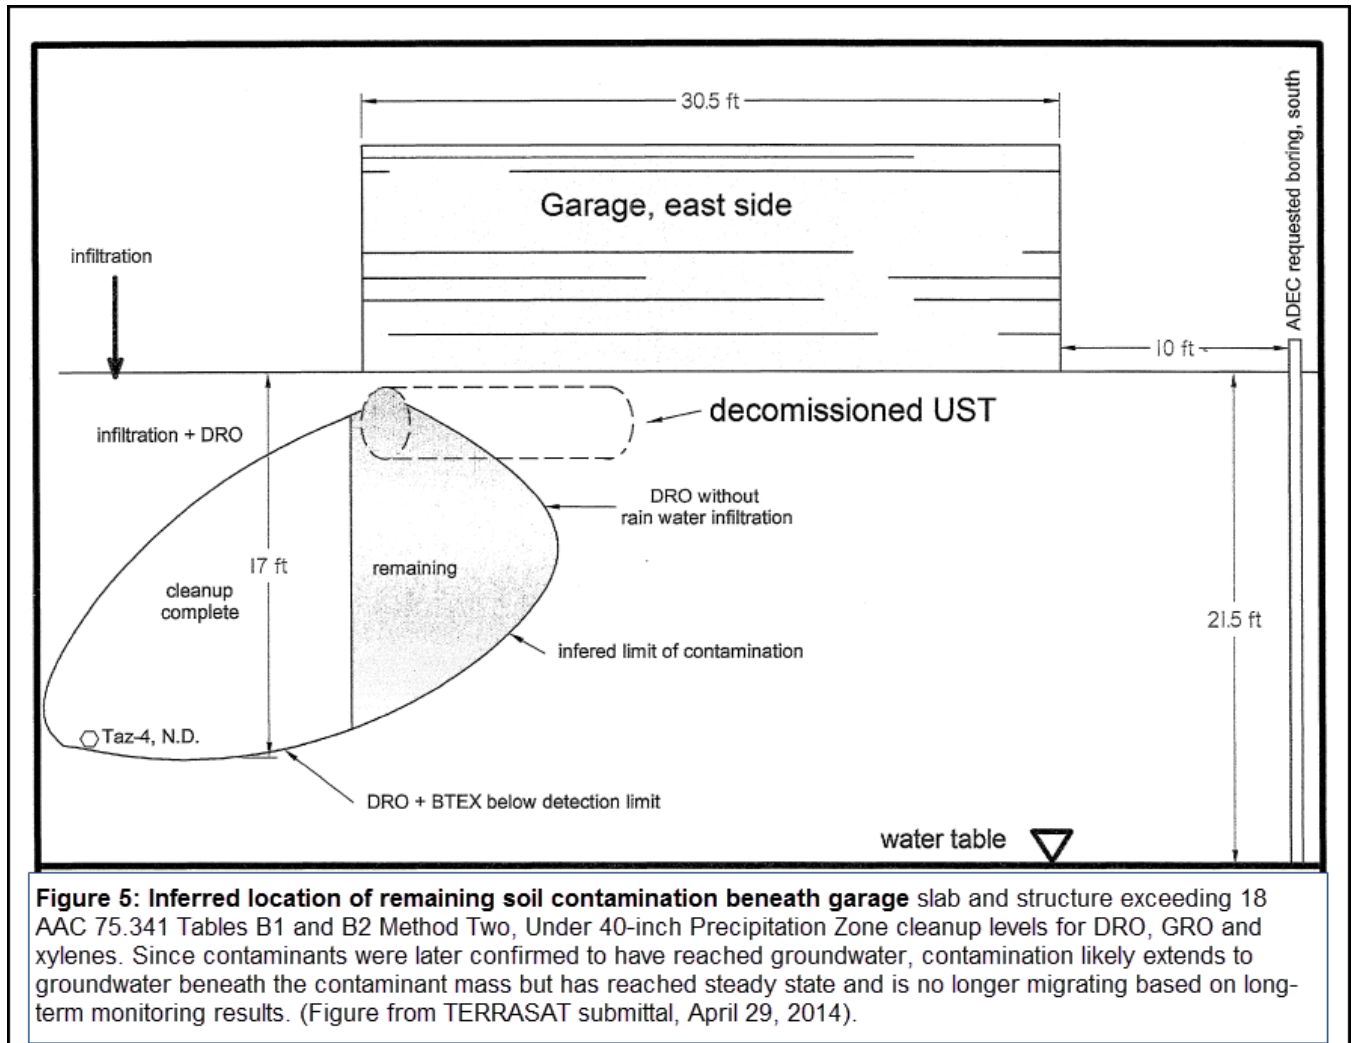
Consultant TERRASAT, Inc. estimated in correspondence dated July 15, 2014 that approximately 85 tons of soil contaminated above migration to groundwater cleanup levels for the compounds of concern remains in soil beneath the garage, with the approximate location of the remaining volume of contaminated soil shown on **Figure 5**.

Soil contamination at the site has been cleaned up to concentrations below the approved human health cleanup levels suitable for residential land use. The contaminated soil remaining beneath the garage structure could not be removed without jeopardizing the building structure. No groundwater contamination exceeded cleanup levels during long-term monitoring, and groundwater flow direction was consistently away from area and on-property drinking water wells during all monitoring events. The remaining contamination present in subsurface soil exceeds migration to groundwater cleanup levels for the compounds of concern but does not exceed human health, ingestion or inhalation levels for any compound.
