1999 SITE INVESTIGATION REPORT  
CITY OF KENAI MAINTENANCE SHOP  
KENAI, ALASKA

PROJECT NO. 99-5  
MAY 11, 2000

Subject: Kenai Maintenance Shop 1999 Investigation Report

ADEC Spill # 94-23-01-101-02

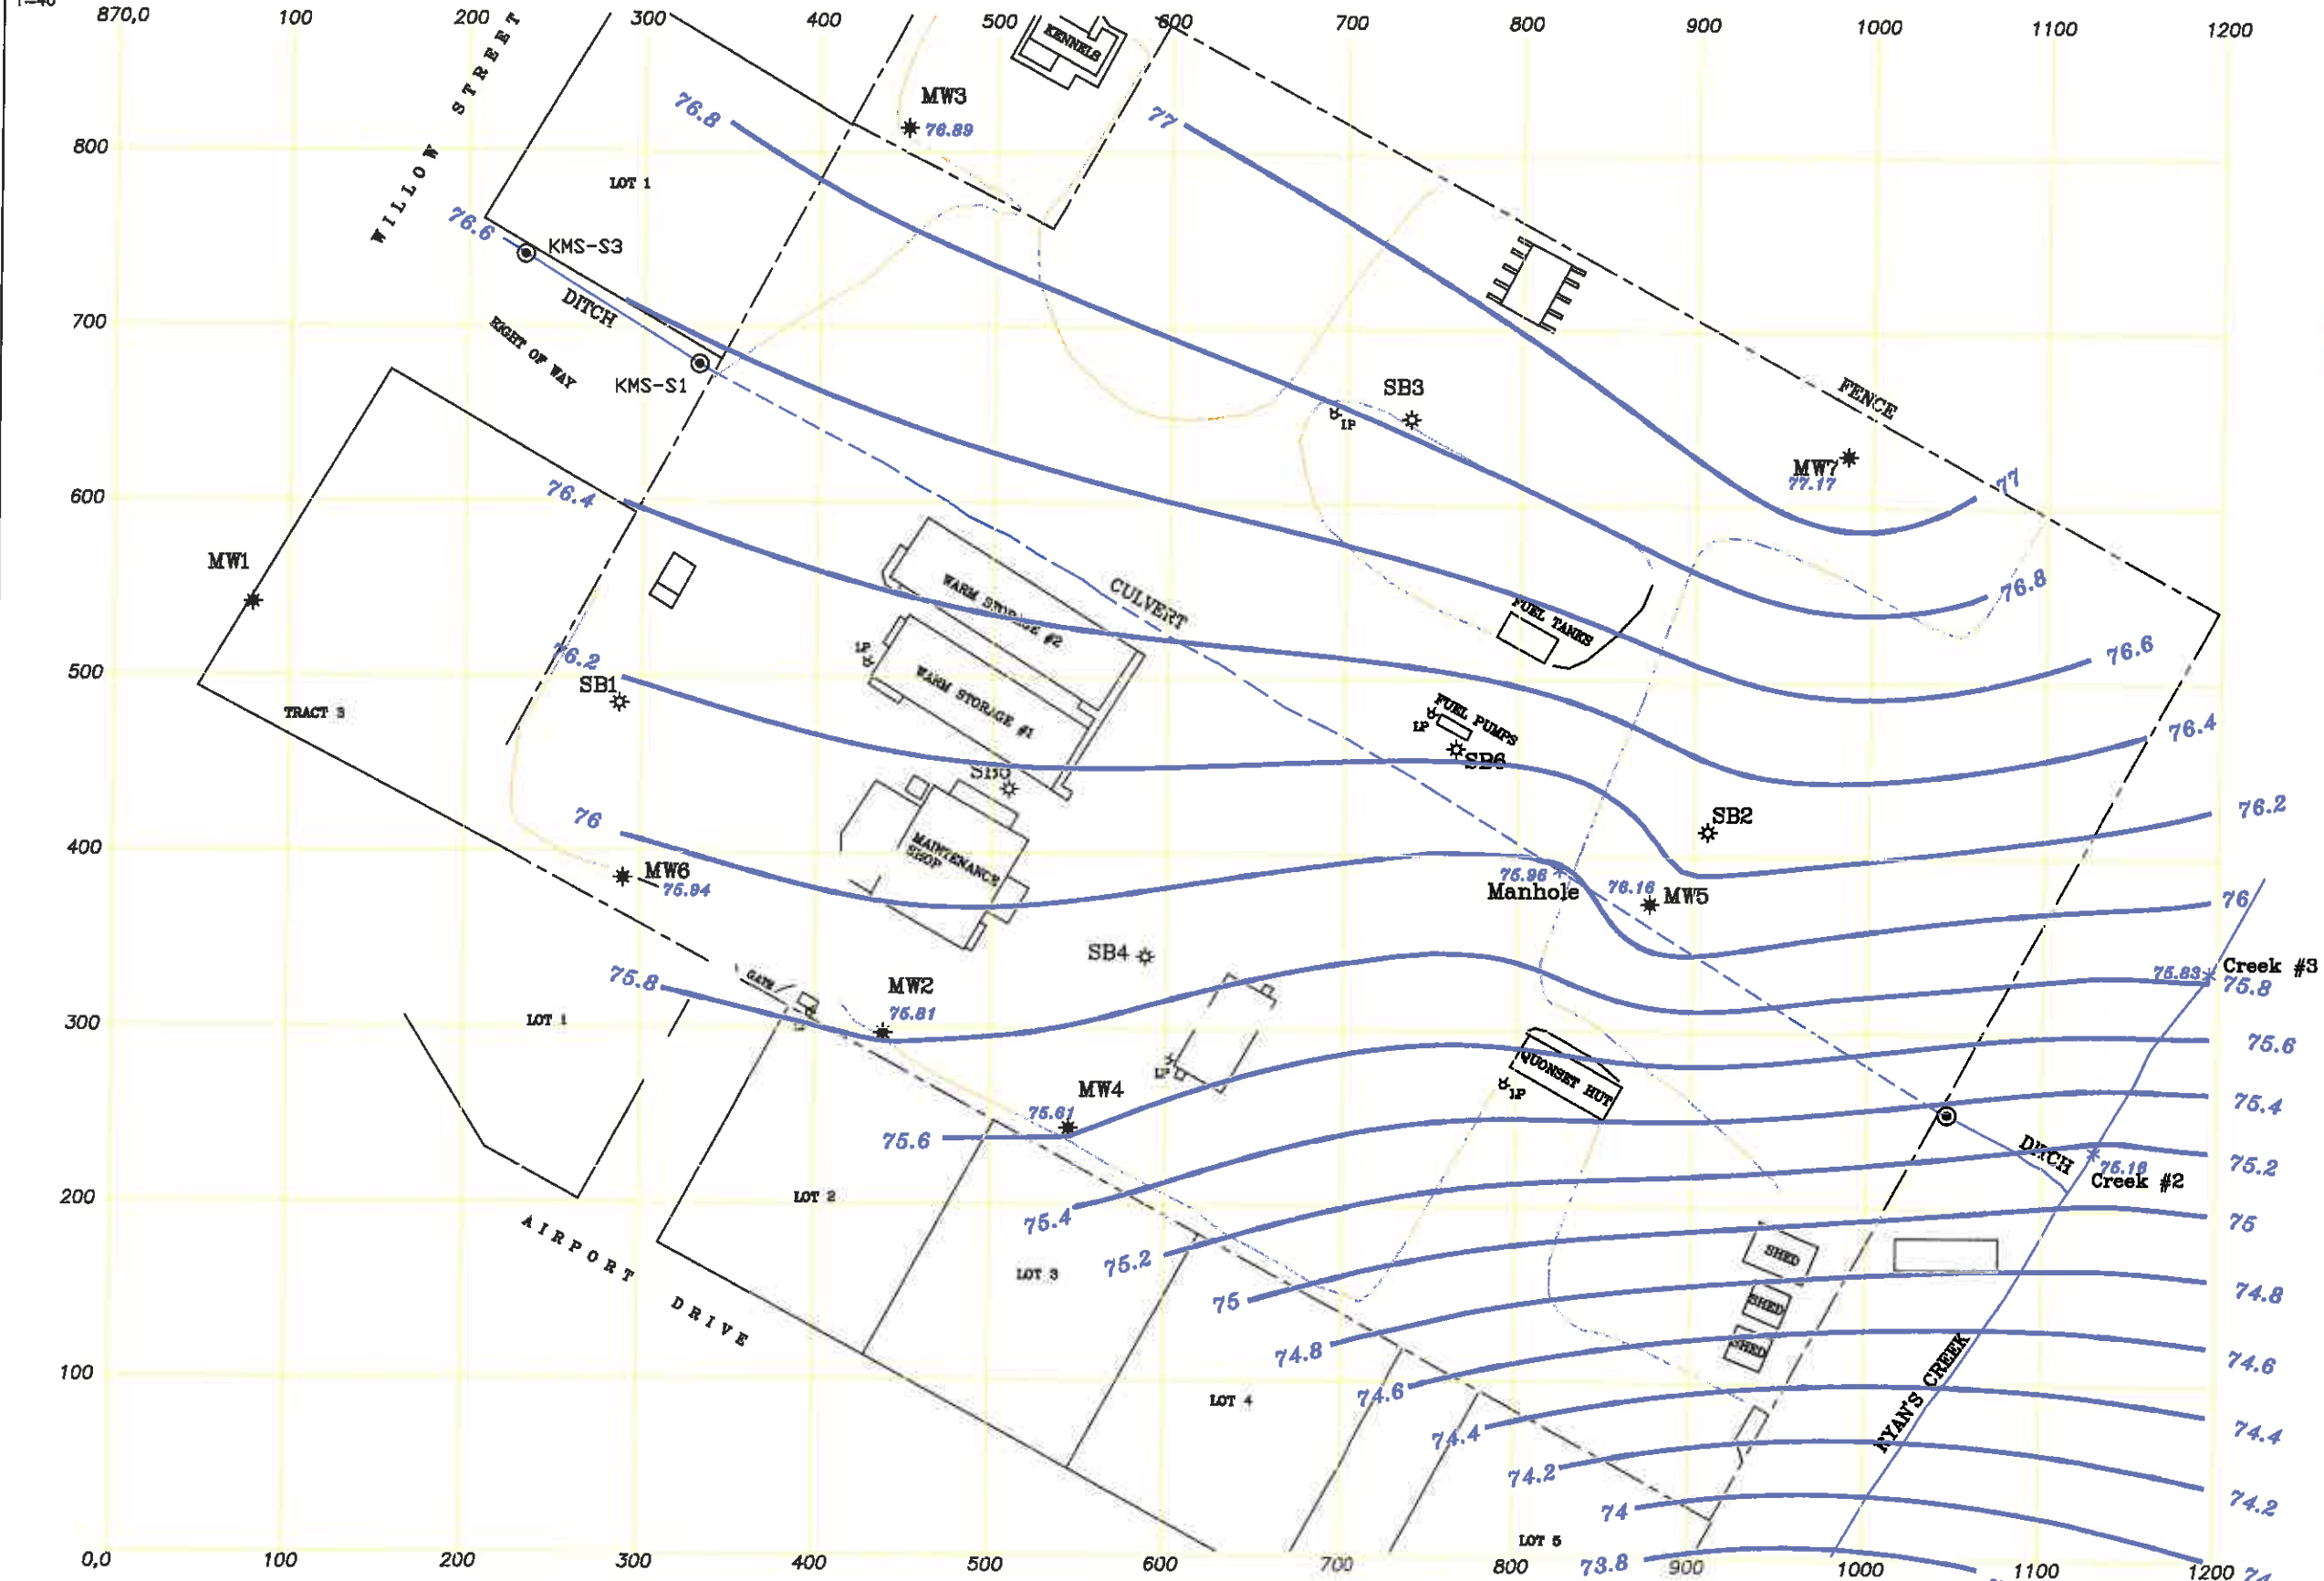
Groundwater Contours 7/22/99

Groundwater flows south-southwest at the maintenance shop (Figure 2). Groundwater occurs from 6.4 to 10.3 feet below ground level (BGL). It appears, after measuring the elevation of the surface water at the site that surface water is hydraulically connected to the groundwater table.

Based on the elevation data compiled in Table 1, and the groundwater contour map presented on Figure 2, groundwater flow is to the south-southeast. Information was also gathered from a property located to the southeast of the maintenance shop. The Halliburton property, located on the corner of Trading Bay Road and Airport Way, has eleven monitoring wells on site. Based on information submitted to ADEC by Halliburton, groundwater flow at the site is also to the south-southeast.

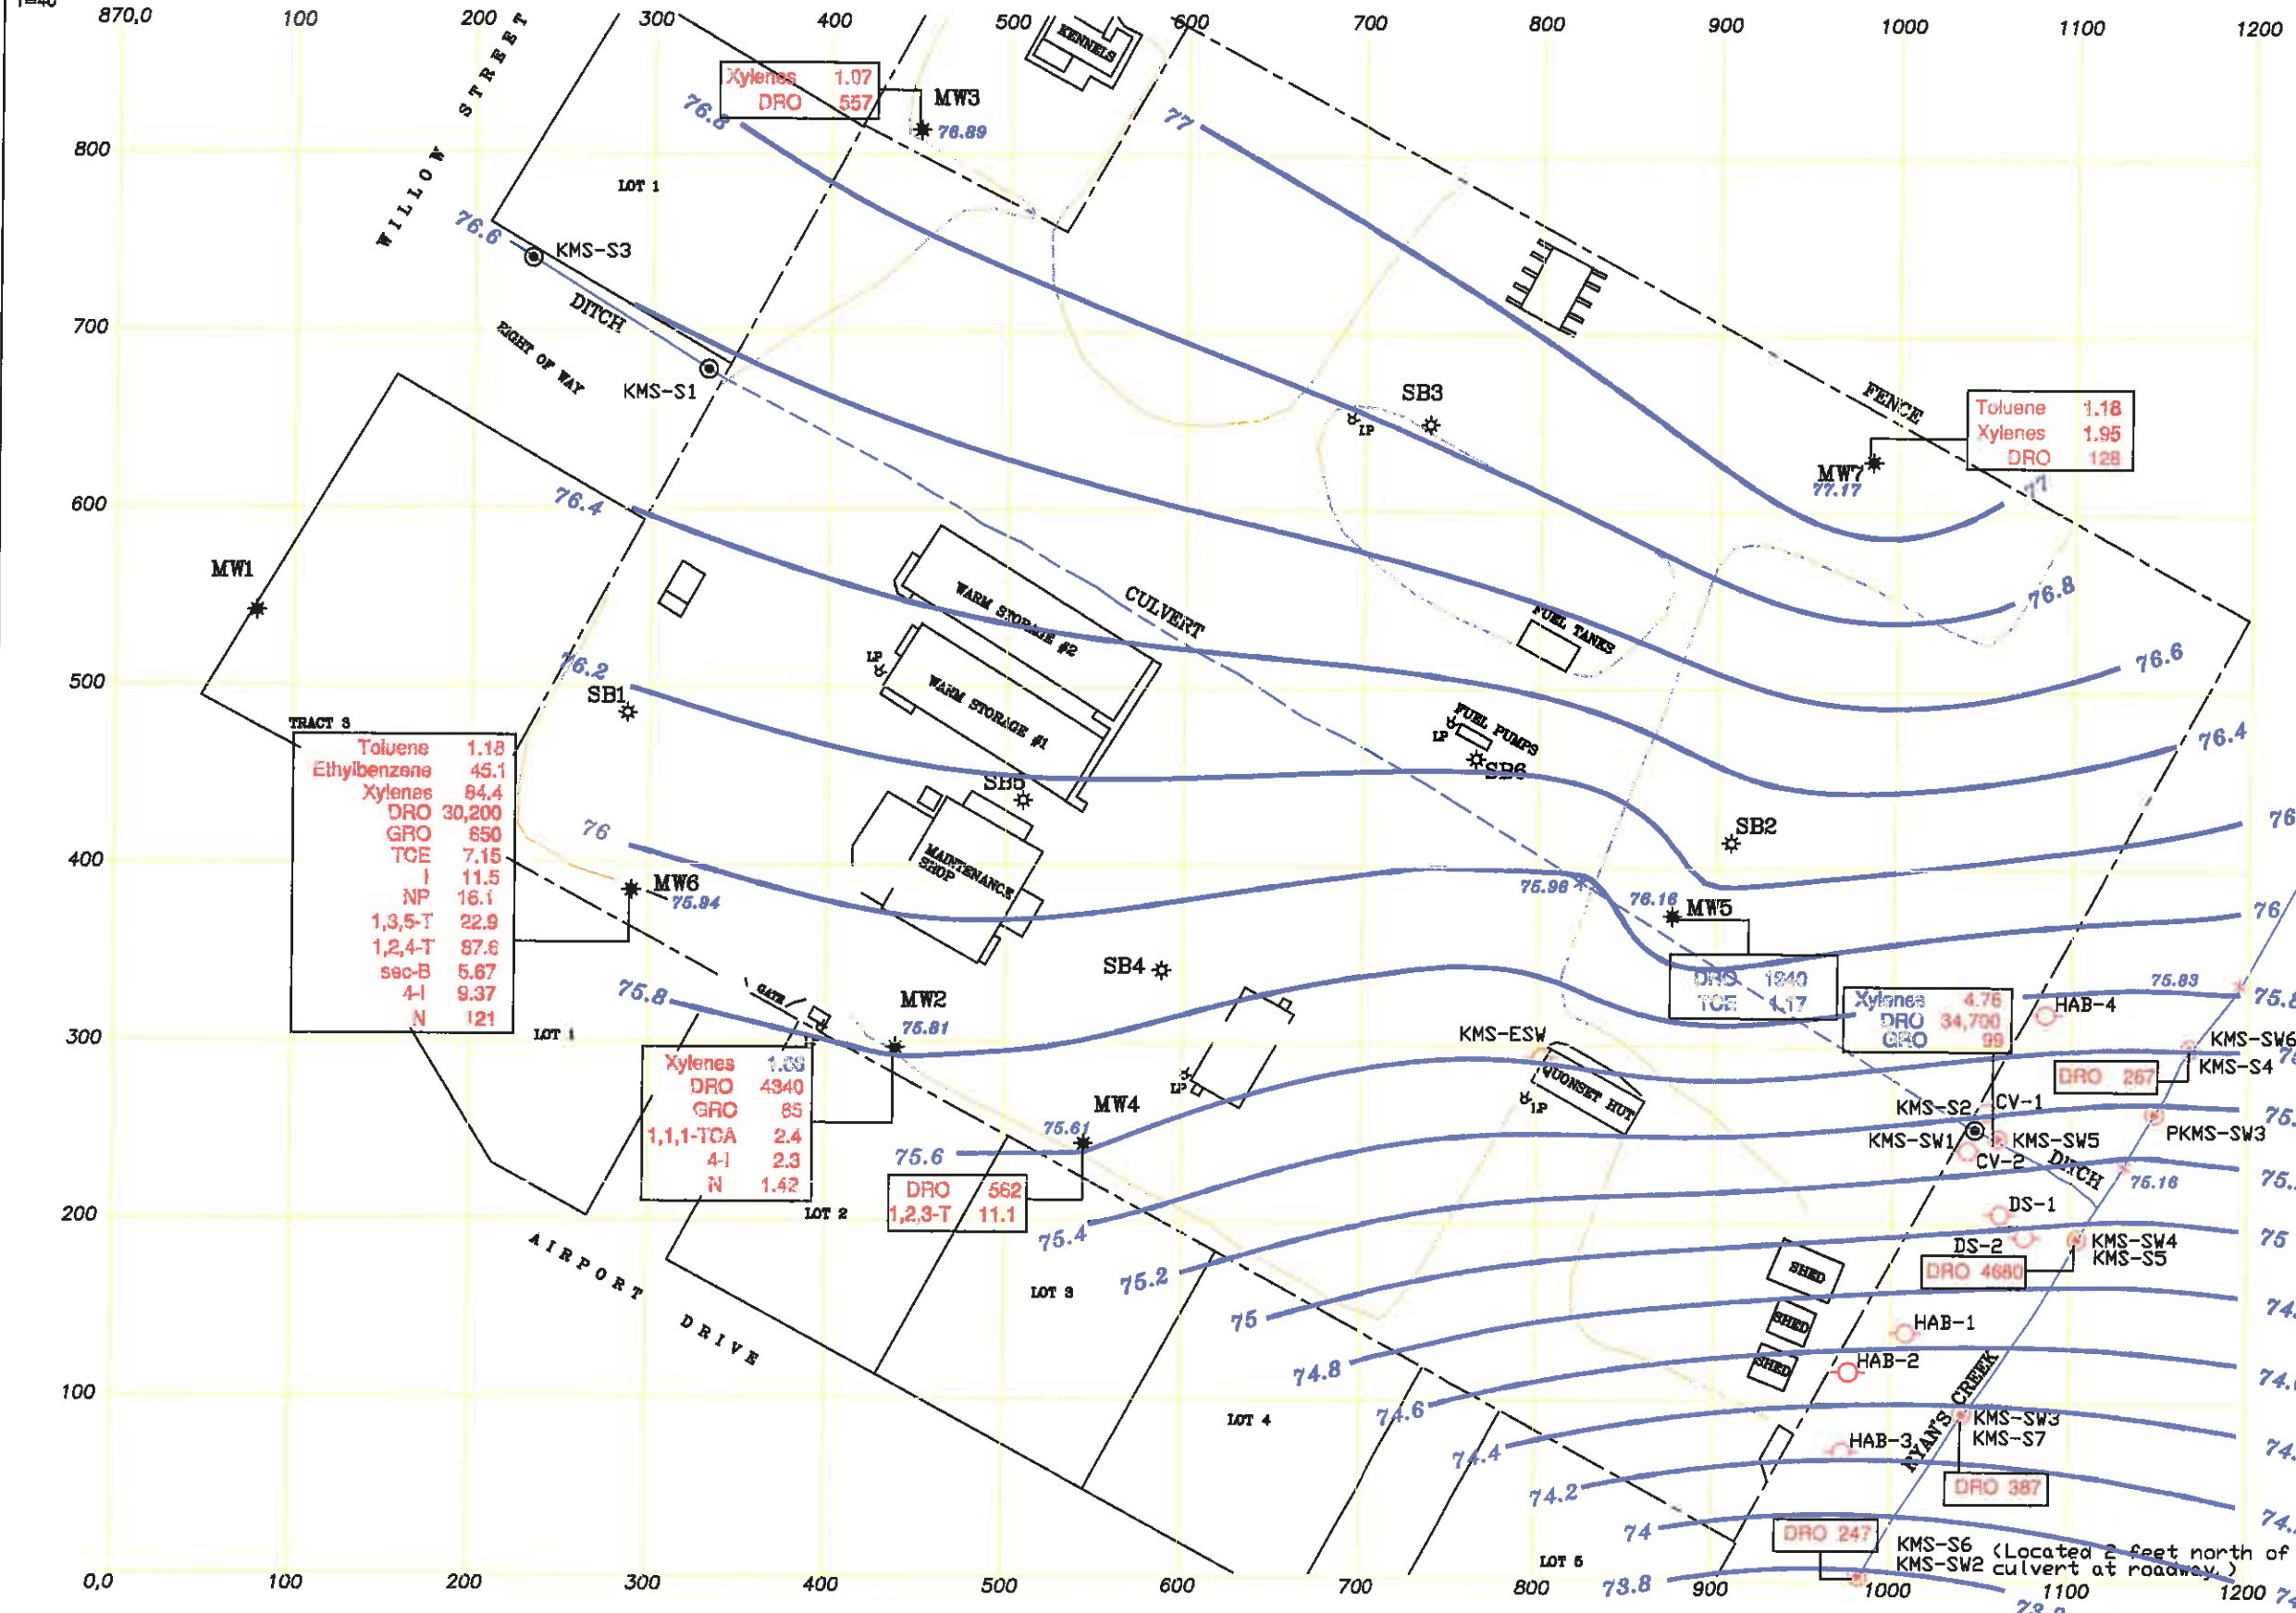
It appears that diesel contamination extends downgradient from the culvert and into Ryan Creek for some distance under the conditions present at the time of sampling. This part of Ryan Creek was in a low flow condition at the time of sampling, and based on the type of vegetation in the creek bed, this is rarely a fast moving waterway. A heavy rainfall could disturb the contaminated sediments and spread contamination downgradient.

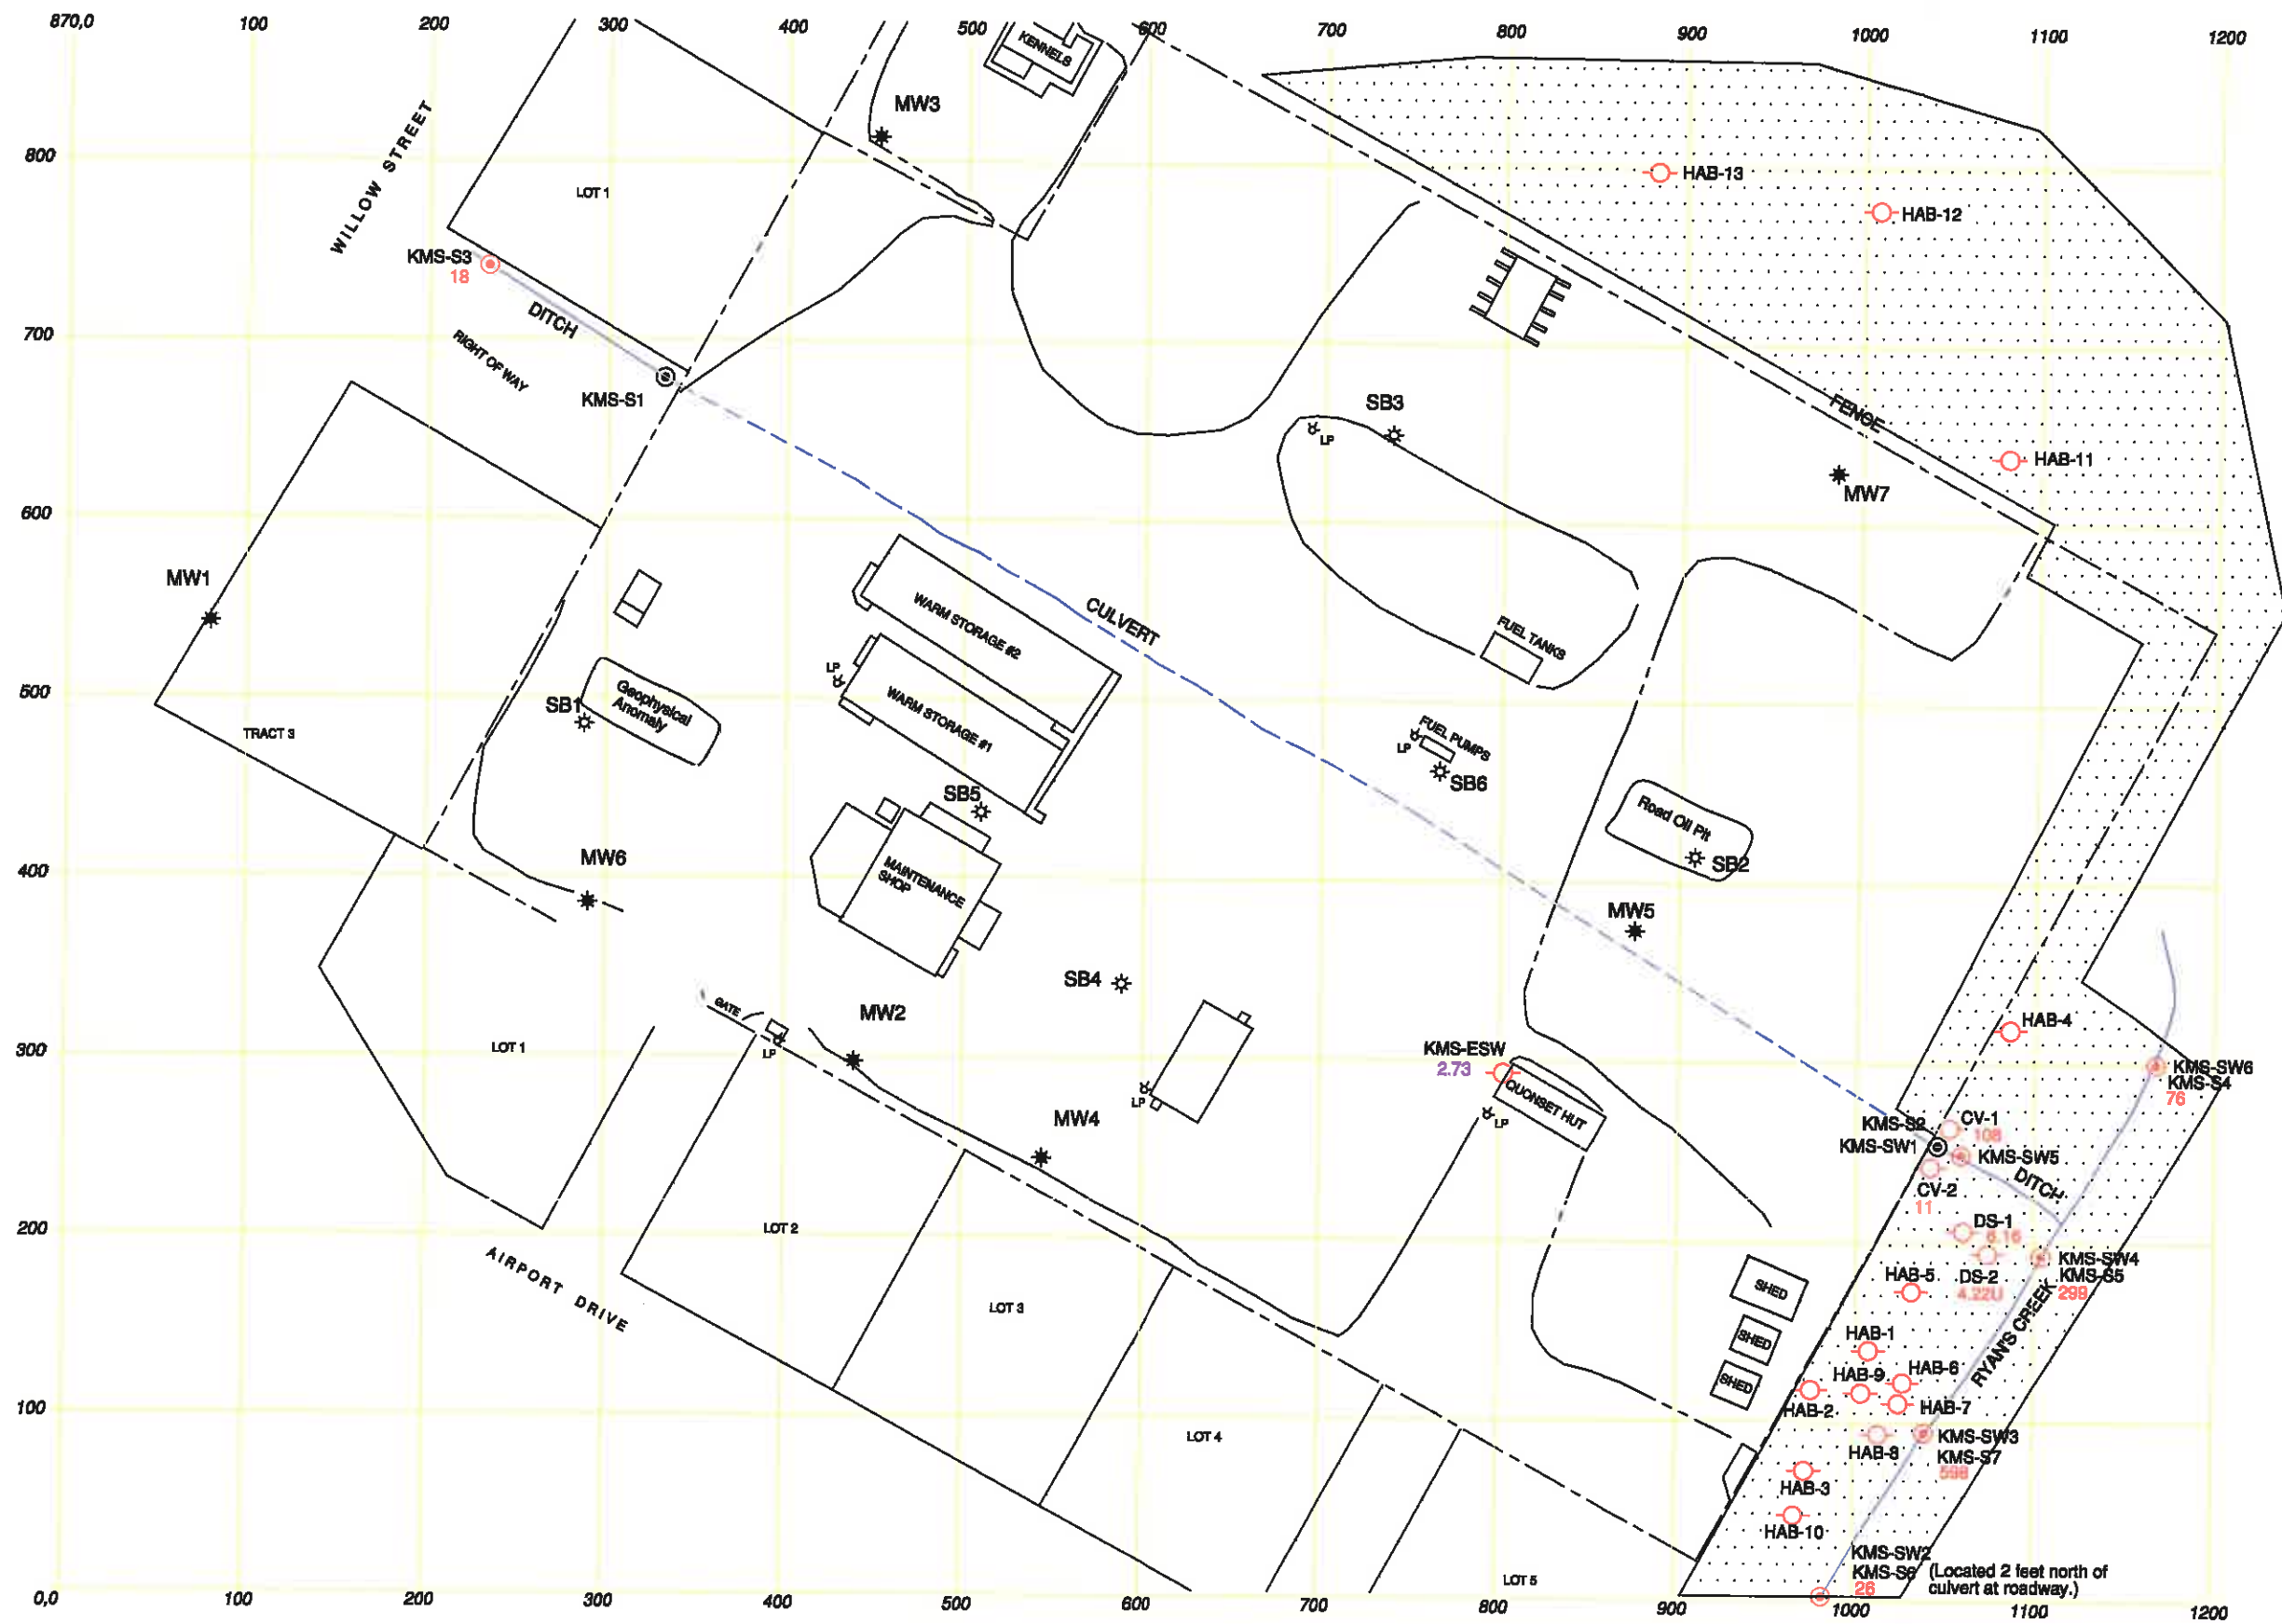
An area of soil staining was encountered outside the front of the Quonset hut. An area about six inches in diameter was noted north of the entrance door. It appeared to be a small quantity spill based on the surface area, but the depth of the soil contamination is unknown. As discussed previously the field test kits did not perform adequately, so a laboratory sample was collected. A soil sample was collected from the stained soils approximately 6 inches below ground level. The sample location is presented on Figure 4. Analytical results indicated 2.73 mg/l of Aroclor 1260 was present in the soil sample (Table 7 and Appendix A).

The regulations define the requirements for cleanup in part 125. PCB waste must be properly stored, labeled and disposed of by a certified remediation contractor. The cleanup goal is 25 ppm (761.125( c ) (ii). Because the sample was collected from the surface, there is a potential for greater concentrations to be present at depth. PCB spills require immediate cleanup. Based on the low concentration of PCB's no further action is recommended on these soils.

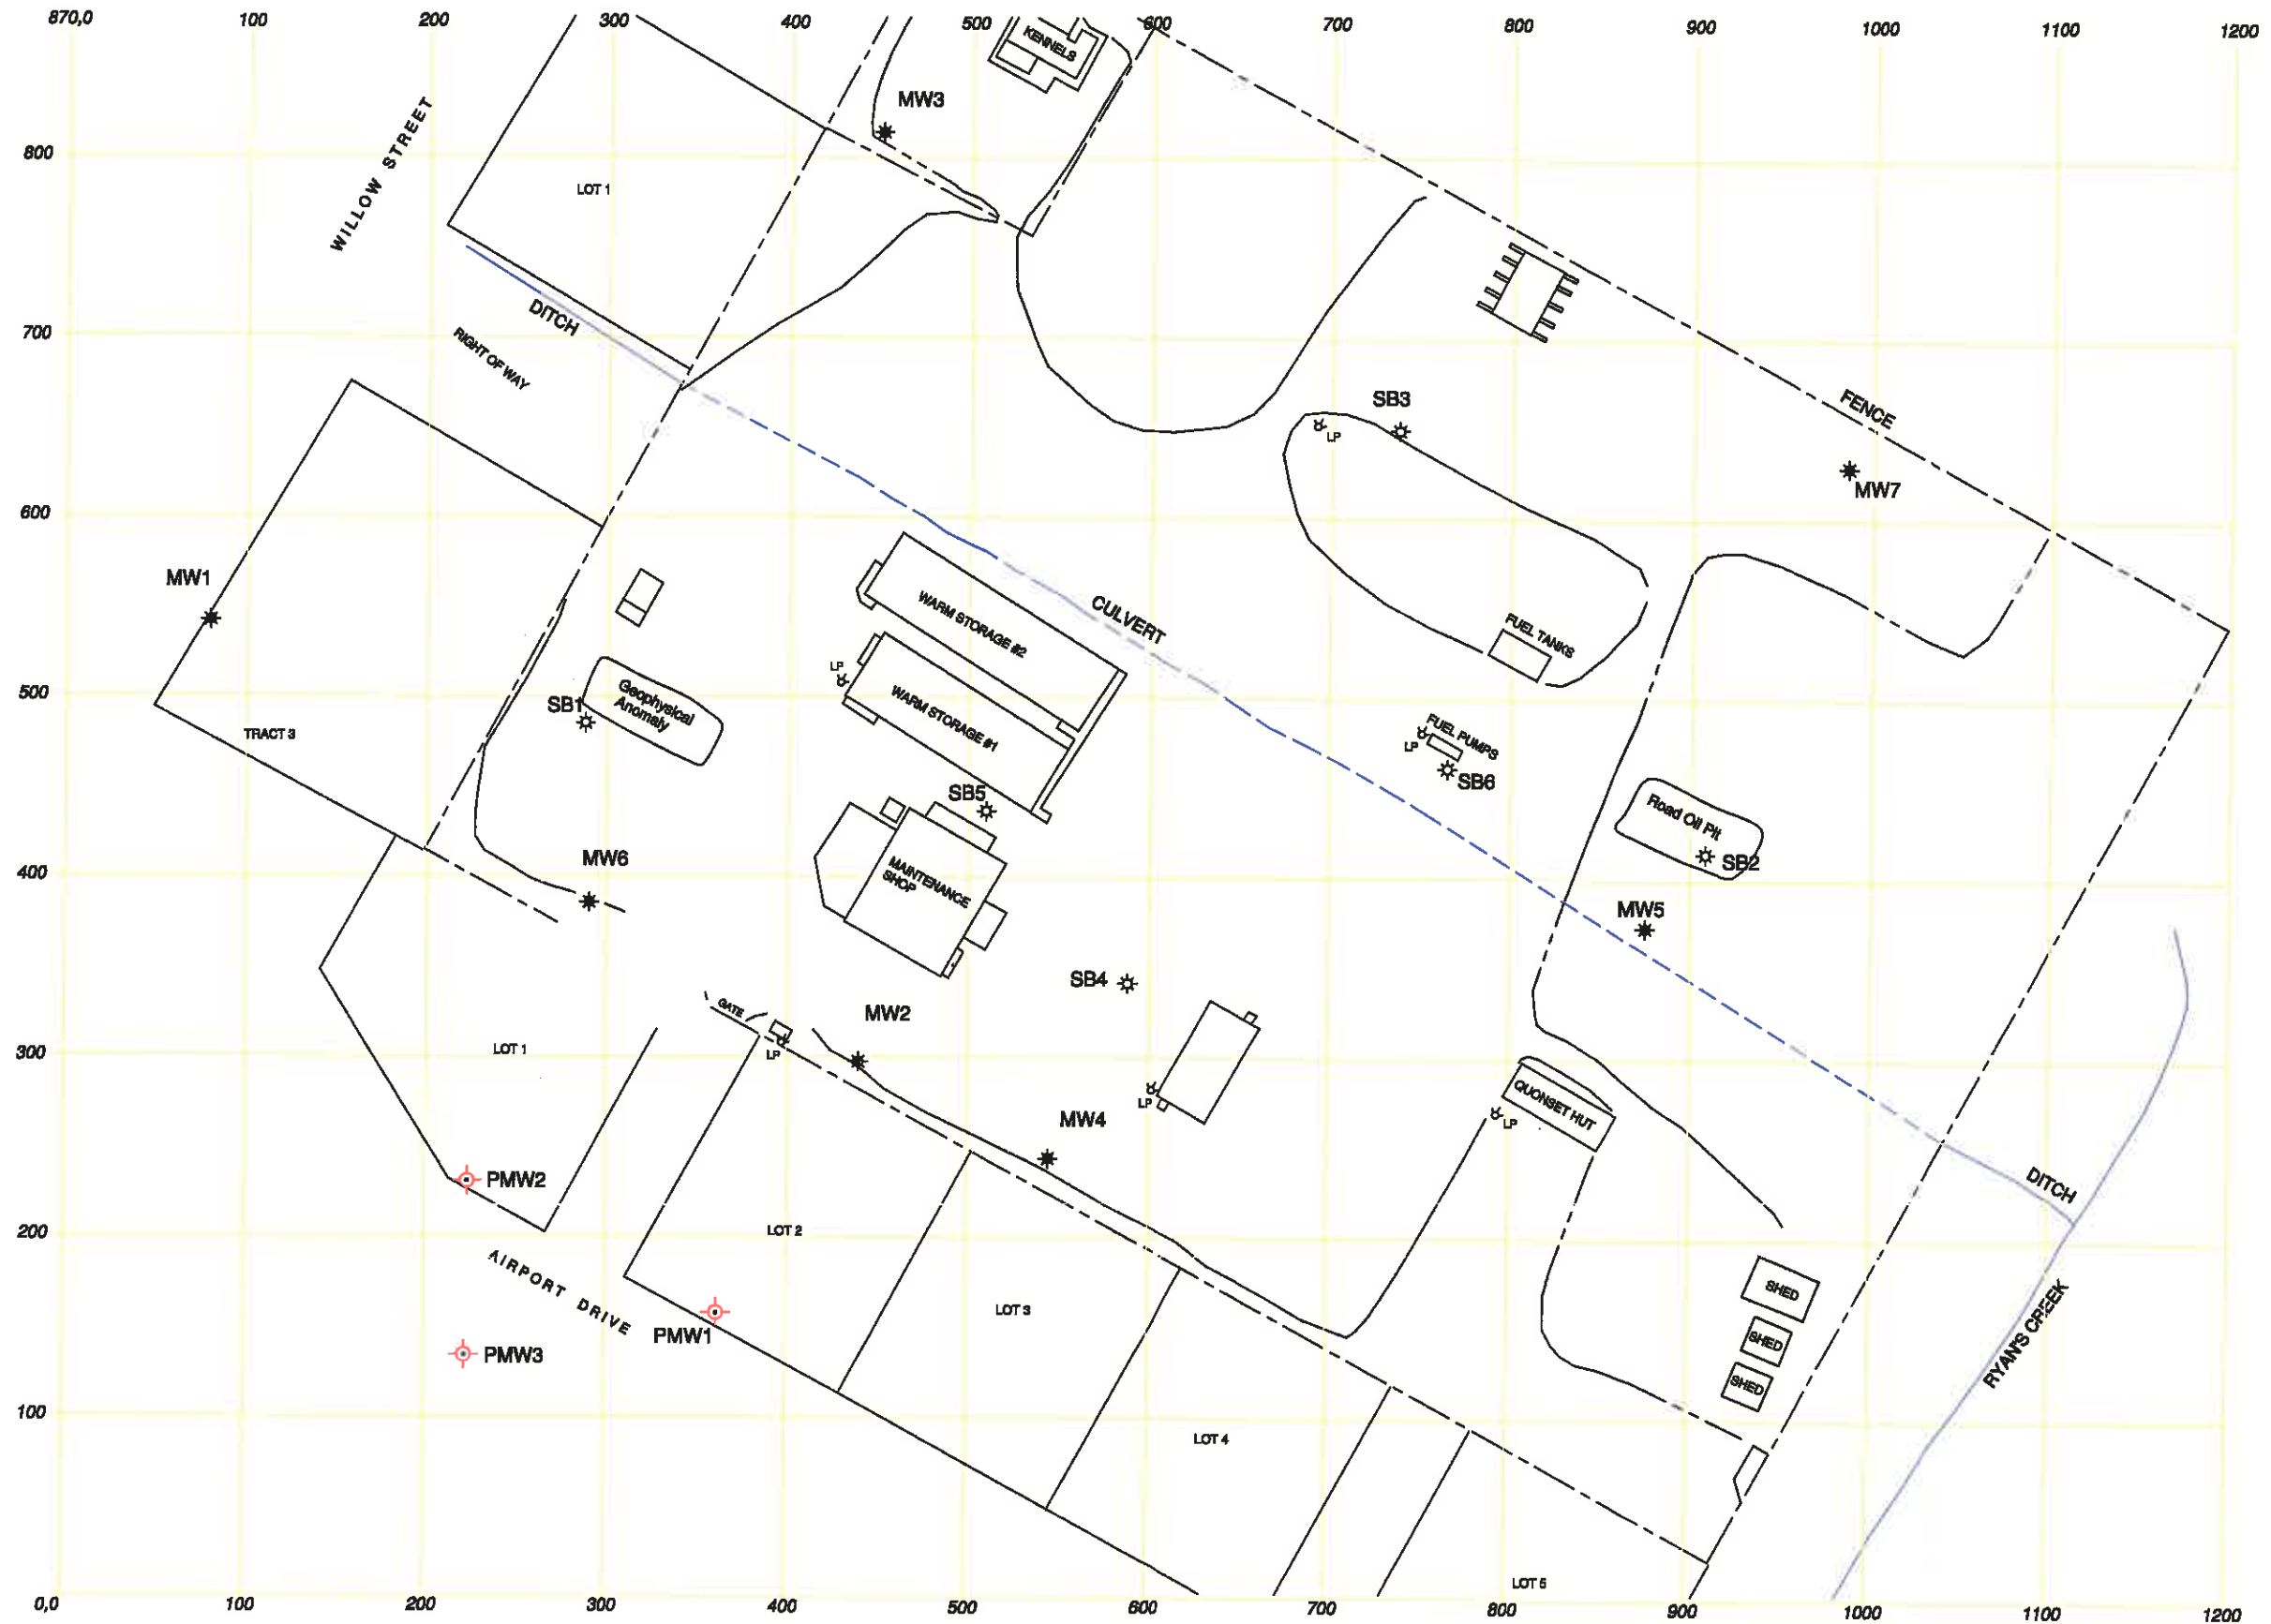
MW-6 is located at the south property line fence, with groundwater flowing to the south. Groundwater flow is transporting contaminated groundwater off site to the south for an unknown distance toward Airport Way. In order to further define the extent of groundwater contamination moving off site we recommend downgradient monitoring wells be installed. Proposed well locations are presented on Figure 5. A series of three wells downgradient from the site should delineate the groundwater plume. The wells would be sampled for parameters measured in this sampling event. There may be some problem distinguishing between contamination emanating from the old Carver property. Information gathered from the new wells will require analytical testing designed to distinguish between jet fuel and petroleum, including examination of the chromatograms

After soil removal, we recommend that groundwater monitoring continue for two years to determine the level of groundwater contamination prior to proceeding with any groundwater remediation. If groundwater remediation were found to be necessary, we recommend that the City examine the possibility of installing a lift station with a skimmer that would send water to the wastewater treatment plant among remedial alternatives.
