**Re: Decision Document: Alaska Aerofuel Vehicle Rollover – Easy Street
Cleanup Complete Determination**

Alaska Aerofuel Vehicle Rollover – Easy Street
Corner of Lakeview Terrace and Easy Street
Fairbanks, Alaska 99701

Asphalt Boring Field Screening Results
 and Estimated Remaining Contaminated Areas
 Easy Street Fuel Spill
 Fairbanks, Alaska

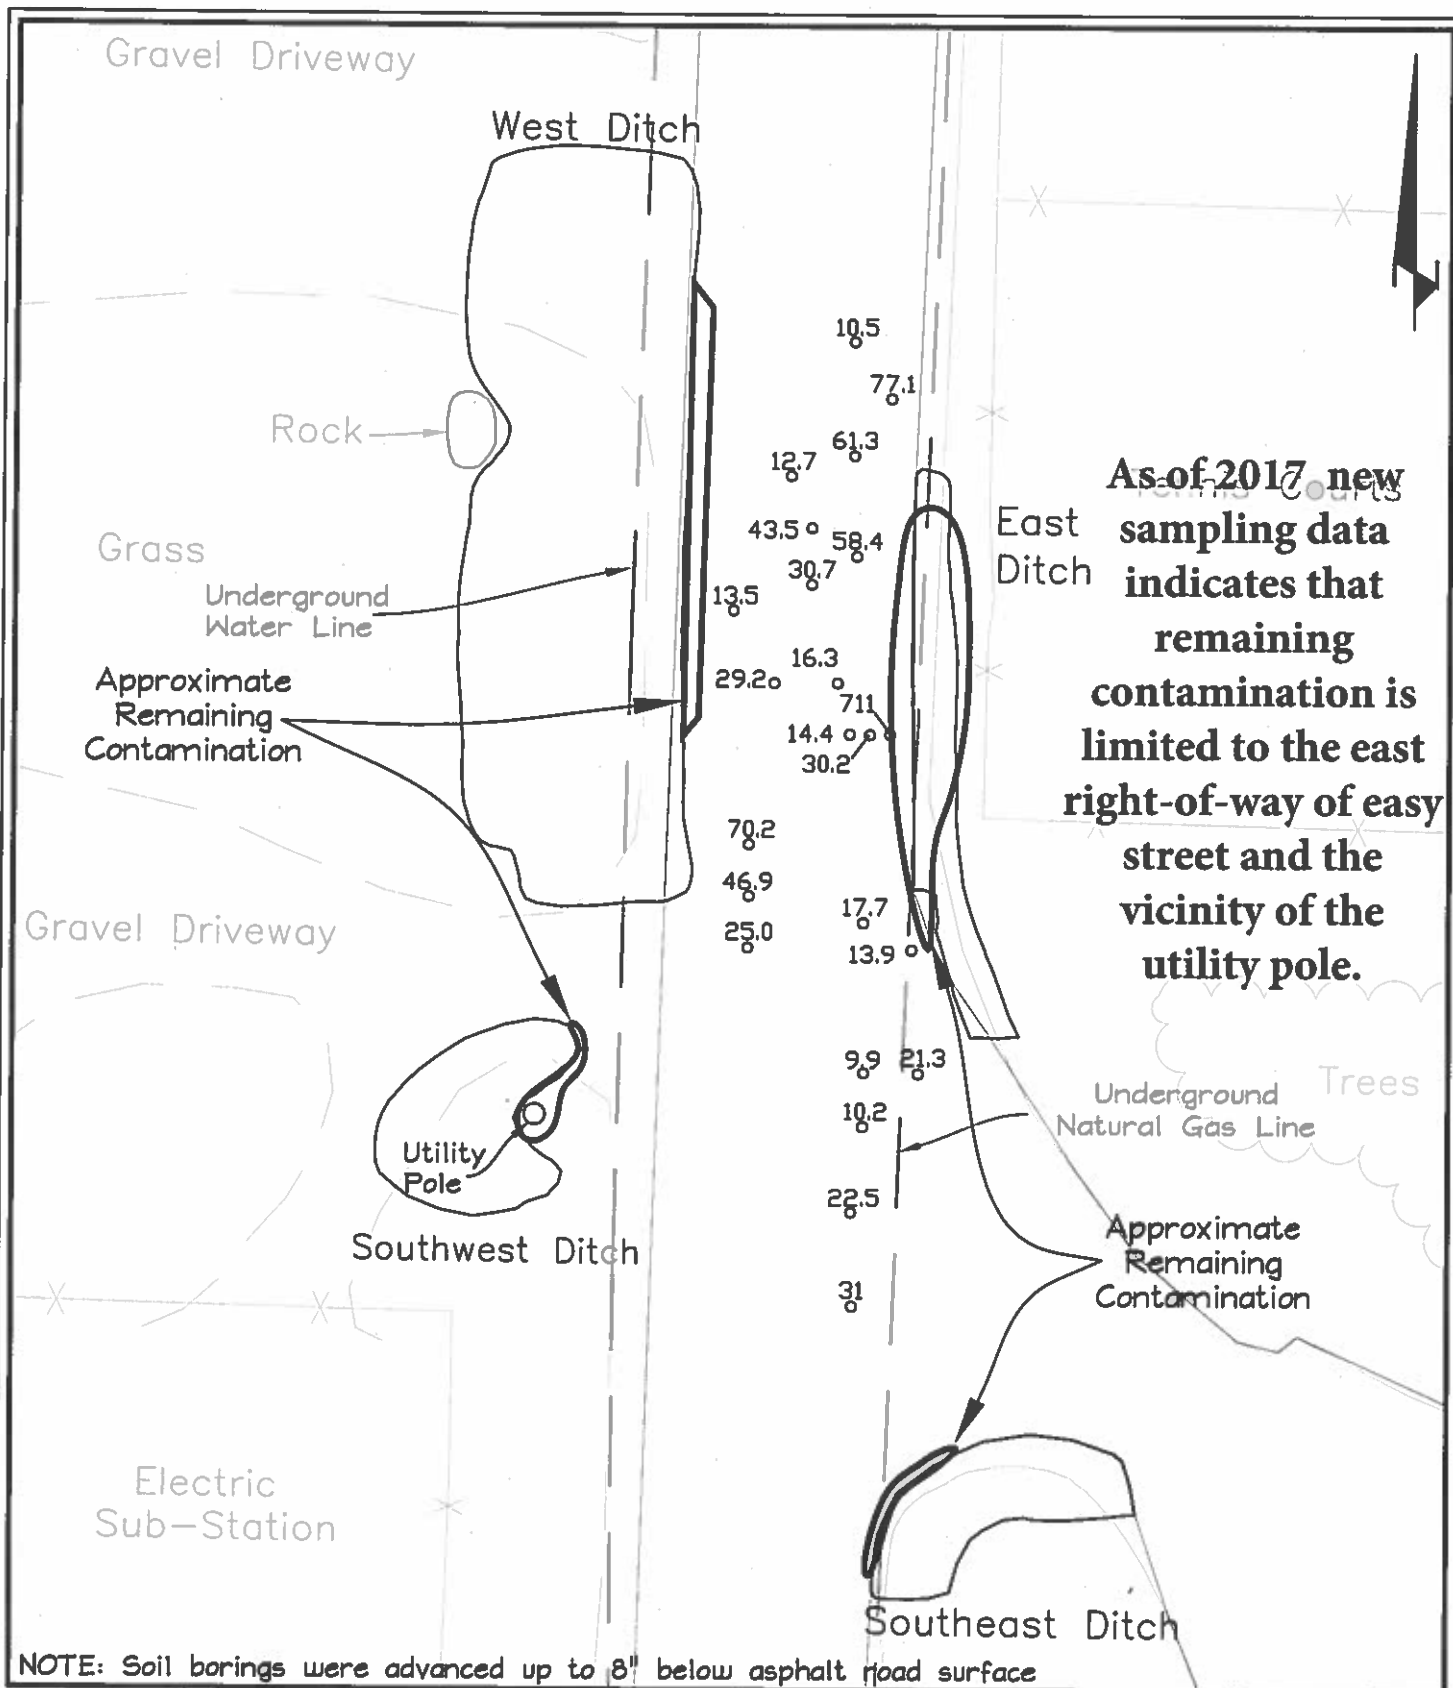
Contamination was left in place in the excavation sidewalls in the the west, east, southwest and southeast ditch excavations. During characterization of the final excavation limits, analytical samples were collected from the locations with the highest field screening results in each excavation (see attached figures for excavation locations). In November 2017, soil borings were installed in each area to evaluate soil conditions near residual contamination and were completed as temporary well points to assess possible impacts to groundwater.

After initial cleanup soil contamination remained in the following locations:

- The west ditch excavation was located between the sun-air sheet metal business and the DOT&PF roadway; 340 cy of contaminated soil were removed from this excavation and an estimated 12 to 15 cy were left in place under the roadway. The soil boring advanced in 2017 indicated that soil contamination in the right-of-way had attenuated to below the soil cleanup levels.

- The east ditch excavation was located between the DOT&PF roadway and the Alaska Club Fairbanks tennis courts; 180cy of contaminated soil were removed and an estimated 52 cy were left in place due to a natural gas line at 3 feet below ground surface (ft bgs). The soil boring sample collected near the tennis courts in the northern extent of the former excavation in 2017 did not contain detectable levels of any contaminants.

- The southwest ditch excavation was located on the Golden Valley Electric Association (GVEA) substation and Easy Street Mini Storage properties; 150 cy of contaminated soils were removed and an estimated 15 cy were left in place surrounding the utility pole. The soil boring west of the utility pole found DRO contamination still exceeded the soil cleanup levels in 2017.

- The southeast ditch excavation was located on the corner of Easy Street and the Lakeview Terrace Trailer Court where the truck rolled over; 50 cy of contaminated soils were removed and approximately 3 to 4 cy were left in place due to the adjacent roads and buried natural gas line. The soil boring near the former excavation in 2017 indicated contamination in the right-of-way may have attenuated to below the soil cleanup levels.

Soil samples collected in 2017 indicate that remaining contamination is limited to the DOT&PF right-of-way and the GVEA substation land. DEC calculated a mean soil concentration for DRO in the areas of remaining contamination at 9,999 mg/kg, below DEC's ingestion and inhalation soil cleanup levels found in 18 AAC 75.341 Tables B1 & B2. Mean soil concentrations were calculated at a 95% upper confidence limit (UCL) as described in 18 AAC 75.380(c)(1) using the most conservative data collected from the contaminated excavation limits in 2011.
