**FORMER CUSTOM TRUCK
4748 OLD SEWARD HIGHWAY
ANCHORAGE, ALASKA**

**BUILDING INVENTORY
FOR VAPOR INTRUSION ASSESSMENT**

MAY 2013

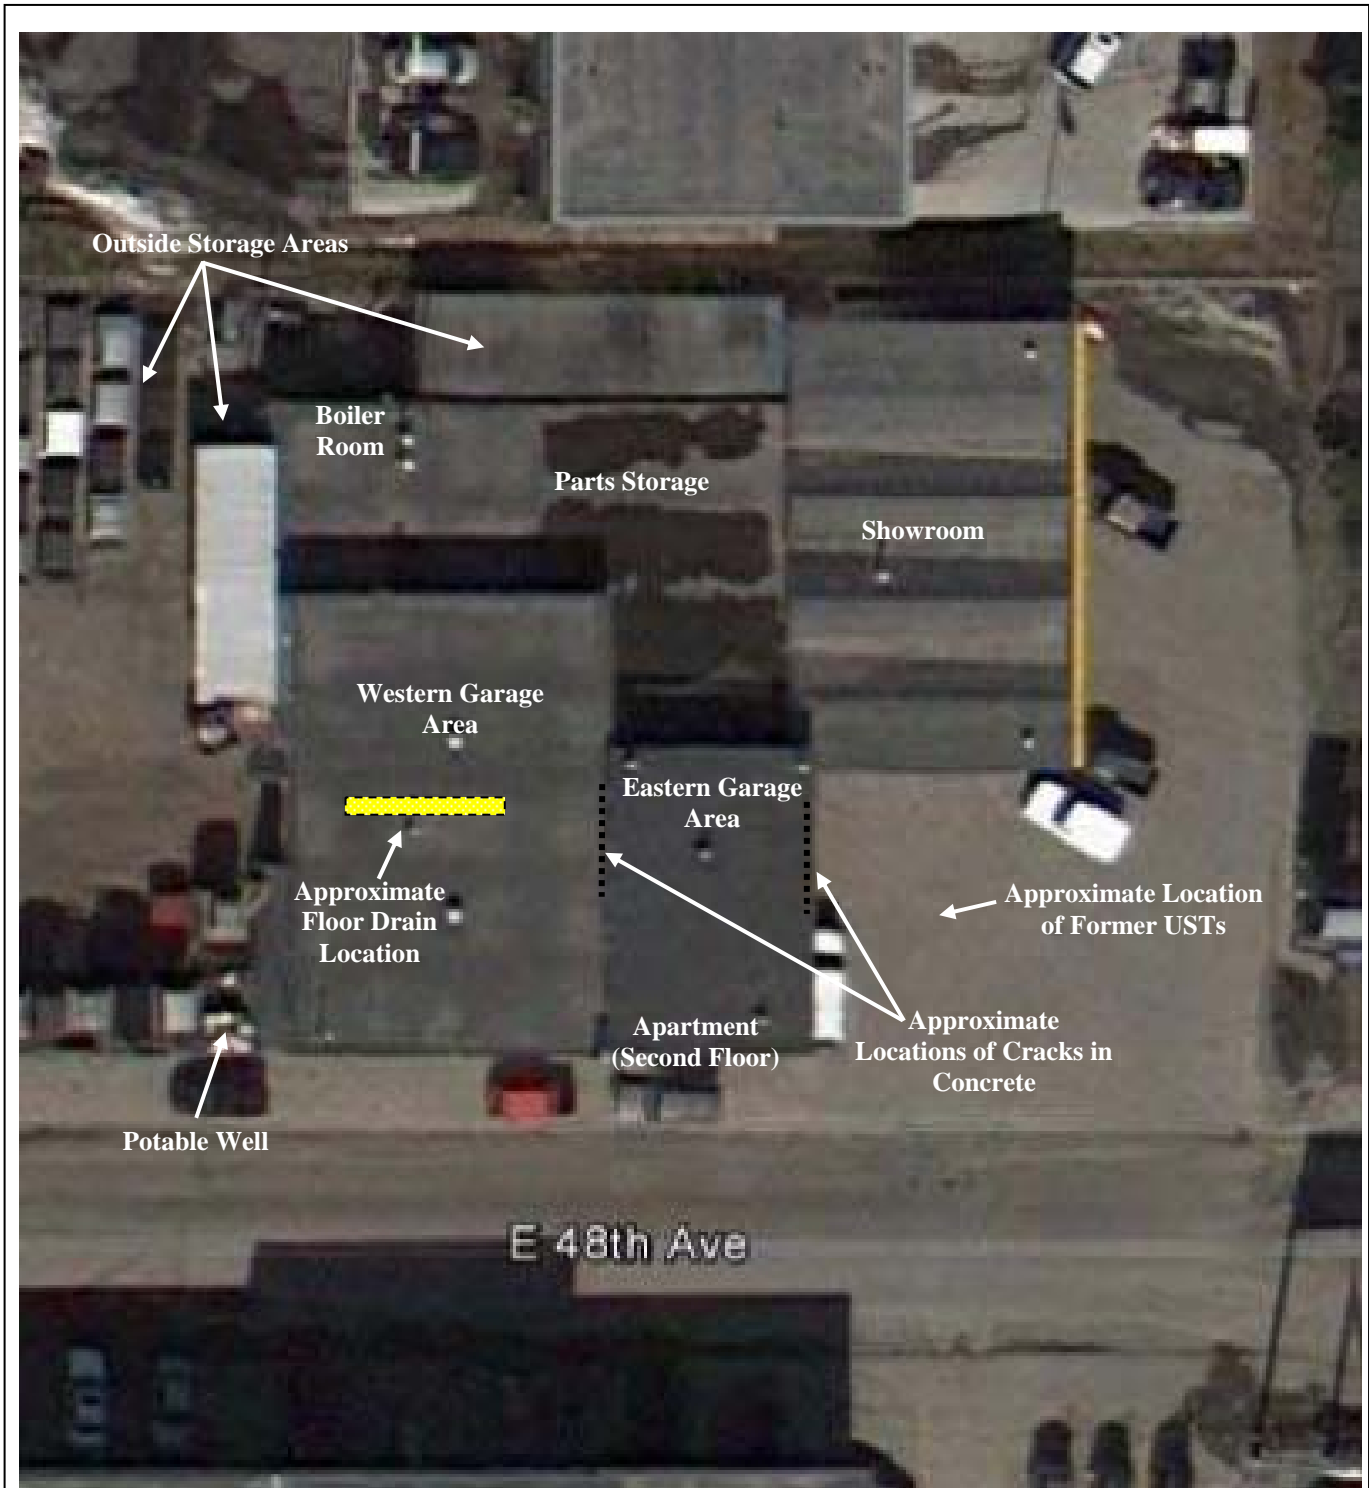
4748 Old Seward Highway Anchorage, Alaska Site Location Map		
BGES, INC.	May 2013	Figure 2

According to the Municipality of Anchorage (MOA) Property Information Database, the building on the subject property was constructed in 1968 and 1990. The building consists of a single story throughout most of the building and two stories in the southeastern portion of the building, where an apartment is located on the second floor (Figure 2).

A copy of the completed Building Inventory form is included in Appendix B. The potential vapor entry points are presented on Figure 2.

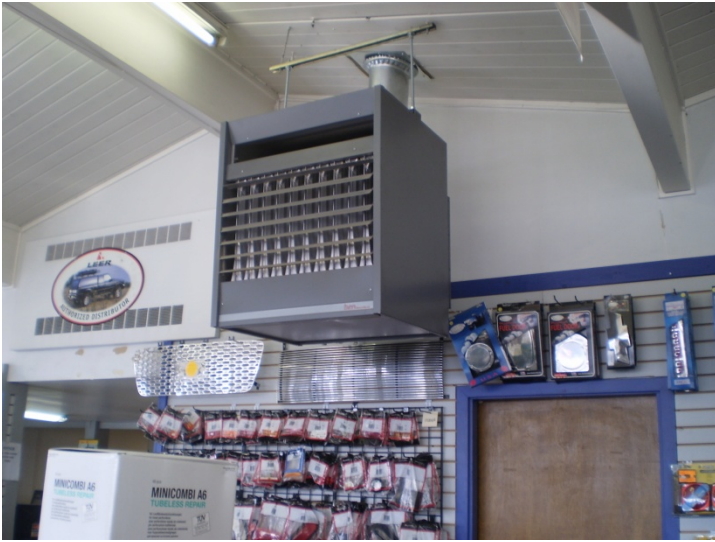
There are no air ducts located in the building. Three space heaters are utilized for heat in the building. One of the space heaters is located in the showroom area (Photograph 1 in Appendix A). The other two space heaters are located in the eastern and western garage areas (Photographs 2 and 3 in Appendix A). There are several vents located between the showroom and the attic area over the offices (Photograph 1 in Appendix A). Several indoor/outdoor passive fresh air vents were noted near the roof of the garage portion of the building.

Photo 1. Heater Located in Showroom

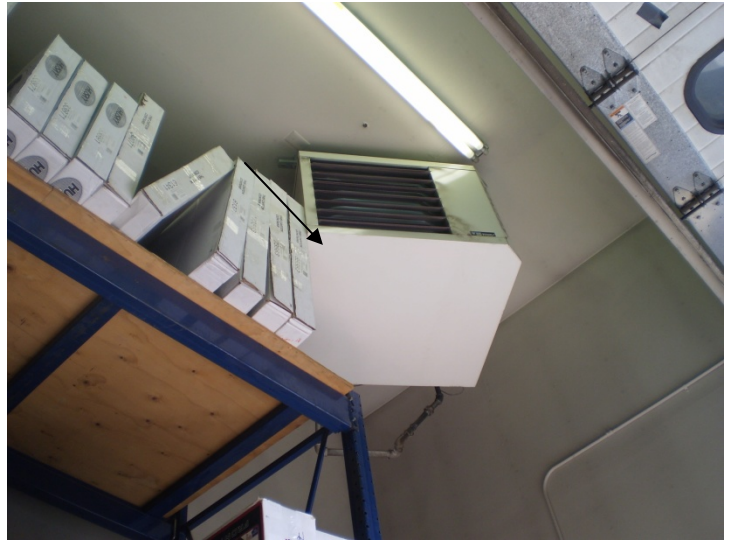
Photo 2. Heater Located in Eastern Portion of Garage

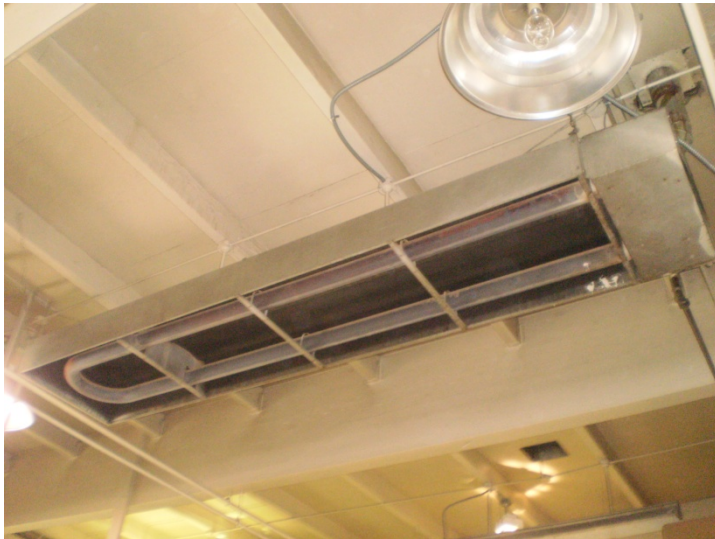
Photo 3. Heater Located in Western Portion of Garage

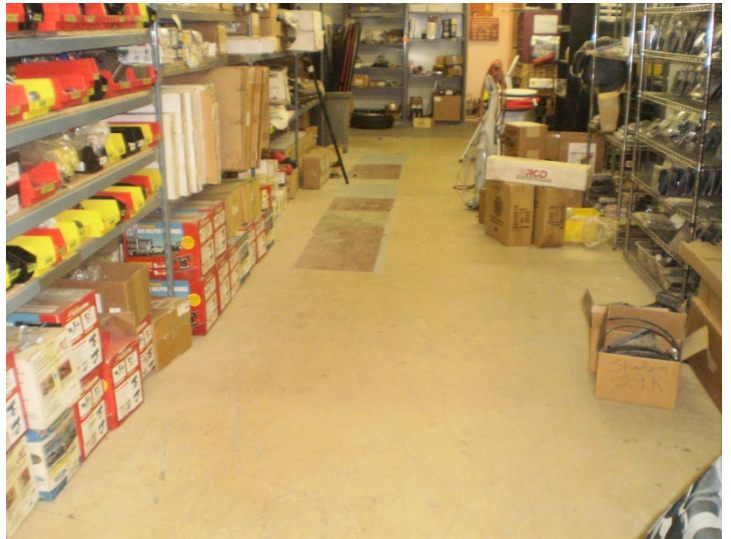
Photo 4. Floor in Parts Storage Area

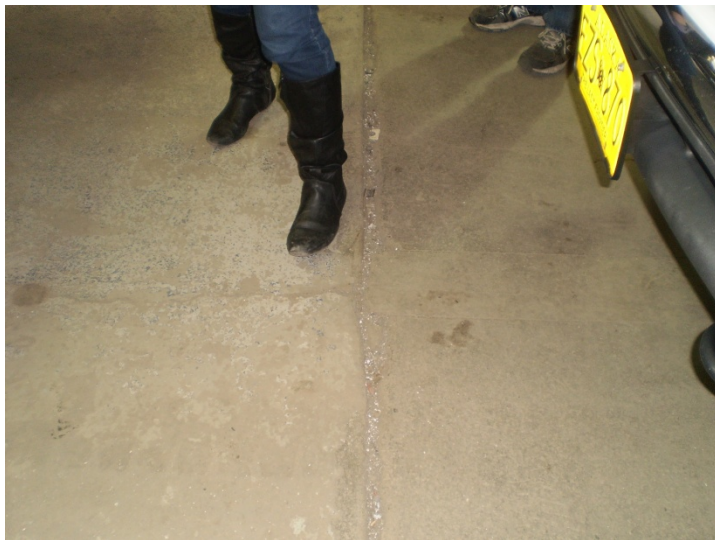
The only potential vapor entry points identified with respect to the building were the floor drain and the cracks through the concrete.

Photo 5. Crack in Concrete Between Garage Areas

CRACK BETWEEN EAST & WEST GARAGE AREAS (~ 1 to 2 inches wide)
CRACK BETWEEN EAST GARAGE AREA AND ASPHALT PARKING LOT
(APPROX. 1 to 2 inches wide)

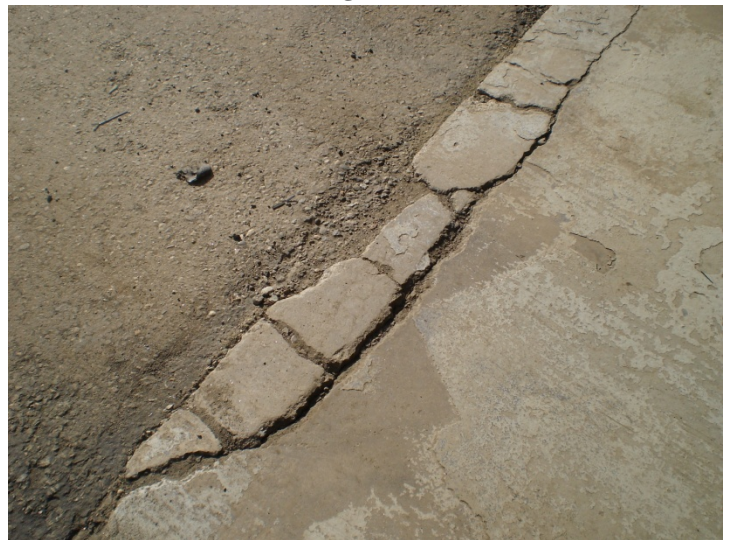
Photo 6. Crack in Concrete Between Garage and Outside Wall

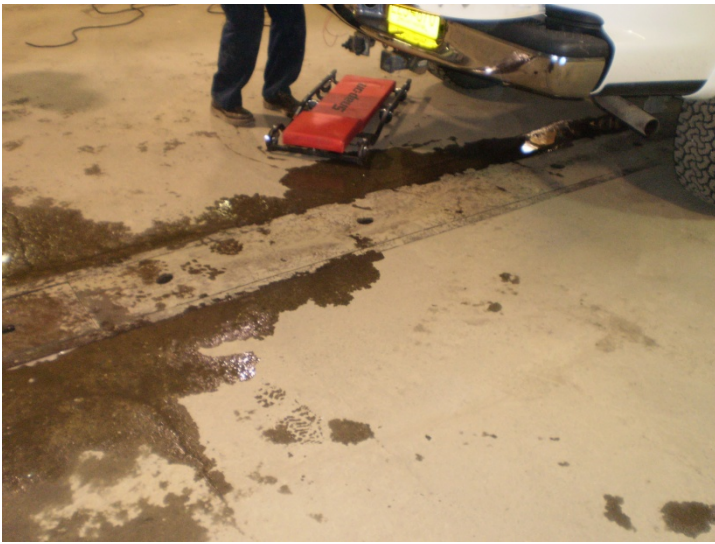
Photo 7. Floor Drain in Western Garage Area

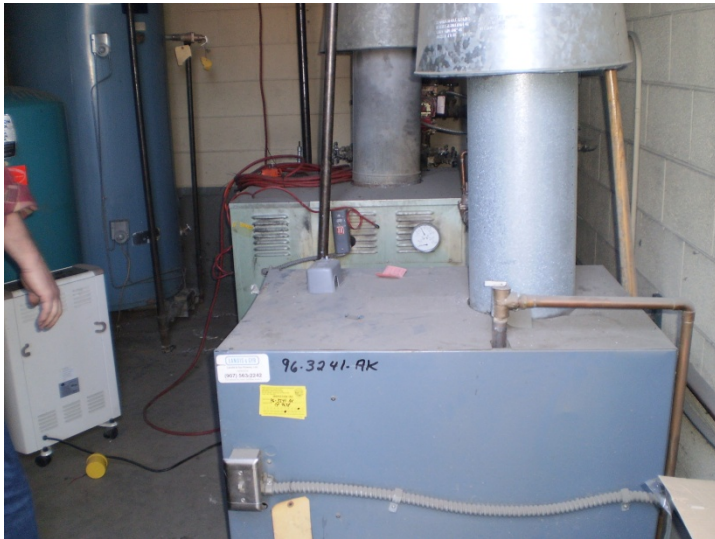
The boiler room was located on the northwest side of the building and was contained within a separate room that was only accessible from the exterior of the building. Two boilers were contained within the boiler room (Photograph 9 in Appendix A). These boilers previously supplied heat to the building via hot water baseboard heating. This heating system is no longer in use at the subject property. An exhaust manifold from each of the boilers was connected via aluminum ducting and the exhaust was vented to the atmosphere above the roof of the boiler room. There were no floor drains in the boiler room. The floor of the boiler room was concrete and no significant

cracking was noted. There were no potential vapor entry points identified with respect to the boiler room.

Photo 9. Boiler Room Near Northwestern Portion of Building. The boiler is no longer in use.
