**ENVIRONMENTAL SITE INVESTIGATION**

**TATITLEK DOCK  
AND  
EQUIPMENT FACILITIES SITE**

**TATITLEK, ALASKA**

**MARCH 1994**

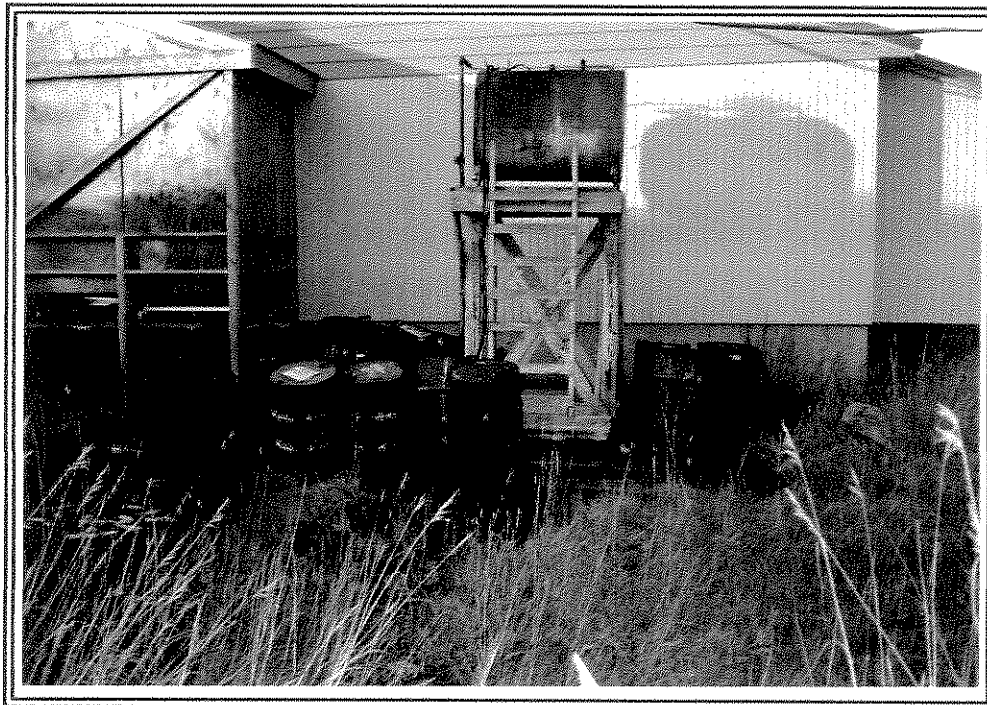
The area immediately south (behind) of the tribal community center (old school) (picture #2); the area around the old generator building (picture #3); the area around and down slope of the generator fuel tanks (picture #4); and the area along the old generator tank refueling line (pictures #5 & 6) had visual indications of potential hydrocarbon contamination (map 3).

- Test hole #4 was located 10± feet from the south east corner of the Community center building which had an 100 gallon barrel on a stand which appeared to supply fuel to the community center (picture #12). There was visual indications of diesel fuel spillage and dead vegetation. Samples 4a, 4b, & 4c were obtained at a depth of 12-18 inches. The hole is located in muskeg with a soil depth of 3½± feet and is 10± feet outside the eastern edge of the proposed right-of-way. The soil was moist with no observed water table.

Picture 2: 100-gallon fuel barrel and dead vegetation.

These visibly contaminated areas were part of the old school complex which reverted to the community when the new school was built. If money becomes available from other sources these areas might be considered for remediation.

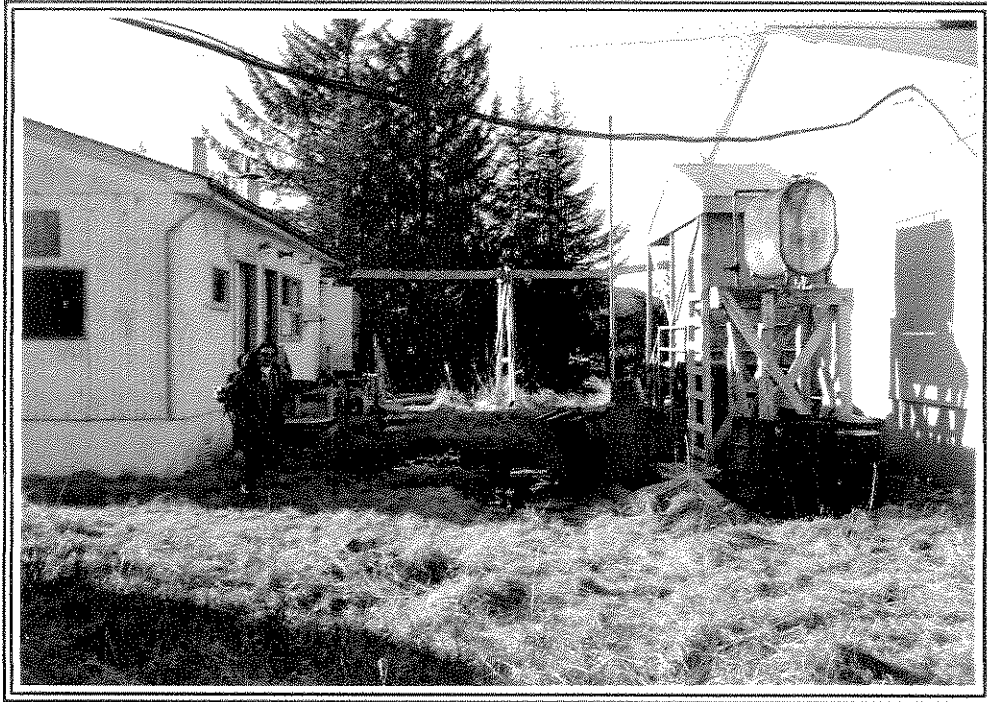
The ground in all of these areas was stained and contained dead vegetation to varying degrees. There appeared to be a crude attempt of containment for the four generator fuel tanks (2 - 1,100± gallons and 2 - 4,500± gallons). Down slope of the tanks was a timber cribbed containment area which had mostly caved in and/or filled in with soil, debris and vegetation (picture #7). Down slope of the containment area was a 5 foot by 5 foot timber cribbed sump (picture #8) which was partially filled in and contained standing weathered hydrocarbons in some of the remaining depressions (picture #9). There also appeared to be seepage towards Tatitlek Narrows which is 130± feet down slope (westerly).

Picture 3: Dead vegetation in front of generator building.

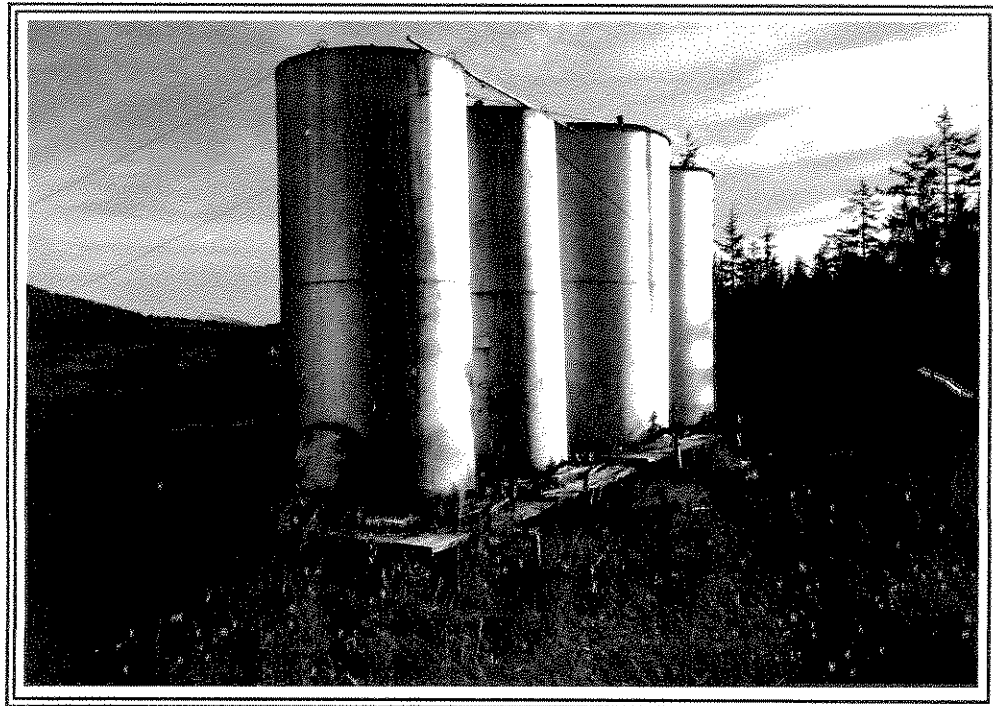
Picture 4: Old school diesel fuel tanks (4).

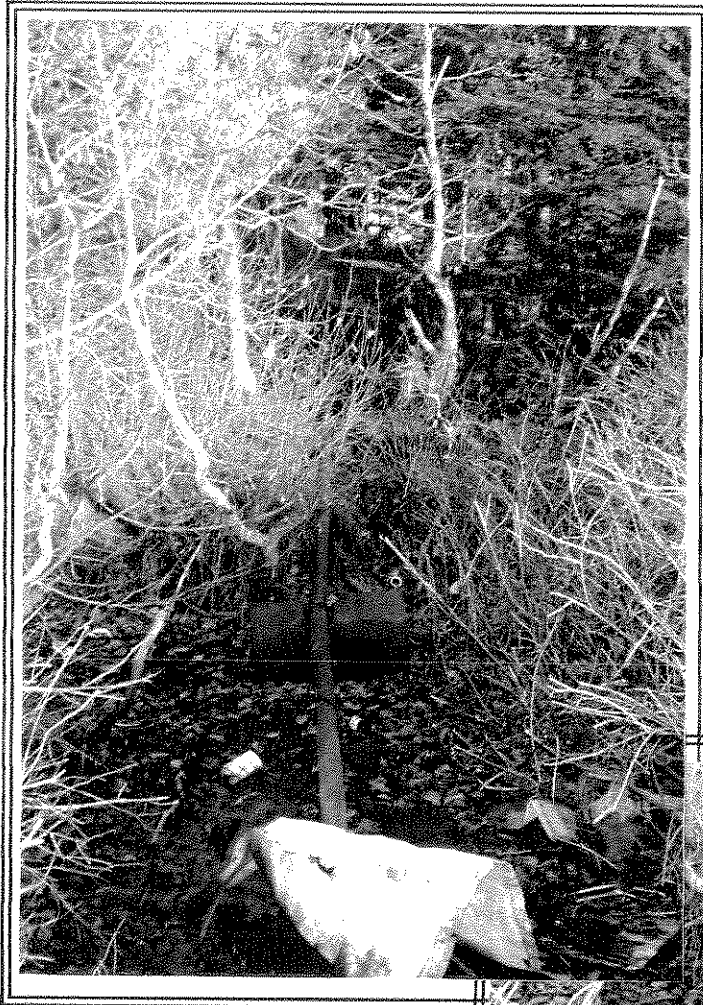
**Picture 5: 3" dia. fuel line from beach.**

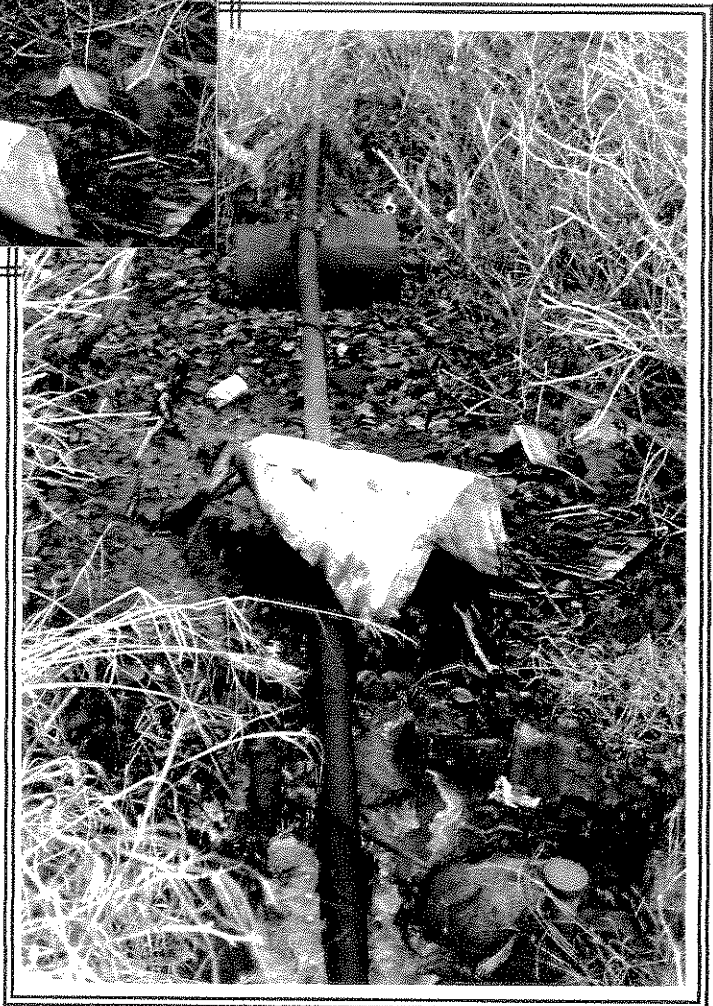
**Picture 6: Stained area around 3" dia. fuel line.**

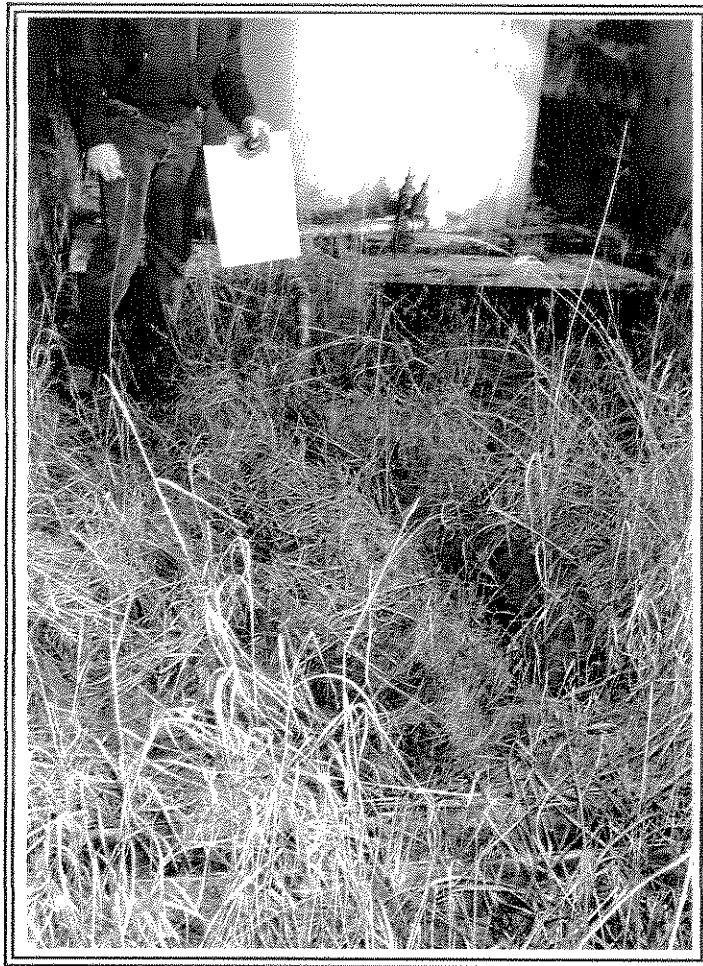
Picture 7: Timber containment structure and piping.

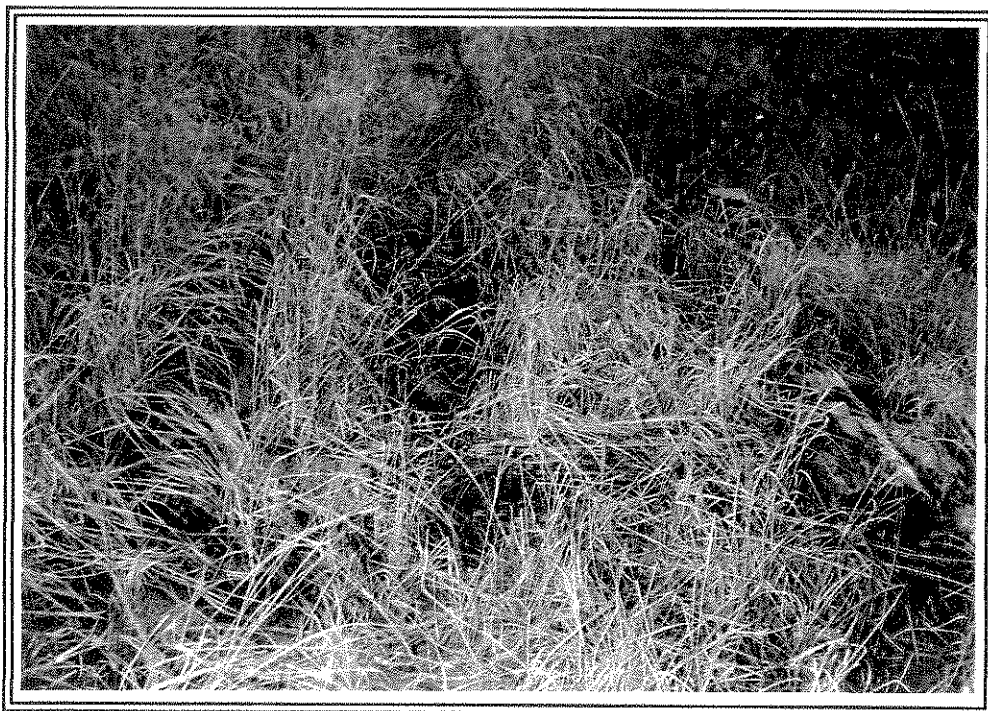
Picture 8: 5' x 5' log crib sump.

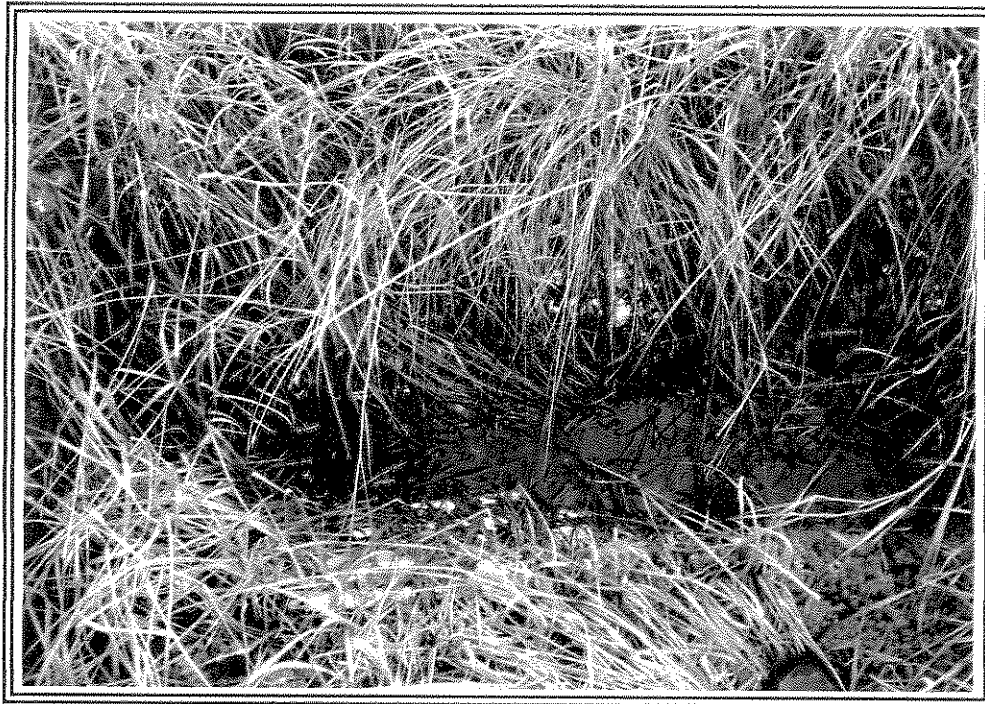
Picture 9: Fuel contained within log crib sump.

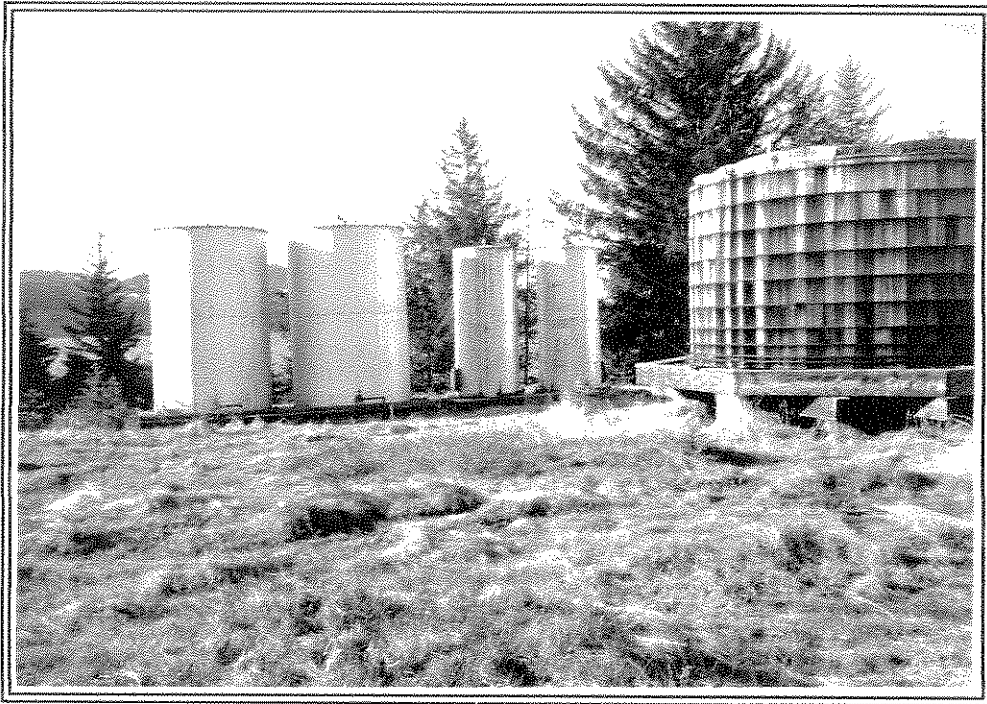
- Test hole #3 was located 130± feet upgradient from the fuel tanks and on the same easterly line as holes #1 & 2 (picture #11). Sample 3 was obtained at a depth of 12-15 inches. The hole is located in muskeg with a soil depth of 4± feet and is just inside the eastern edge of the proposed right-of-way. The soil was moist with no observed water table.

Picture 11: Typical sample area.

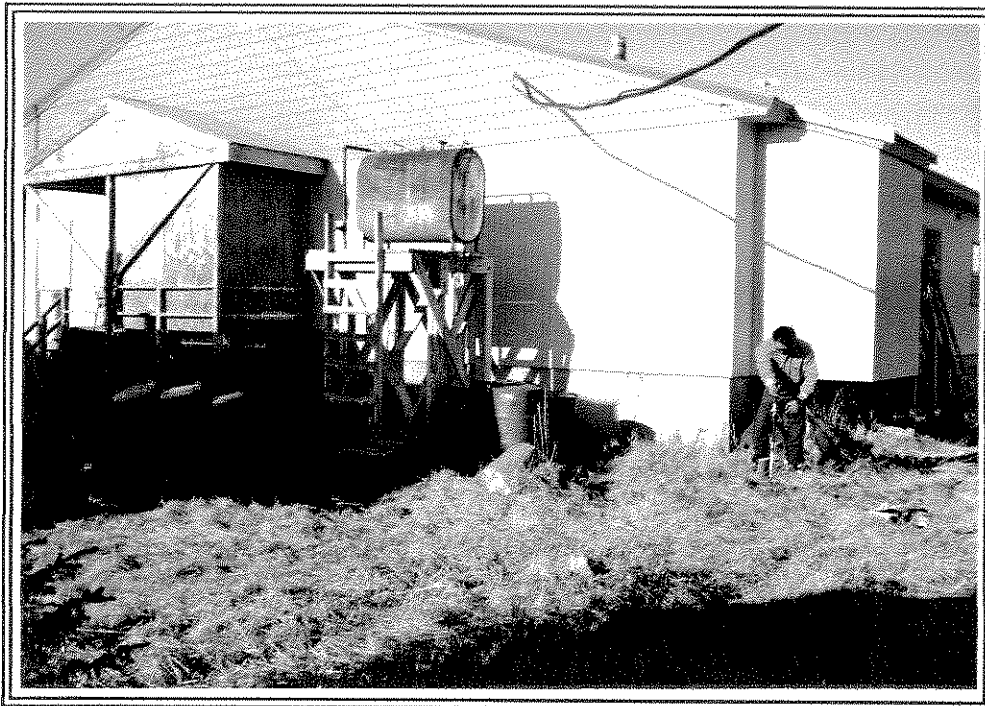
The results of the laboratory testing would indicate that due to the organic nature of peat soils the background level of TPH is high. As an example, due to their upgradient locations from existing contamination sources, the probability of Samples #1, 2, 3 & 5 being contaminated is nil. Sample #4 is within 10 feet of stained soil and dead vegetation but generally exhibits the same characteristics as the other samples. The oil/grease 418.1/413.2 ratio is marginally higher than the other samples which might indicate slight middle range contamination, but the majority (if not all) of the reading still relates to the soil's biogenic content.

Picture 12: Sample hole #4.
