**AGRA EARTH & ENVIRONMENTAL, INC.  
PHASE I ENVIRONMENTAL SITE ASSESSMENT  
GOLD HILL LIQUOR AND GROCERY  
FAIRBANKS, ALASKA**

September 1994

32-01110-00

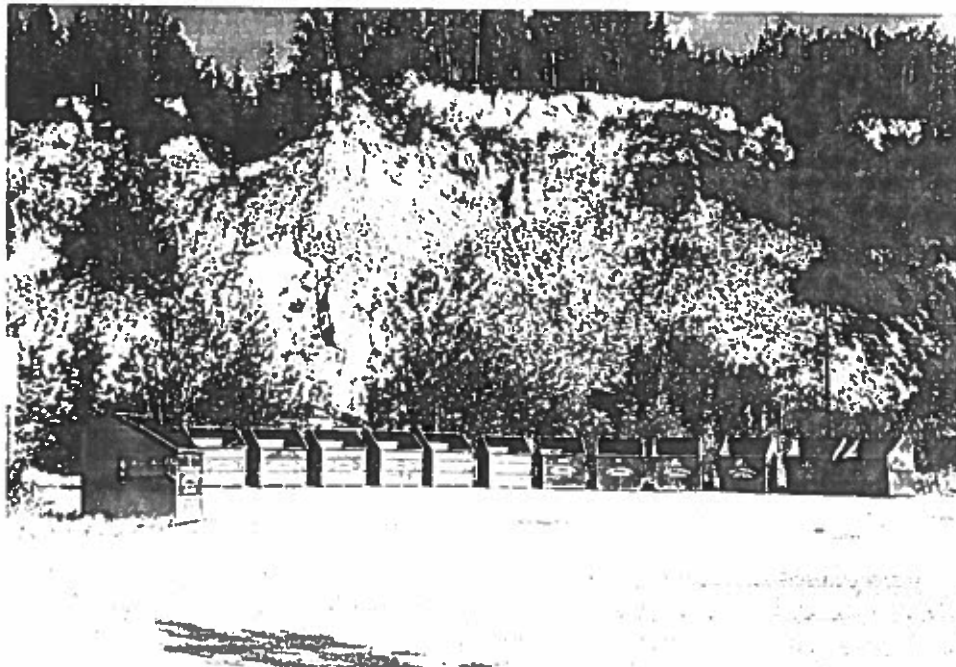
The southeast quadrant containing the solid waste dumpster station was the last area to be inspected. The ground surface in this quadrant has been graveled to provide access to the dumpsters and appeared to be generally free of staining. The single monitoring well installed during a previous site investigation is located directly in front of the dumpsters.

Photo 2: View of the solid waste dumpster station on the southeast portion of the site.

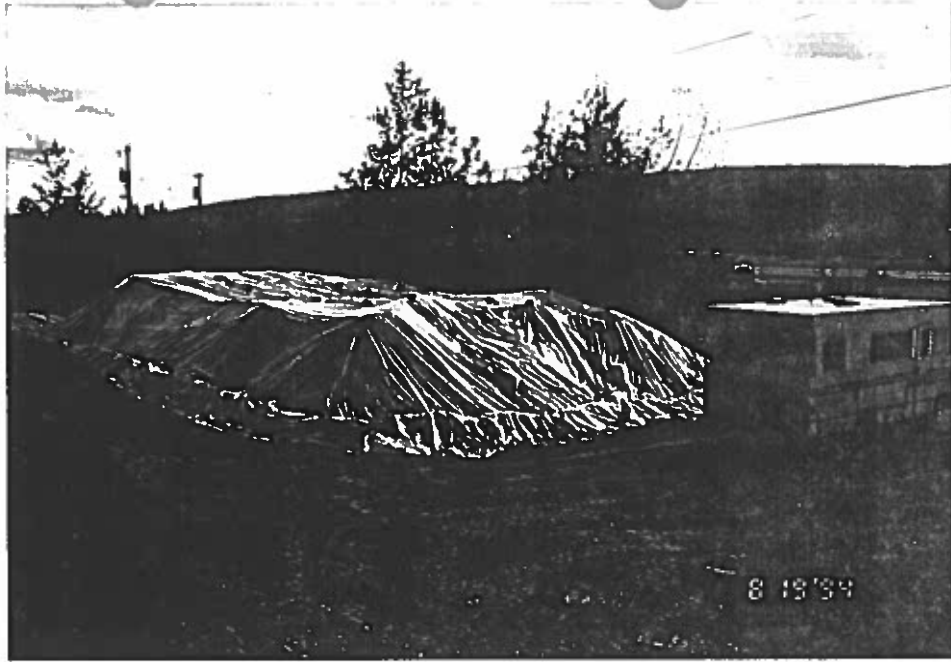
The stockpile of contaminated soil in the northeast quadrant had been in place approximately one month at the time of the site visit. The liner and cover were still in place and no indication of runoff from the stockpile was observed. There were no indications of the condition of the ground surface prior to the placement of the stockpile as the soil in the area had been freshly graded and turned in preparation for the stockpile.

Photo 3: Soil stockpile on the northeast portion of the site.

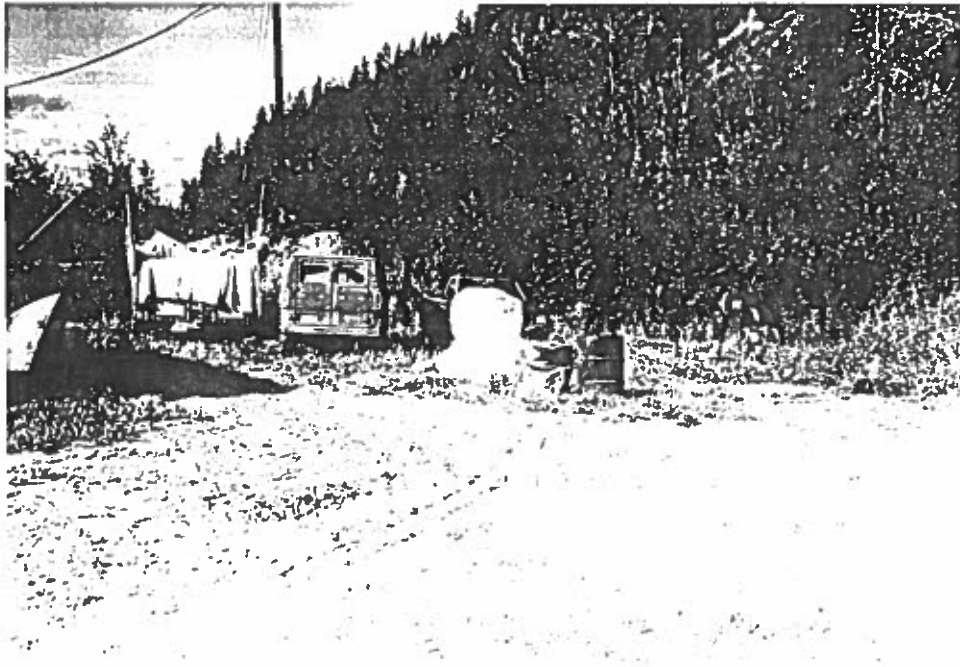
The material stored in the northwest quadrant included three old vehicles and ten 55-gallon drums. The area around the vehicles was inspected for soil staining but none was observed. Six of the drums were stacked on their sides in a small pyramid (Photo 7). The drums were sealed, appeared to be empty, and were labeled as "Mondur MR (Light)" and "component A" in the production of urethane foam. Mr. Carboy reported that he had received the drums as empties from the company that used the contents. The remaining four drums, all empty, were in groups of two. The two closest to the pyramid of six drums included one crushed drum labeled as "jet fuel" and one intact, open drum without a label. The other two drums were heavily rusted and appeared to be in use as trash barrels and/or burn barrels. Also in the vicinity of the drums was a small fenced burn pit. The unburned material within the pit consisted of wood and cardboard.

Photo 4: Storage area in the northwest portion of the site.

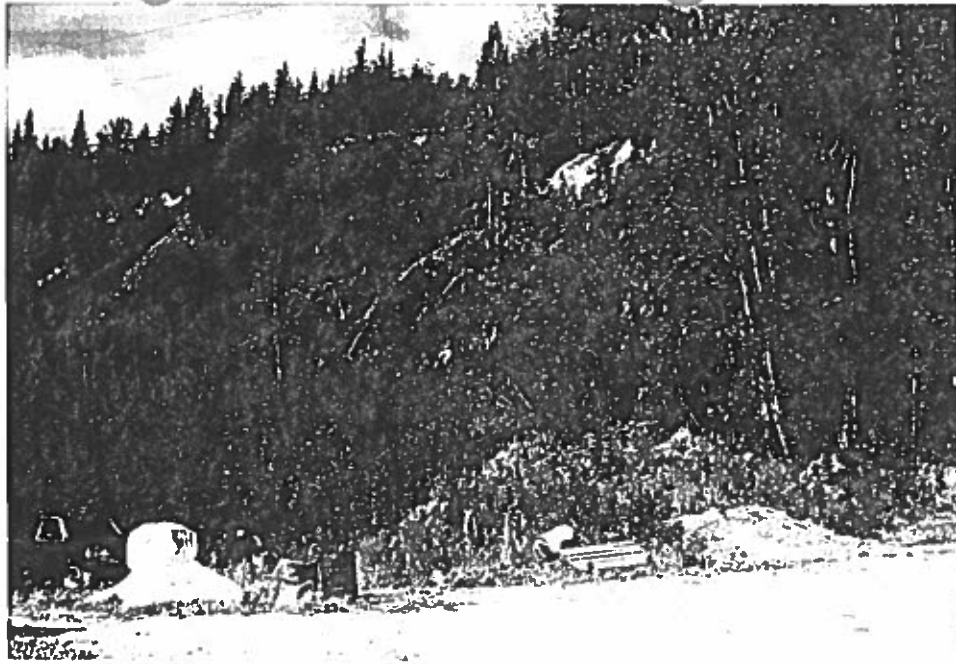
Partway up the bluff near the northwest corner of the property was a small depression containing what appeared to be two discarded and heavily damaged appliances. One appeared to be either a refrigerator or upright freezer and the other was most likely an old chest freezer. No indication of stressed or damaged vegetation was observed around these items.

Photo 5: View of the northwest corner of the Gold Hill property showing typical vegetation.

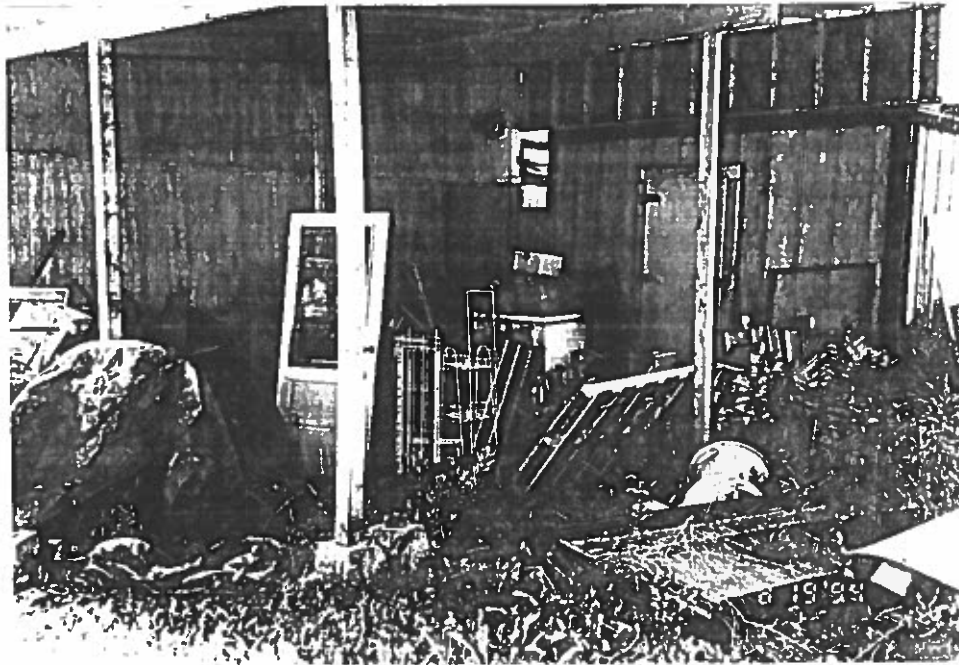
Most of the material storage on the property is located directly behind the store or in the northwest quadrant. The items stored around the store appeared to consist almost entirely of shelving, display cases, and old signs associated with the store (Photo 6) or old furniture and outdoor equipment typical of residential use. The only exception to this was three old car batteries stored along the back wall of the building.

Photo 6: Storage area at the north corner of the Gold Hill Store.

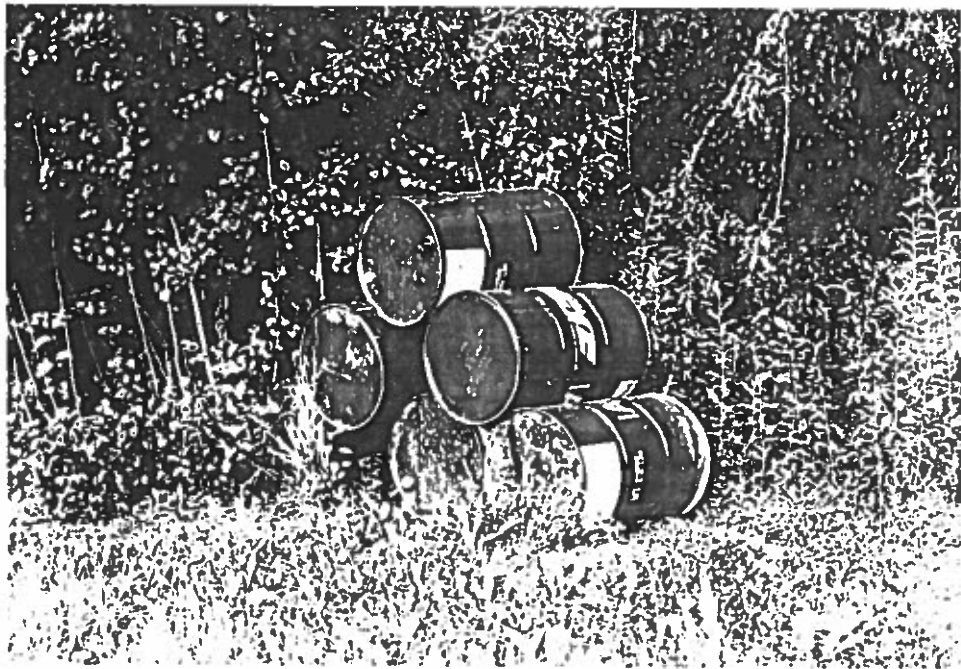
Photo 7: Empty drums stored on the site.

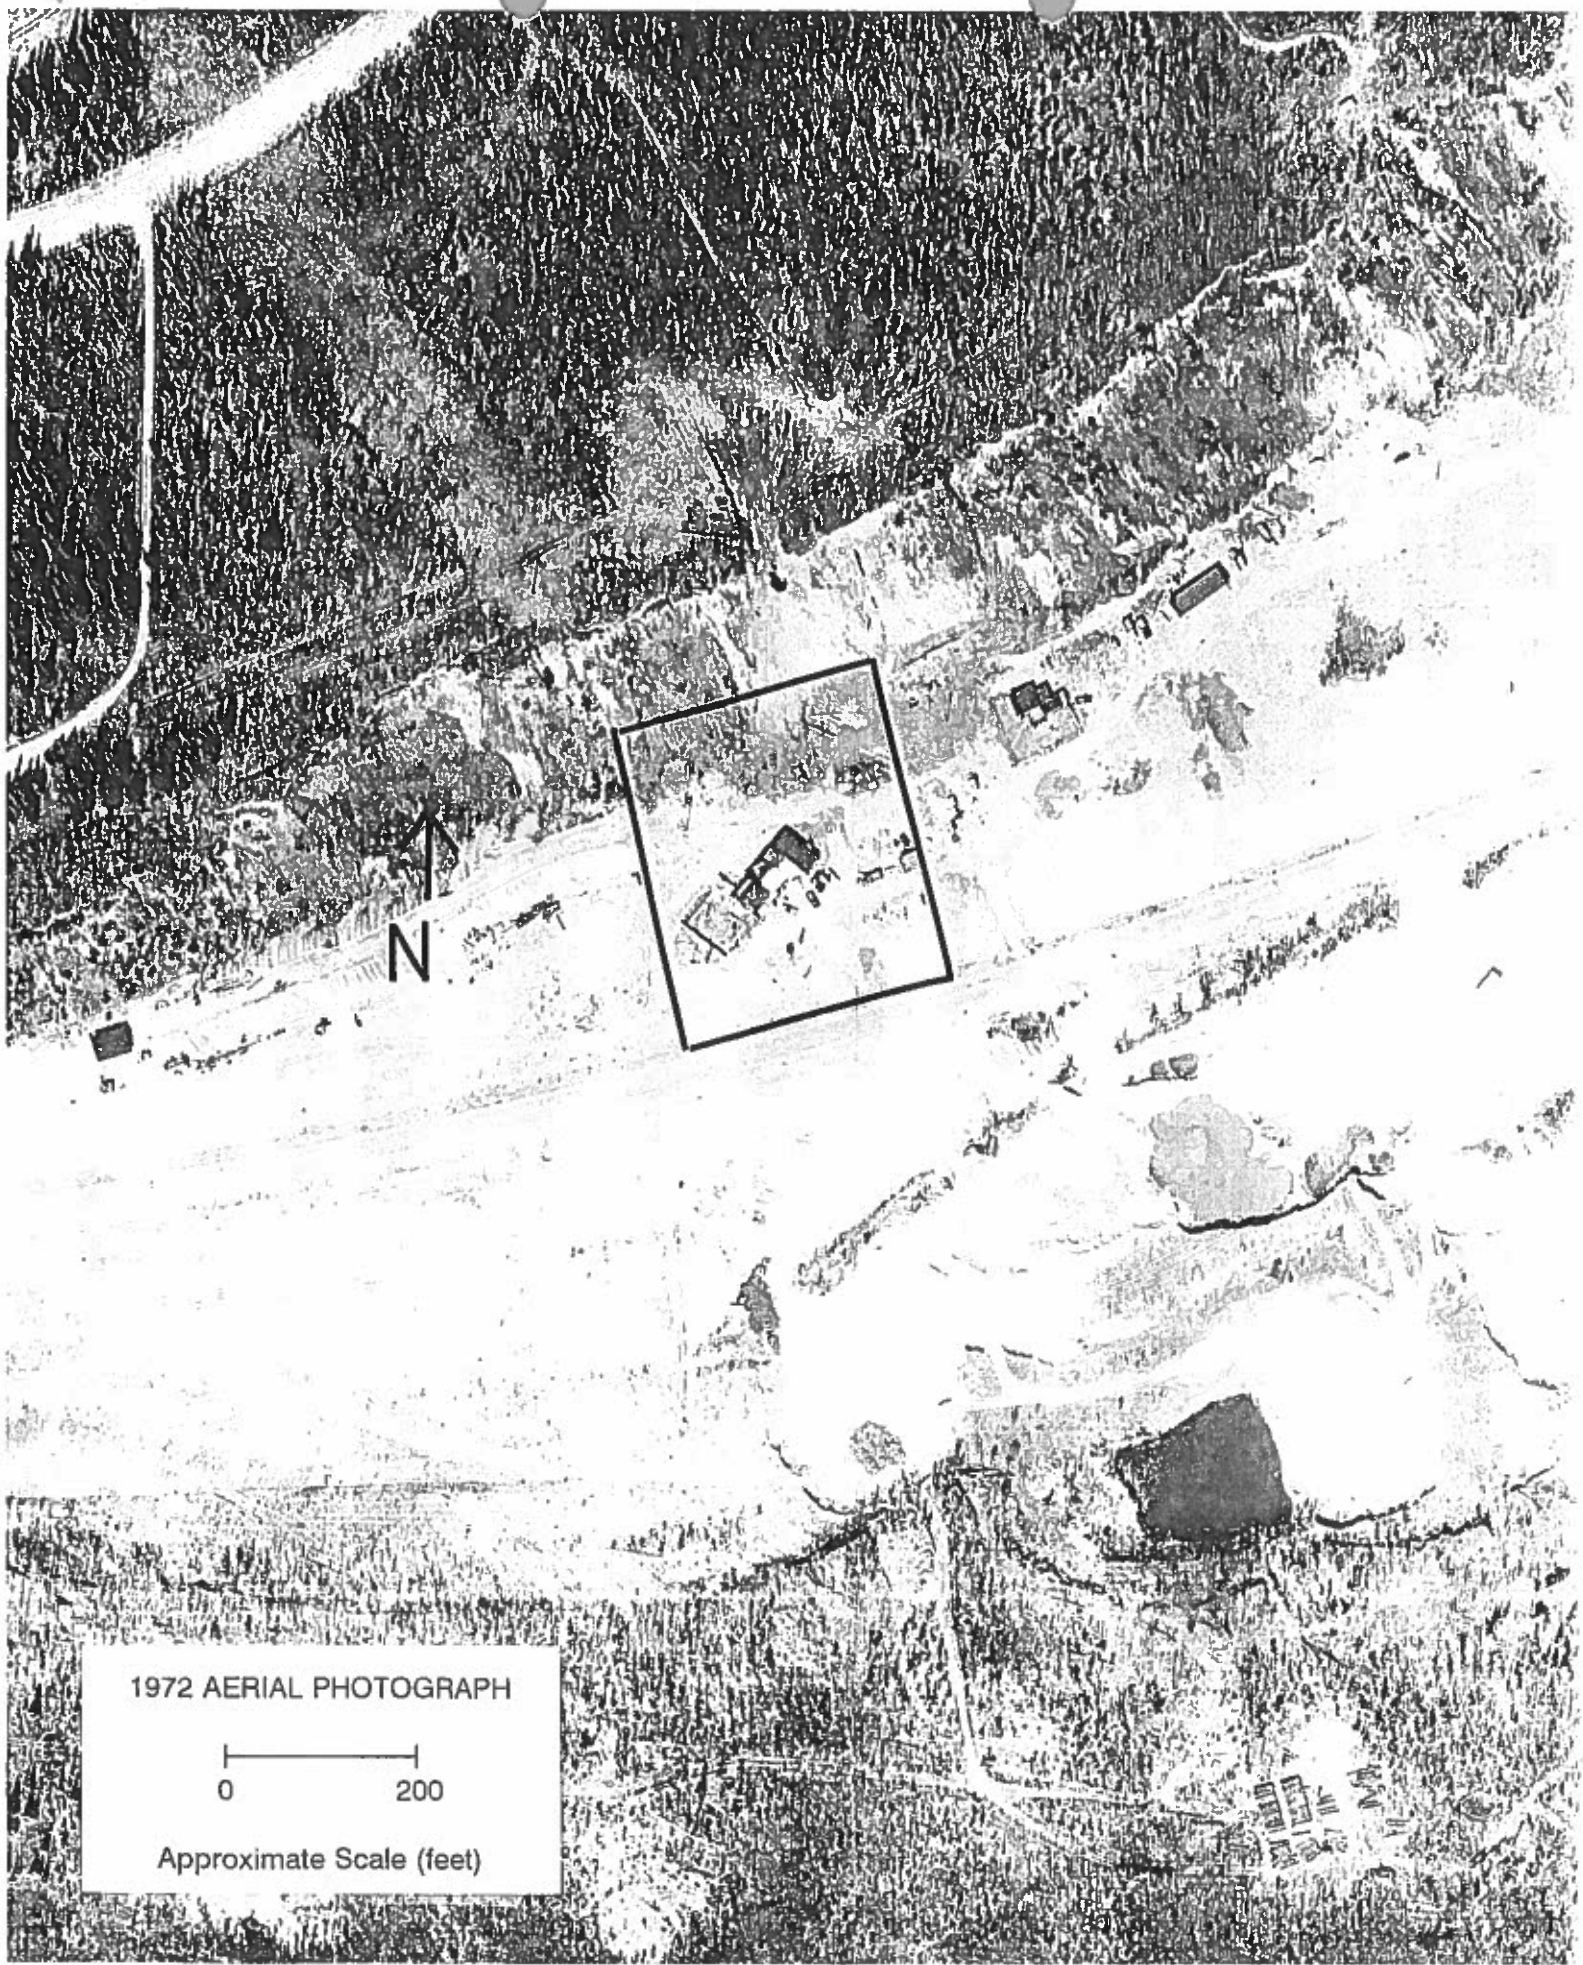
1972 AERIAL PHOTOGRAPH

**1972 Aerial Photograph:** The subdivision of the mining claim is evidenced in this photograph by the development of the site and adjacent lots along the north side of the highway. The site contains a single building in the same location and of similar configuration as the existing building. The number of cars parked in front of the building seems to indicate a commercial rather than residential use for the property. In addition to the main building on the lot, there appears to be a smaller building located east of the main building. The object casting the long shadow in front of the main building is probably a single fuel dispenser. A recent mass wasting event is apparent on the bluff at the north limit of the property.

Tax Lot 931, immediately to the east, contains an apparent residence on the northern portion of the lot. A large rectangular building can be seen on Tax Lot 932 and appears to be the building currently used as a garage by the Northstar Center. Another rectangular building can be seen a few hundred feet west of the site. Across the highway, the placer mining operation is still evident, but does not appear to be active. Further development in the area of the photograph is limited to a few private residences located west of the site and along the south side of Gold Hill Road.

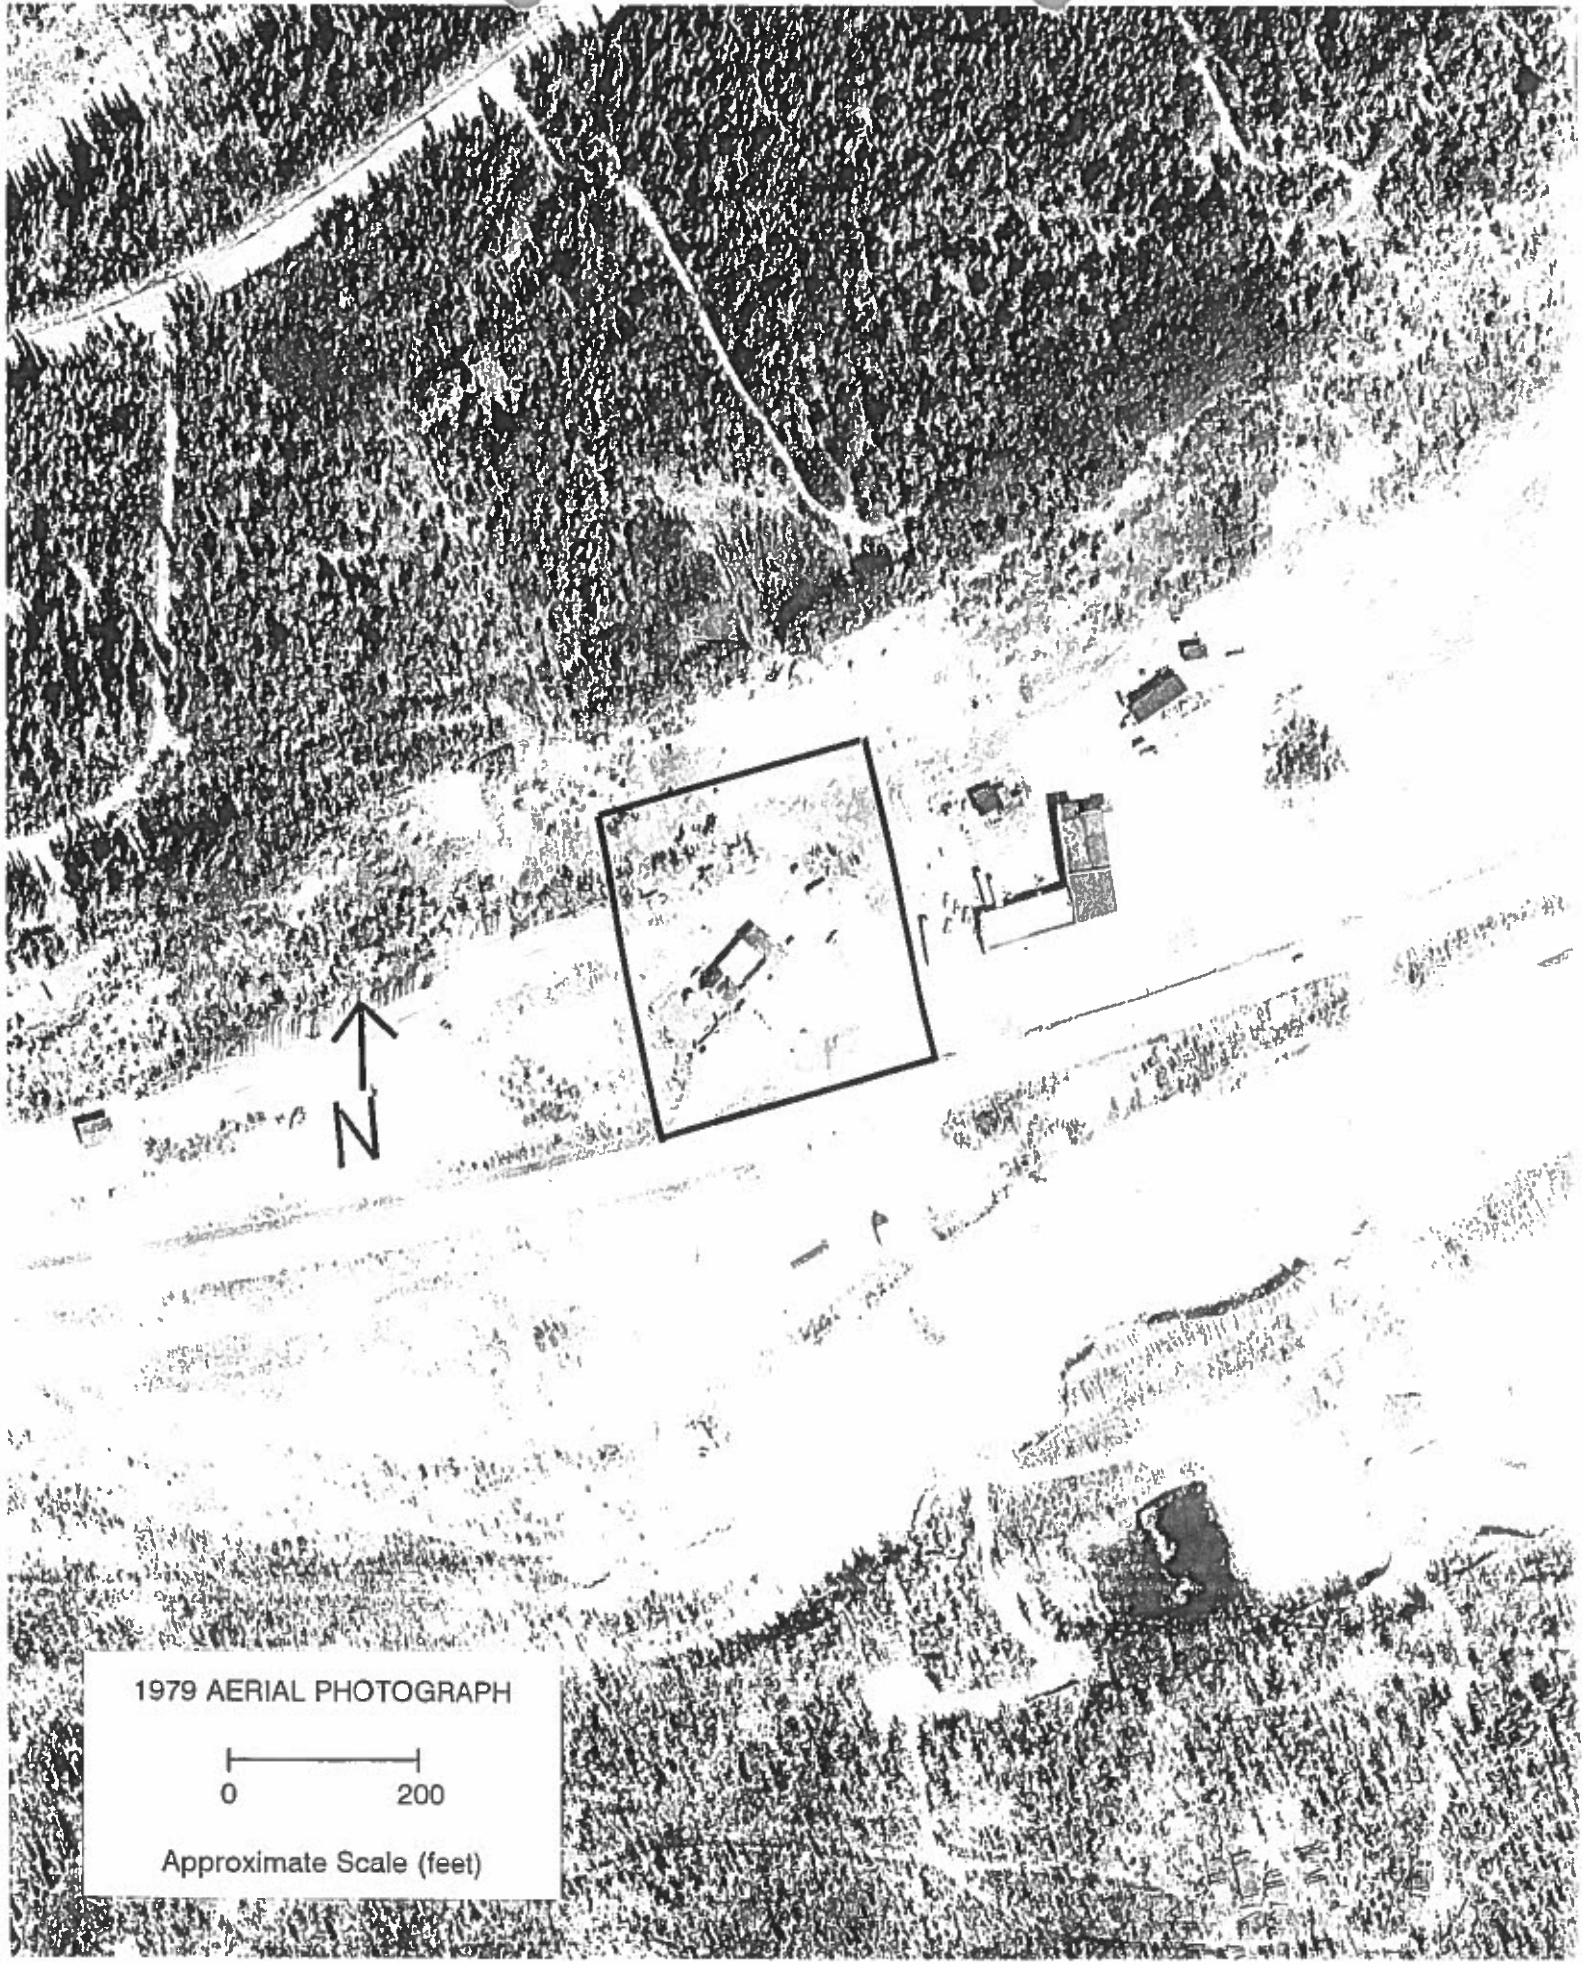
1979 AERIAL PHOTOGRAPH

1979 Aerial Photograph: This photograph records only a few minor changes to the site and some additional development in the site vicinity. On the site, the main building appears to have undergone some exterior remodeling and the small, square building has been removed from the property. Two storage tanks are located on the northern portion of the lot near the base of the bluff but neither tank appears to be in use.

Development in the site vicinity includes the addition of the motel/restaurant building (the current Northstar Center) to Tax Lot 931, and a second building to Tax Lot 932. The latter building is probably the waste treatment plant associated with the septic system for the building on Tax Lot 931. Several vehicles and a collection of unidentified material can be seen outside the garage on Tax Lot 932. Beyond the immediate site vicinity, the Gold Channel Subdivision property to the east of Tax Lot 932 has been graded smooth, apparently in preparation for future development, and two properties across the highway have been developed. The first of these, Tax Lot 934 directly opposite the site, contains two small buildings. FNSB tax records indicate these were probably a private residence and garage. The second property, Tax Lot 1014, is about ¼-mile east of the site and appears to have been developed as a trucking company. No positive assessment of land use could be determined from the tax records. Further development within the area of the photograph is limited to several additional private residences along Gold Hill Road.

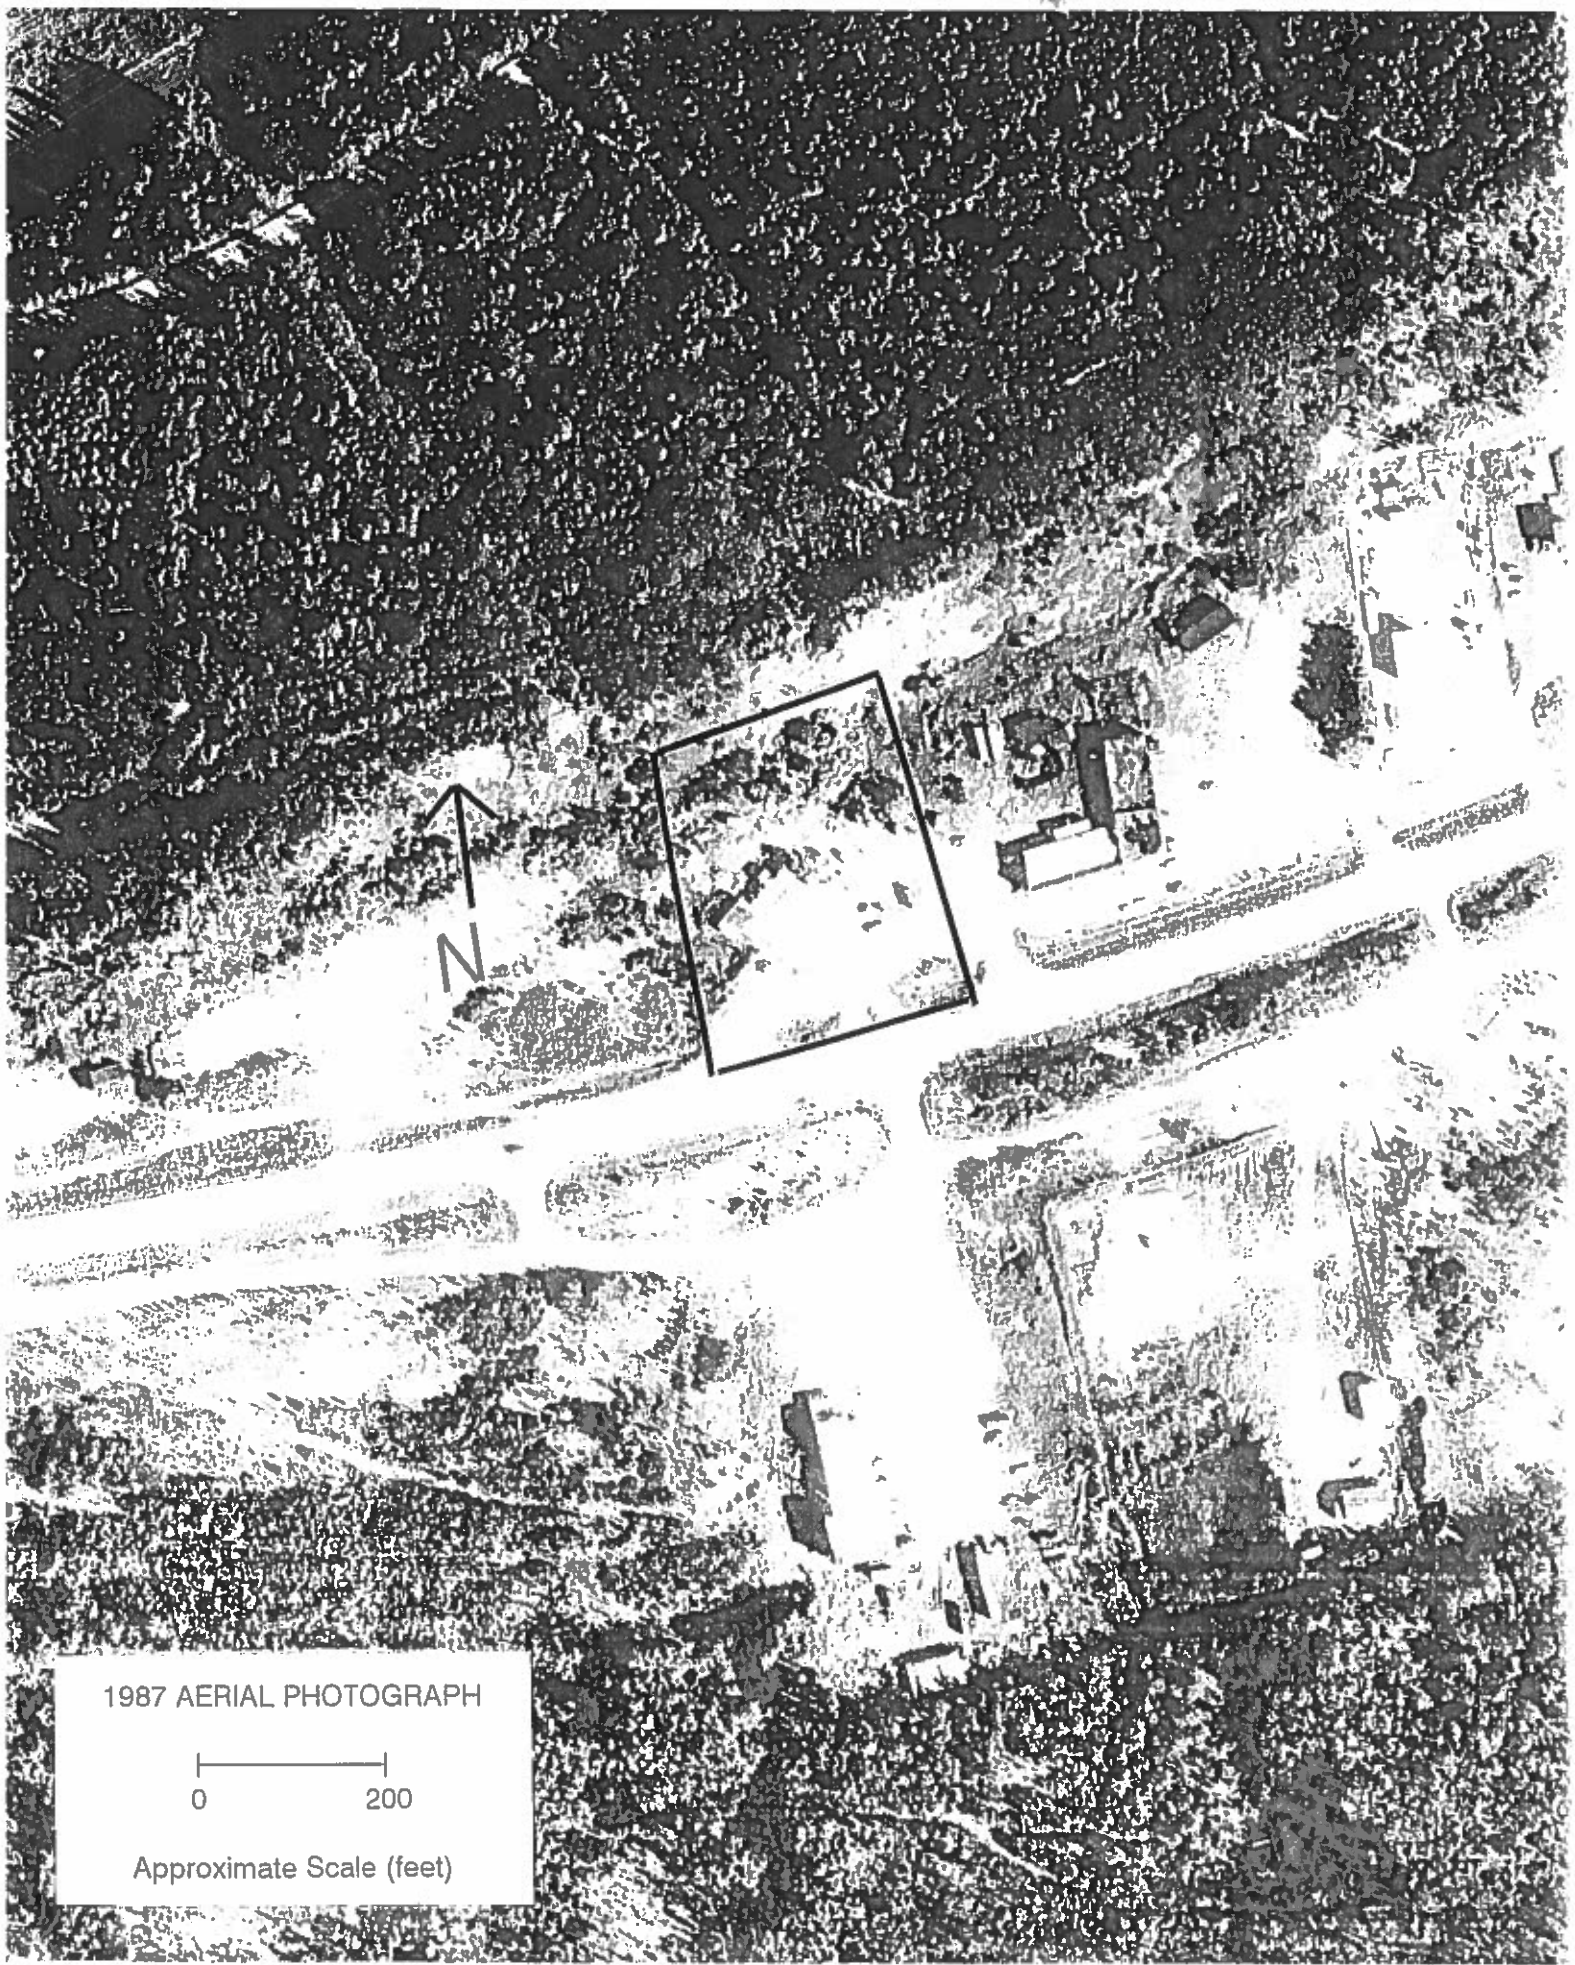
1987 AERIAL PHOTOGRAPH

1987 Aerial Photograph: Several minor changes to the Gold Hill property can be seen on this photograph. These changes include the addition of several small buildings/trailers to the northern portion of the lot and the removal of the two storage tanks seen in the previous photograph. In addition, there is an obvious increase in vegetative growth and a dumpster has been placed on the eastern portion of the lot.

Tax Lots 931 and 932 are unchanged except for the addition of two trailer vans adjacent to the former private residence on Tax Lot 931. Tax Lot 212, west of the subject site, continues to be a vacant lot. Most of the development recorded by this photograph is on the north side of the highway in the Gold Channel Subdivision. The westernmost property within the subdivision appears to be used for materials storage. Moving east, the next lot includes a large warehouse building which, according to tax records, was owned by the Alaska Window Company. The remaining portion of the subdivision appears to have been used for the storage for raw timber.

Changes on the south side of the highway include the removal of the private residence from Tax Lot 934 and the addition of a commercial garage to that same property. Immediately east of this property, two small buildings have been added to Tax Lot 939. The tax records indicate that in 1987 the property was owned by the Northern Leasing Company. The use of the buildings could not be determined from this information. Based on the absence of equipment, the trucking company on Tax Lot 1014 appears to have gone out of business.
