Department of
Environmental Conservation

April 19, 2019

Re: Decision Document: Wrangell Junkyard
Cleanup Complete Determination

Wrangell Junkyard
4 Mile Zimovia Highway
Wrangell, Alaska

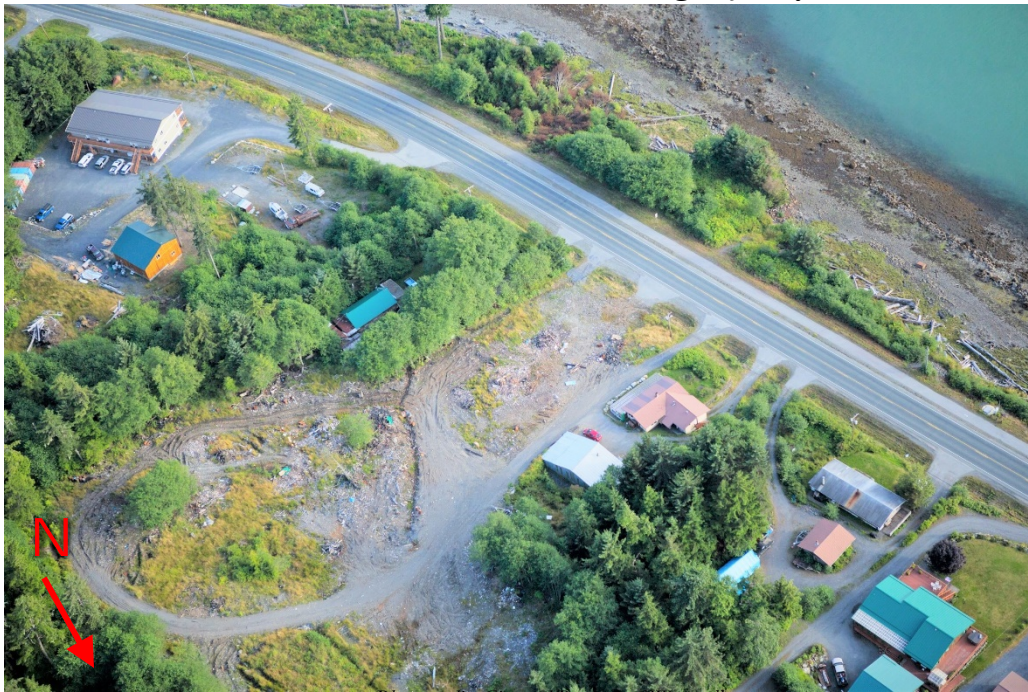
Photo 1: Aerial view of the Wrangell Junkyard

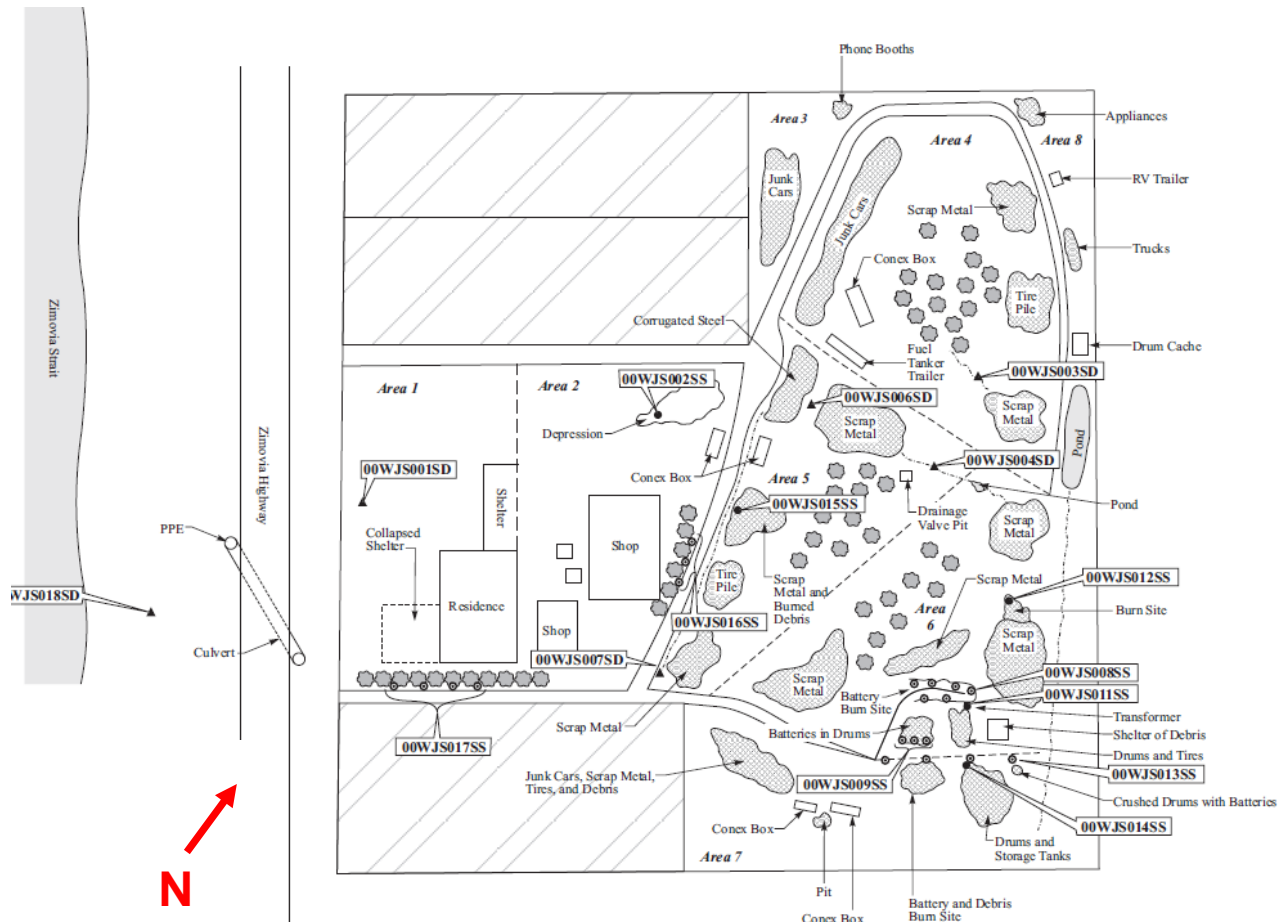
analytes. Contamination was reported above DEC cleanup levels for semi-volatile organic compounds (SVOCs), PCBs, and several heavy metals, particularly lead, which was found as high as 120,000 mg/kg. The PCB Aroclor 1242 was found at a concentration of 140 mg/kg in a battery burn site called Area 6. A concentration of 1200 mg/kg lead was found in Zimovia beach sediments downgradient of the site. Significant concentrations of lead in soil found throughout the site were determined the result of large amounts of crushed batteries and poor handling practices over decades of salvage operations. No water samples were collected. Figure 1, taken from the report provides a diagram of the site, with sample locations and areas of concern.

Figure 1: Site Diagram (Ecology & Environment 2000)

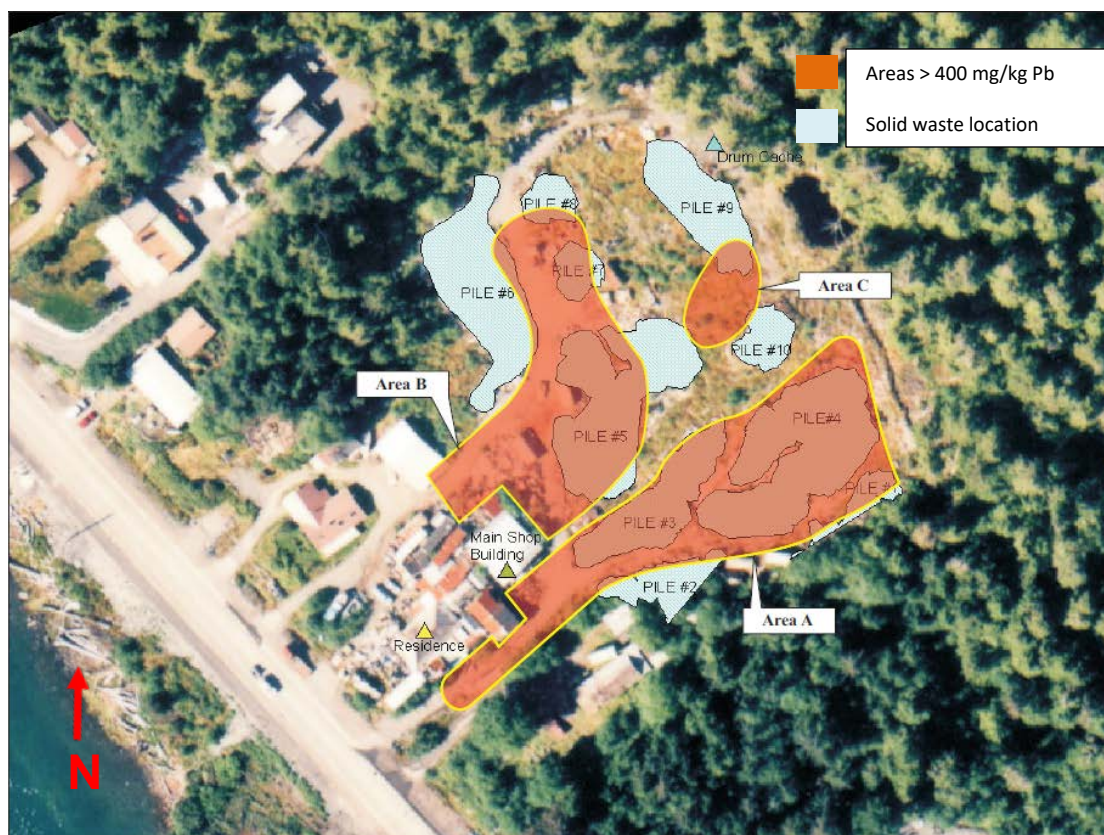
Lead concentrations in soil exceeding the DEC cleanup level of 400 mg/kg were measured in 43 of 65 sample locations, with concentrations as high as 98,500 mg/kg, although only two subsurface samples, had concentrations above the 400 mg/kg cleanup level. Concentrations of lead in the downgradient

wellpoint were non-detect for the filtered sample. The total volume of soil contaminated with lead was estimated at 3,490 cubic yards. See Figure 2.

Figure 2: Site Diagram of the Wrangell Junkyard, denoting contaminated areas (Ecology & Environment, June 2002)

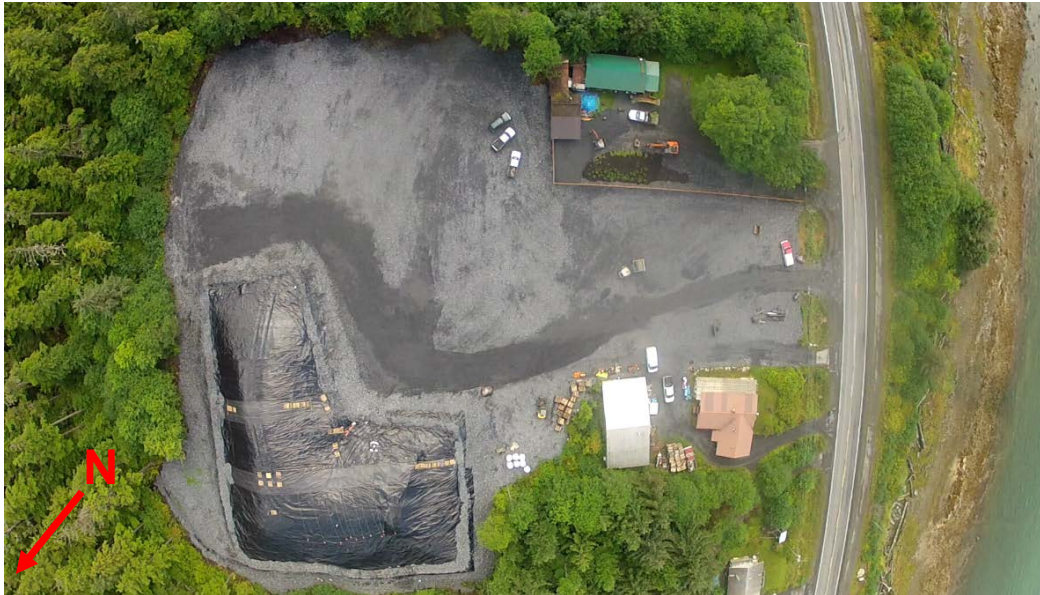
Photo 2: Drone aerial of site following 2016 cleanup

Following the confirmation sampling, each area of the excavation was backfilled with clean material from an offsite quarry. Simultaneously, the stockpile for the treated material was constructed on the closed out areas of the site. Following completion of the cleanup, backfilling and removal of equipment and staging areas, the site was graded and contoured around the stockpile. The post cleanup site conditions are shown below.

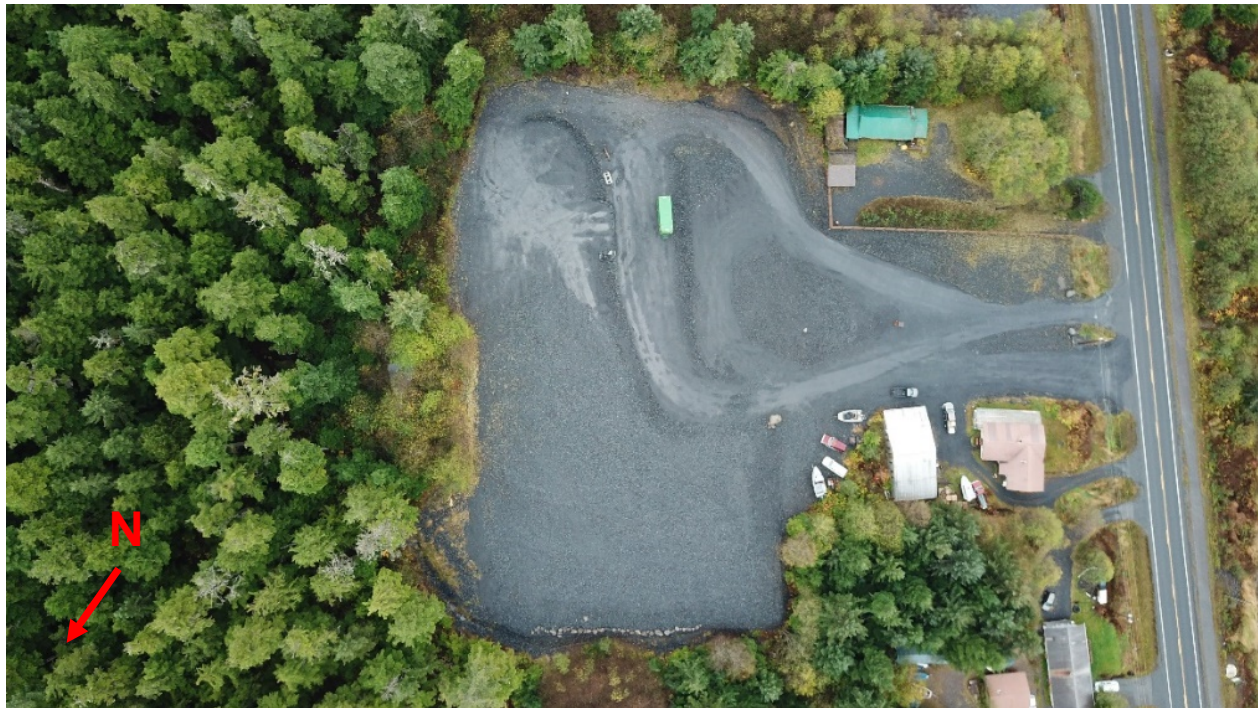
Photo 3: Drone aerial of final site conditions – October 2018

Following results of the verification sampling, the site was re-contoured according to a site restoration plan approved by the City and DEC. The restoration plan included subsurface drainage features and preserving and enhancing drive ways on the site. In April 2019, NRC Alaska submitted the final *Site Restoration and Closure Sampling Report*, approved by DEC on April 19, 2019. The report documented the above results and restoration work.
