Healy Power Plant - Unit No. 1
Diesel Emergency Generator
Lube Oil Spill
Clean-Up and Site Characterization Report
Healy, Alaska

Prepared For:

Golden Valley Electric Association, Inc.
P.O. Box 71249
758 Illinois Street
Fairbanks , Alaska 99707

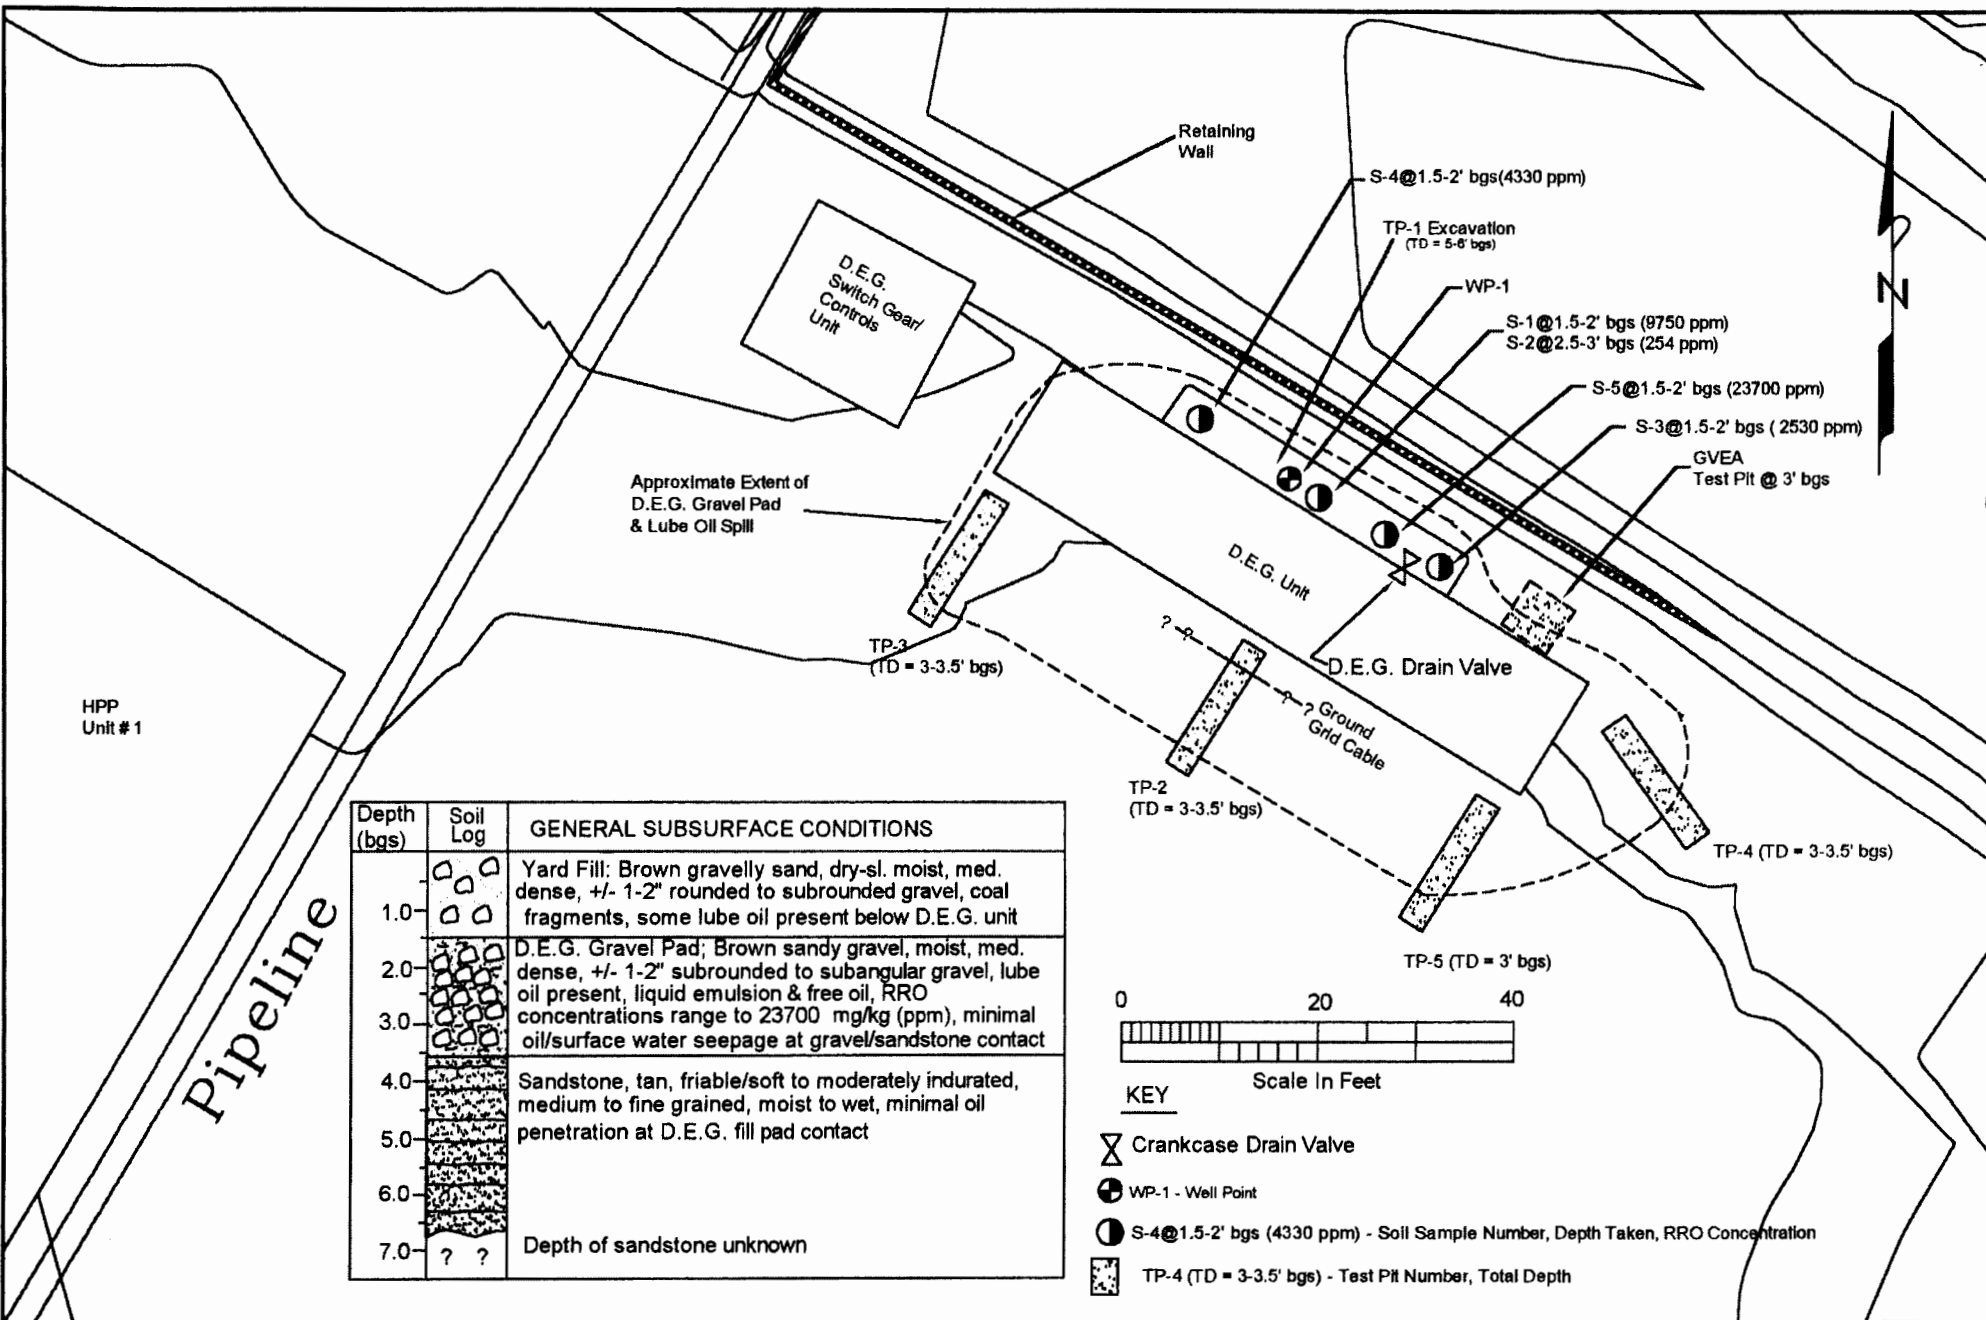
Figure 2
Healy Power Plant-Unit No. 1
Diesel Emergency Generator (D.E.G.)
Site Exploration & Excavation Map
Healy, Alaska

Approximately 10 cy of contaminated soils was removed from the lube oil spill source area along north side of the DEG. The excavated area is shown as the TP-1 Excavation on Figure 2. The total depth excavated in this area was from 3.5 to 5 feet bgs. The depth of excavation was limited by the presence of the sandstone bedrock and stability of both the DEG and retaining wall foundations (PHOTO 5). Contaminated soils were blended into the coal feed for the Unit No. 1 power plant for energy recovery and thermal treatment. Soil processing was completed by August 12, 1999.

Four test pits (TP- 2 thru 5) were excavated along the south and east side of the DEG to delineate the extent of the impacted area (Figure 2). Test pit excavation on the west side of the DEG unit was restricted by underground utilities associated with the DEG control unit building and the HPP-Unit No. 1 facility. Subsurface conditions were generally consistent in the area explored. They consisted of approximately 1 to 1.5 feet of brown gravelly sand "yard fill" overlying 2 feet of compacted brown sandy gravel, which is the

DEG foundation pad. Lube oil contamination was present primarily in the DEG pad as staining, free oil and emulsion. The DEG gravel pad is underlain by a soft to moderately indurated tan sandstone showing minimal lube oil penetration and surface water seepage at the formation contact (PHOTO 6). Groundwater was not encountered in the DEG excavation or test pits. A general geologic log is presented in Figure 2. The area impacted by the lube oil spill consists of the DEG gravel pad and yard fill soils beneath the DEG unit and is approximately 1325 sf in size (0.03 acre). The approximate volume of contaminated soil ranges from 124 - 150 cy. Figure 2 shows the approximate extent of the impacted area.

After completion of the selective excavation and test pit explorations, the holes were backfilled and graded to control surface water infiltration. The source area excavation was covered with an impermeable polyethylene liner and covered with clean fill (PHOTOS 7 & 8).

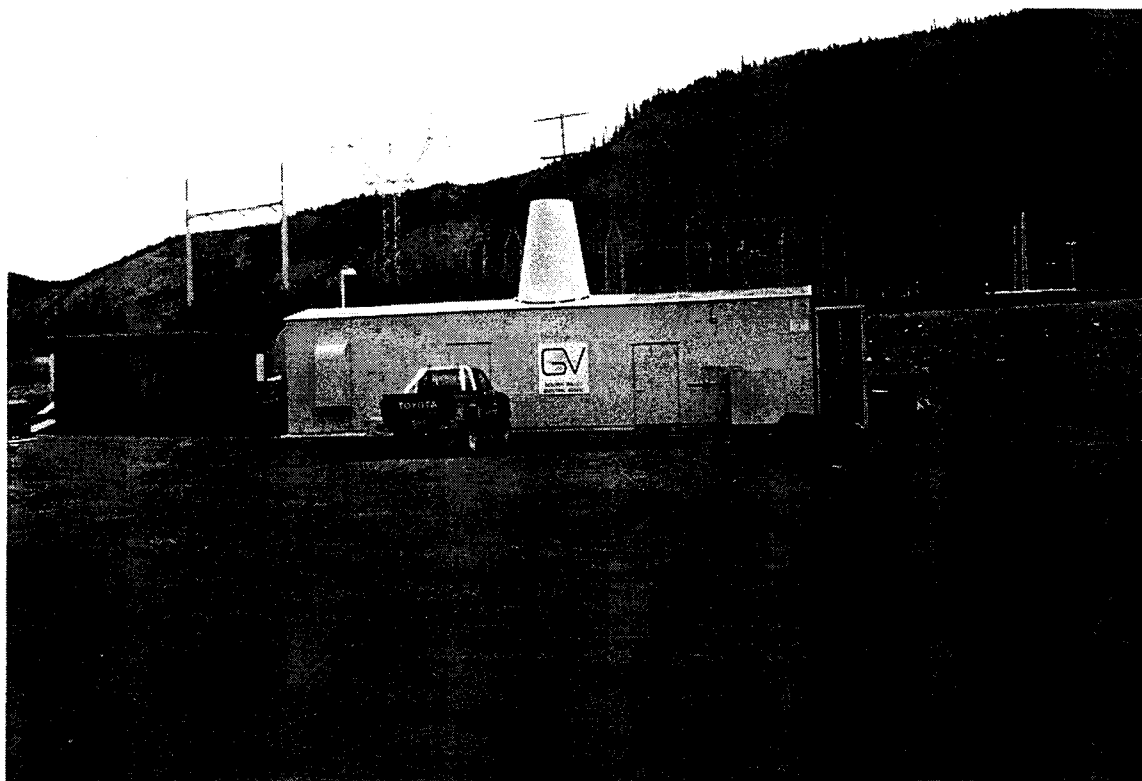
PHOTO 1 - Diesel Emergency Generator (DEG) Unit at the HPP -Unit No. 1

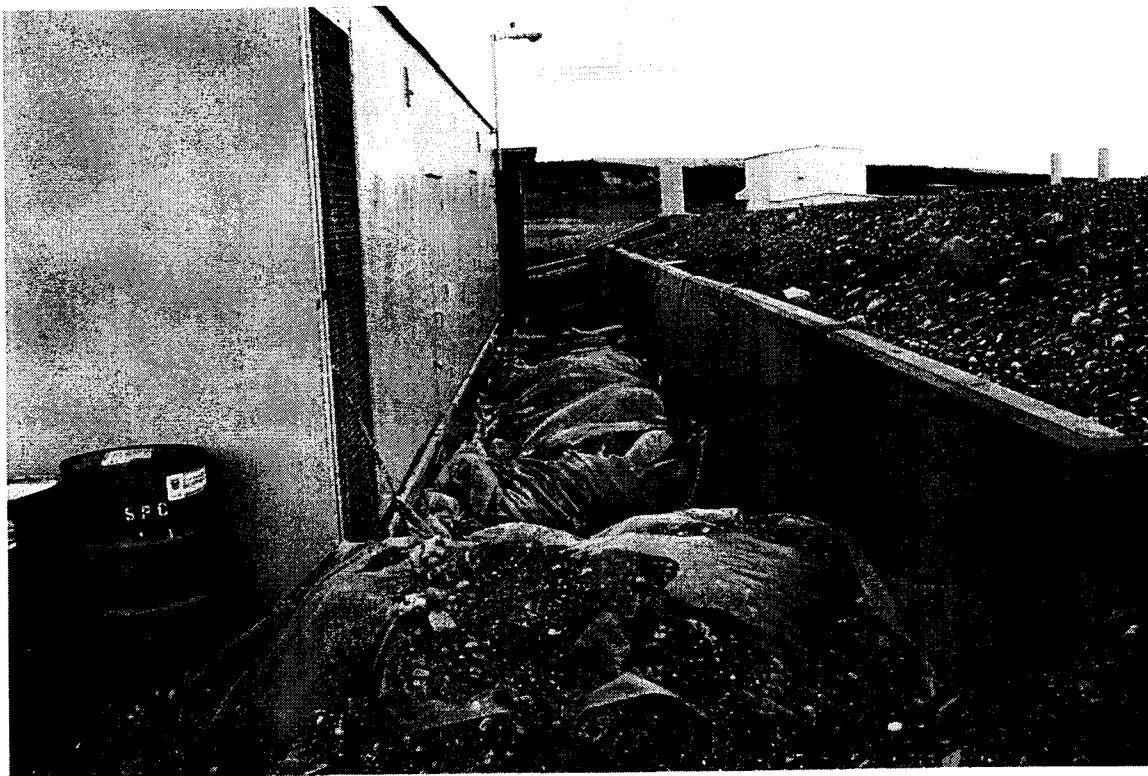
PHOTO 2 - Lube Oil Spill Source Area between DEG and Coal Truck Retaining Wall

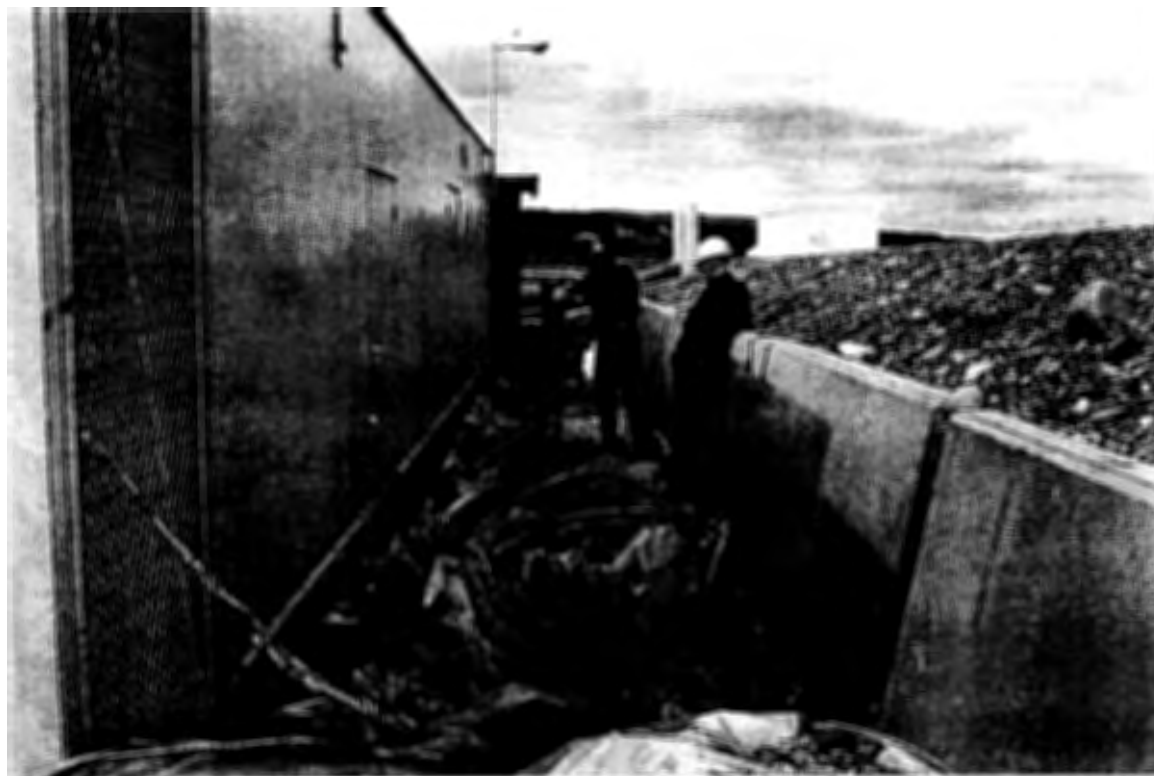
- Penetration refusal of the well point was due to sandstone bedrock at 3 to 3.5 feet bgs.
- The screen section did intersect the approximate 2-foot thick DEG gravel pad contaminated with the lube oil and the top of the bedrock formation. The moist to wet sandstone bedrock surface acted as a less permeable barrier to the downward migration of the oil spill.
- Vacuum enhanced free product recovery was not successful due to the viscosity of the SAE 40 weight lube oil. This finding suggests that the lube oil contained within the DEG gravel pad is relatively immobile and that lateral migration due to gravitational forces or from surface water infiltration is minimal. It should also be noted that the lube oil is designated as insoluble by the manufacturer's MSDS.
- Shallow, perched groundwater was not encountered.

PHOTO 4 - Well Point Installation in Lube Oil Spill Source Area at the DEG

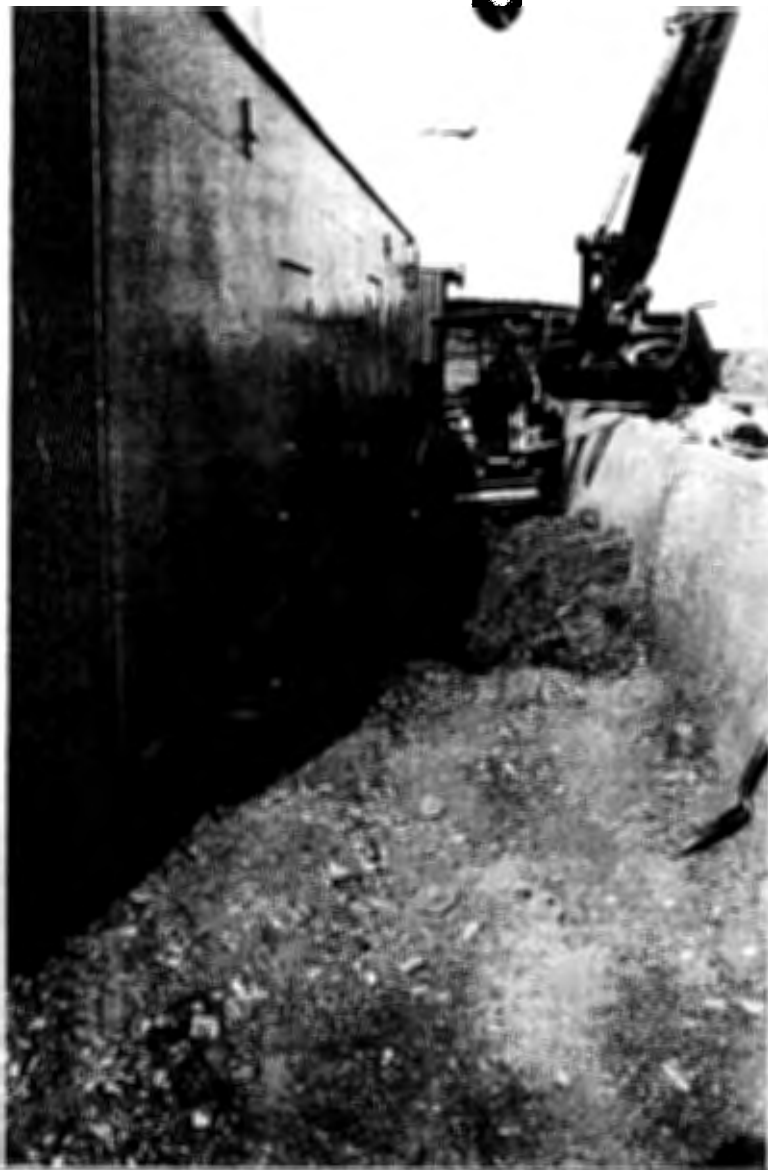
PHOTO 5 - DEG Spill
Source Area Excavation

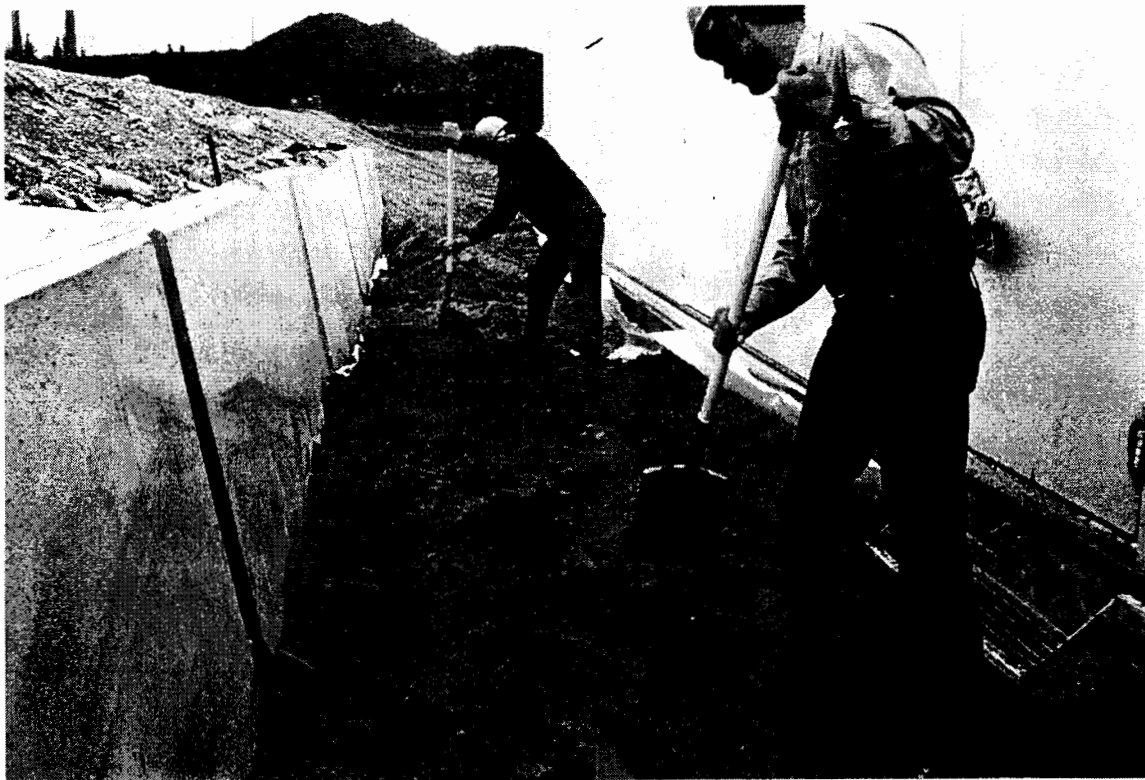
PHOTO 7 - DEG Source Area Backfill, Liner Placement and Grading

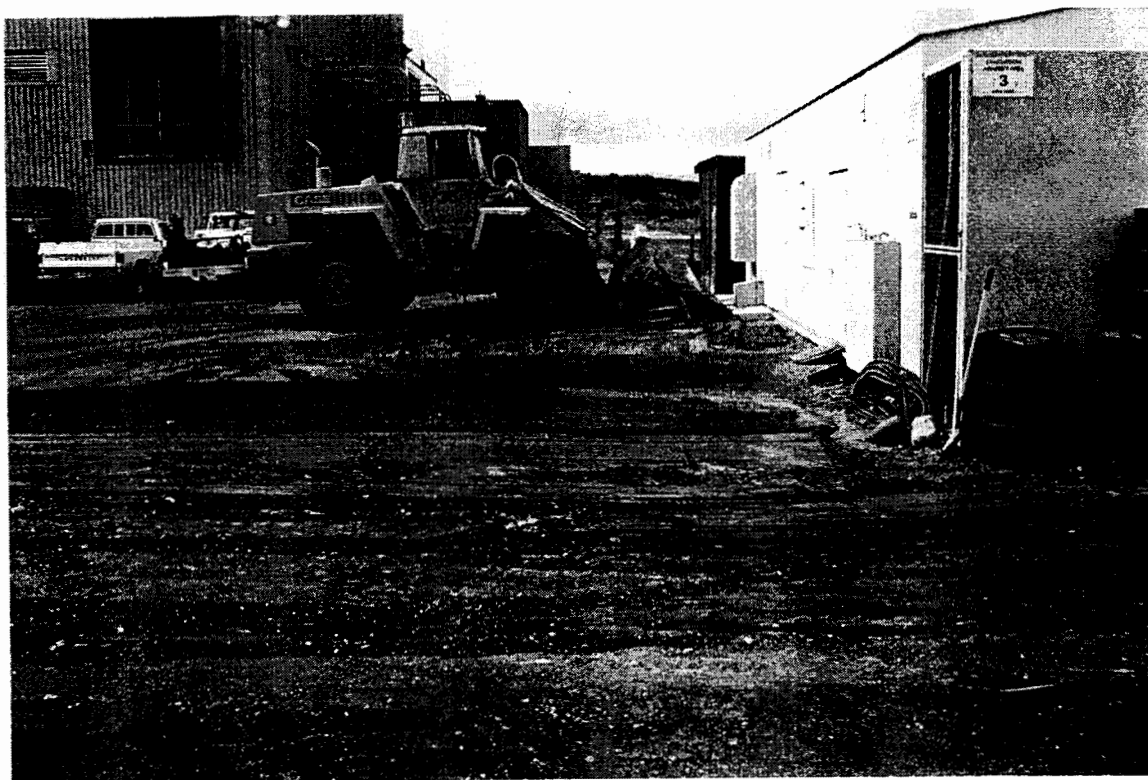
PHOTO 8 - DEG Test Pit Area Backfill and Grading
