### **REHABILITATION REPORT FOR THE KUPARUK RIVER STATE #1 EXPLORATORY WELL SITE, PRUDHOE BAY OILFIELD, ALASKA SITE**

Prepared by OASIS Environmental, Inc. Anchorage, Alaska and BP Environmental Studies Group

*13 December 2005*

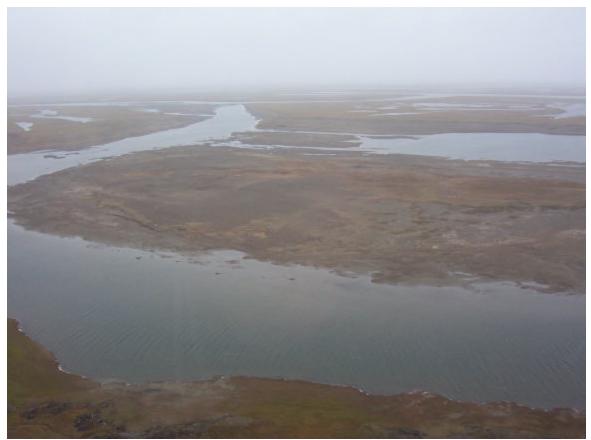
Figure 1. Kuparuk River State Rehabilitation Site (looking northwest), August 2005, 4 years after restoration began.

SITE DESCRIPTION: Figure 1 shows an aerial photograph of the Kuparuk River State #1 Rehabilitation Site. The site footprint is 7.1 acres and includes the airstrip, reserve pit, staging and wellhead areas. Riverine processes had affected this site for a number of years before its removal. Evidence that these processes are still occurring include: debris and ripples in the sand and irregularly placed gravel on the pad by flooding water levels. The site is located in the braided river channel of the Kuparuk River, which consists primarily of gravel and sand deposits. A number of species were noted colonizing on and around the site (See Appendix 1 for site photographs) including the grasses *Agropyron spp., Elymus arenarius*, and *Poa glauca*, forb species including *Astragalus alpinus*, *Gentiana propinqua, Hedysarum mackenzii, Papaver* sp., *Potentilla* sp., *Sagina intermedia, Salix arctolitoralis, Artemisia glomerata*, and *Cochlearia officinalis*. Several other unidentified grass and forb species were also present at the site. Substantial vegetation cover is present on the higher elevation areas of the site, in particular *Elymus arenarius* clumps. Low lying areas adjacent to the river are eroded to some extent, likely from flowing water.

The only performance standard that has been determined for this site is that it should become visually integrated with the adjacent habitat by Year 10 (2011). Due to the observed changes in the aerial photographs from 2003 to 2005, it is expected that this site will meet this standard.

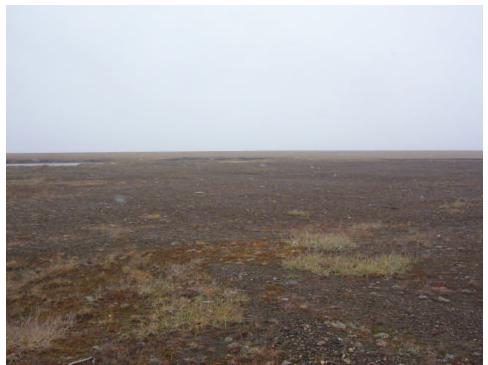
Photo 1. Dune grass colonies forming and capturing sand at the Kuparuk River State Exploratory Well Site (looking southwest), 30 August 2005, 4 years after restoration began.

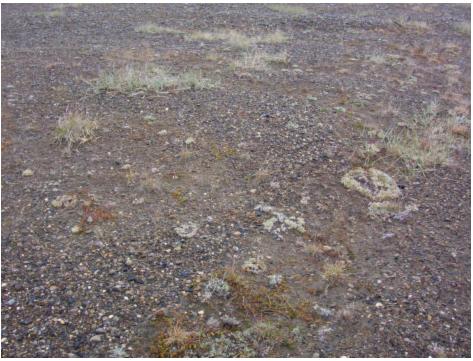
Photo 2. Natural colonization of the gravel surface at the Kuparuk River State Exploratory Well Site 30 August 2005, 4 years after restoration began.

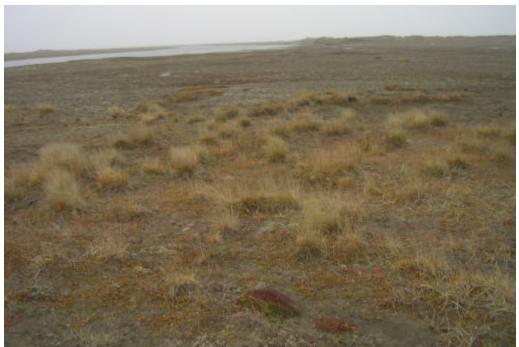
Photo 3. Dune grass colonizing the pad at the Kuparuk River State Exploratory Well Site (looking southwest) 30 August 2005, 4 years after restoration began.
