AJT Mining Properties, Inc
Treadwell Mine Cyanide Tailings Investigation Report
Douglas Island, Alaska

Site Investigation Report

Client: AJT Mining
 Project: Treadwell
 Tailings Site Sampling

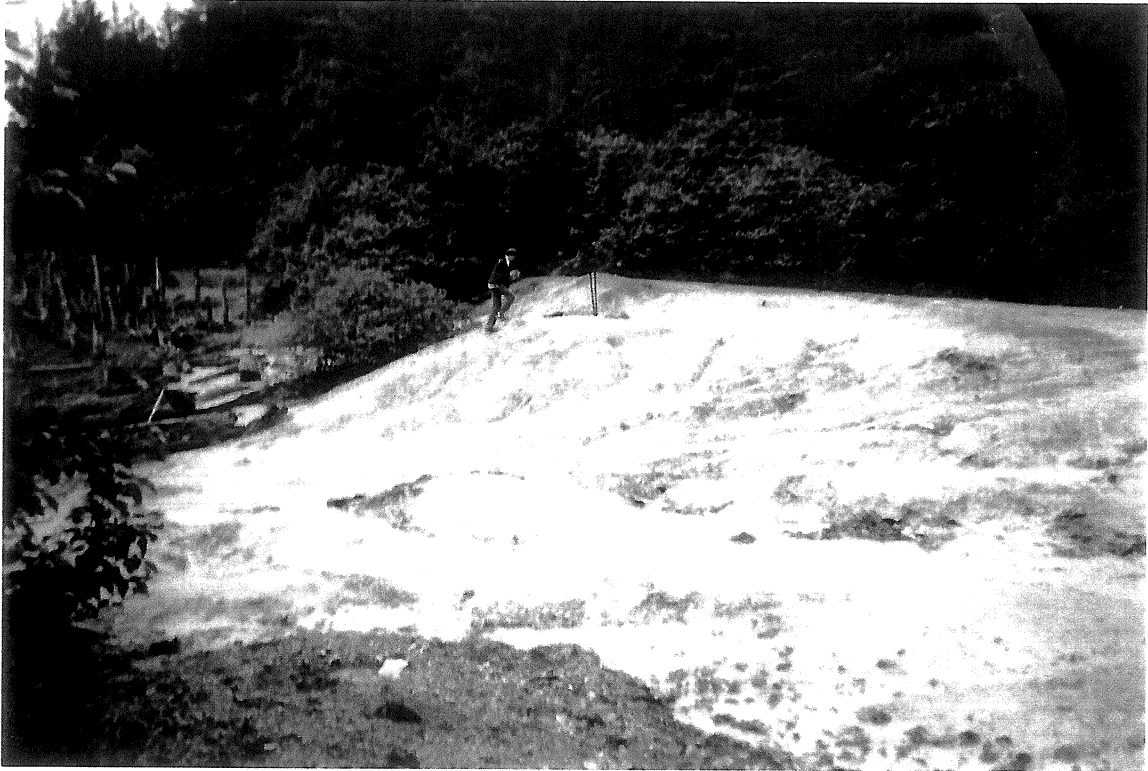
Lower tailings area.

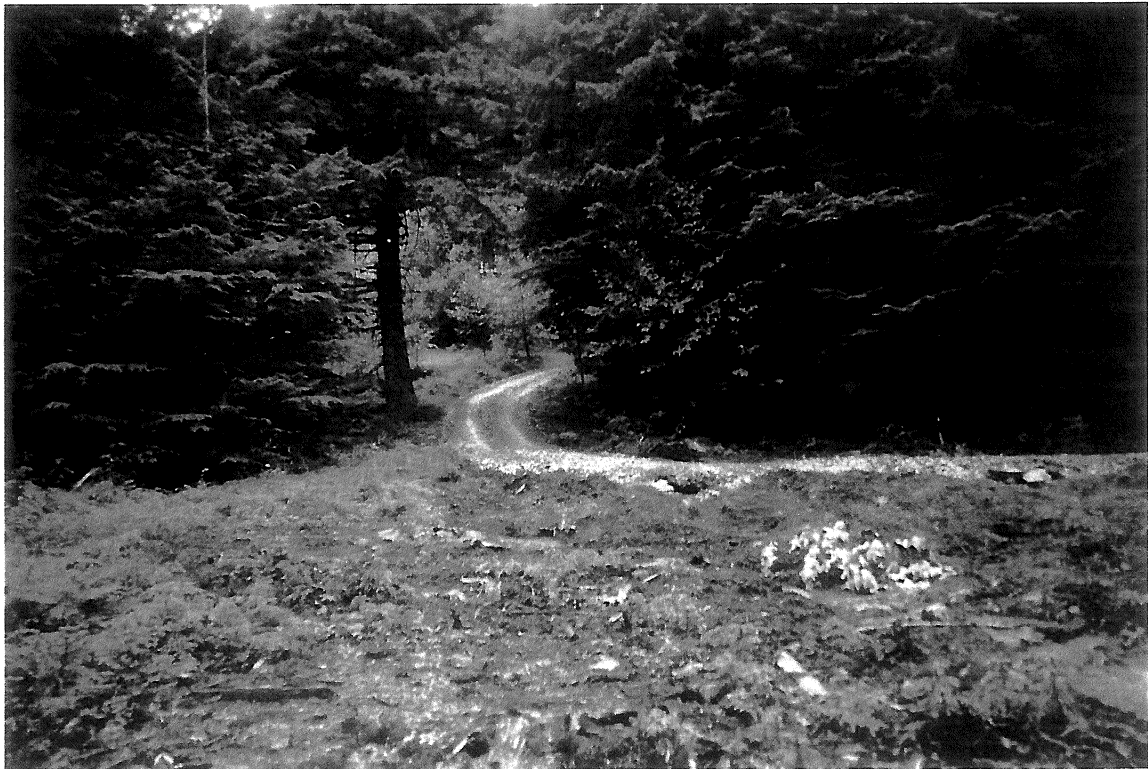
Upper tailings area.

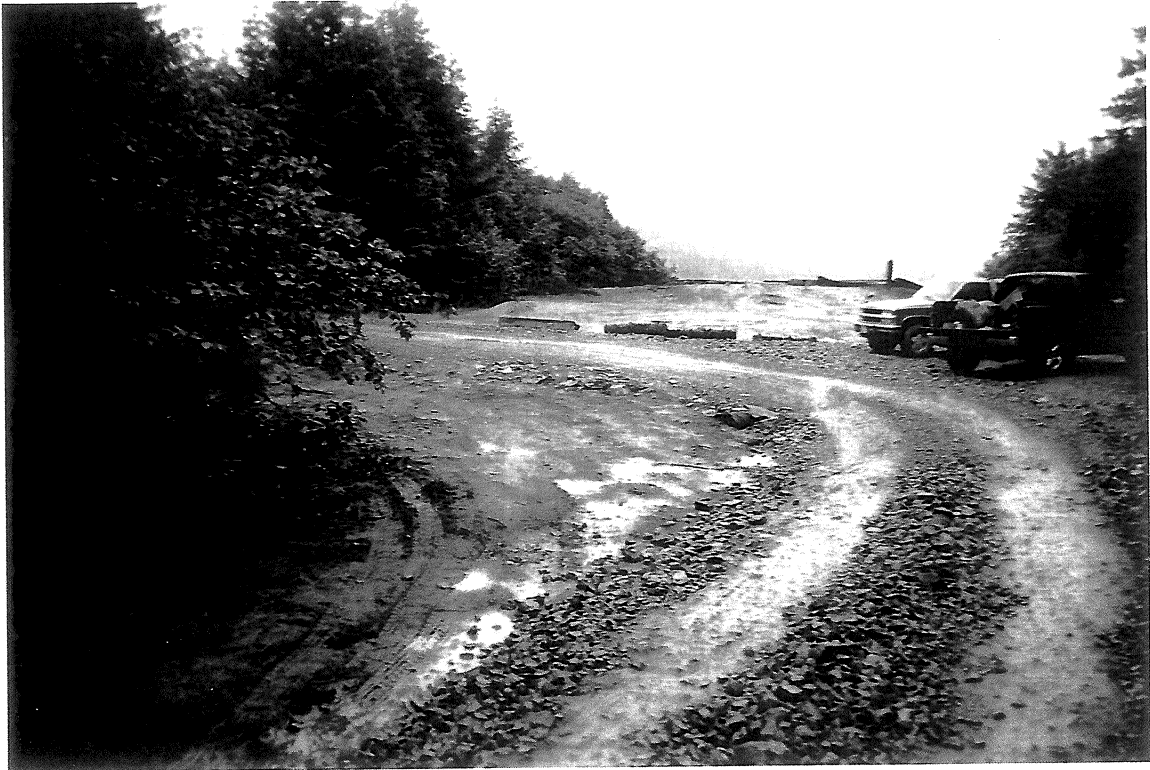
The improved ATV trail used by Alaska Canopy Adventures has not impacted the tailings area. AJT Mining plans to perform reclamation on the lower tailings area similar to the reclamation work by DNR on the upper tailings area in 1996. AJT will cover the area with a geotextile fabric such as Typar 3401, Mirafi 140N or equivalent. This will be covered with a layer of topsoil, fertilized and seeded with a blend of grass and wildflowers. AJT will continue to ensure that all water drainages are situated to prevent surface water run-off from entering the tailings area.

Gravel road over lower tailings area.
