# SITE CHARACTERIZATION, CORRECTIVE ACTION AND DECOMMISSIONING REPORT

**HIPAS OBSERVATORY  
7795 CHENA HOT SPRINGS ROAD  
FAIRBANKS (TWO RIVERS), ALASKA**

**MARCH 5, 2013**

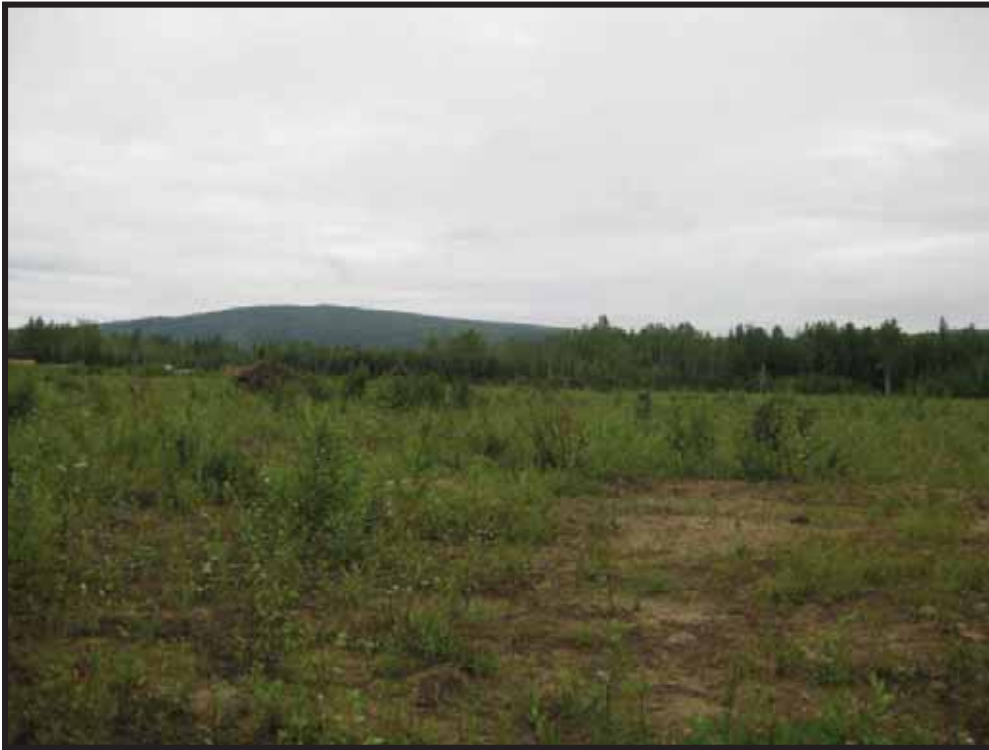
**Surface Debris Removal**

**NORTECH** was responsible for the disposal of wire collected from the grounding grid beneath the primary antenna array. This grid was primarily chicken wire and was determined to be a physical hazard at the Site due to damage and access following the removal of the primary antenna array. Mr. Richards “bundled” the wire using heavy equipment in September 2011 and this material was disposed of later that fall.

**Photo 3:** *Looking southeast across Main Transmitter Array Area after removal of antenna with bundles of grounding grid ready for disposal (2011)*

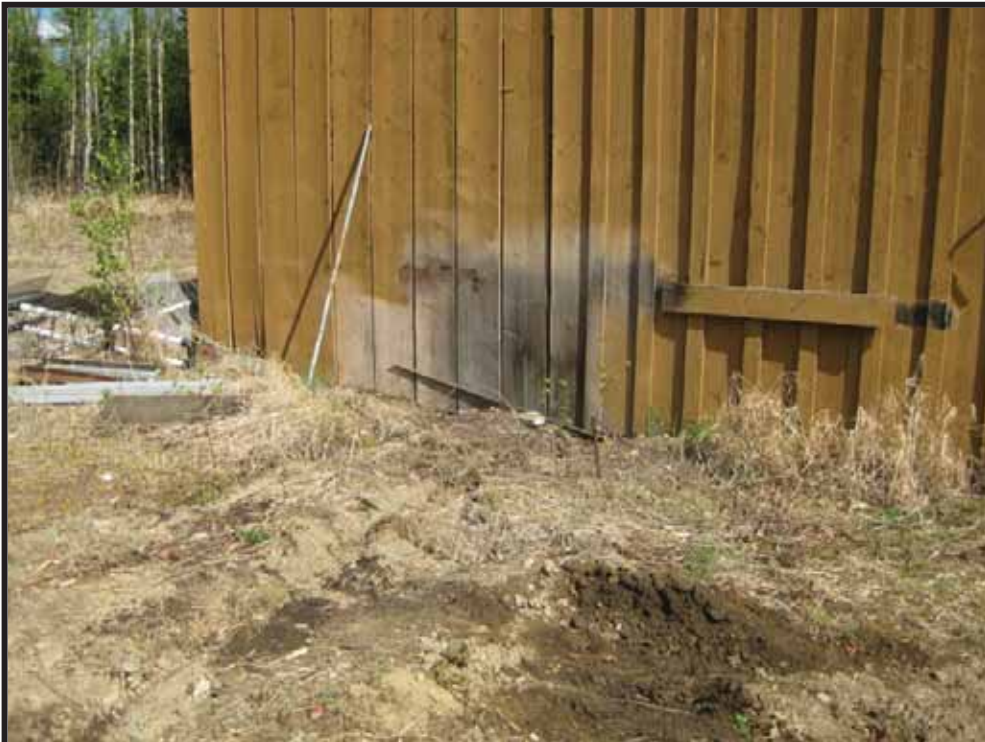
**Photo 2:** Photo taken facing south showing staining in the vicinity of the former location of the heating oil AST and to the north.

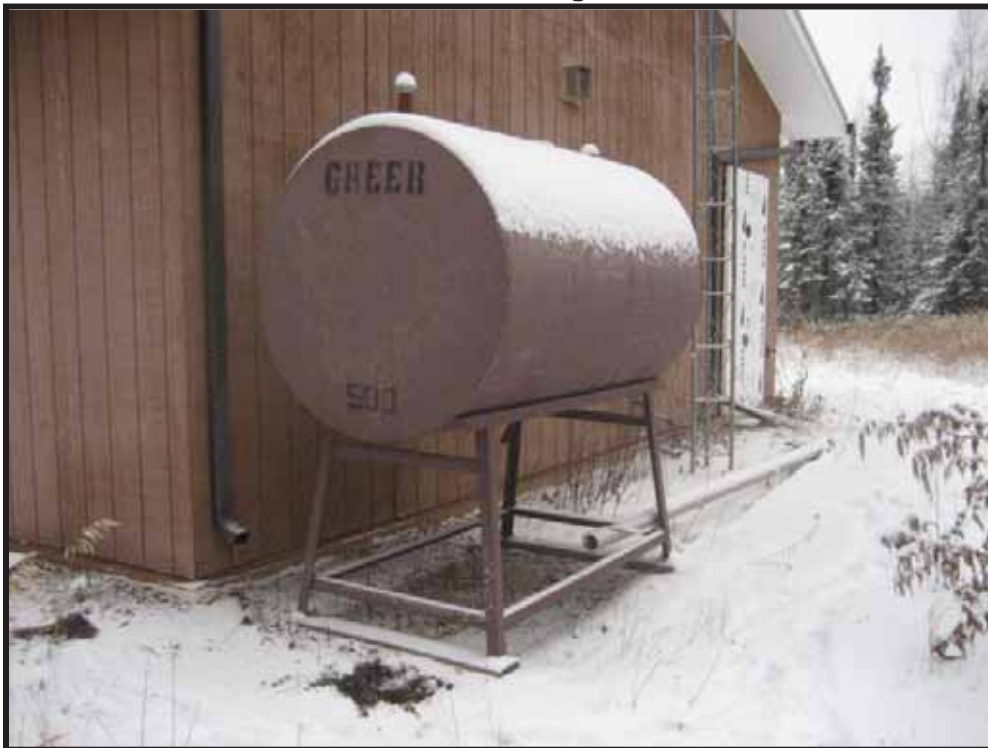
**LIDAR Building AST**

The ESA identified two recognized environmental conditions (RECs) at the property, both of which were located at the LIDAR Building. The first REC was the reported accidental overfilling of the LIDAR heating oil tank, which resulted in a release estimated to be more than 10 gallons and less than 150 gallons. The release had not been reported to ADEC. The ESA recommended the tank should be removed and the release area assessed to identify vertical and horizontal limits of contamination and the potential for contamination beneath the building slab. The assessment data should then be used to develop a corrective action plan for submission to ADEC as notification of the release and for approval of the proposed corrective action.

**Photo 1:** Above ground fuel tank at north end of LIDAR building that was reputedly overfilled (2008).

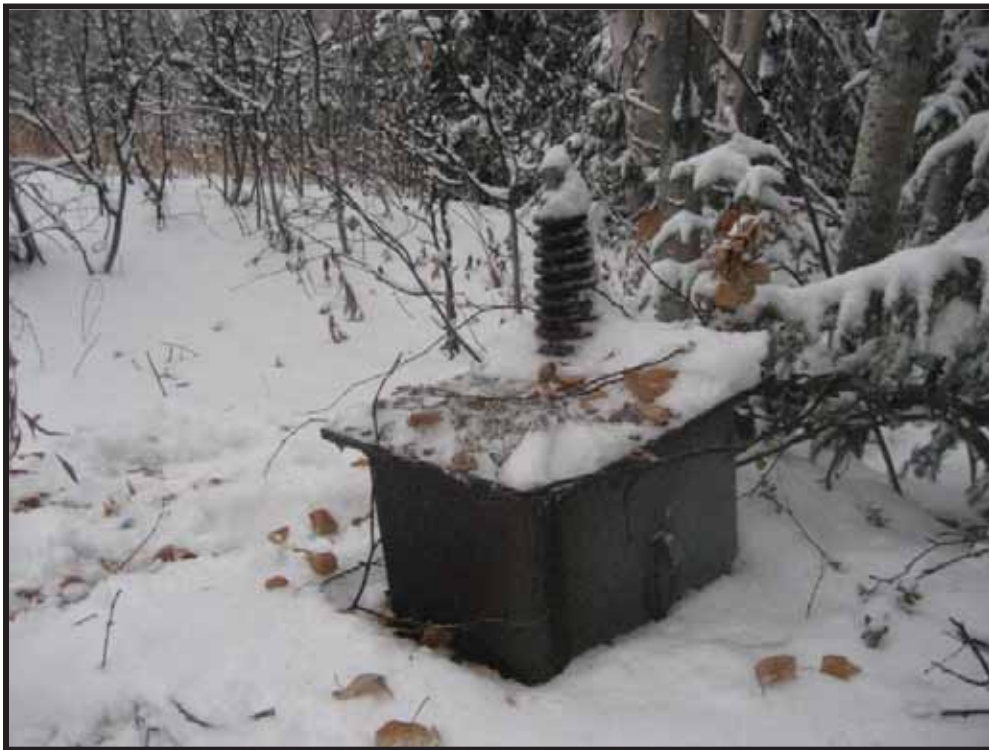
**LIDAR Transformer**

*Photo 1: Abandoned transformer in the LIDAR area.*

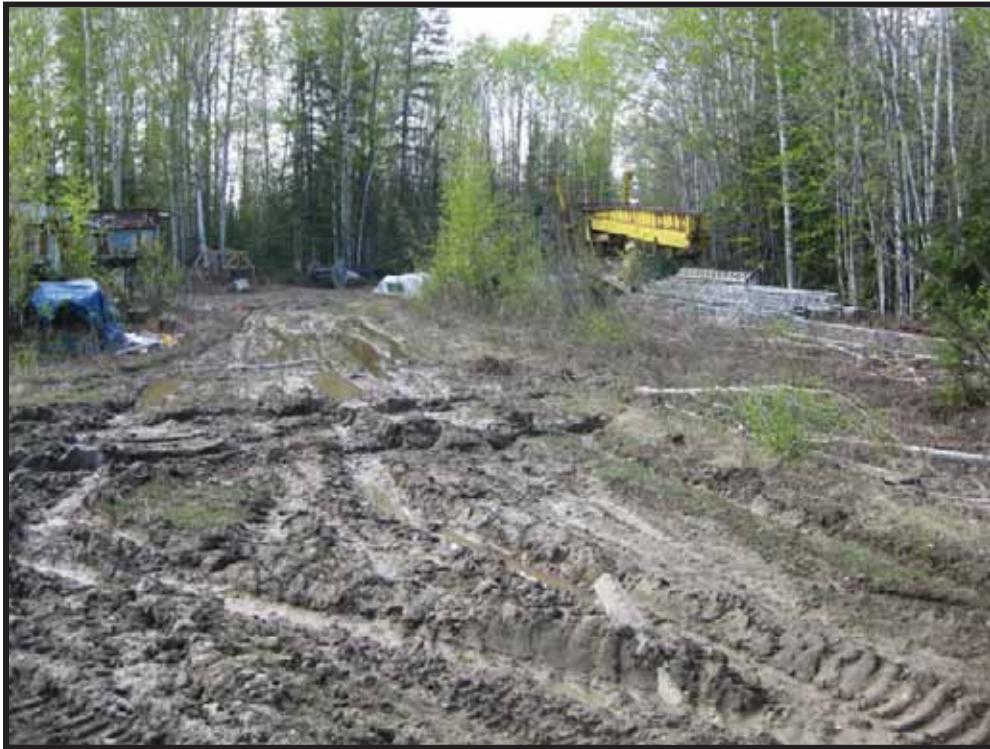
**Boneyard Hydraulic Stain**

*Photo 1: Hydraulic lift (yellow) visible in upper right of image, source of the hydraulic stain in the Boneyard area.*

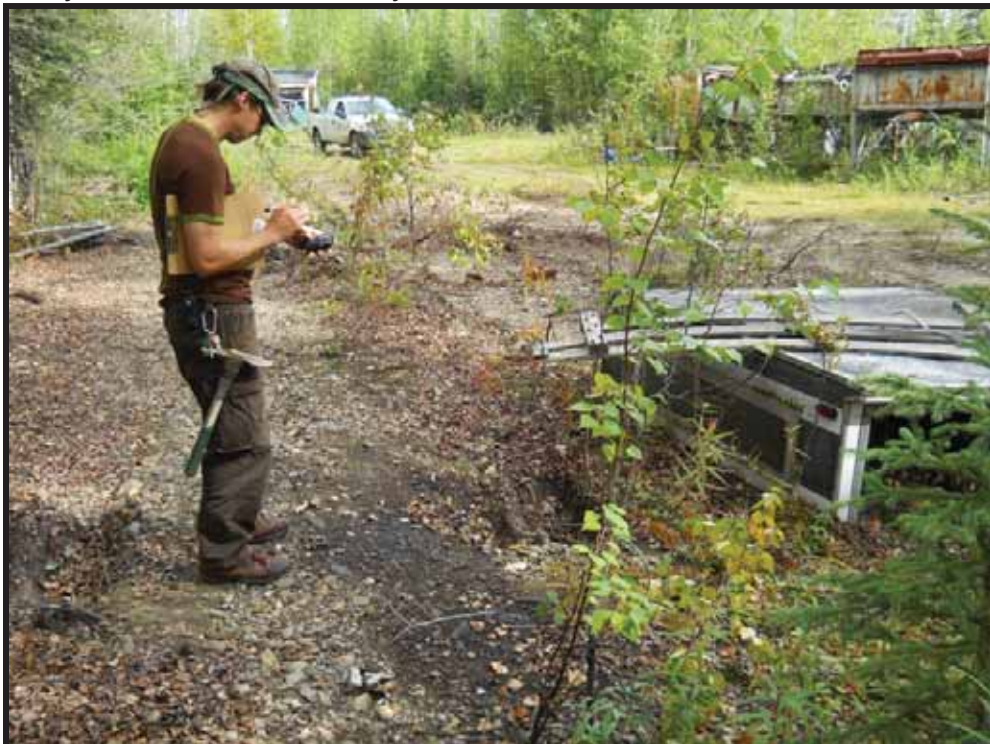
*Photo 2: Hydraulic stain observed following removal of lift in the Boneyard area.*

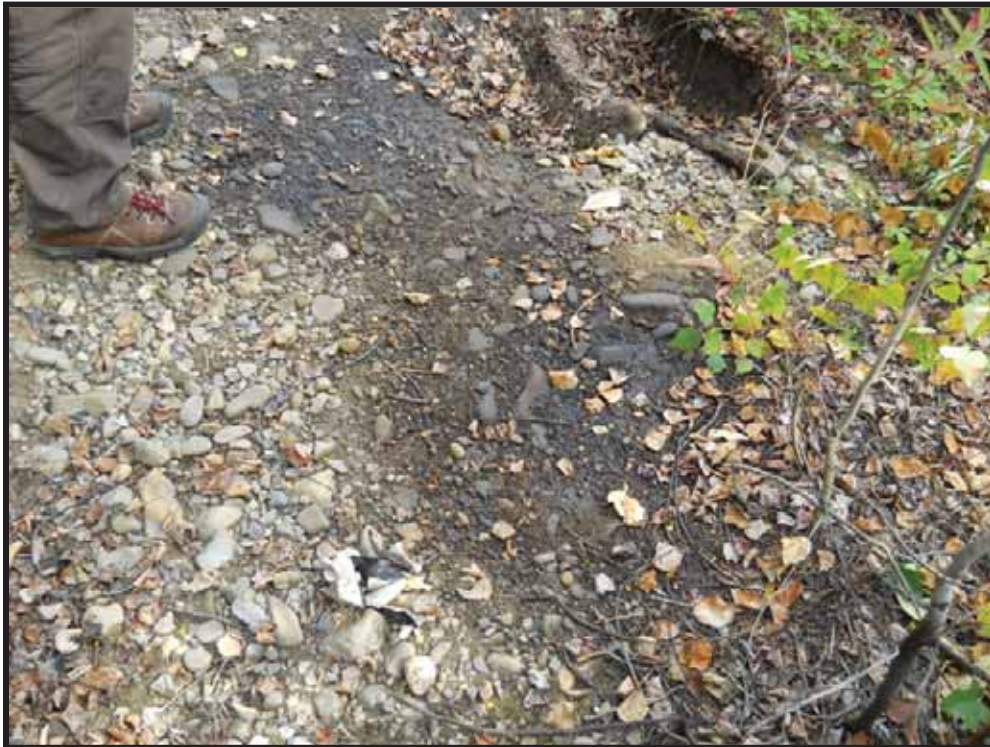
**Boneyard Hydraulic Stain**

*Photo 3: Close up of the hydraulic stain in the Boneyard area.*

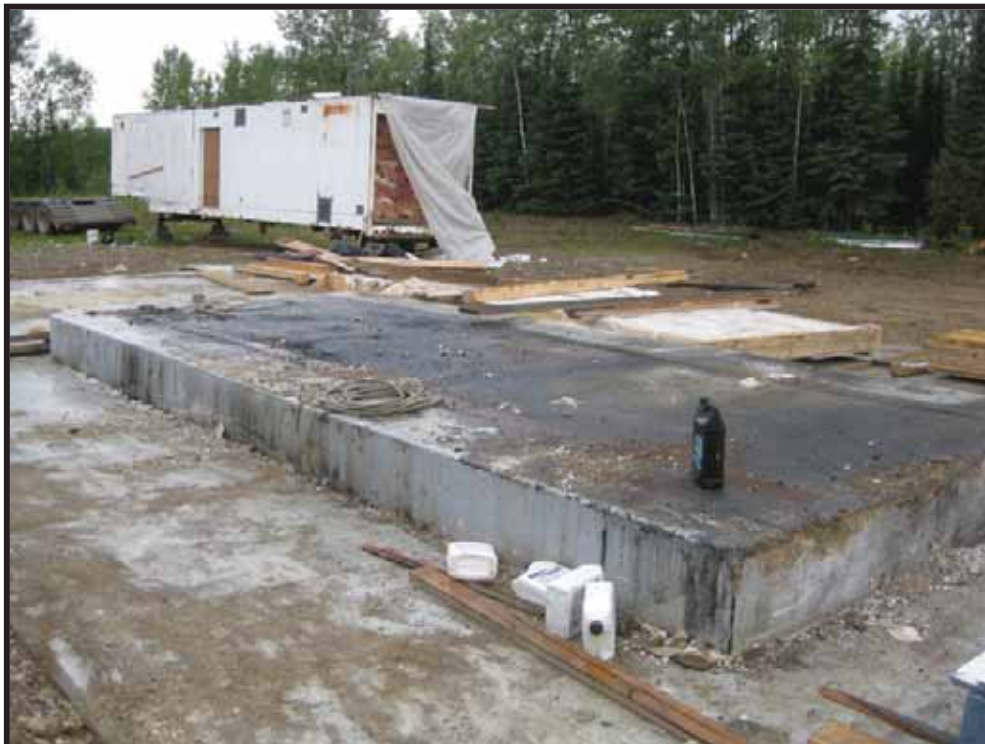
**Photo 2:** North generator pedestal after removal of generator and Generator Building. Stained concrete from release of fluids during removal.

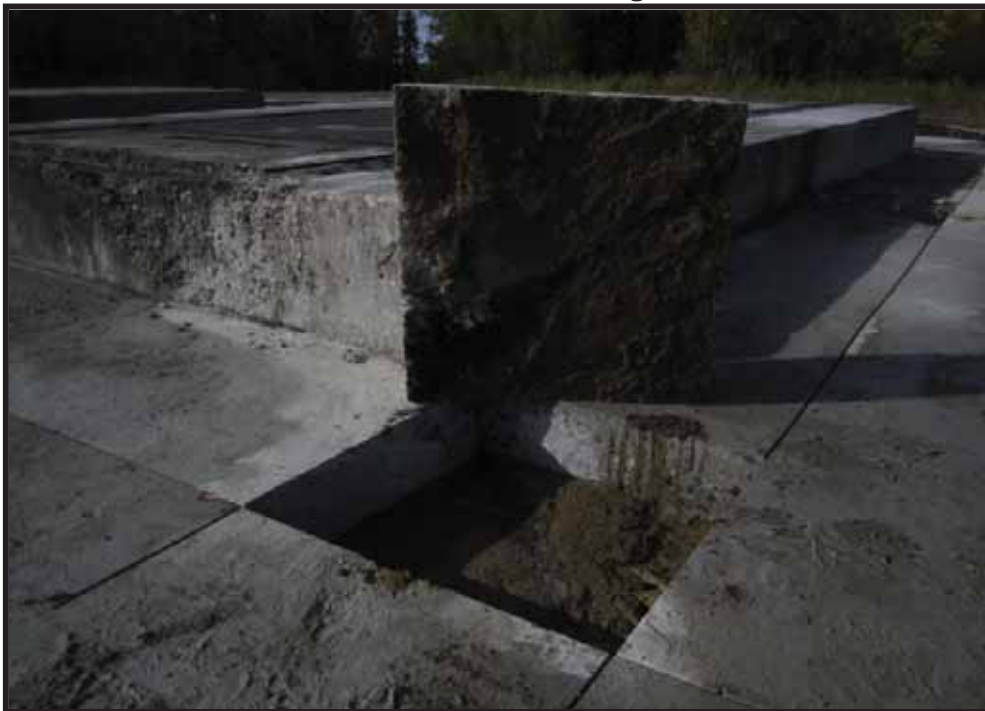
**Generator Building**

**Photo 3:** *The concrete around the central and north generator pads in the former powerhouse was cut in a two foot wide perimeter around the pads. Typical cut around generator pedestal for assessment.*

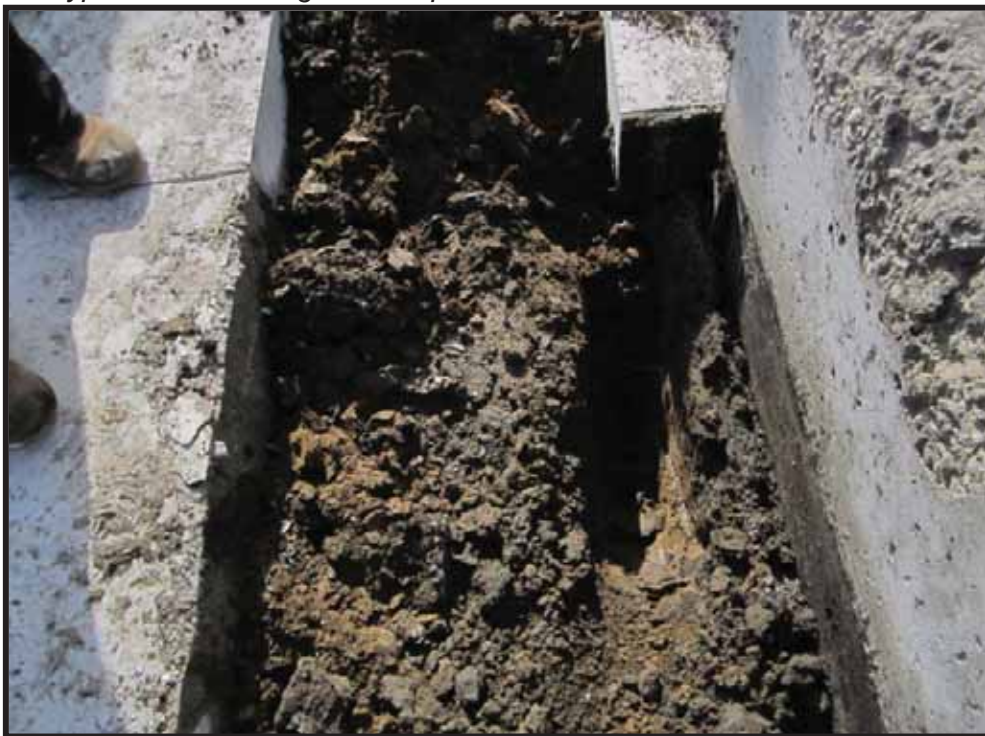
**Photo 4:** *Hydrocarbon odor and evidence of staining on southeast corner of north generator pedestal during initial assessment. Additional concrete removal necessary.*

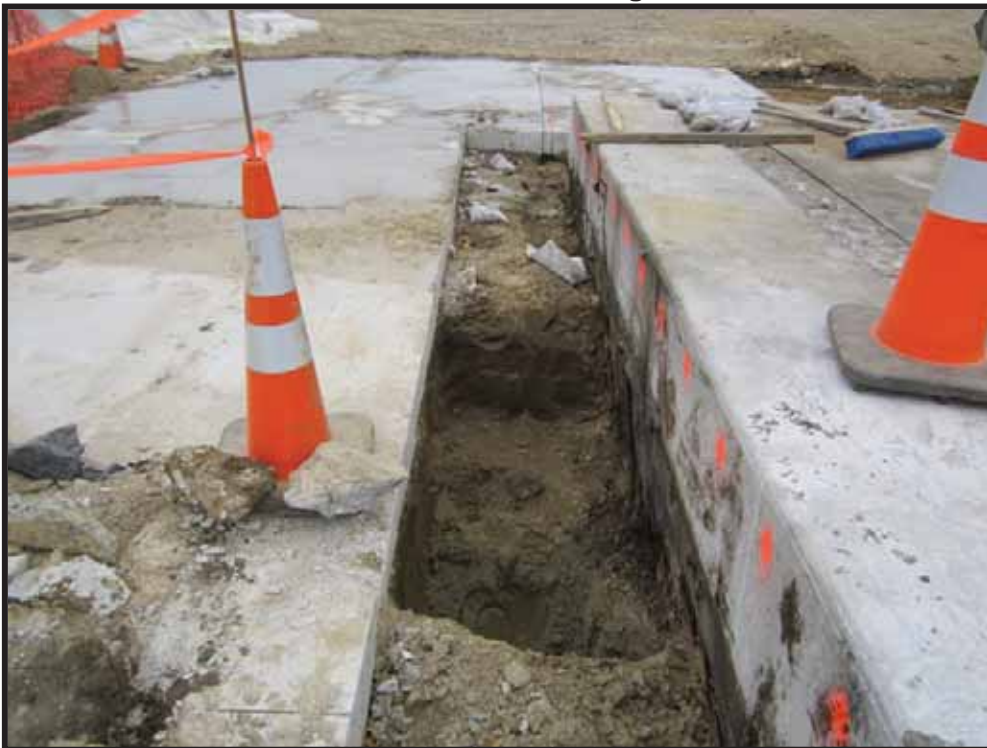
**Generator Building**

**Photo 9:** Hand excavation of stained soil on north side of central pedestal, typical of perimeter lubrication oil stains.

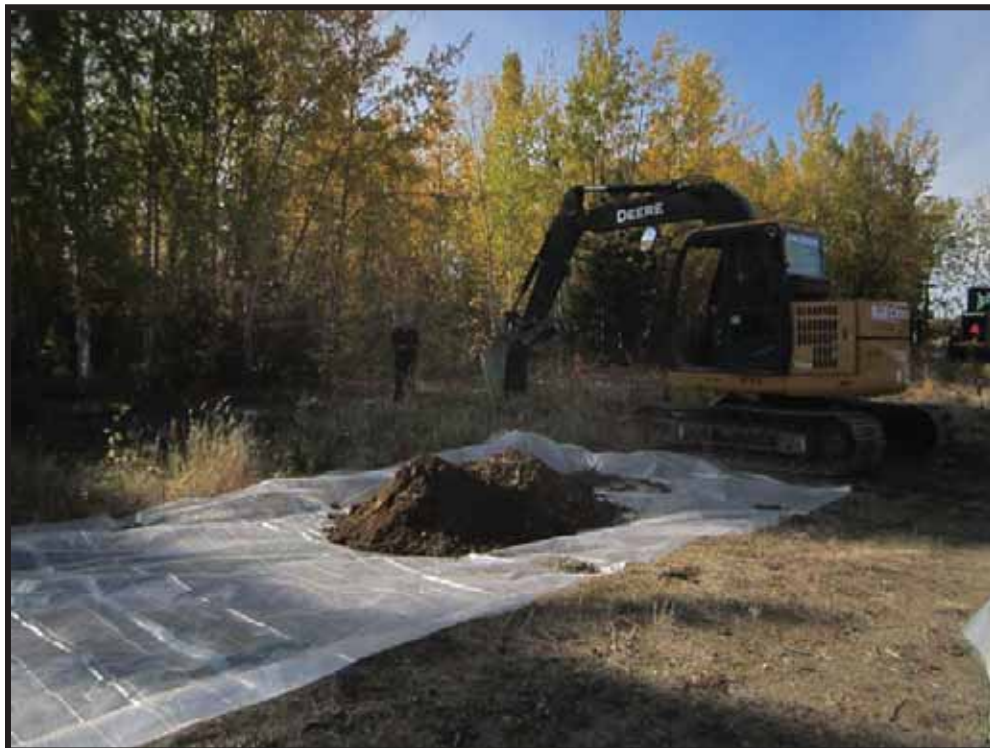
*Photo 2: Looking west southwest at the parts generator stain and excavation.*

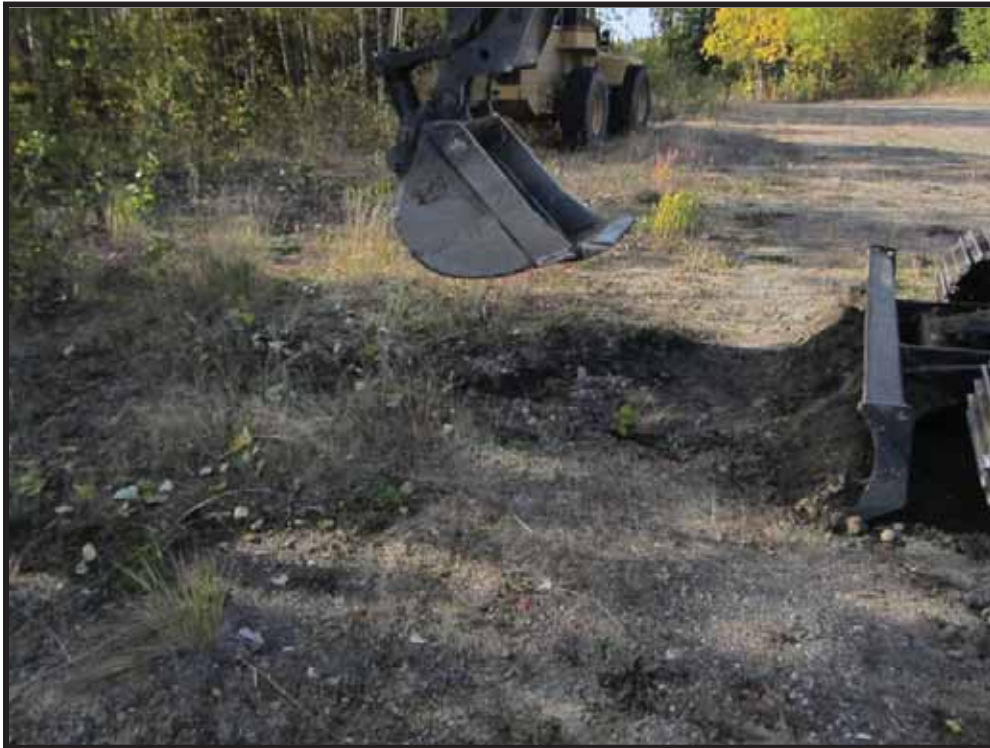
**Driveway Surface Stains**

**Photo 3:** *Looking west at the hydraulic stain west of the parts generator stain and south of the generator building.*

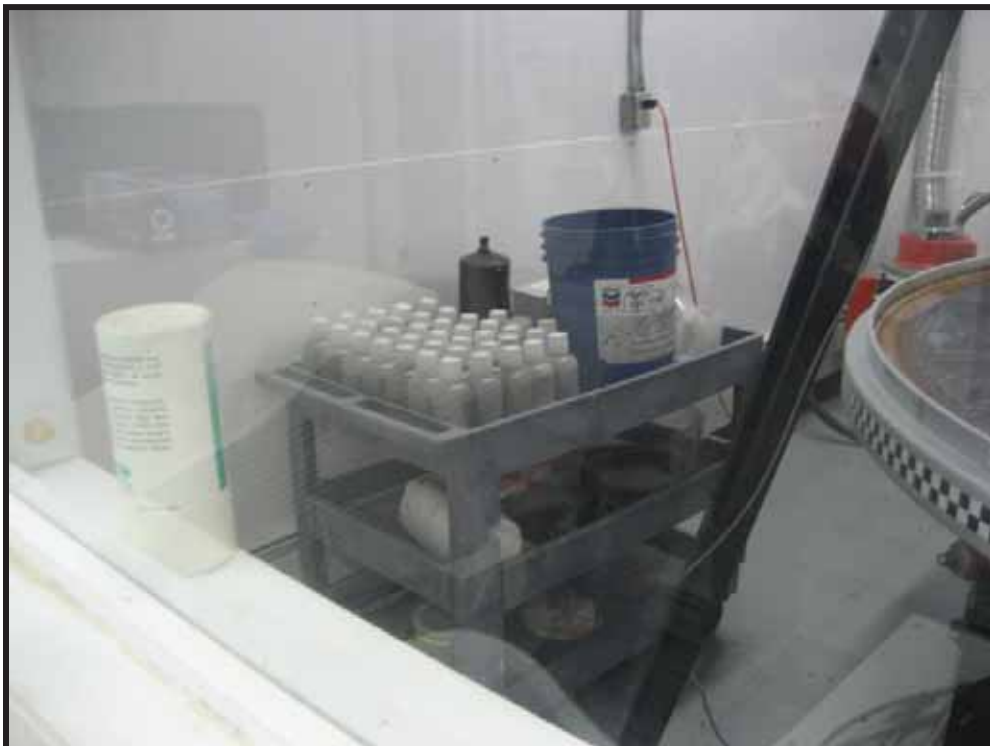
The second REC was related to the LIDAR Building, which housed a liquid mirror telescope (LMT) that utilized a rotating disk of mercury to create a lens used for research projects. Normal use of this equipment was assumed to have contaminated the LMT room and all contents with mercury. At the time of the ESA, use of the LMT had been discontinued and decommissioning was recommended. The ESA recommended development of a work plan for assessment and cleanup of the LMT to address the decontamination and disposal of the mercury that remained containerized in the LMT room, other items in the LMT room, and building materials within the LMT space. Operational controls appeared to have limited the migration of mercury outside the LMT room, but the work plan also outlined a limited sampling effort outside the LMT to verify that mercury contamination was not present outside the sealed area. This work plan was also expected to address the mercury containing switches stored near the LMT room and the mercury shipping containers located in the Shop.

*Photo 2: Containers of mercury in LMT room, LMT table to right.*
