## INFORMATION PAPER

SUBJECT: Poleline Road Disposal Area (PRDA), 6th ID (L), Ft Richardson, AK

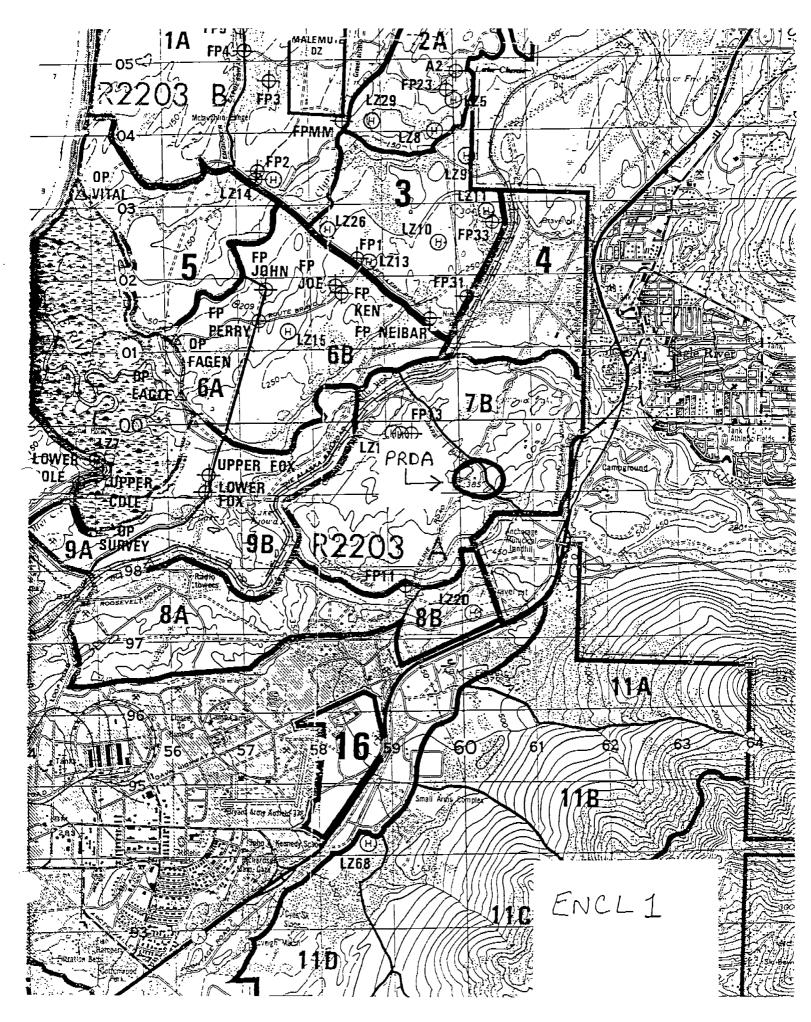
b. Enclosure 1 shows the location of PRDA. A Corps of Engineers-contracted removal action at PRDA commenced the week of 27 Sep 93. Two parallel trenches (Trench A and Trench B) were to be excavated in accordance the Scope of Work. On 1 Oct 93, the contractor reported discovery of items not anticipated by any preliminary investigations or site-specific historical information. Approximately 20' short of completion of Trench A, the contractor discovered some opened, glass bottles and pages from a chemical training manual that were possibly components of late 1940's/early 1950's Gas Identification Set, Instructional. Excavation on Trench A was halted and shifted to Trench B. Shortly after starting Trench B, related components potentially from a Gas Identification Kit, Detonation, were uncovered by the contractor. These items were two unopened, steel, tube-shaped shipping containers, or "pigs". A diagram of the original site layout and location of the trenches and suspect glass bottles and pigs are shown at enclosure 2.
