Department of Transportation and
Public Facilities

Re: Kalsin Bay Landfarm Report

KALSIN BAY MAINTENANCE STATION
KODIAK ISLAND, ALASKA

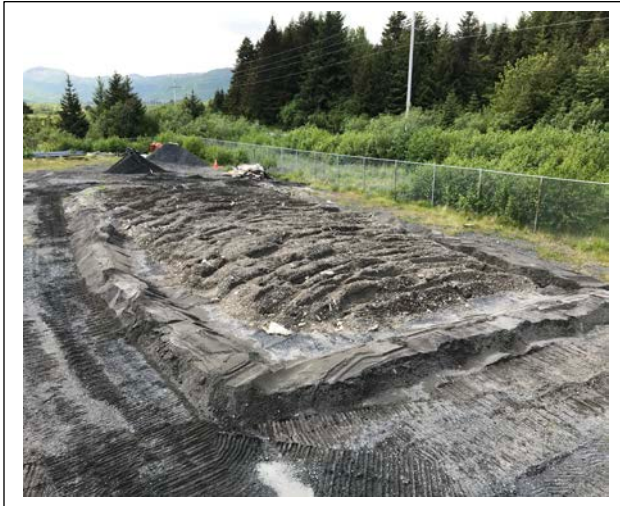
Photo 1. View of the stockpile cell located on the north side of the property. The photo is facing northwest.

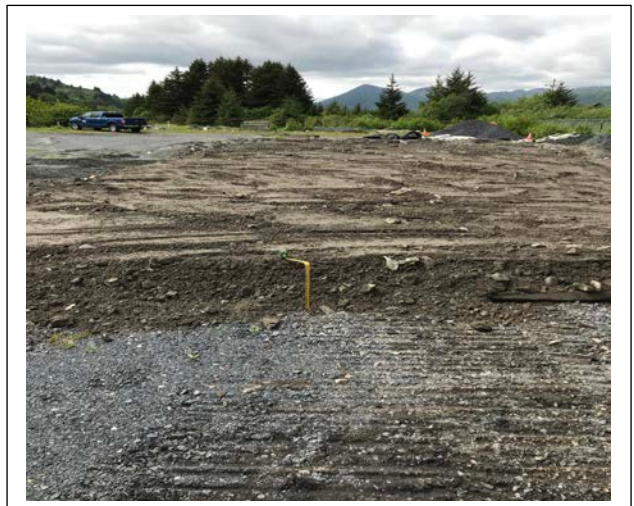
Photo 2. The depth of the landfarm material is 8–12 inches.

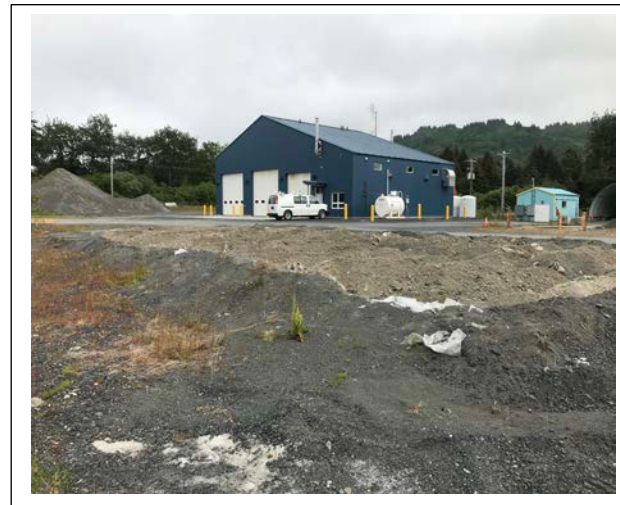
Photo 3. View of the material facing south.

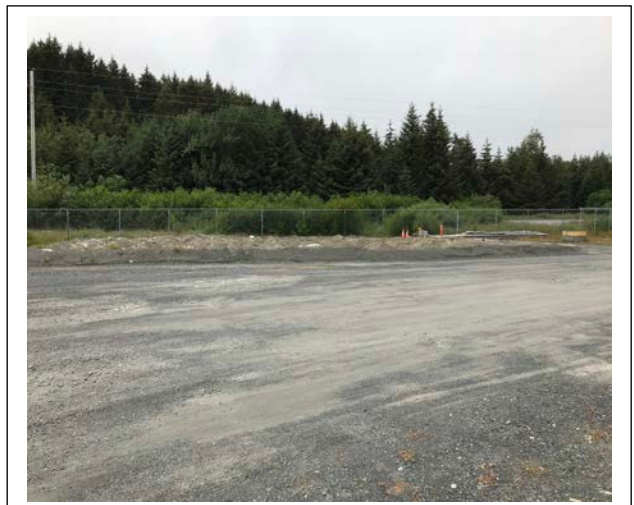
Photo 4. View of the material facing northeast.

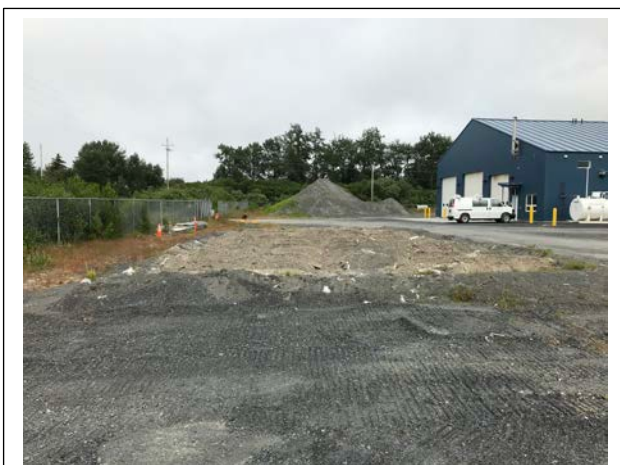
Photo 5. View of the material facing east.
