United States Air Force 611th Air Support Group 611th Civil Engineer squadron

SECOND CERCLA FIVE-YEAR REVIEW & SECOND NON-CERCLA PERIODIC REVIEW REPORT

CAPE ROMANZOF LRRS, ALASKA

FINAL JUNE 2013

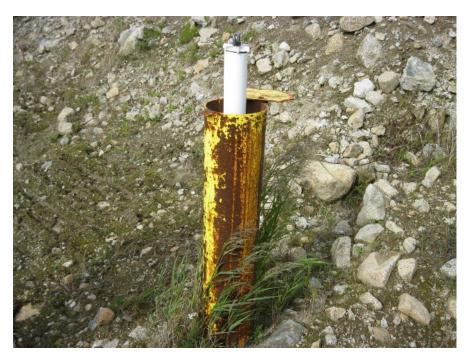
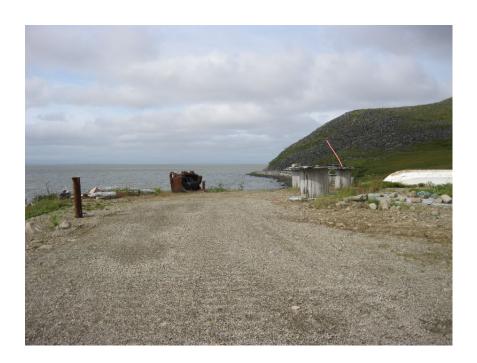
Photo No. 5 – 20 August 2012 ST009 Spill/Leak No. 3; MW-5; view facing northwest.

Photo No. 6 – 20 August 2012 ST009 Spill/Leak No. 3; MW-5; view facing northwest.

Issues and Recommendations Identified in the Five-Year Review:						
OU(s): SS013 Issue Category: None						
	Issue:.None					
	Recommendation Review.	Recommendation: Continue ICs and schedule the third Five-Year Review.				
Affect Current Protectiveness	Affect Future Protectiveness	Implementing Party	Oversight Party	Milestone Date		
No	No	Other (611 CES)	State (ADEC)	2013		
OU(s): SS015	Issue Category: N	/lonitoring				
	Issue: WW-3 lock side of site is unma	and protective cap arked.	are broken off; WV	V-01 on south		
Recommendation: Replace the lock and cap at WW-3 and mark W 01. Continue ongoing monitoring and schedule the third Five-Year Review.						
Affect Current Protectiveness	Affect Future Protectiveness	Implementing Party	Oversight Party	Milestone Date		
No	No	Other (611 CES)	State (ADEC)	2013		
OU(s) : ST009	Issue Category: Monitoring					
	Issue: MW-5 has experienced frost jacking.					
	Recommendation: Inspect MW-5 for proper functioning.

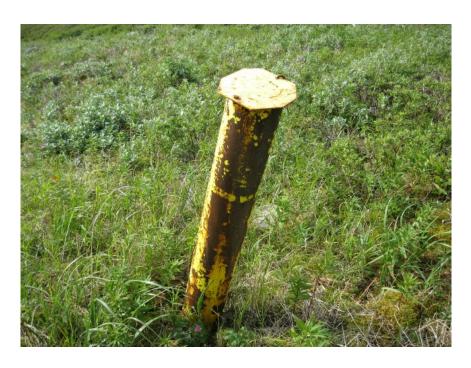
Photo No. 11 – 20 August 2012 SS014 Drum Storage Area; MW3; view facing west

Issues and Recommendations Identified in the Five-Year Review (Continued):						
OU(s): SS014	Issue Category: Monitoring					
	Issue: MW-1, MW	-2, and MW-3 have	experienced frost	jacking.		
	Recommendation functioning.	Recommendation: Inspect MW-1, MW-2, and MW-3 for proper functioning.				
Affect Current Protectiveness	Affect Future Protectiveness	Implementing Party	Oversight Party	Milestone Date		
No	No	Other (611 CES)	State (ADEC)	2013		
OU(s): SS014	Issue Category: (Change in Site Cond	dition			
	Issue: Broken glas	ss surrounding old v	wooden platform.			
	Recommendation	n: Remove broken g	glass.			
Affect Current Protectiveness	Affect Future Protectiveness	Implementing Party	Oversight Party	Milestone Date		
No	No	Other (611 CES)	State (ADEC)	2013		
OU(s): DP011	Issue Category: S	Site Inspection				
		eather conditions pr accessible for any di ted.				
	Recommendation: Continue monitoring and schedule the second and third periodic reviews.

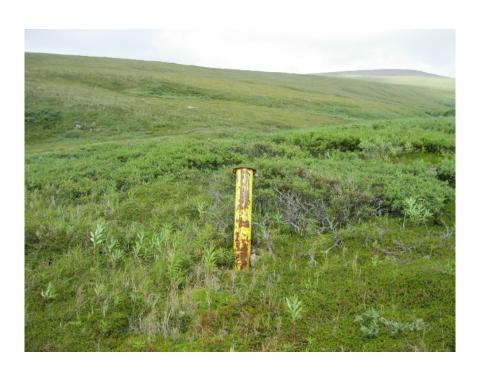
Photo No. 12 – 20 August 2012 SS014 Drum Storage Area; MW1; view facing west.

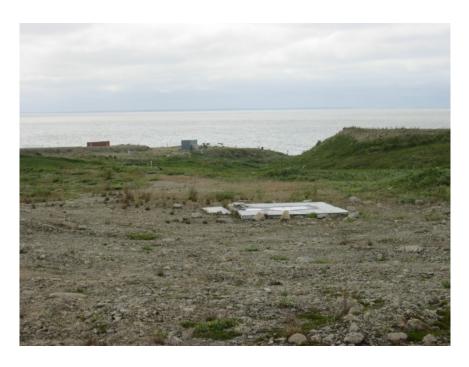
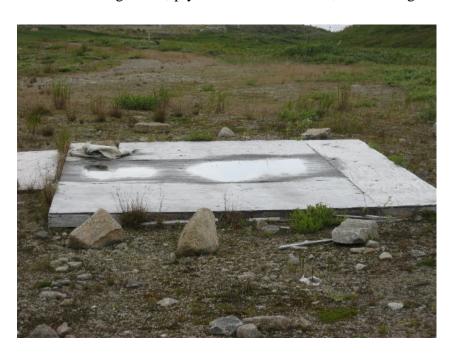
Photo No. 13 – 20 August 2012 SS014 Drum Storage Area; plywood tent foundation; view facing south.

Photo No. 14 – 20 August 2012 SS014 Drum Storage Area; plywood tent foundation; view facing south.

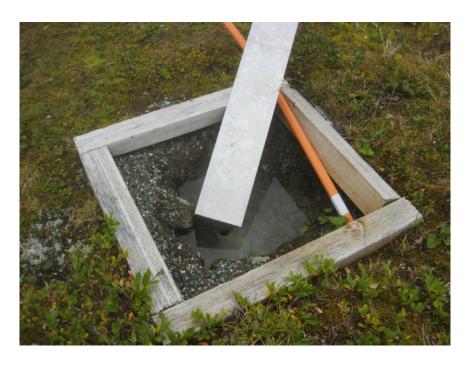
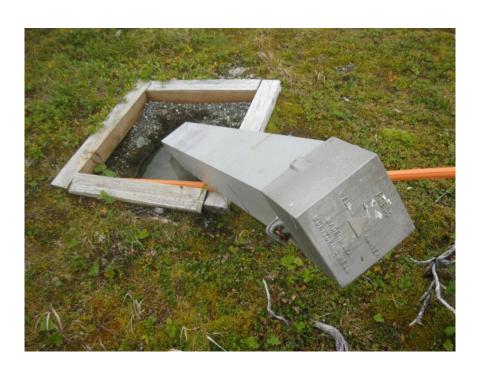
- At LF003, Monitoring Well CMW7 has an exposed wellhead and should be repaired and inspected for proper function; the protective metal casing has fallen to the ground and standing water surrounds the well.
- Monitoring Well WW-03 at SS015 has a broken lock and cap that need repair and protective casing, and Monitoring Well WW-01 on the south end of SS015 is currently unmarked.
- Monitoring Wells MW-5 at ST009 have experienced frost jacking and should be inspected for proper function.
- Monitoring Wells MW-1, MW-2, and MW-3 at SS014 have also experienced frost jacking and should be inspected for proper function. Additionally, at SS014, broken glass surrounds a plywood platform, which should be removed.

Photo No. 23 – 20 August 2012 LF003 Landfill No. 2; CMW7; view facing southeast.

Photo No. 24 – 20 August 2012 LF003 Landfill No. 2; CMW7; view facing northeast.

Issues and Recommendations Identified in the Five-Year Review:					
OU(s) : LF003	Issue Category: Monitoring				
	Issue: The protective metal casing at CMW-7 has exposed the and standing water surrounds the well.			sed the wellhead	
	Recommendation	: Repair CMW-7.			
Affect Current Affect Future Implementing Oversight Protectiveness Party Party				Milestone Date	
No	No	Other (611 CES)	State (ADEC)	2013	
OU(s) : LF003	Issue Category: None.				
	Issue: N/A				
	Recommendation: Continue ongoing monitoring at LF003 and schedule the third Five-Year Review.				
Affect Current Protectiveness	Affect Future Implementing Oversight Protectiveness Party Milestone Date				
No	No	Other (611 CES)	State (ADEC)	2013

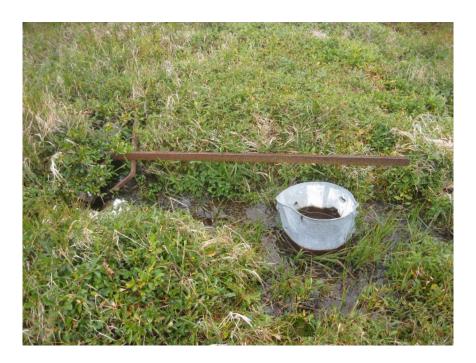
Photo No. 25 – 20 August 2012 LF003 Landfill No. 2; debris located at south end of site.

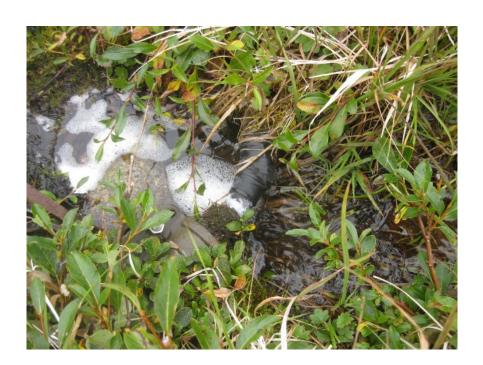
Photo No. 26 – 20 August 2012 LF003 Landfill No. 2; hose near CMW7.

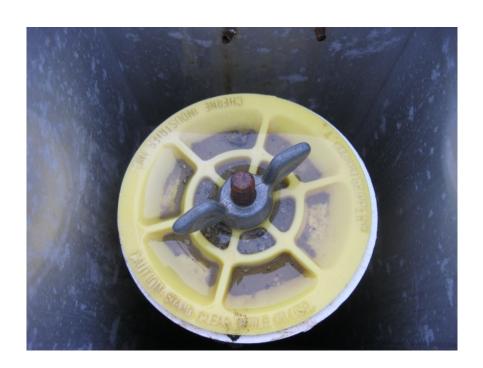
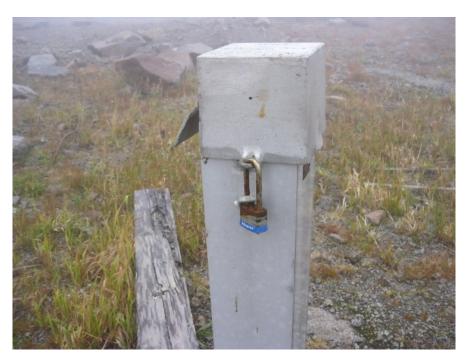
Photo No. 32 – 21 August 2012 SS015 UST Spill Area; WW03; top view.

Photo No. 33 – 21 August 2012 SS015 UST Spill Area; WW03; view facing north.
