THIRD CERCLA FIVE-YEAR REVIEW AND THIRD NON-CERCLA PERIODIC REVIEW REPORT FOR SITES DP011, LF003, SS010, SS013, SS014, SS015, SS016, SS017, AND ST009 AT CAPE ROMANZOF LONG RANGE RADAR STATION, ALASKA

Final November 2018

United States Air Force Joint Base Elmendorf-Richardson, Alaska

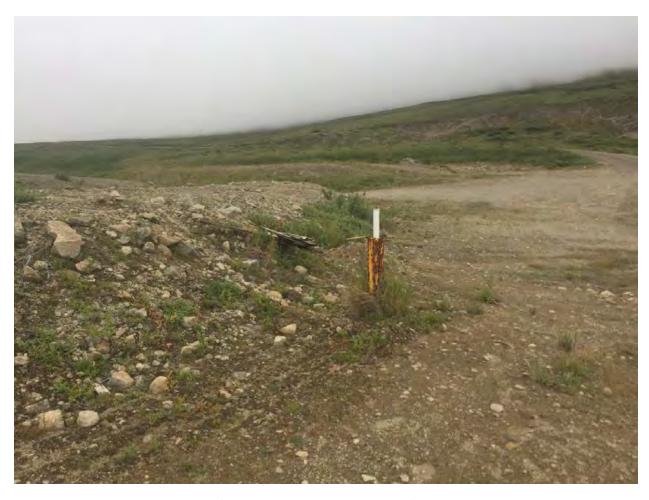
ST009 view north. MW5 shown in foreground. Also shown are the former borrow pit and biocell foundation.
