FORMER LANDFILL (LF03) SURFACE SOIL  
INVESTIGATION REPORT

CAPE ROMANZOF LRRS, ALASKA  
FEBRUARY 8, 2005

United States Air Force  
611th Air Support Group  
611th Civil Engineer Squadron  
10471 20<sup>th</sup> Street, Suite 338  
Elmendorf AFB, Alaska 99506-4420

Paug-Vik Development Corporation  
1600 "A" Street; Suite 306  
Anchorage, Alaska 99501

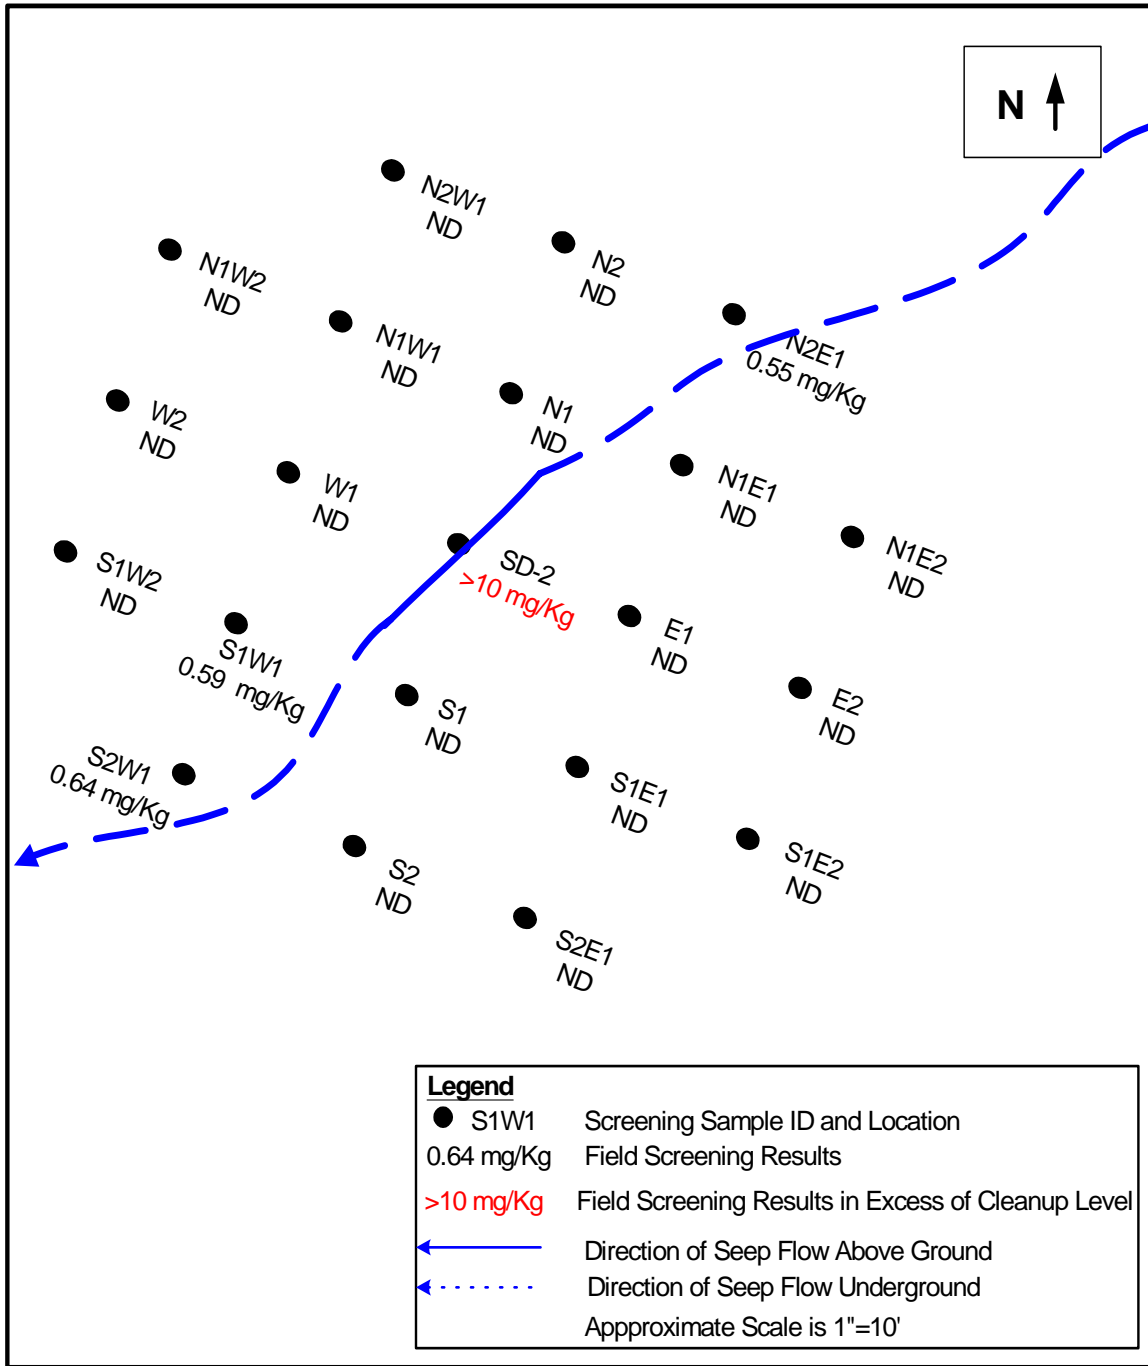
Figure 3-1: Field screening results from the gridded area around SD-2

Twenty-one samples were taken from the grid area established around SD2. Field screening results are displayed on Figure 3-1. Of the 21 samples, 17 samples had no detectable concentrations of PCBs. Three samples had concentrations of PCBs above the field screening detection limit (0.5 mg/kg), but below the ADEC cleanup level of 1 mg/kg. One sample, SD2 (the formerly identified PCB hotspot), showed a PCB concentration of over 10 mg/kg.

Detectable concentrations of PCBs were noted to be along a seep path, emanating from the northwest corner of the landfill.

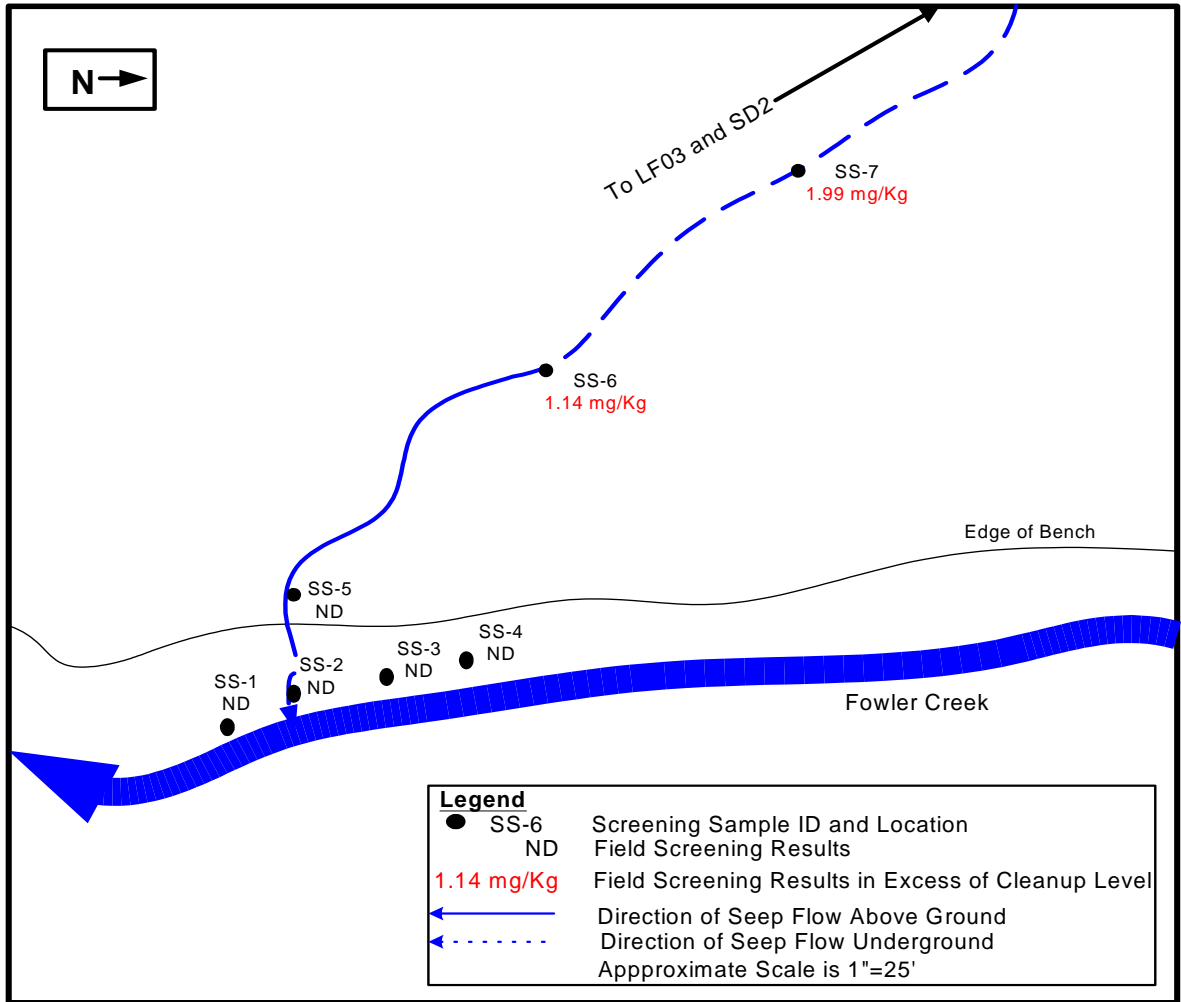
Figure 3-2: Field screening results from the lower seep area

Based on these results, seven additional field-screening samples were taken downgradient of SD2 and along the seep path. These additional samples were denoted with the prefix "SS-," to differentiate these samples from the samples taken from the grid areas. Field screening results for the downgradient sample locations are presented on Figure 3-2. Detectable concentrations of PCBs (above 0.5 mg/kg) were noted up to 600 feet downgradient from SD2.

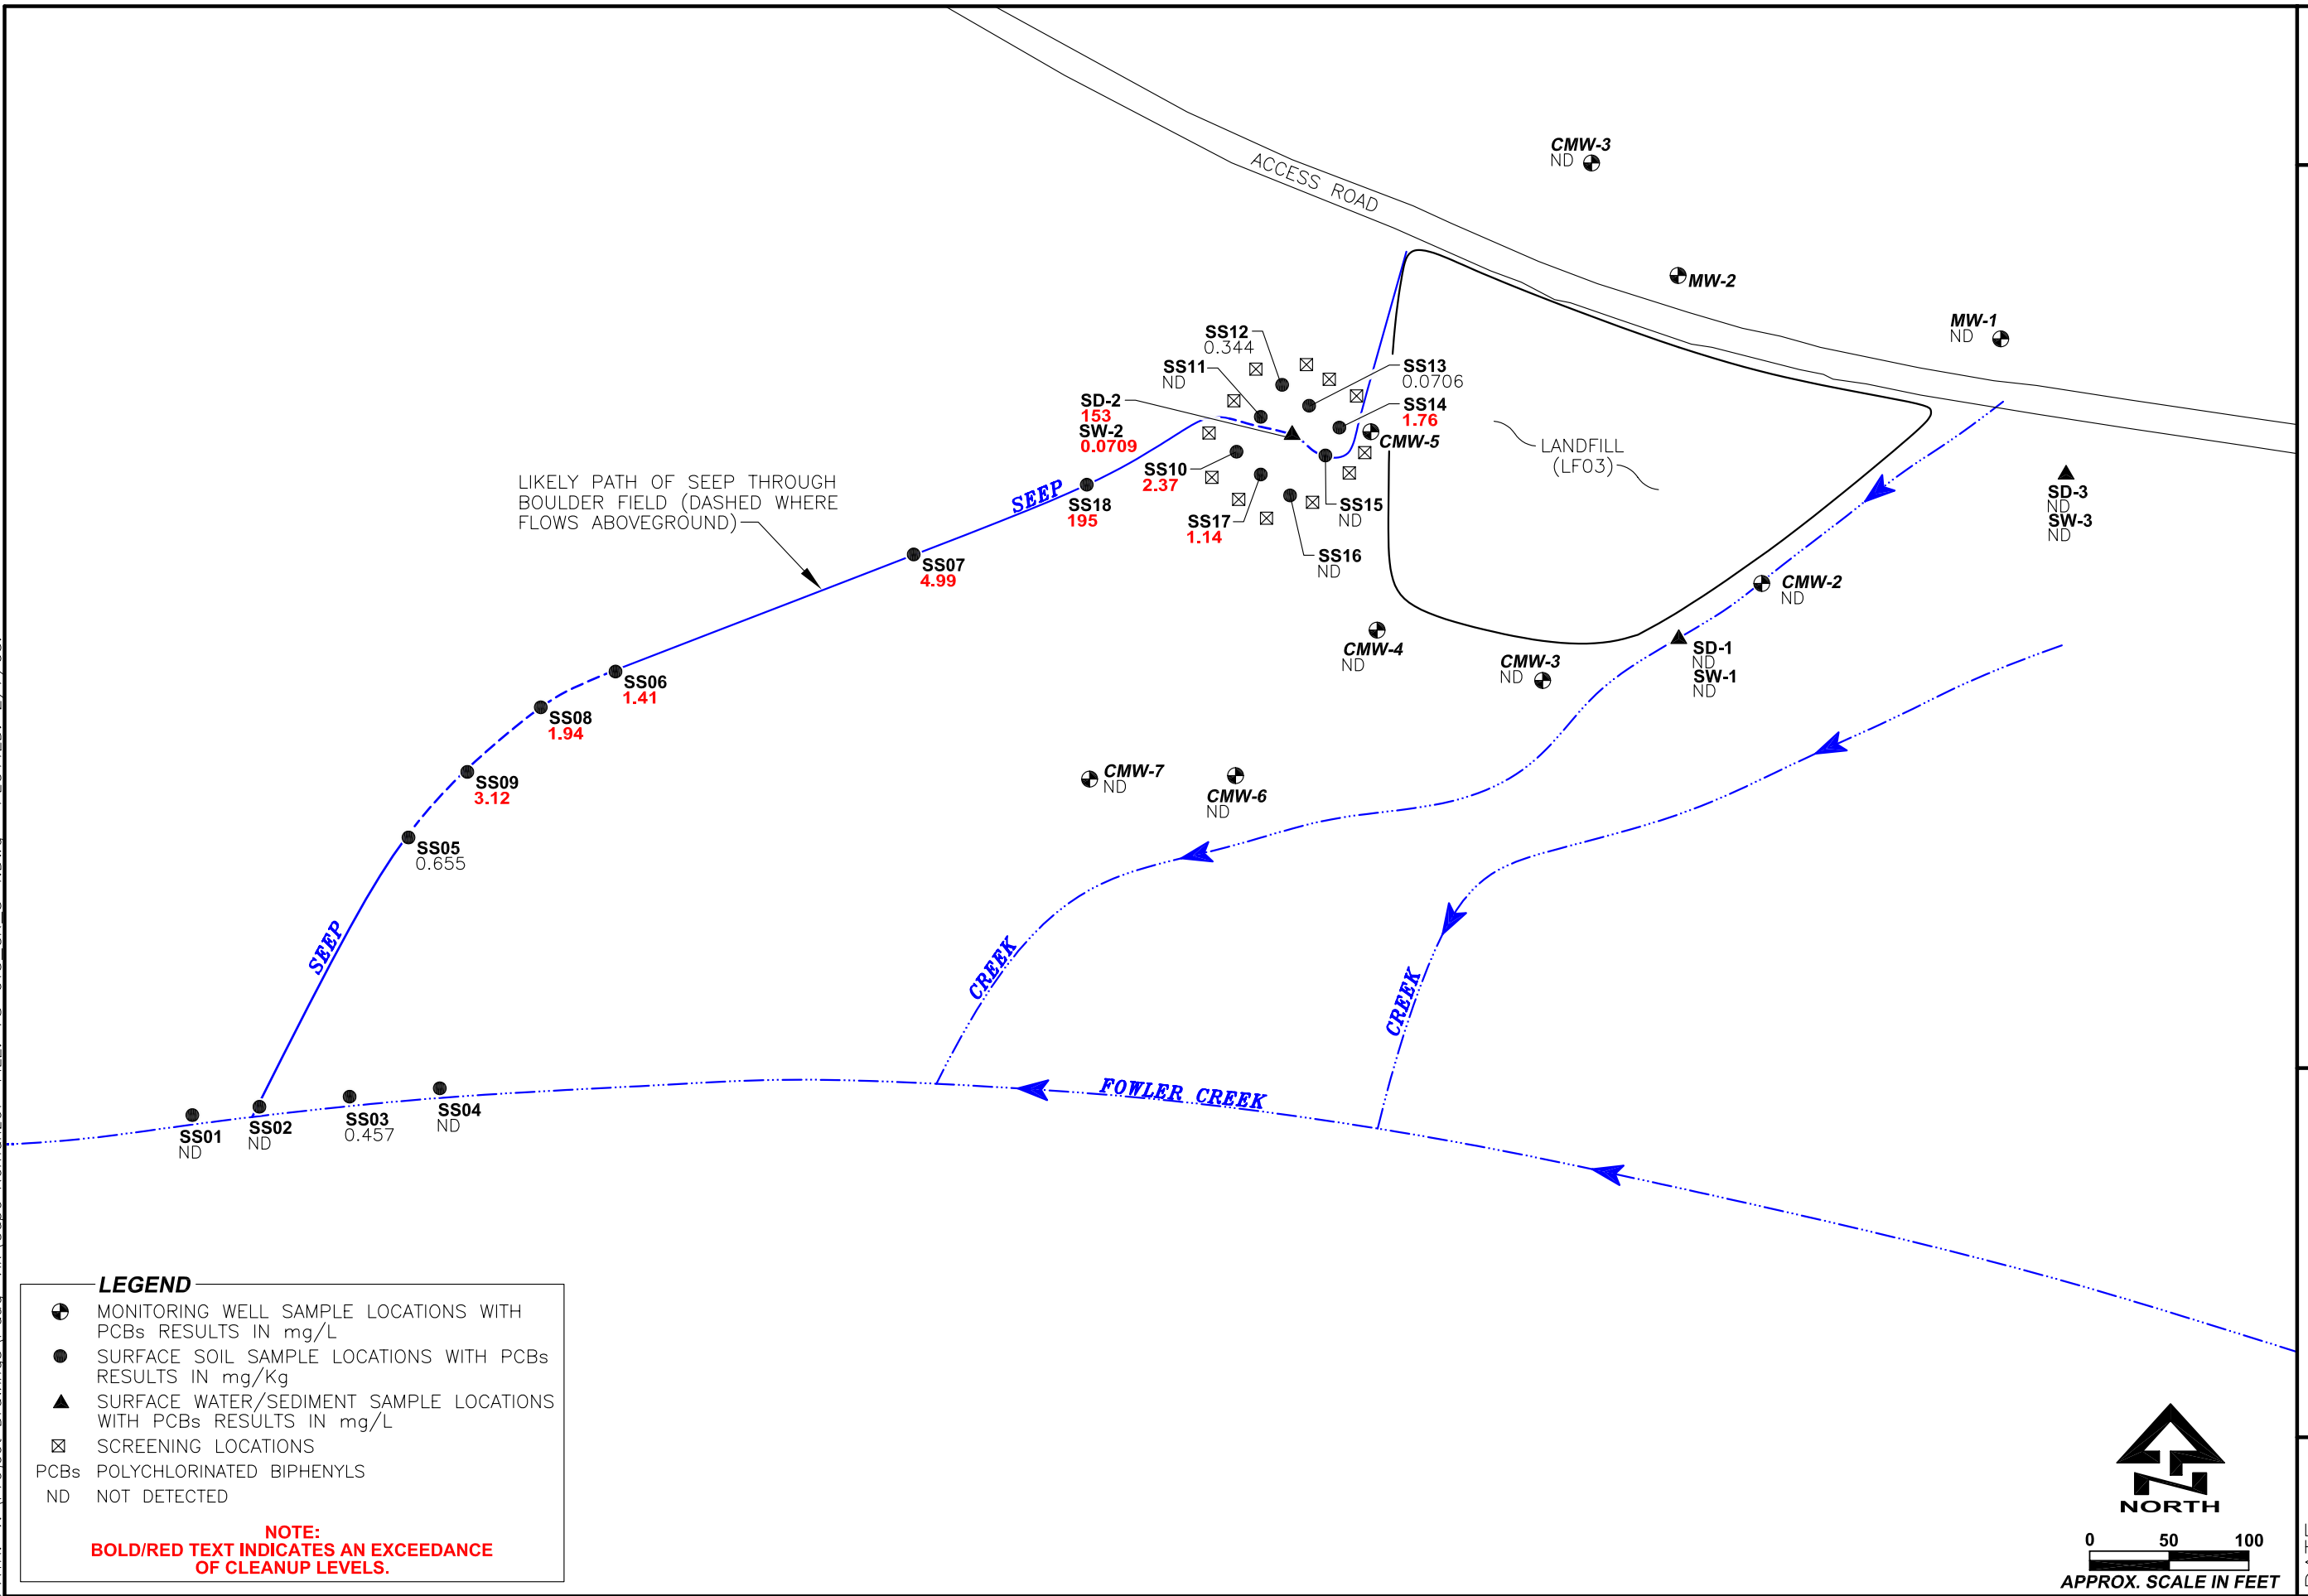
FIGURE  
3-3

Sample locations are provided on Figure 3-3. GPS Coordinates are presented in Table 1.

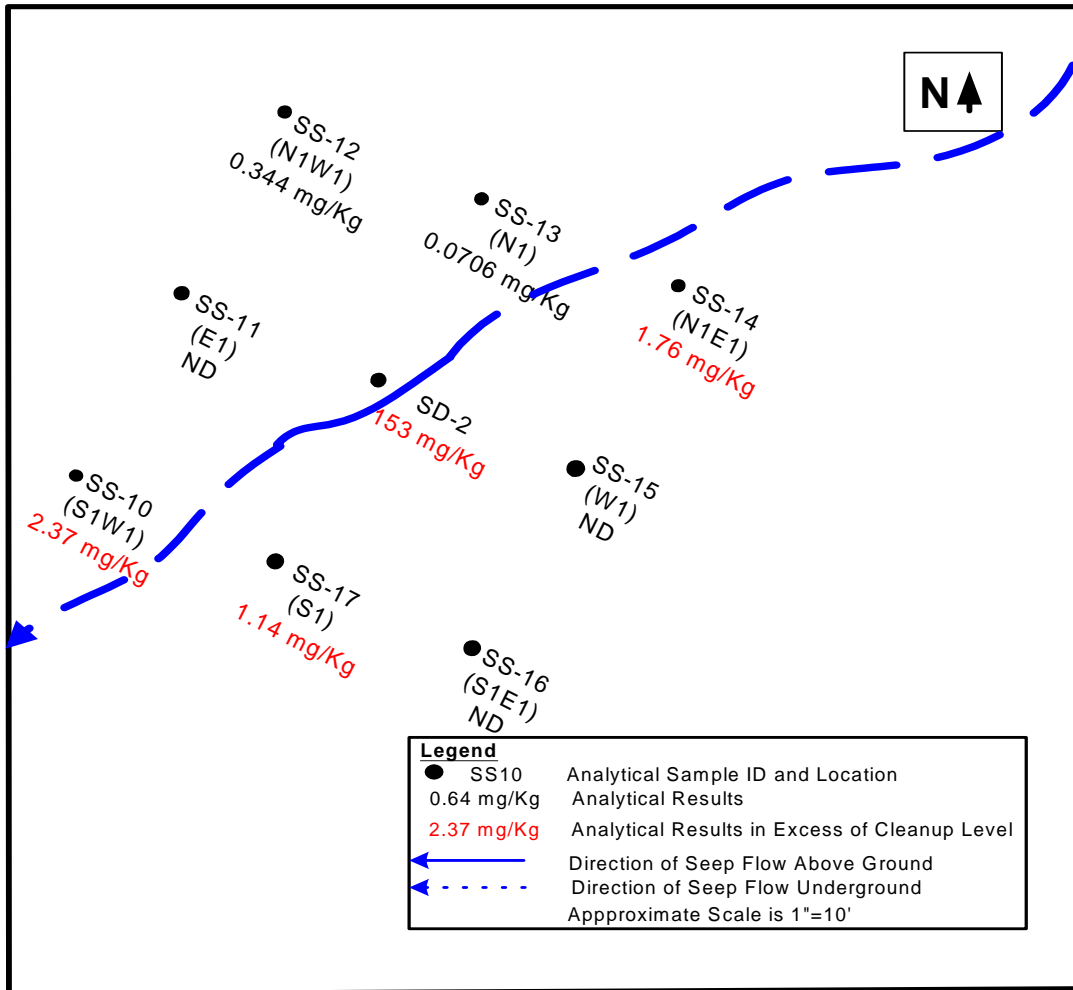
**Figure 3-4: Analytical results from the gridded area around SD-2**

Analytical results are displayed in Figures 3-4 and 3-5. Nine of the 18 samples had PCB concentrations above the ADEC cleanup level of 1.0 mg/kg. Araclor-1260 was the only PCB compound detected during the investigation.

Concentrations of PCB-1260 are consistently above the cleanup level in samples taken along the seep flow path. PCB concentrations are generally higher closer to the landfill and decrease down gradient. The highest concentration of PCB was noted in sample SS-18, just downgradient from SD2, with a concentration of 195 mg/kg. SS-18 was collected west and down slope of SD2 in the approximate location of where PCBs at previously been detected at a concentration of 395 mg/Kg.

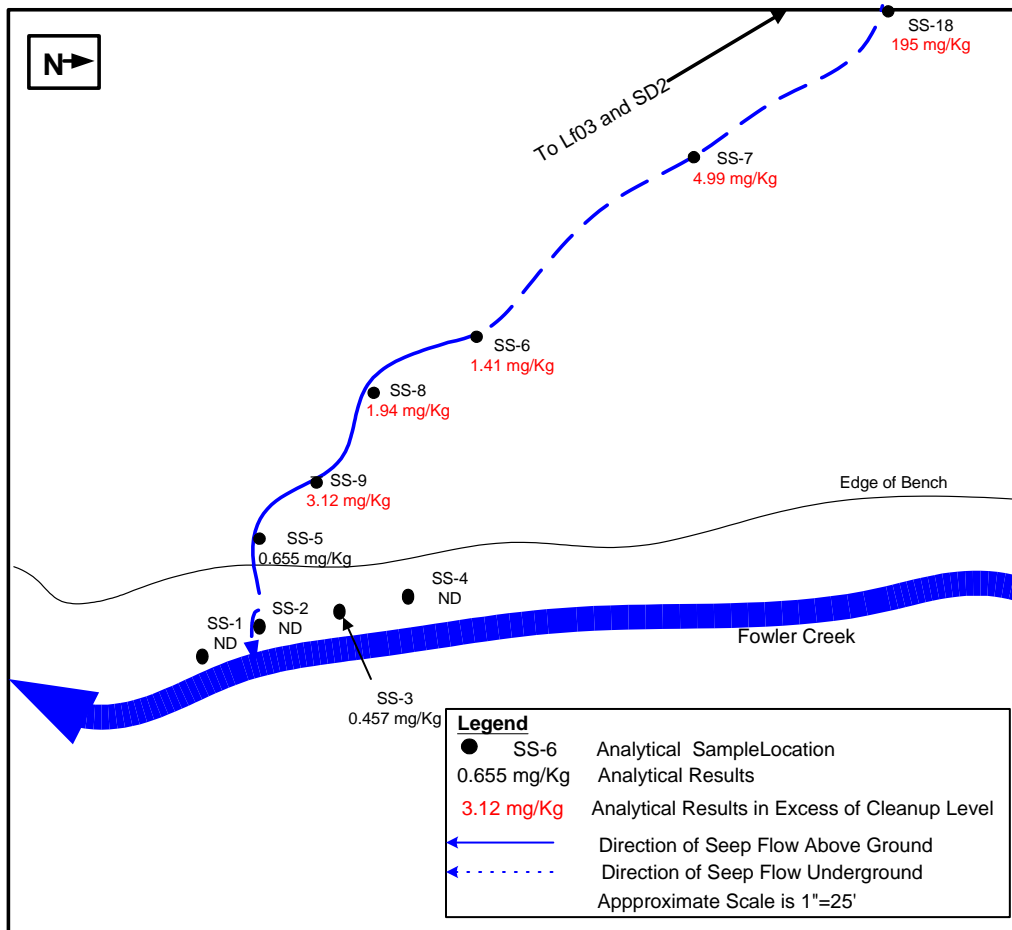
Figure 3-5: Analytical results from the lower seep area

No samples taken from the Fowler Creek area were above the cleanup level.

Soils taken in the immediate vicinity of Fowler Creek did not have PCB concentrations above the ADEC cleanup levels. We recommend verification sampling both upgradient and further downgradient from the seep confluence with Fowler Creek, to confirm that Fowler Creek has not been significantly impacted.

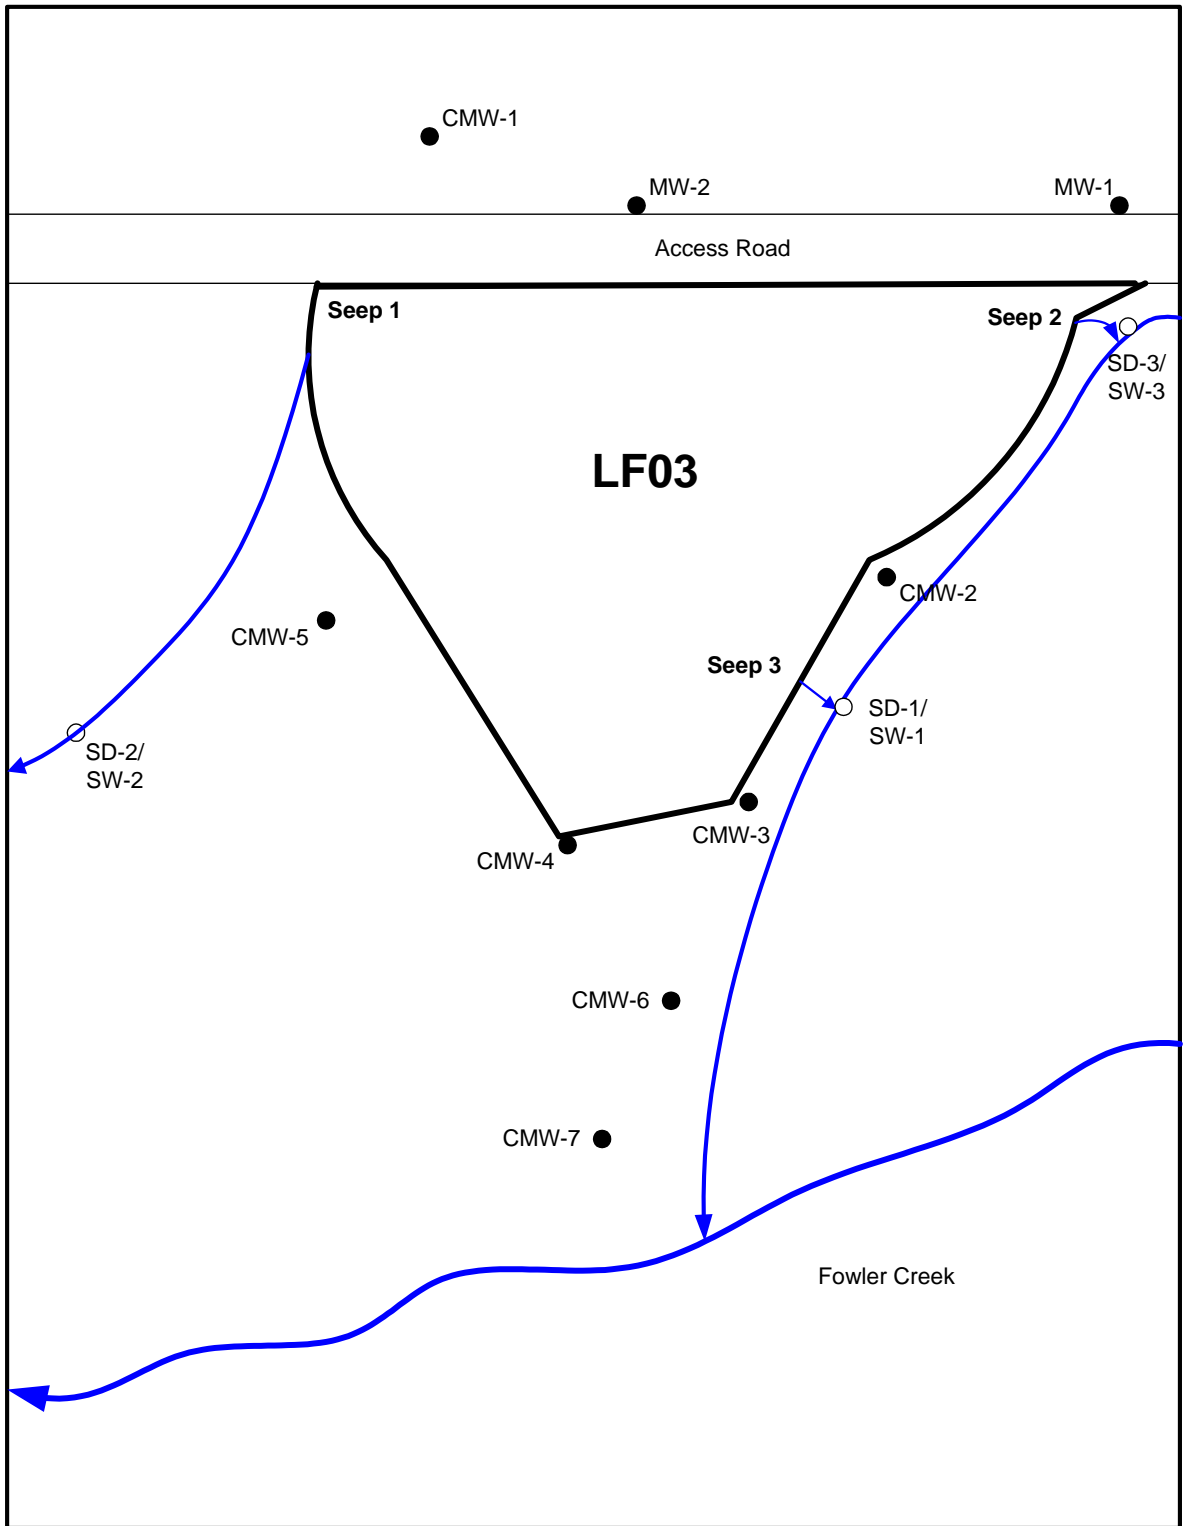
Figure 3-6: Seep Locations at LF03

A thorough landfill cap inspection was conducted during the sampling event. Three seeps appear to be flowing out of the capped landfill area. The seeps are shown on Figure 3-6, and in photographs 2, 15-18 (Appendix A). The seeps are described below:

- Seep 1 flows from the northwest corner of the landfill (near the access road) downgradient through the PCB sampling grid area. Pieces of the landfill liner were observed at this site.

- Seep 2 originates from the northeast corner of the landfill and quickly joins Fowler Creek. Orange soil staining was observed near this seep. Surface water and sediment samples were taken from this area (SD-3 and SW-3) under a different project (Paug-Vik, 2004).
- Seep 3 emanates from the landfill at its toe between monitoring wells CMW-2 and CMW-3. This area was also sampled in the Paug-Vik 2004 Cape Romanzof long term monitoring (LTM) effort (SD-1 and SW-1). In June, obvious orange staining existed, but the seep itself was dry. During the August visit, water was freely flowing and a sheen was noted.

The landfill liner was exposed in several places, both around the top and at the toe of the landfill, during the June 2004 field visit. While the liner was exposed at places, no liner rips or tears were noted. During the reconnaissance in August 2004, it was noted that a layer of soil from a decommissioned biocell was added to the top of the landfill by the 611 CES. While the new soil covered exposed areas at the top of the landfill, the liner was still exposed at areas near the toe of the landfill.

As evidenced by the three seep emerging from the landfill toe, water is still entering the landfill, despite the landfill cap. Future efforts to prevent water from entering the landfill is recommended, as these efforts may prevent further migration of PCBs downgradient towards Fowler Creek. Possible efforts to prevent infiltration of water could include:

- Divert drainage ditch upgradient of road.
- Build impermeable water device layers upgradient of landfill.
- Construct a bottom liner for landfill.
