**Environmental & Engineering Consultants**

April 9, 2002

**RE: Indoor Air Quality/VOC Monitoring
239 Ina Street, Fairbanks**

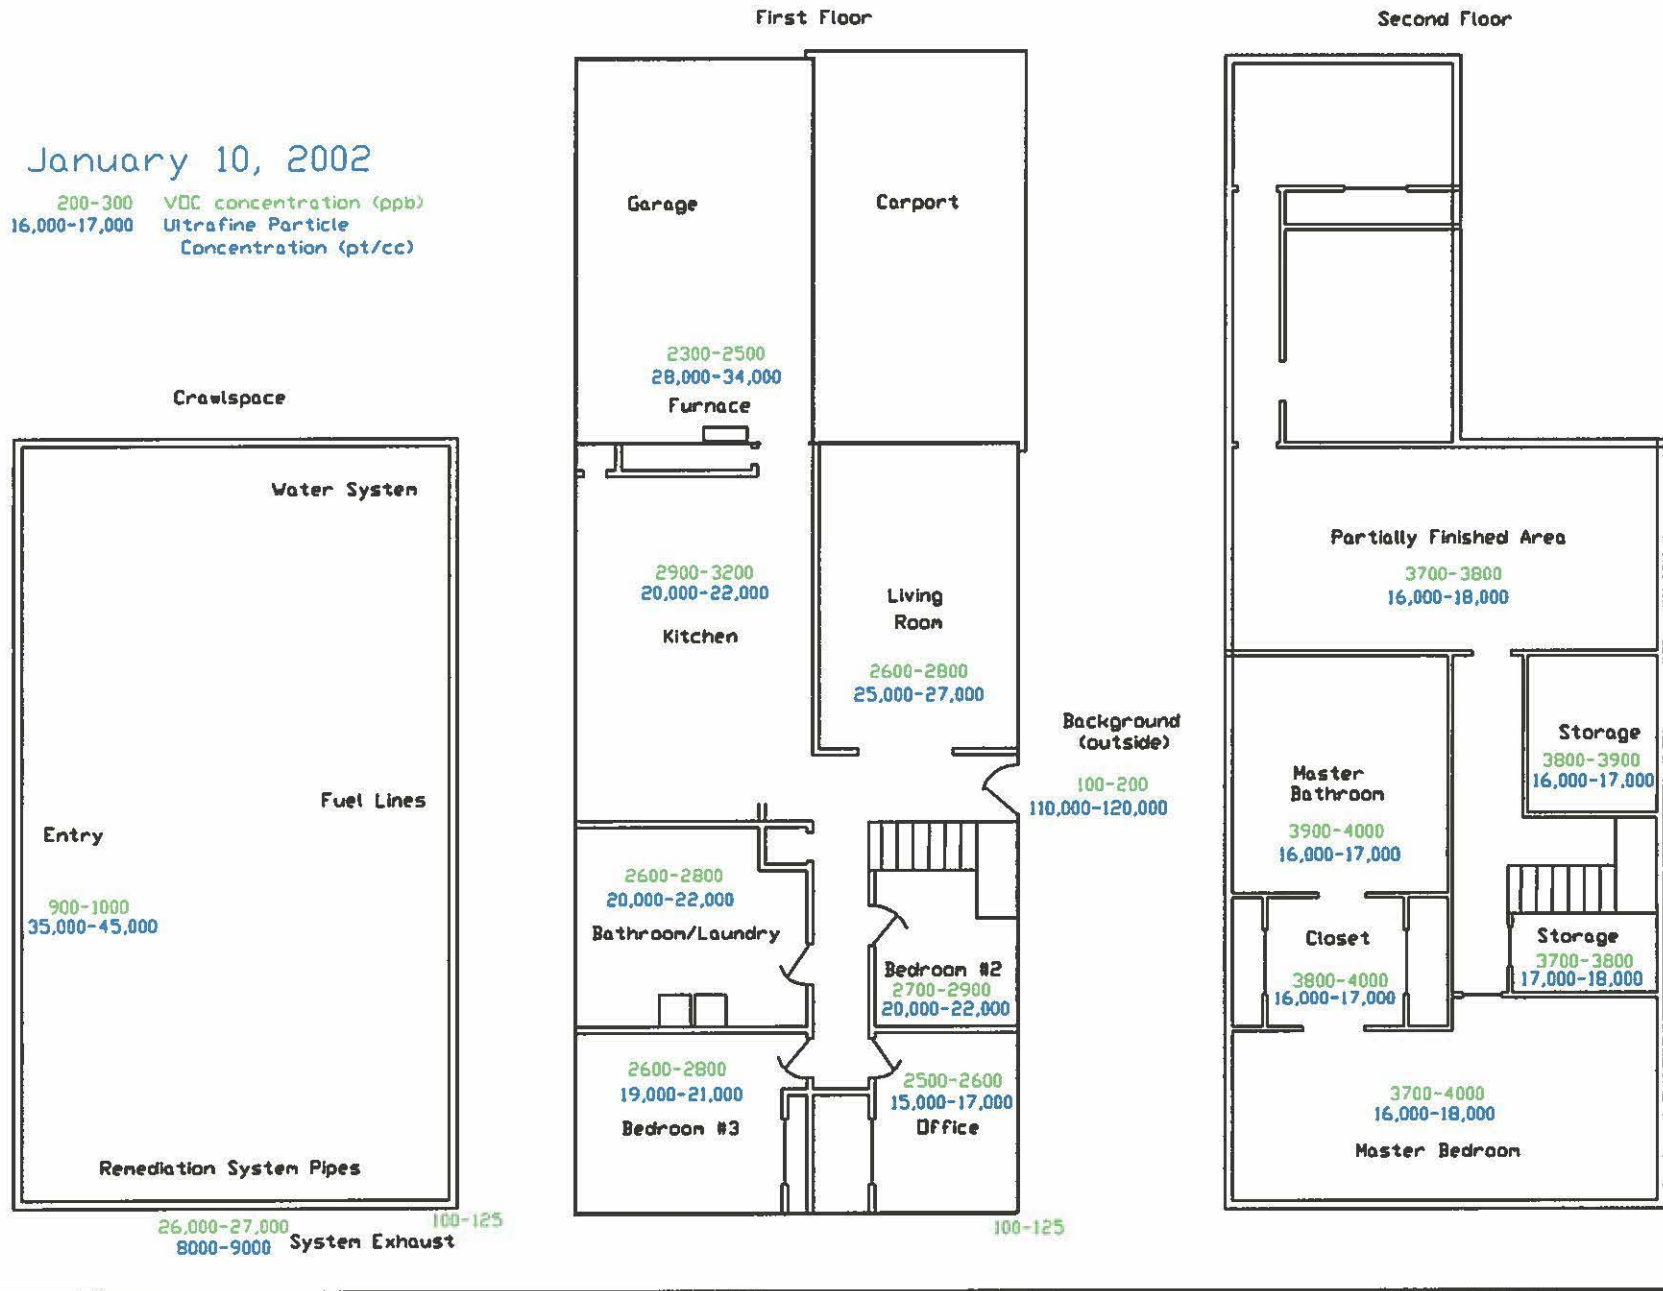
FIGURE
 1

NORTECH and Rockwell E&C personnel conducted an interior/exterior site visit with the ppb and ultrafine meters and the results are shown in Figure 1. The homeowners had installed new vinyl flooring on the previous day and the odor from the mastic was observed. Downstairs interior VOC readings (2500-3000 ppb) were about 10 times higher than outside (200-300 ppb) and slightly lower than upstairs readings (3500-4000 ppb). Crawlspace readings (900-1000 ppb) were slightly higher than background. The footer vent was running at the time and the concentration inside the vent pipe was 26.5 ppm (26,500 ppb).

Ultrafine particle concentrations inside the house (15,000-34,000 pt/cc) were about about five times lower than outside (110,000-120,000 pt/cc) and crawlspace concentrations (35,000-45,000) were also lower than outside. Interior readings were highest in the attached garage (28,000-34,000), where the furnace and a vehicle were located, and generally decreased across the first floor with distance from the garage. The lowest reading in the house (15,000-17,000 pt/cc) was in the office area, which had the door closed at the time of the inspection. Upstairs readings were 16,000-18,000 pt/cc in all spaces.

The walkthrough on January 10, 2002 was conducted a day after new linoleum was installed in the kitchen of the residence. The linoleum mastic odor was immediately identifiable upon entering the house. TVOC concentrations inside the house were at least 10 times the outside level and ultrafine particle concentrations were lower inside the house than outside. The TVOC data suggested that the kitchen (and new linoleum) was acting as a source for the rest of the house, although the second floor had consistently higher levels than the kitchen. Lower TVOC levels and higher ultrafine levels in the garage indicated that air from the house might be leaking into the garage and mixing with some air from outside. Higher ultrafine levels in the living room might also be associated with the outside air from the nearby doorway. Increased VOCs and lower ultrafine levels in the crawlspace suggest that air exchange might be occurring from the house to the crawlspace. The vapor extraction system may increase this effect, but this hypothesis was not tested.

Ultrafine and ppb Measurements
 January 10, 2002 Walkthrough
 239 Ina Street, Fairbanks, Alaska

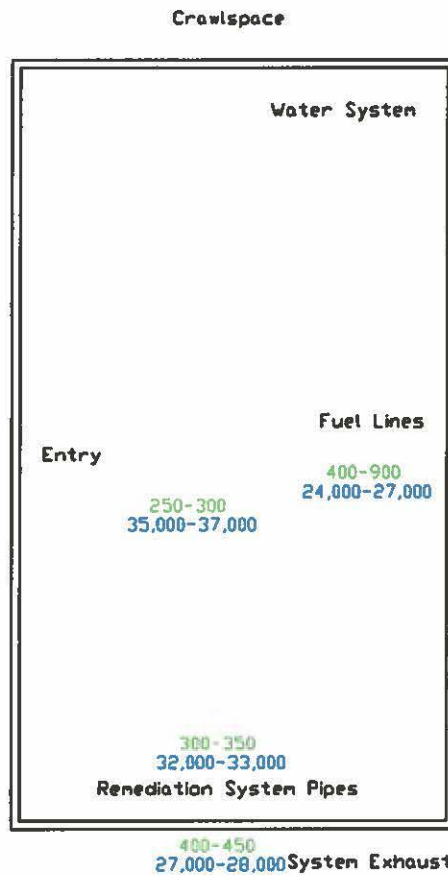
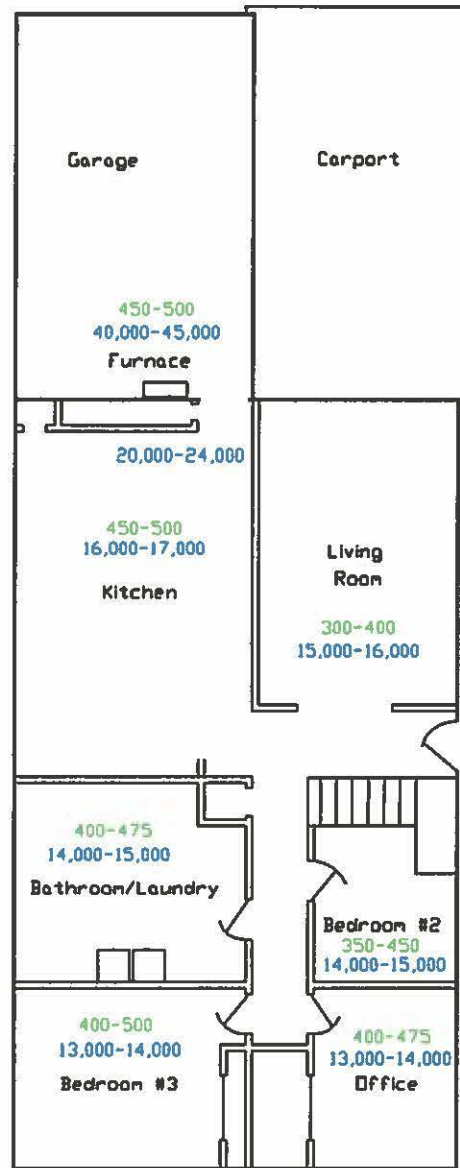
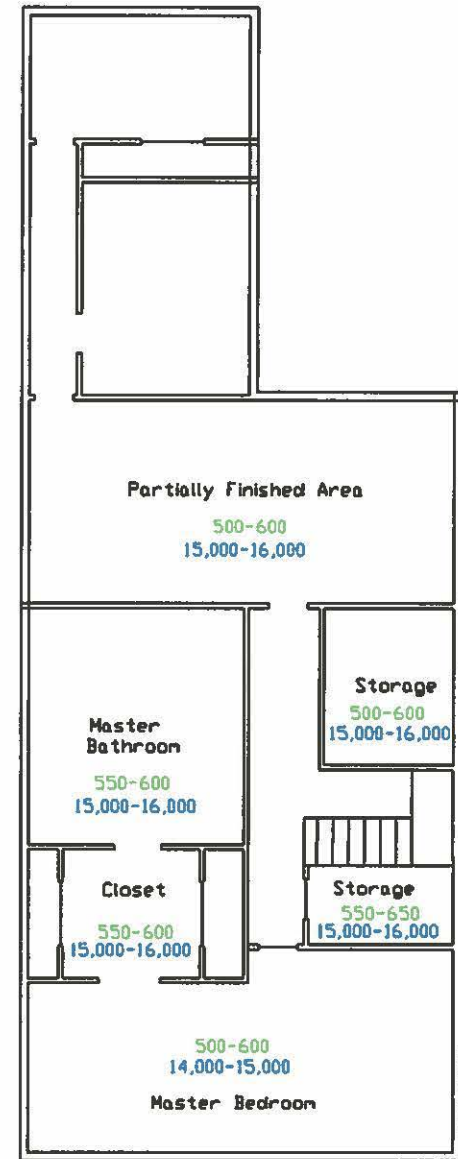
FIGURE
2

NORTECH and Rockwell E&C personnel conducted an interior/exterior site visit with the ppb, ultrafine, and smoke tube equipment and the results are shown in Figure 2. VOC concentrations upstairs (500-650 ppb) were slightly higher than downstairs (300-500 ppb) and both were slightly higher than outside (150-250 ppb).

Ultrafine concentrations outside the house were about 26,000-27,000 pt/cc. The garage (40,000-45,000 pt/cc) was higher than outside and had a cigarette odor. Particle concentrations near the kitchen/garage door were about 20,000-24,000 pt/cc. Particle concentrations inside the remainder of the house (13,000-16,000) were lower than outside with no other interior areas significantly higher or lower than others.

A gap of approximately one inch was observed under the door between the kitchen and the garage. Smoke tube testing around the kitchen/garage door indicated that air is flowing from the garage to the house while the furnace is off. Airflow from the kitchen to the garage was observed while the furnace is running. All other exterior doors and windows appear well sealed with little or no observed draft around the frames or seals. Smoke tube testing in the middle of most rooms indicated limited air movement within the house.

A walkthrough was conducted on March 7, 2002, after mastic odors were expected to have dissipated significantly. No odor was detected upon entering the residence. TVOC readings were consistent on the first and second floors, with the second floor slightly higher than the first. The crawlspace reading was again higher than background, but below the interior level, suggesting that vapors are not accumulating in the crawlspace. Ultrafine readings were higher in the garage than elsewhere in the house and outside, suggesting an ultrafine source in the garage. The furnace, a vehicle, and the odor of cigarettes, are all ultrafine sources that were observed in the garage. Smoke tube testing indicated little air movement within the house and air exchange with the outside primarily occurring through the garage (under the kitchen/garage door) with airflow from the house to the garage while the furnace was running and from the garage to the house while the furnace was off.

Ultrafine and ppb Measurements
 March 7, 2002 Walkthrough
 239 Ina Street, Fairbanks, Alaska

- The soil vapor extraction system should be turned on and occupants should contact Rockwell E&C/*NORTECH* if a petroleum odor is observed inside the house.
- A properly fitted and closing door should be installed between the kitchen and garage to prevent furnace and vehicle contaminants from entering the living spaces.
- An active ventilation system should be considered for proper air exchange in the house.

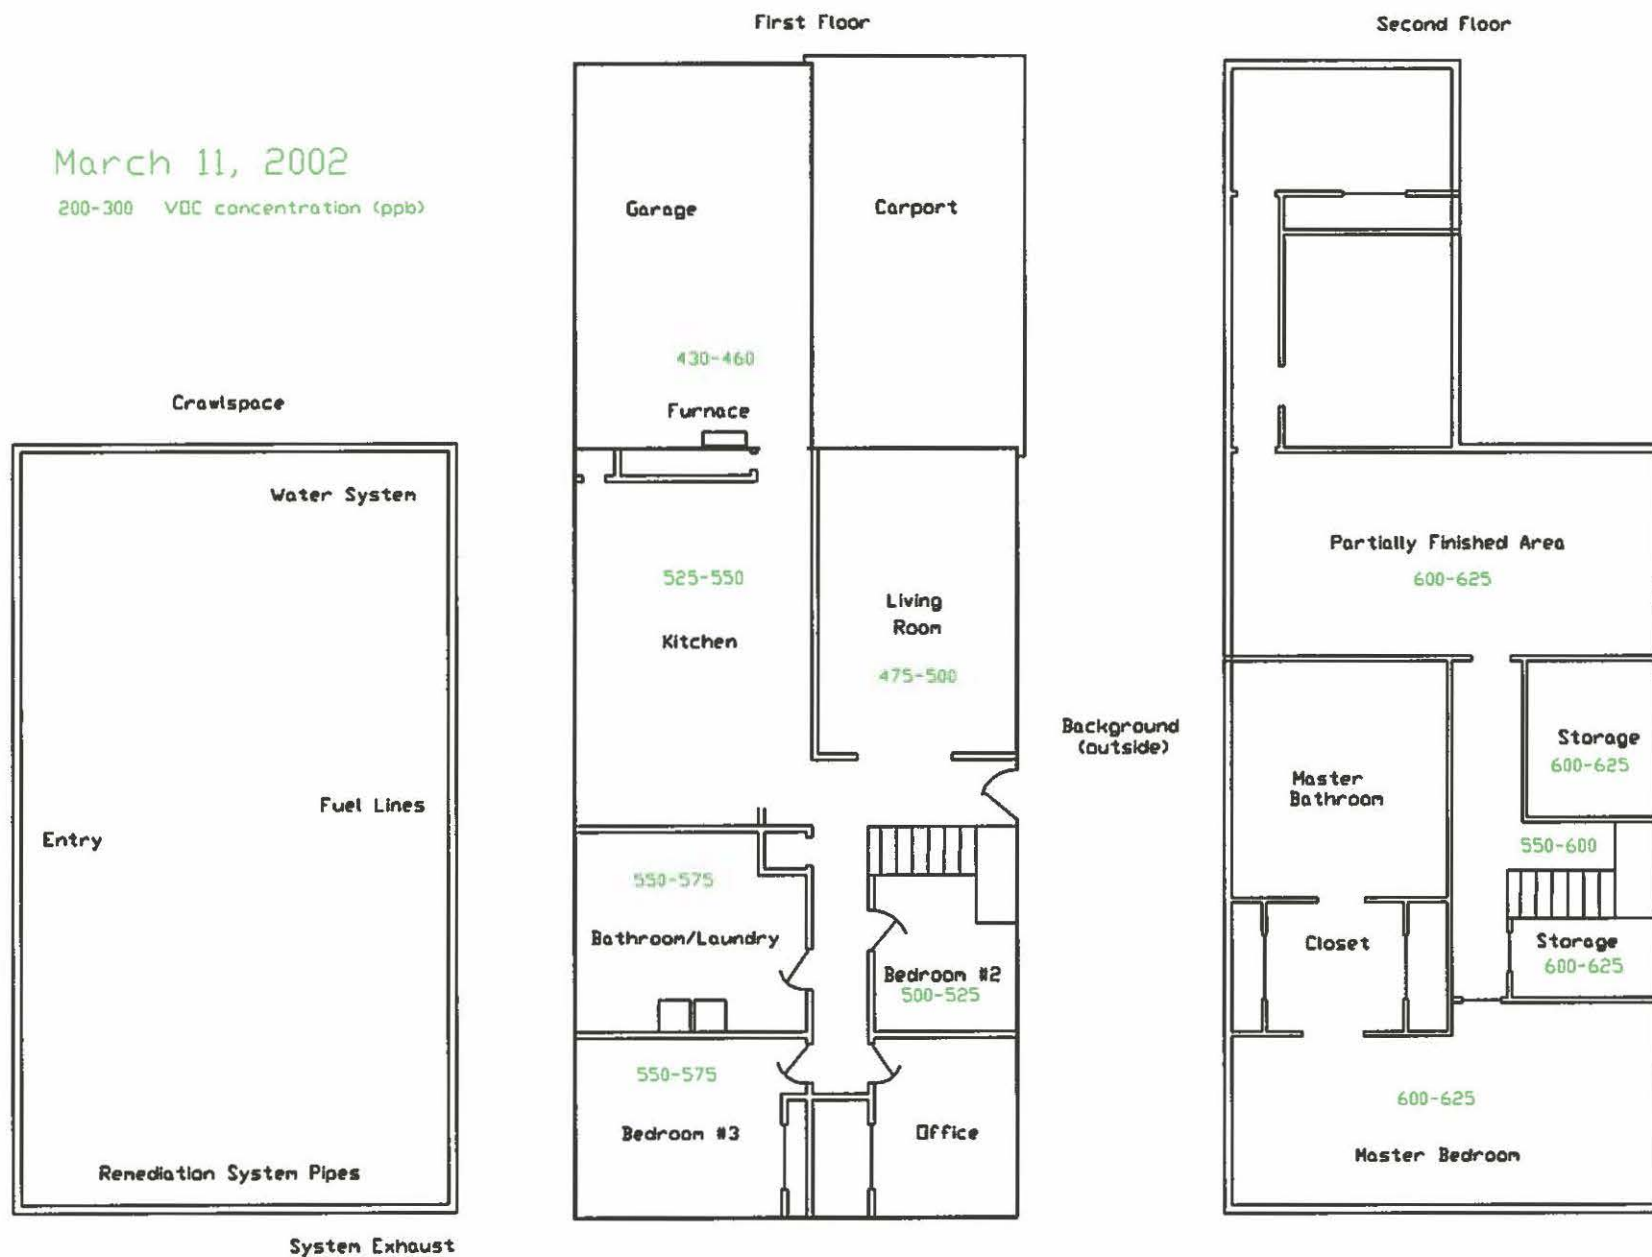
FIGURE
3

NORTECH personnel collected the multiday testing equipment and conducted a site walkthrough with the ppb meter. Interior (500-650 ppb) and exterior (150-250 ppb) readings were generally consistent with the March 7 walkthrough (see Figure 3), although the garage had slightly lower readings (430-460 ppb) than the rest of the interior spaces.

Ultrafine and ppb Measurements
March 11, 2002 Walkthrough
239 Ina Street, Fairbanks, Alaska

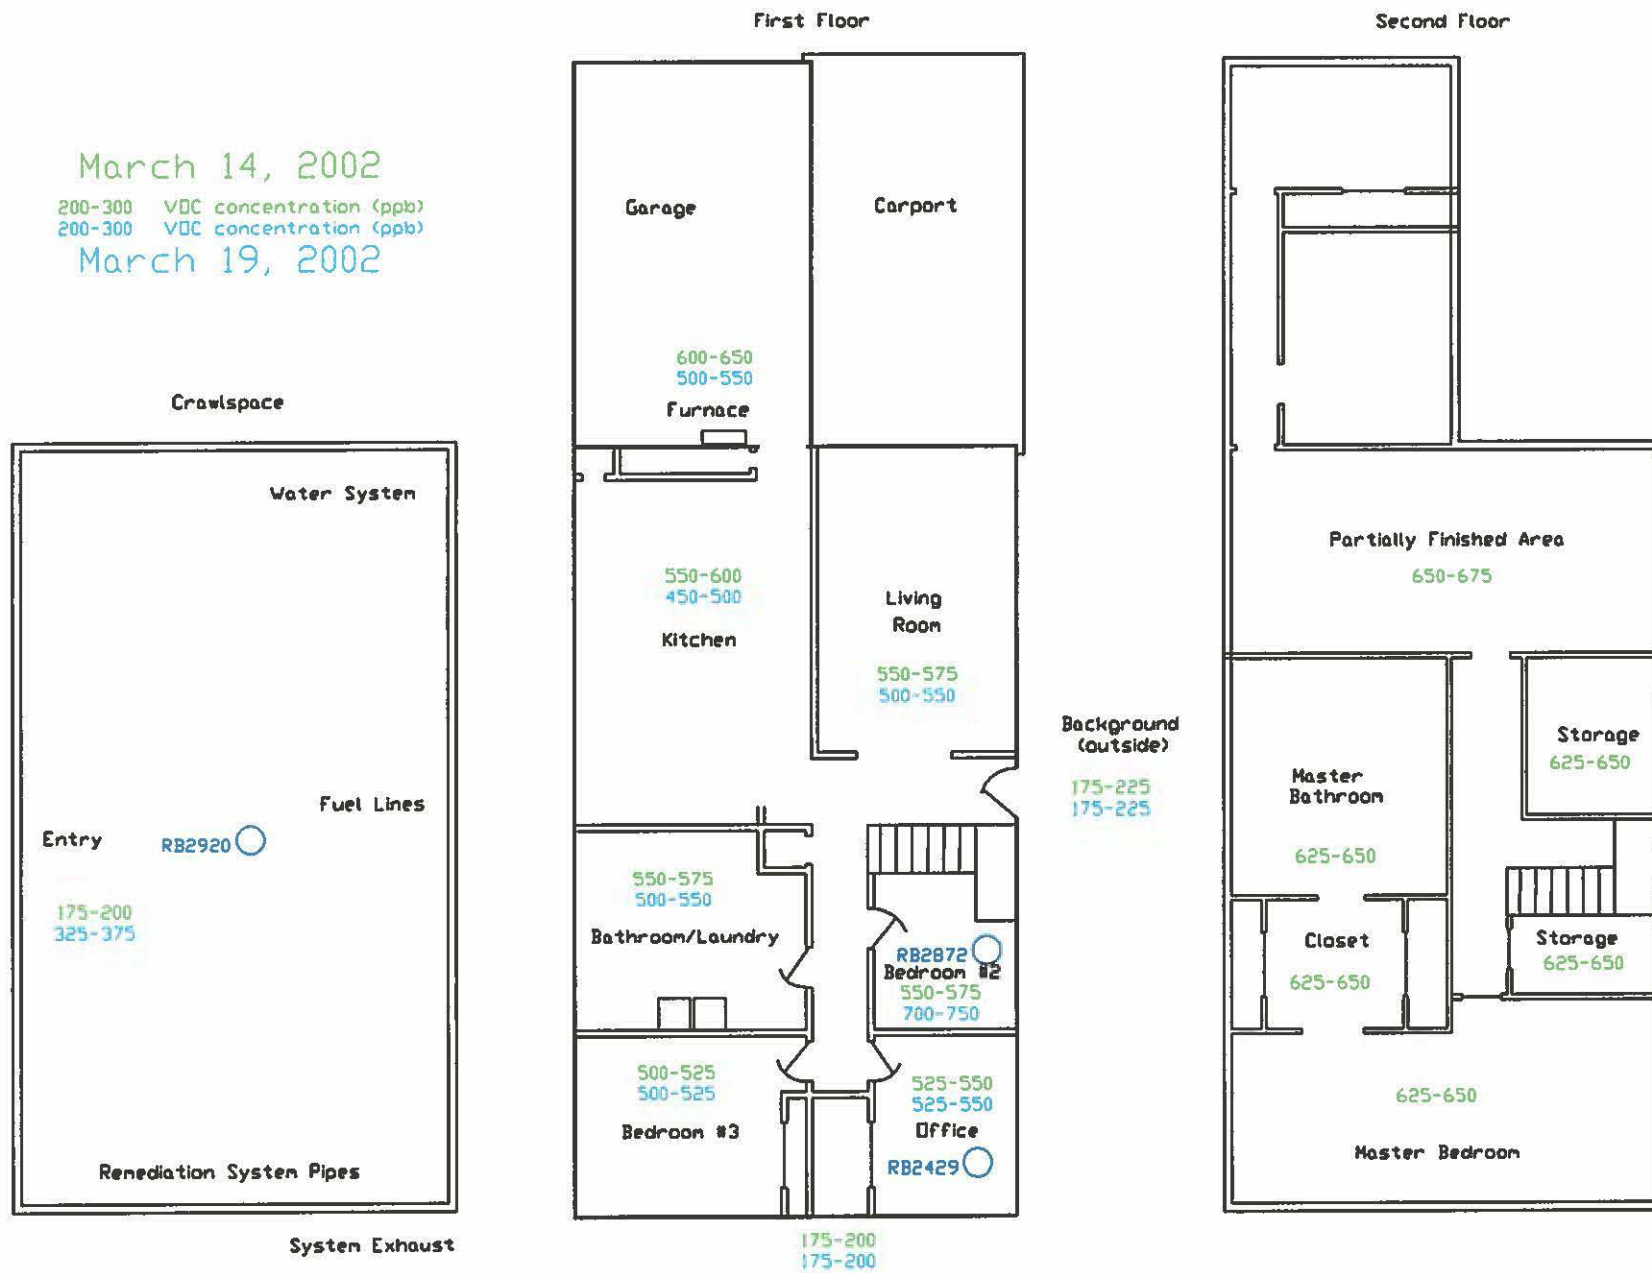
FIGURE
4

NORTECH personnel conducted another walkthrough with the ppb meter prior to setting up multiday equipment, including charcoal badges (see Figure 4). The walkthrough data was consistent with previous events (interior 500-650 ppb, crawl space 175-200 ppb, exterior 175-225 ppb). Three charcoal badges were installed at the residence. One badge was installed in the crawlspace at the same location as the previous crawlspace monitoring. The other two badges were installed in the two rooms on the southeast corner of the house (above the contaminated soil and near the vents) as shown in Figure 4. The continuous monitoring equipment was setup near the badge in the office area.

NORTECH personnel conducted a brief walkthrough of the house and collected the monitoring equipment and badges for laboratory analysis. As seen in Figure 4, the walkthrough results were similar to previous events, (interior 500-650 ppb, exterior 175-225 ppb), although the crawlspace was slightly higher (325-375 ppb).

Sample Locations and ppb Measurements
March 14 - 19, 2002 Sampling Event
239 Ina Street, Fairbanks, Alaska

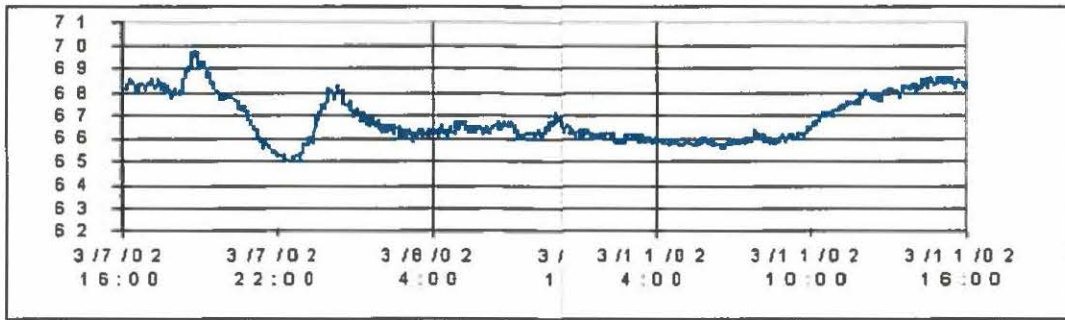
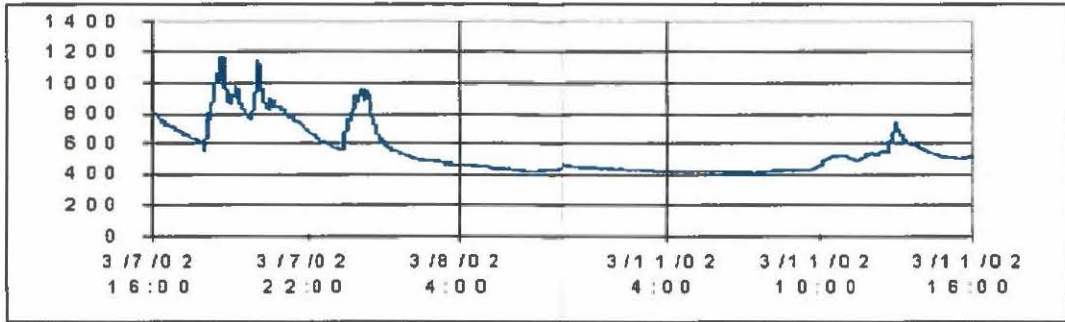
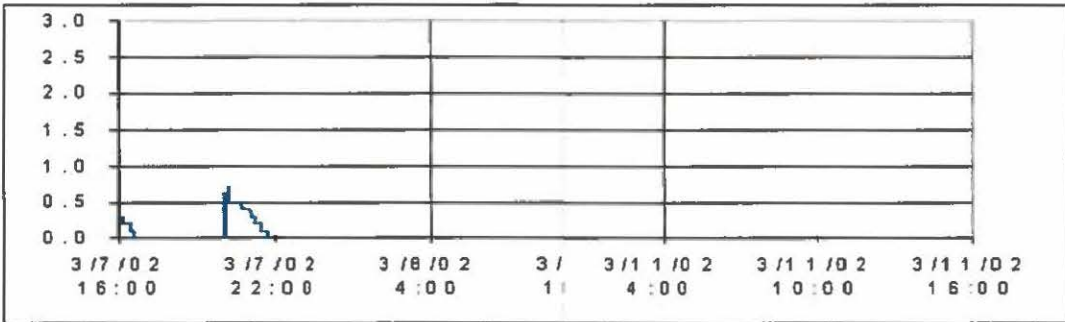
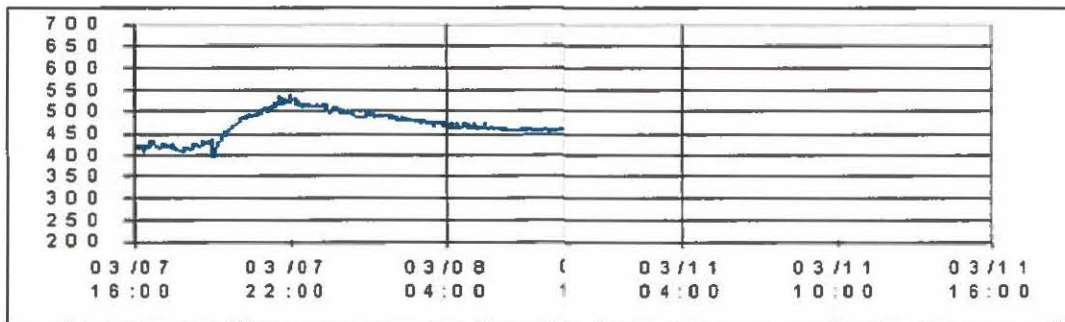
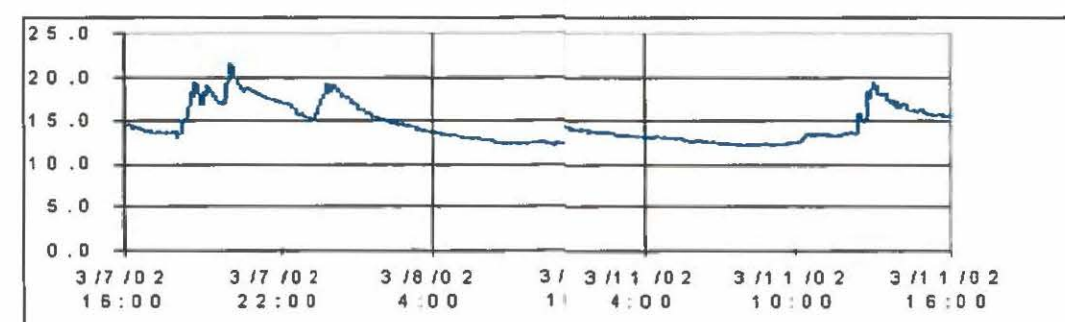
Two multi-day monitoring events were run during March 2002. The first started in the afternoon of March 7 and concluded in the afternoon of March 11. The second event started in the afternoon of March 14 and concluded on March 19. The temperature, carbon dioxide, carbon monoxide, ppb TVOC, and relative humidity results are shown in Figures 5 and 6 for the two events. The meters were setup in the office area in the southeast corner of the house during both monitoring events based on the use of the room and proximity of the room to the contaminated soil and remediation system vents.

Two instrument problems were encountered during the multi-day monitoring events. The ppb meter stopped recording after 24 hours during the first event and approximately 84 hours during the second event due to configuration and memory problems so the TVOC data is somewhat limited. Additionally, the CO instrument recorded negative values for substantial portions of the two monitoring events although it had been calibrated before the first monitoring event. A negative CO value is essentially meaningless and the negative values are not shown, although the overall shape of the CO data is similar to the CO₂ data.

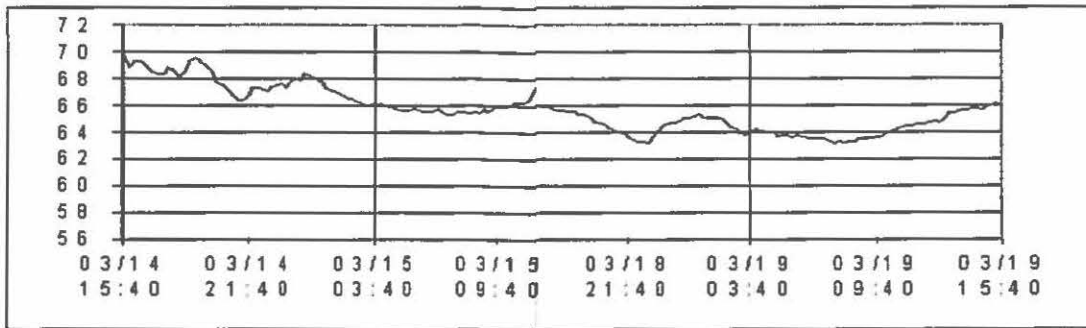
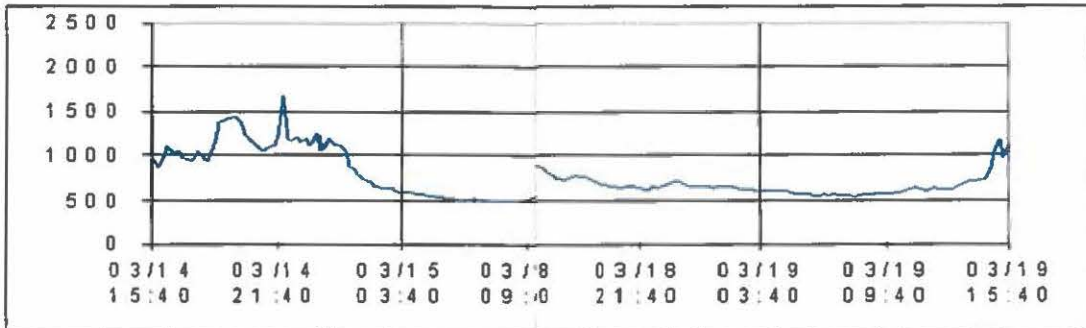
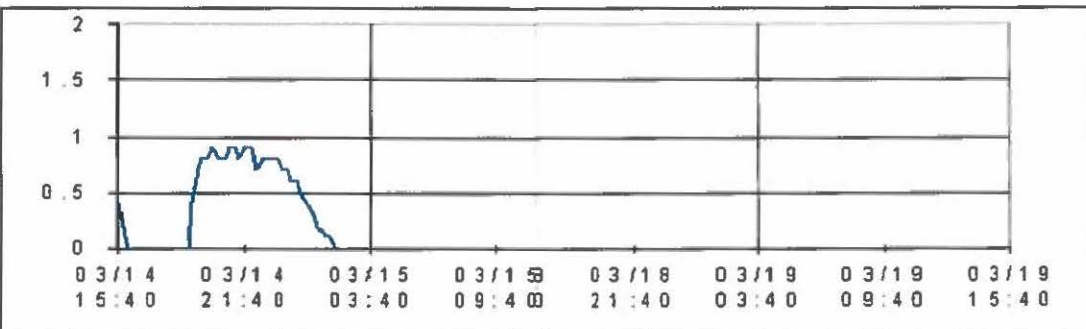
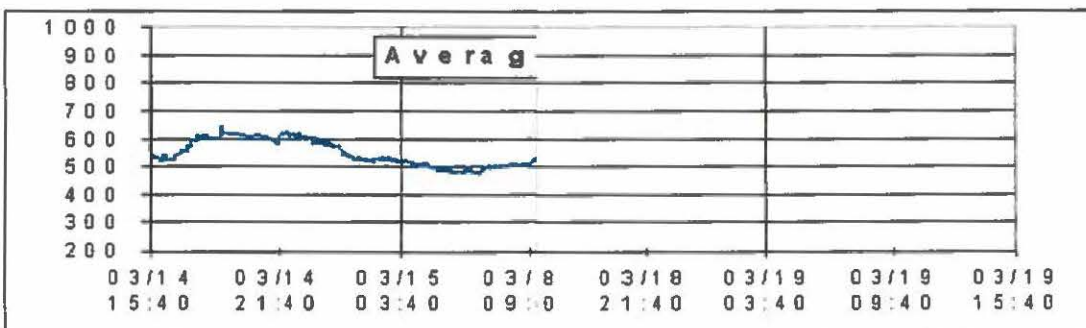
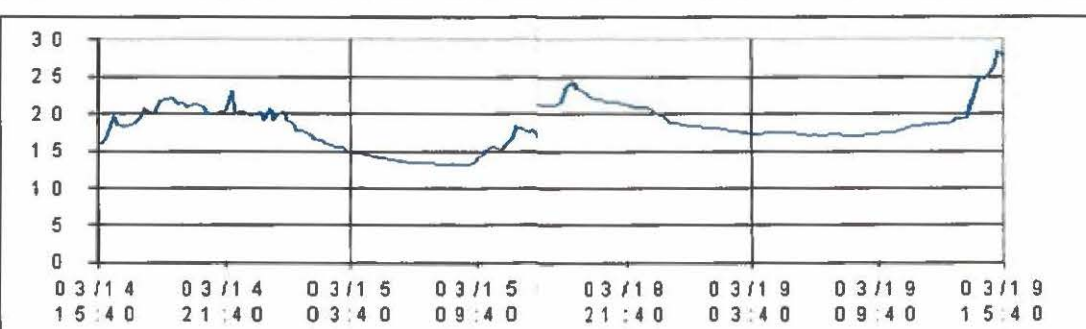
6

TVOC values recorded during the monitoring events suggest that the stabilized background reading in the residence during the events is between 400 and 600 ppb, three to four times the outside concentrations. The highest recorded value for the two monitoring events is about 900 ppb. Peak events generally appear to increase suddenly and then return to background over a longer period of time. Peak events also occur at the same time as CO and CO₂ peak events, suggesting a common source or activity for these events. This again points to limited air exchange in the house. The peak values and patterns suggest internal sources for the increases instead of the slow accumulation of vapors in the house over time.

For optimum human comfort, ASHRAE recommends relative humidity between 30 to 60%. Typically in Alaska, a more appropriate goal is 30-40 percent. While this is generally attainable during the summer months it is not uncommon for relative humidity to be much lower (15-20 percent) in the winter due to the typical cold dry arctic air. The relative humidity in this residence was typically in the range of 15-25% during the monitoring events. The data shows the same patterns as the CO₂, CO, and TVOC readings.
