RCRA RELEASE ASSESSMENT AND CORRECTIVE ACTION TECHNICAL MEMORANDUM

SITE 29 - Elephant Cage Site

ELMENDORF AIR FORCE BASE ALASKA

September 2000

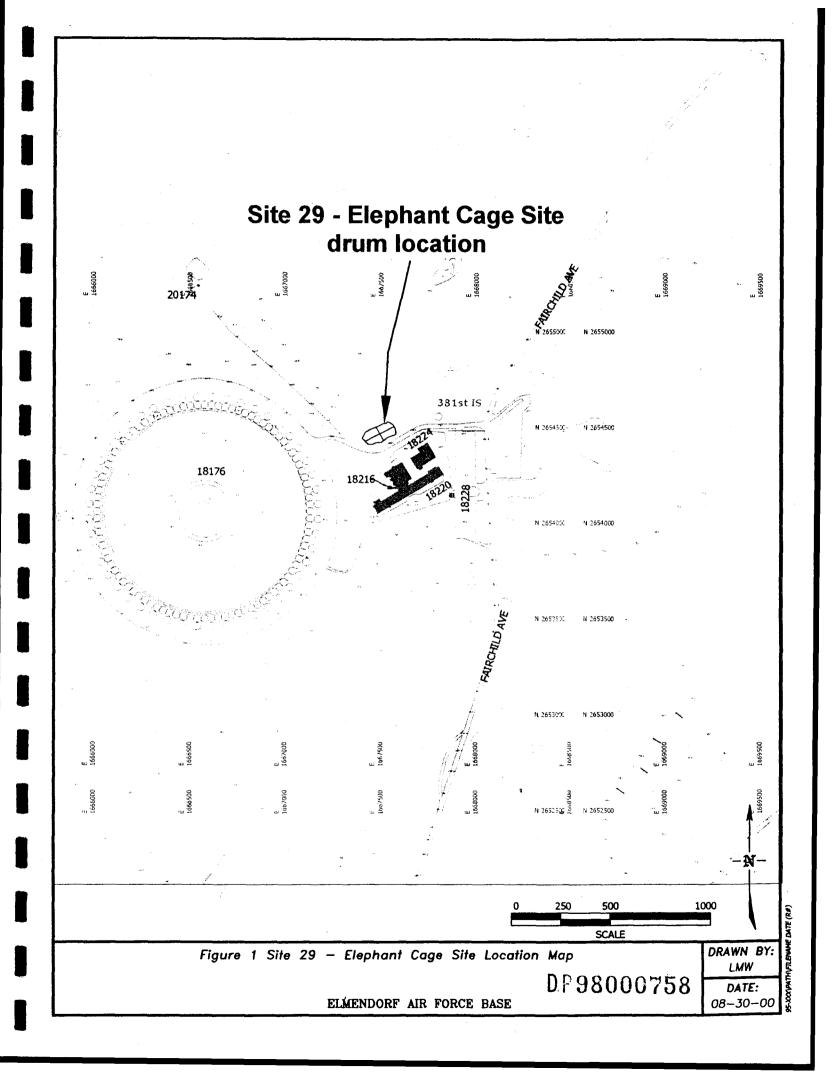
Site 29 - Elephant Cage Site is located at the 381st IS on Fairchild Avenue (Figure 1). Approximately 15 drums and containers were identified scattered in the woods north of the Elephant Cage access road extending west from Fairchild Avenue and east of the sewage lagoon access road (Figure 2).

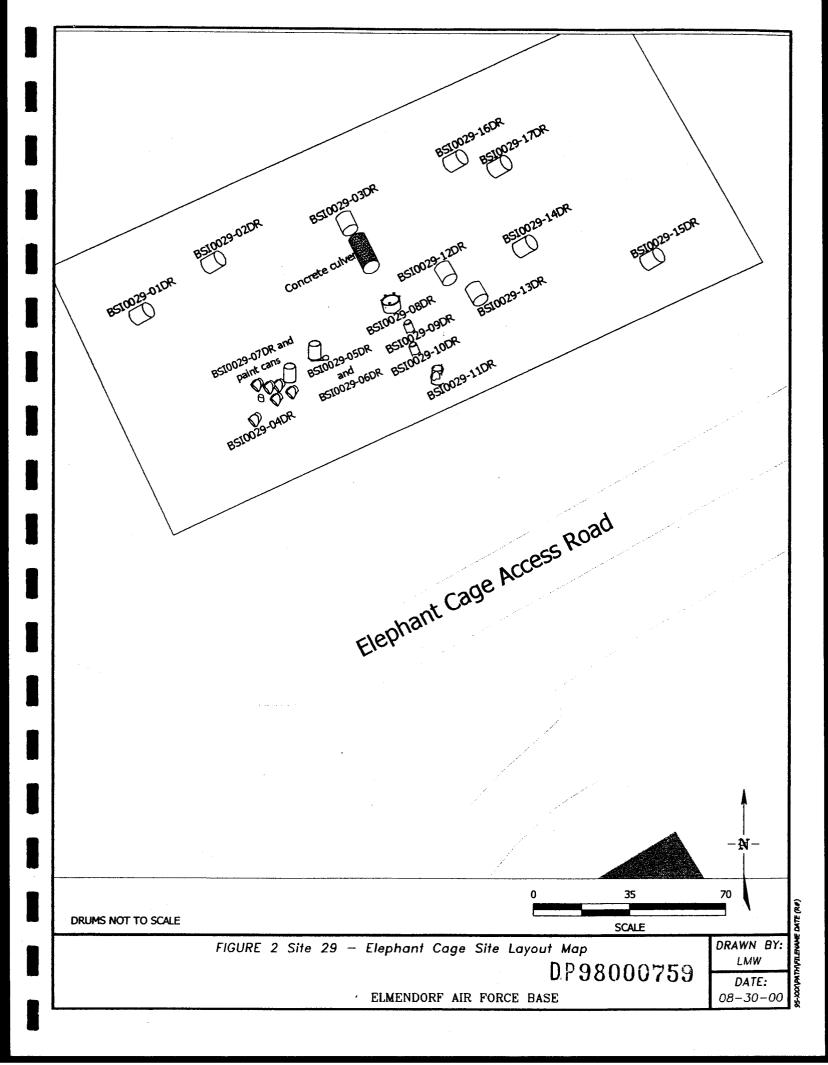
Reconnaissance and investigation of a ridged area extending east-west approximately 50 feet north of the Elephant Cage access road (Figure 2) indicates that the area may have been used as a building debris dump site. Corroded metal, paint chips, crumbled tile, broken cement blocks, "2 by 4's" and other assorted building debris was buried in the "ridged" area. Assorted rebar, sheet metal, cable spools and pieces of discarded machinery and rubbish were found sticking out of the surface throughout the wooded area. Research was conducted at the Elmendorf History Office and at the Corps of Engineer map vault. The area where the ridge is now located was not vegetated and no buildings can be seen in aerial photos from 1968.
