**U.S. AIR FORCE
FORMER PORT HEIDEN RADIO RELAY STATION,
ALASKA**

Final Report

**First Five-Year Review
of Environmental Restoration Program Sites OT001,
WP002, SS004, LF007, and Four Unnumbered Sites
(Antenna Pads, Contaminated Soil Removal Areas, Drum
Storage Area, and Focus Area) Former Port Heiden Radio
Relay Station**

AUGUST 2014

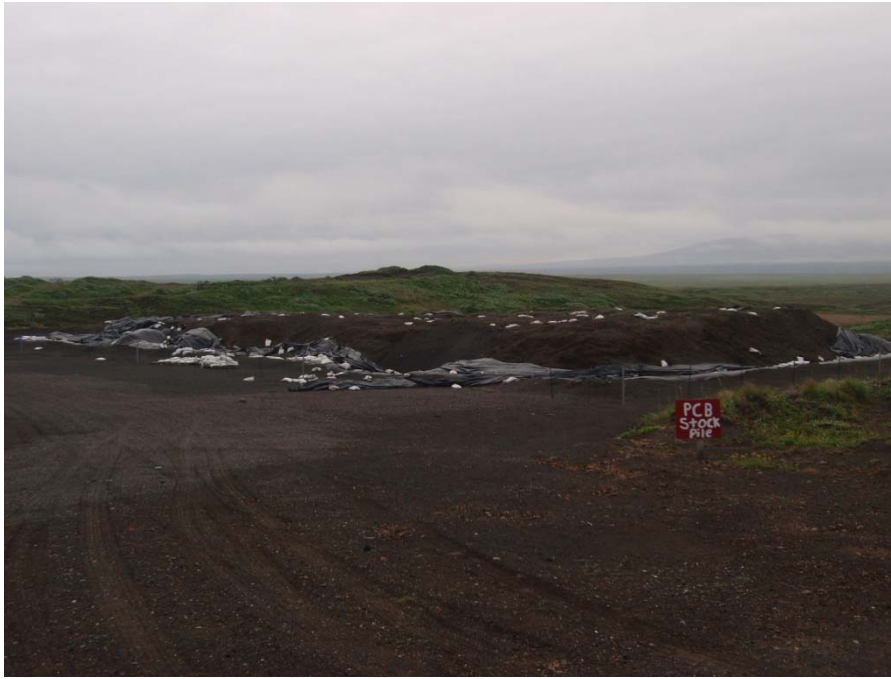
There were two stockpiles at the northern portion of the pad. The pile on the northwest side was approximately 5 to 10 feet high and covered with plastic sheeting that was held in place with sandbags. The pile on the northeast side was labeled "PCB Stockpile" (Photographs 3 and 4, Attachment 5). The stockpile was uncovered, although, plastic sheeting and sandbags were present around the base, and it appeared as though it was covered at one time. Previous reports (NVPH, 2010) have documented that high winds in the area have caused the migration of PCB-contaminated soil to other areas of the site, such as Site Road (NVPH, 2010). As a result, the uncovered soil is a potential issue.

Photograph 3: OT001 - Uncovered PCB stockpile at the northeast end of OT001, facing northeast.

1. Issues and Recommendations Identified in the Five-Year Review:	
	Issue Category: Remedy Performance
	Issue: During the site inspection, polychlorinated biphenyl (PCB)-contaminated soil stockpiles were observed to be uncovered. The stockpiles were likely uncovered as the soil remedial action (RA) was ongoing at the time of the inspection; however, the U.S. Air Force should assess if additional

OU(s): ¹ Former Port Heiden Radio Relay Station (RRS) Environmental Restoration Program (ERP) Sites	measures are needed to prevent migration of PCB-contaminated soil as a result of wind or runoff.			
	Recommendation: Review and modify stockpile maintenance plans to ensure contaminated soil stockpiles are covered and contained in a manner that prevents exposure to, and migration of, PCB-contaminated soil.			
Affect Current Protectiveness	Affect Future Protectiveness	Implementing Party	Oversight Party	Milestone Date
No	Yes	Federal Facility	State	October 2015

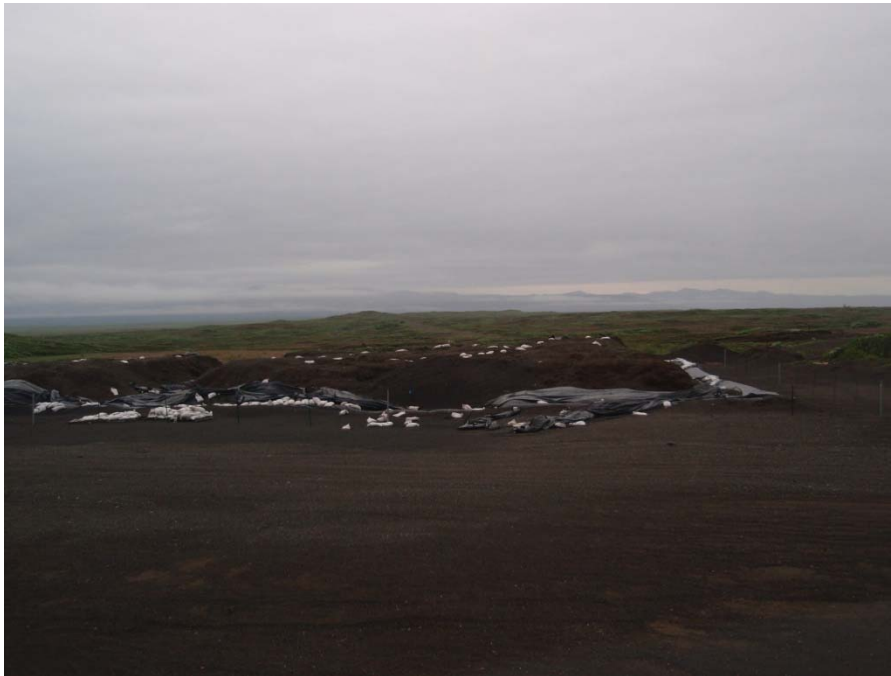
Photograph 4: OT001 - Uncovered PCB stockpile at the northeast end of OT001, facing north.

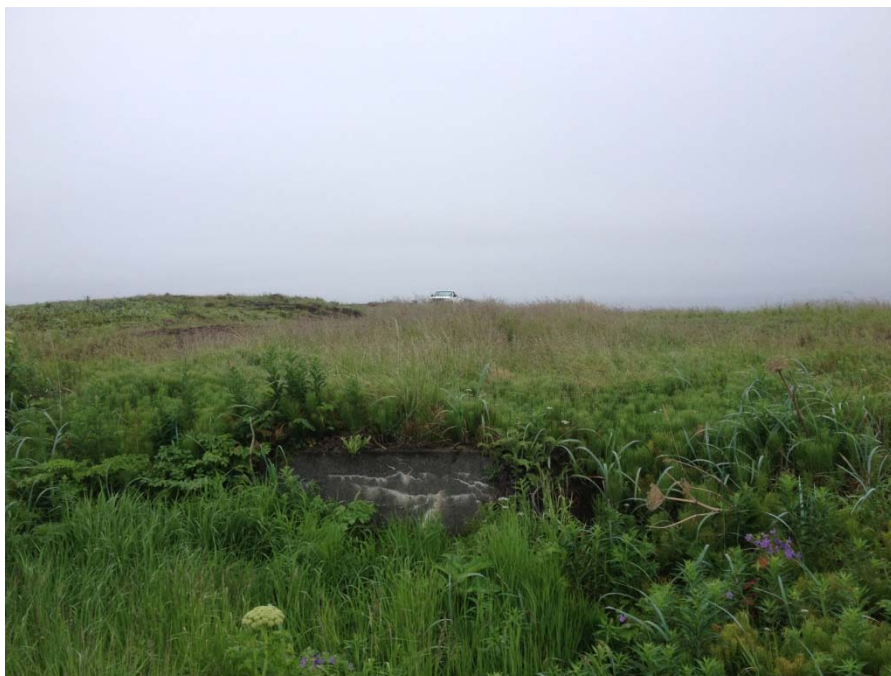
The second portion of ERP Site SS004 consisted of the former septic system outfall. The outfall was located approximately 1,100 feet northwest of the ERP Site OT001 gravel area. A concrete wing wall with an approximately 8-inch-diameter steel pipe was noted during the site inspection (Photographs 6 and 7, Attachment 5). The pipe discharged to the north into a depressed area that had relatively new vegetation.

Photograph 6: SS004 outfall wing wall, facing southeast.

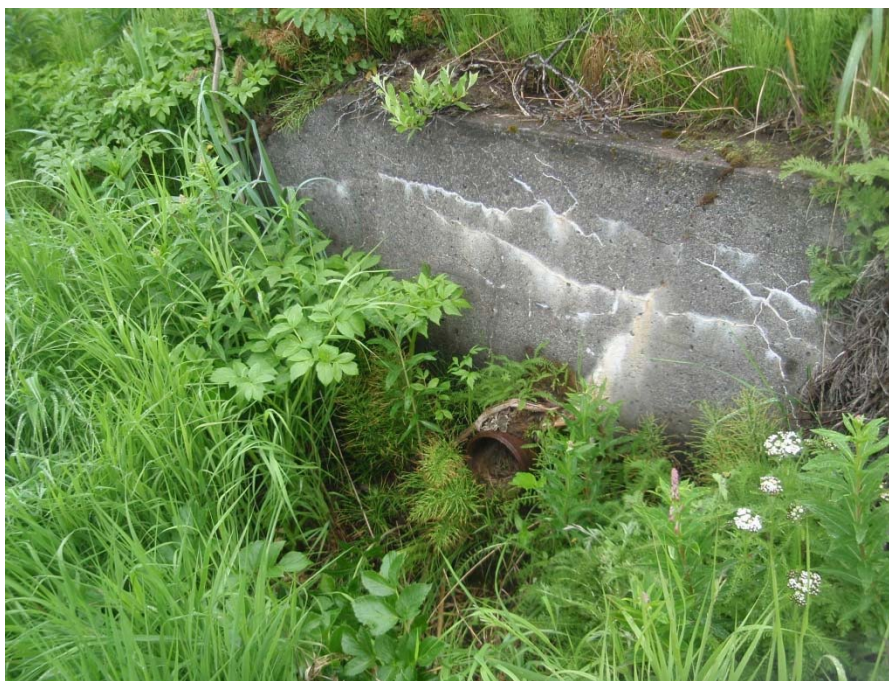
Photograph 7: SS004 outfall wing wall, facing east.

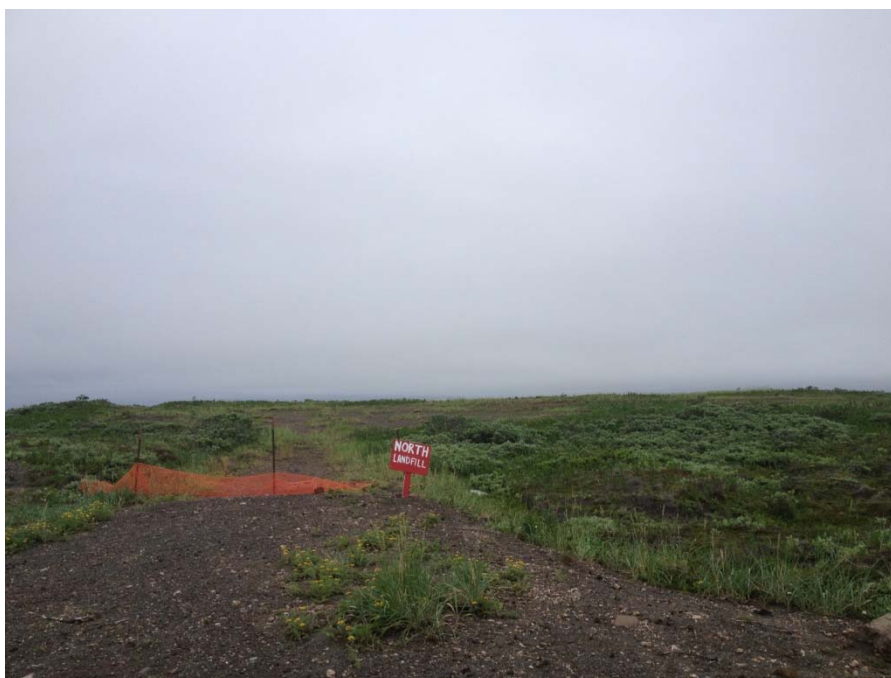
ERP Site LF007 is located north of the former Port Heiden RRS (ERP Site OT001 and the four unnumbered sites). The site was marked with a sign that read "North Landfill" (Photograph 8, Attachment 5). Similar to the gravel area under and around ERP Site OT001, it also consists of a gravel area with some sparse vegetation, surrounded by tundra. Three depressed areas were noted during the site inspection. One of the depressed areas was located at the central portion of ERP Site LF007 and appeared to be approximately 5 feet by 3 feet and approximately 1 foot deeper than the surrounding area (Photograph 9, Attachment 5). The largest depressed area was located at the north-central portion of ERP Site LF007. A 3-foot by 3-foot sink hole with metal debris and metal drums was identified in this area (Photograph 10, Attachment 5). The sinkhole appeared to be approximately 3 to 4 feet deep. The third, and smallest depression, was located at the southern portion of ERP Site LF007. There were also various rusted metal debris on the ground surface at ERP Site LF007, some of which appeared to be pieces of metal drums.

Photograph 8: LF007, facing north.

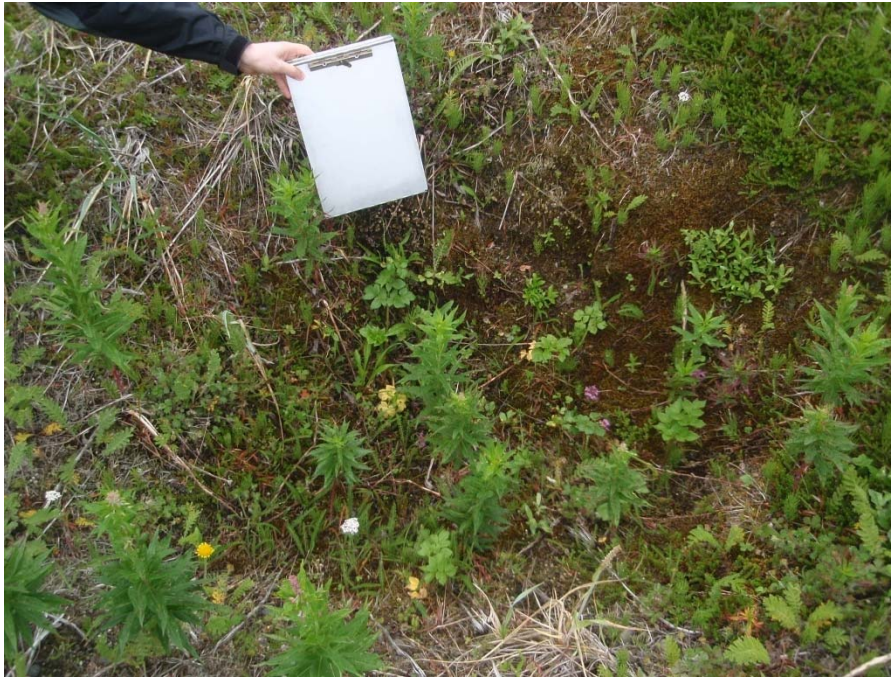
5. During the site inspection of ERP Site LF007, it was observed that the landfill appeared to have subsided in places, and in one instance, the subsidence exposed metallic debris. Some metal debris was also visible on the ground surface. While this is not indicative of current exposure, if left unchecked, the landfill cap may further erode and contaminated soil may be exposed.

Photograph 9: LF007. Central portion of LF007 facing downward toward area of subsidence.

OU(s): Port Heiden RRS Source Areas	Issue Category: Operations and Maintenance			
	Issue: During the site inspection of ERP Site LF007, it was observed that the landfill appeared to have subsided in places, and in one instance, the subsidence exposed metallic debris. Some metal debris was also visible on the ground surface. While this is not indicative of current exposure, if left unchecked the landfill cap may further erode and contaminated soil may be exposed.			
	Recommendation: Address exposed debris and subsidence at ERP Site LF007.			
Affect Current Protectiveness	Affect Future Protectiveness	Implementing Party	Oversight Party	Milestone Date
No	Yes	Federal Facility	State	October 2016

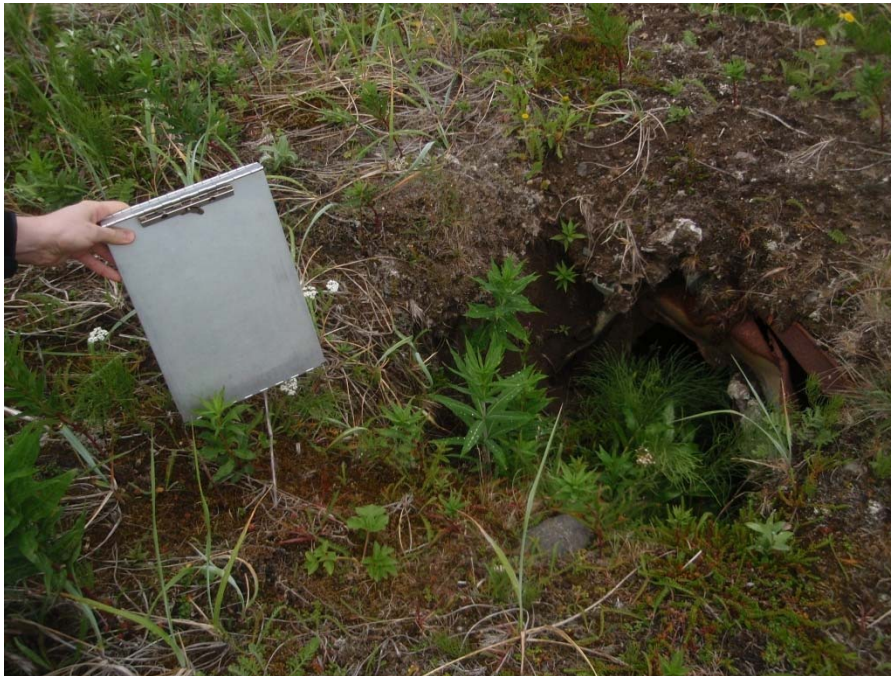
Photograph 10: LF007. North side facing downward toward subsidence with exposed debris.
