## PRELIMINARY ENVIRONMENTAL SITE ASSESSMENT

### NSB SOUTH PAD

North Slope Borough  
Barrow, Alaska  
South Pad Staging Area

August 5, 1997

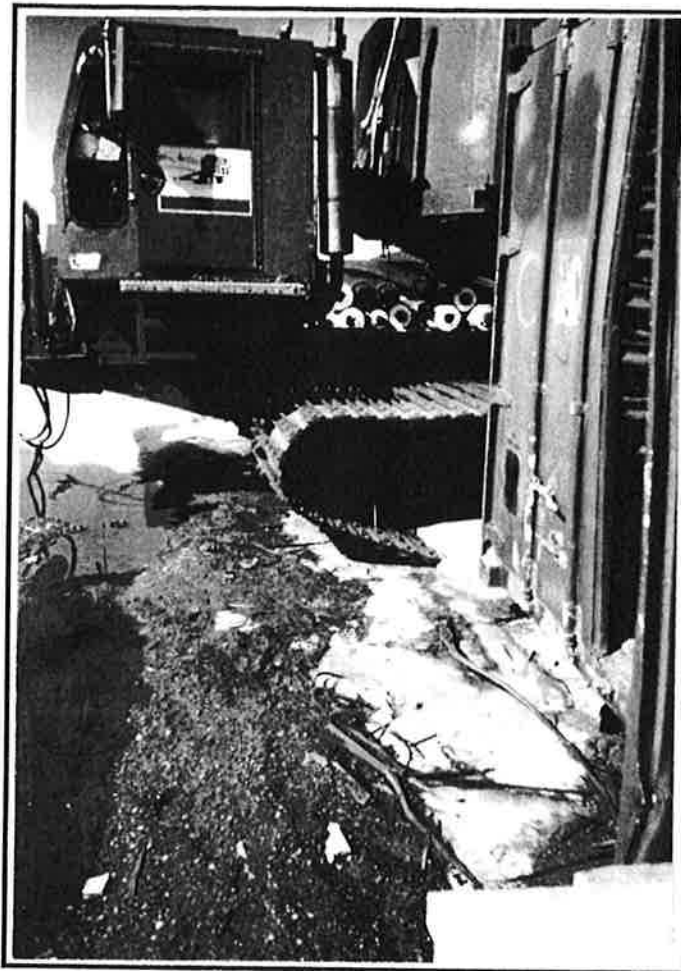
- There is no defined area of vehicle storage but several heavy equipment vehicles and DMS trucks are stored on the pad. Some vehicles stored here, such as the tractor in the eastern portion of the pad near the lumber stockpile, are clearly junk vehicles which have leaked fluids onto the ground (Photo 1).

**PHOTO 1:**  
POL product spill from tractor  
vehicle on east side of pad.

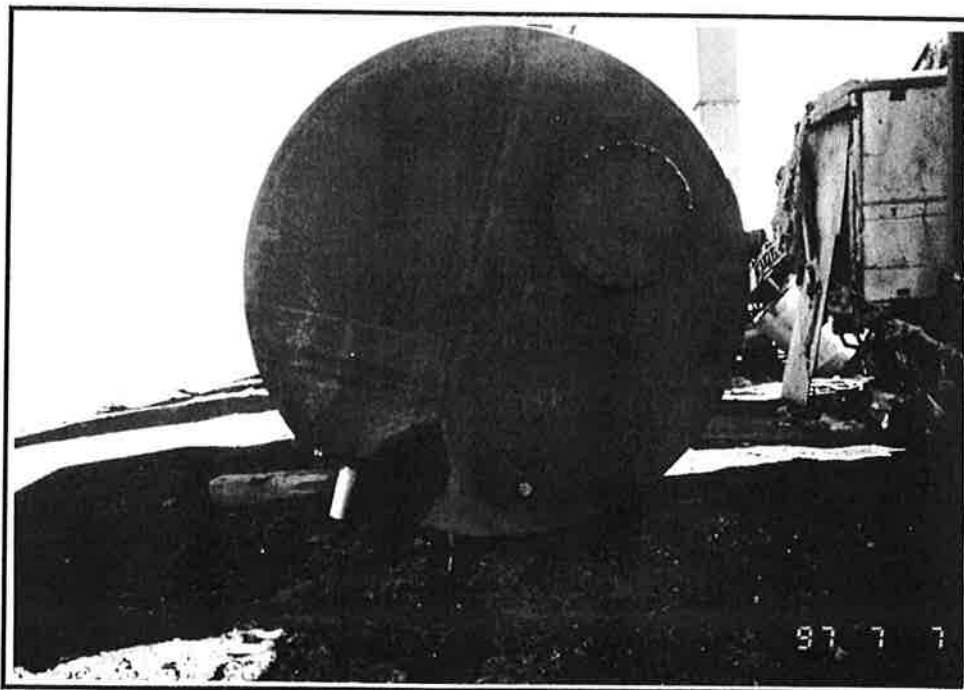
- Twenty-two above ground fuel storage tanks (AST) are stored on site. It is unknown which, if any, of these tanks have been properly emptied and cleaned. At least one 10,000 gallon tank has seeped around the valve stem and stained the soil beneath it (Photo 2).

**PHOTO 2:** 10,000-gallon AST. Note: seeping around valve & spill on  
ground.

- There is potential for soil contamination associated with the numerous fuel storage tanks residing on the pad. It is not known whether they have been emptied and properly cleaned. Some of the tanks show evidence of seeping near the valve stem, and at least one has leaked enough to cause an area of stained soil approximately one foot in diameter.

- Some of the ASTs on site have inadequate secondary containment according to 40 CFR 112.1(d), 112.7(d), and 112.7(e)(2)(ii). Secondary containment should have the capacity to hold the volume of the largest tank within the containment area, plus enough additional capacity to allow for local precipitation (18 AAC 75.075(a), (c), and (f)). The 45,000 gallon tank near the Service Shop has a small dike area that is completely full of water. If the tank is has been emptied and cleaned, it should be marked as such.

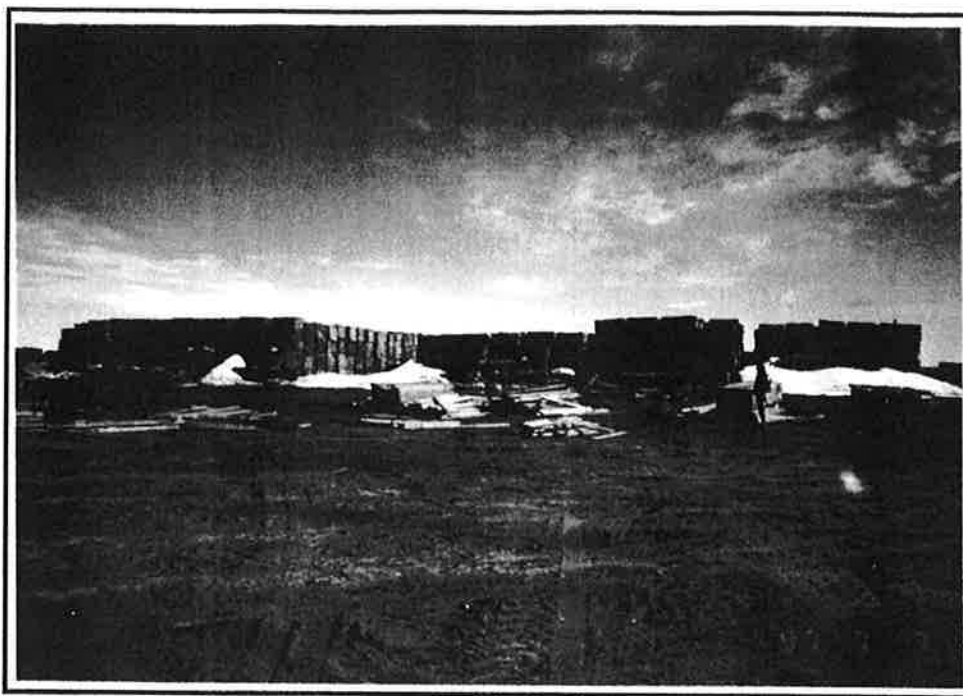
**PHOTO 3:** Lumber stockpile.

- There is potential for soil contamination associated with leaching of chemicals from the lumber stockpile. Although the treatment process used for this lumber was not determined, Chromated Copper Arsenate (CCA) is often used in the process of pressure treating lumber. Arsenic is rated by the EPA as a class A carcinogen. Although CCA retards decay, it does not stop it. Estimates of rot resistance of 20 to 50 years are common, but the wood will eventually decay and leach its metals.

- Although the treatment process used for the lumber at South Pad was not determined, Chromated Copper Arsenate (CCA) is a common chemical used to treat lumber. This type of wood has been tested by the Minnesota Pollution Control Agency, Hazardous Waste section to be over 3000 parts per million arsenic. The exposed ends of the boards are most likely to leach arsenic than the rest of the board, and should be resealed every two years. Particular caution should be taken if the wood has a white, gritty residue on the surface, as these may be arsenic crystals. Disposal is currently allowed in conventional and demolition landfills, but it should be recognized that although CCA retards decay, it does not stop it. Estimates of rot resistance of 20 to 50 years are common. The wood will eventually decay and leach its metals. The wood should not be

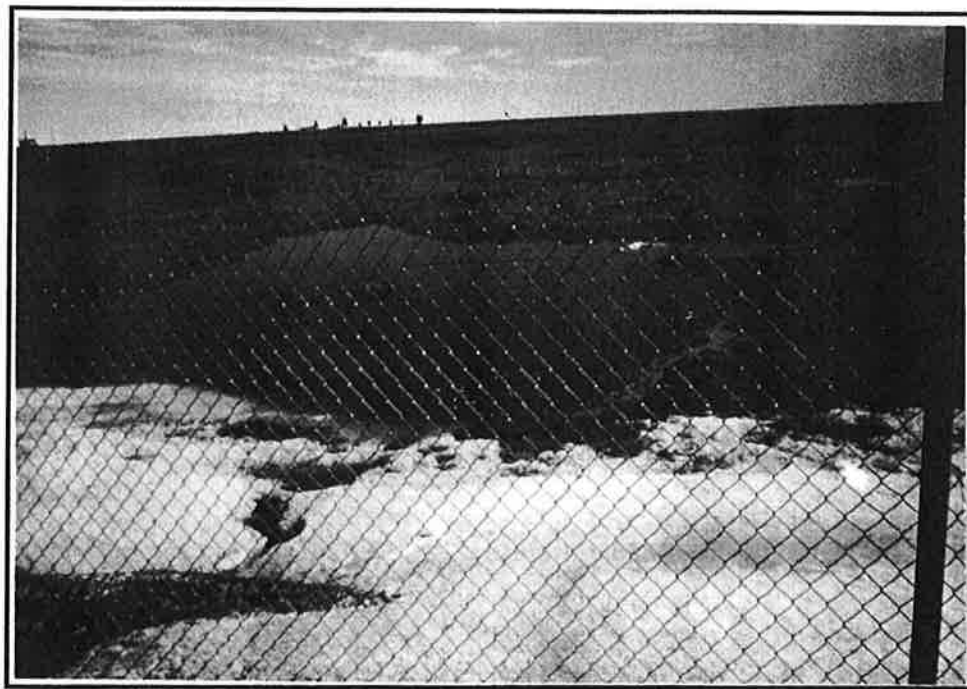
**PHOTO 4:** Water to the east of the lumber stockpile.

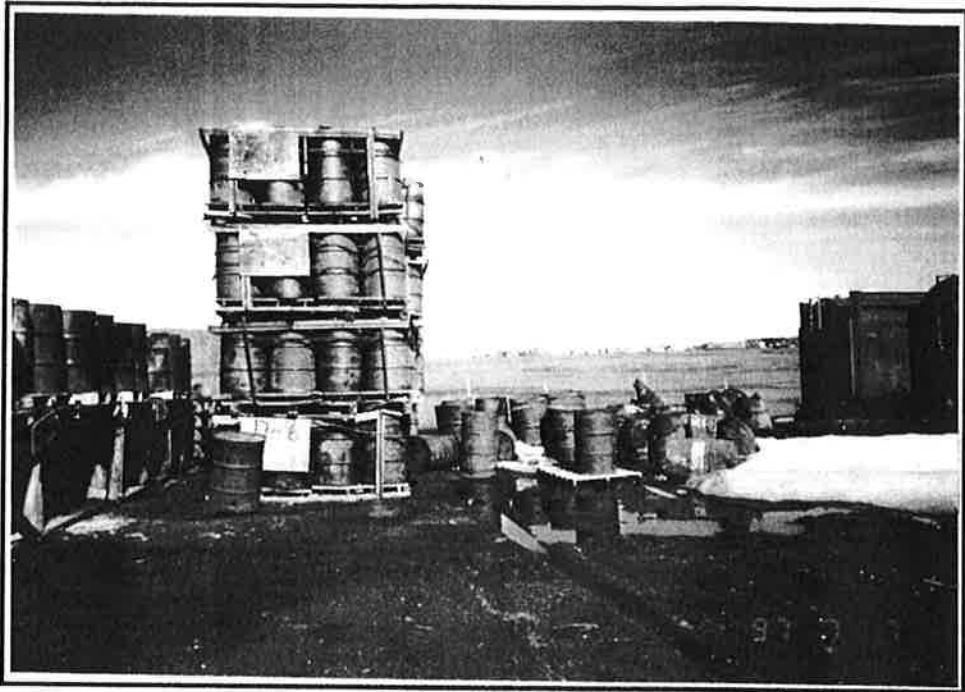
- There are about 150 drums of asphalt (Photo 5), of which at least four are leaking (Photo 6). About 50 rusted and dented drums of various product including glycol, kerosene, and oils are stored on a wooden platform (Photo 7) just west of the asphalt drums. Several of these drums have worn labels and many are leaking (Photos 8 and 9). Six crates, each containing ten 5-gallon rusted cans of flammable "Acrylic Enamel" are located south of these drums (Photo 10). Another platform located further to the east contains eight rusted, dented, and unlabeled drums (Photo 11) of which one has leaked (Photo 12). There are five 5-gallon cans and two 55-gallon drums located southeast of this platform. Some of these are open, some unlabeled, and some contain grease. Ten more rusted and dented drums are located in the northeast corner of the pad. Four of these contain either transmission fluid or lube oil, four are unlabeled, and two are empty. A pallet of small containers of flammable materials including chemical grout, automotive paint, carburetor cleaner, brake fluid, and lacquer primer as well as two cylinders of nitrogen gas are located on the north side of the Storage Building (Photo 13). A platform located on the west side of this building holds 5 transformers. Two pallets of compressed gas cylinders located west of the abandoned service shop (Photo 14) hold both acetylene and oxygen cylinders. The eighteen storage conexes on the west side of the property contain mostly surplus automotive parts.

**PHOTO 5:** About 150 drums of asphalt material. Drums stacked 4 high plus 13 more stored haphazardly just right of the stacked drums.

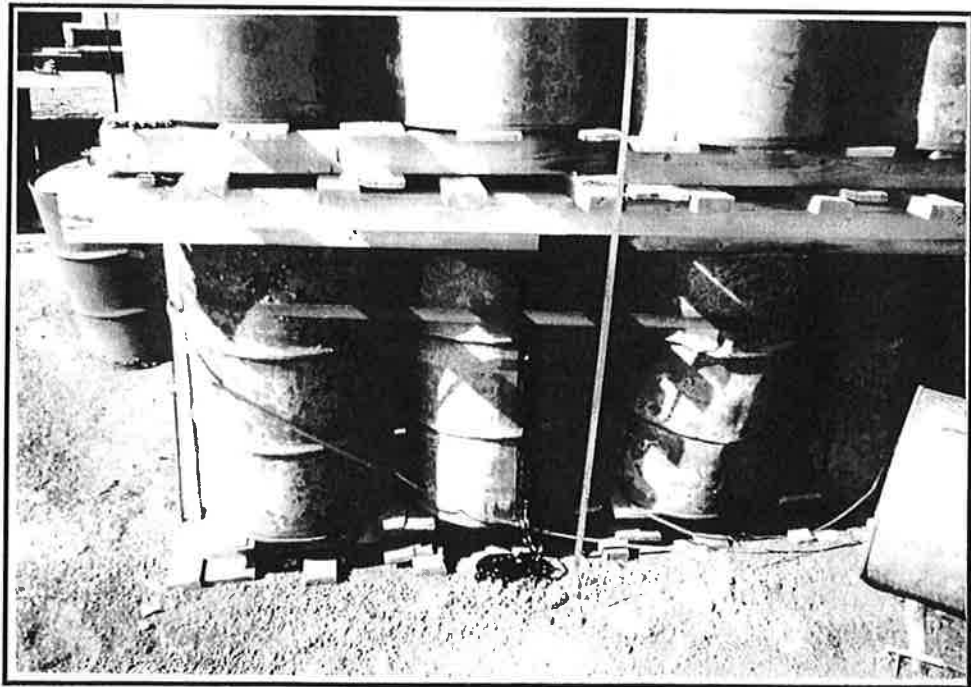
**PHOTO 6:** Spilling drum of asphalt - typical of at least 4 drums in the pile.

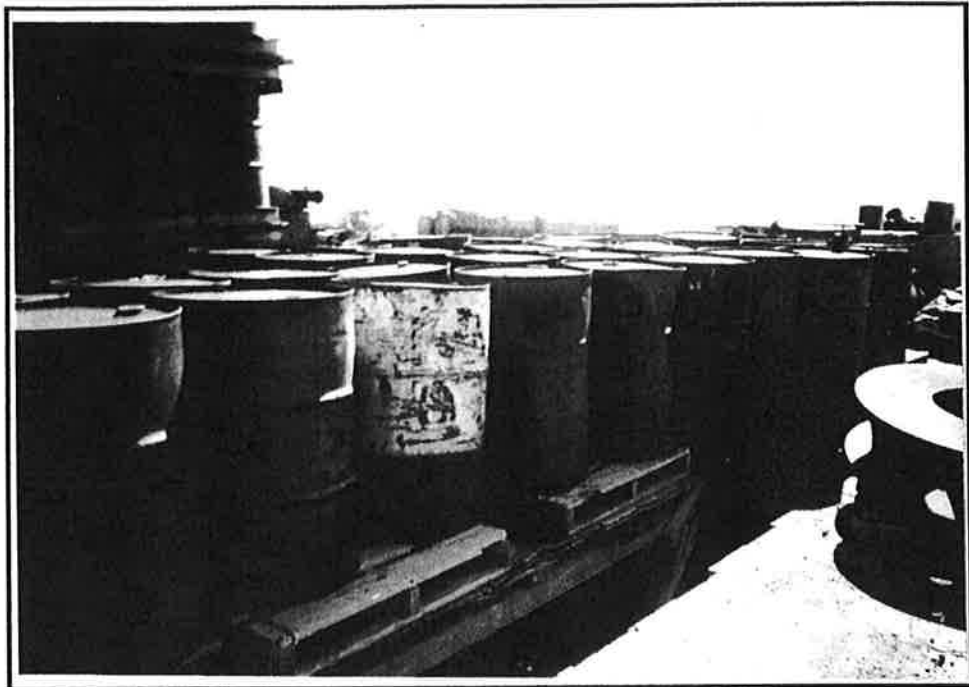
**PHOTO 7:** View of half of the unused product drum stockpile.

- Sample the soil at the drum storage area on the north side of the pad to determine the extent of contamination in this area.
- Cleanup any spills that have occurred in the drum storage area and dispose of all clean up materials according to ADEC requirements. To prevent future spills, identify unneeded, unused, or expired materials. Appropriately store materials which are determined to be needed and/or usable. Replace or provide secondary containment for deteriorated containers. Recycle or dispose of the remaining wastes properly.

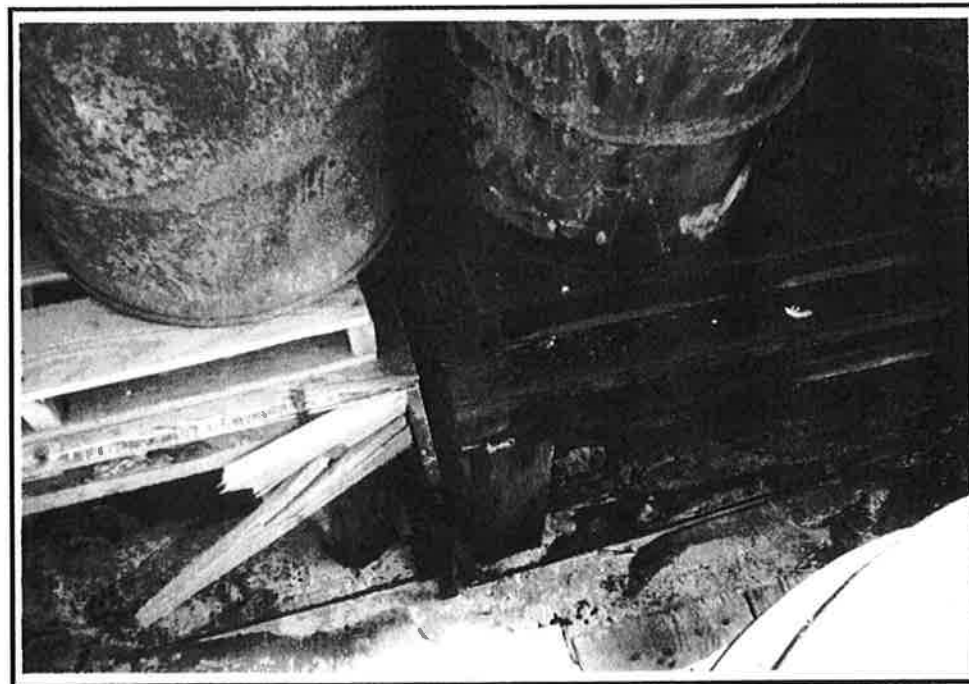
**PHOTO 8:** Unlabeled leaking drum is typical of several drums in stockpile.

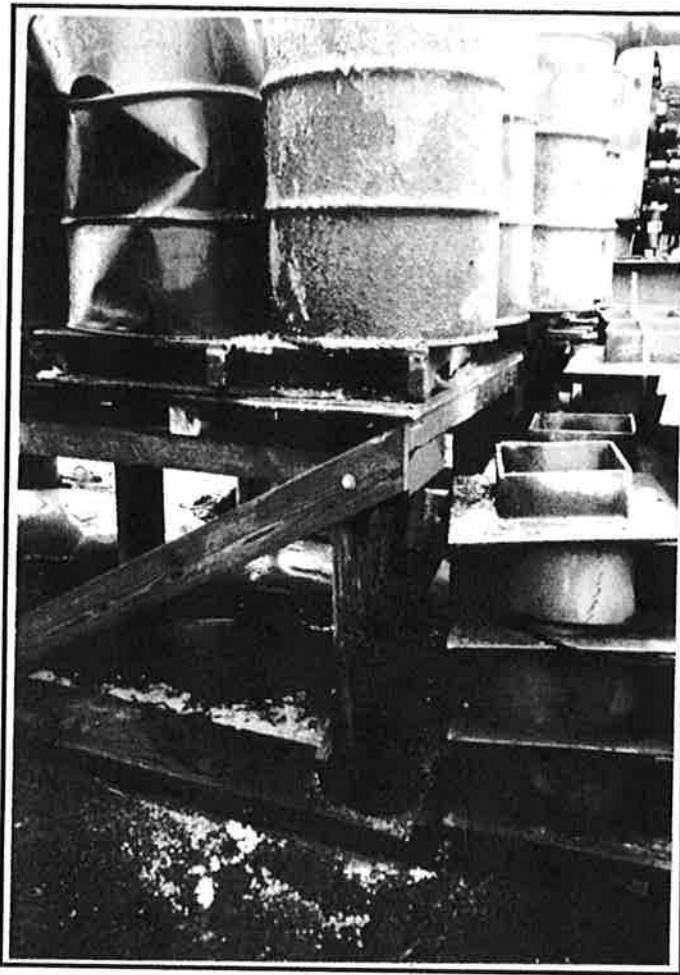
**PHOTO 9:**  
Drum storage area -  
degraded spilling drum.

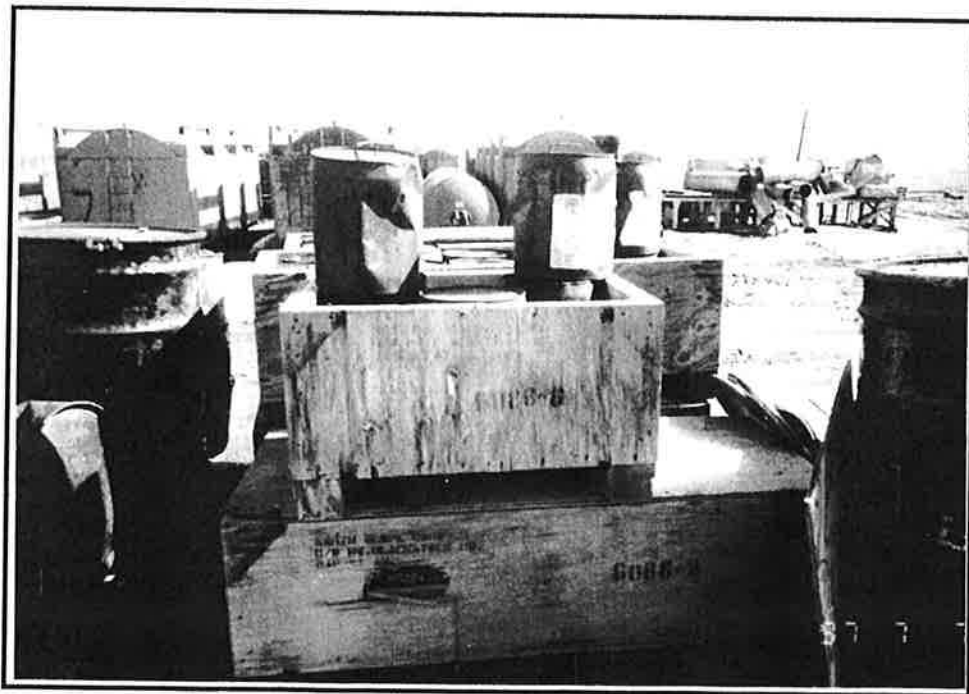
**PHOTO 10:** Six crates of 5-gallon rusted cans of flammable "Acrylic Enamel".

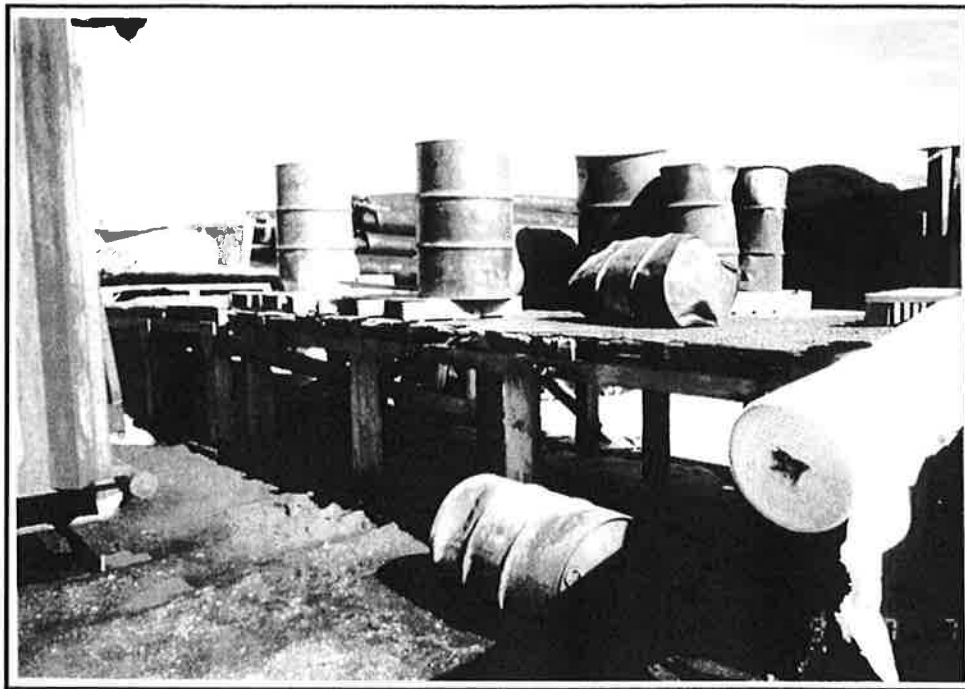
**PHOTO 11:** Eight drums - rusted, dented, and unlabeled.

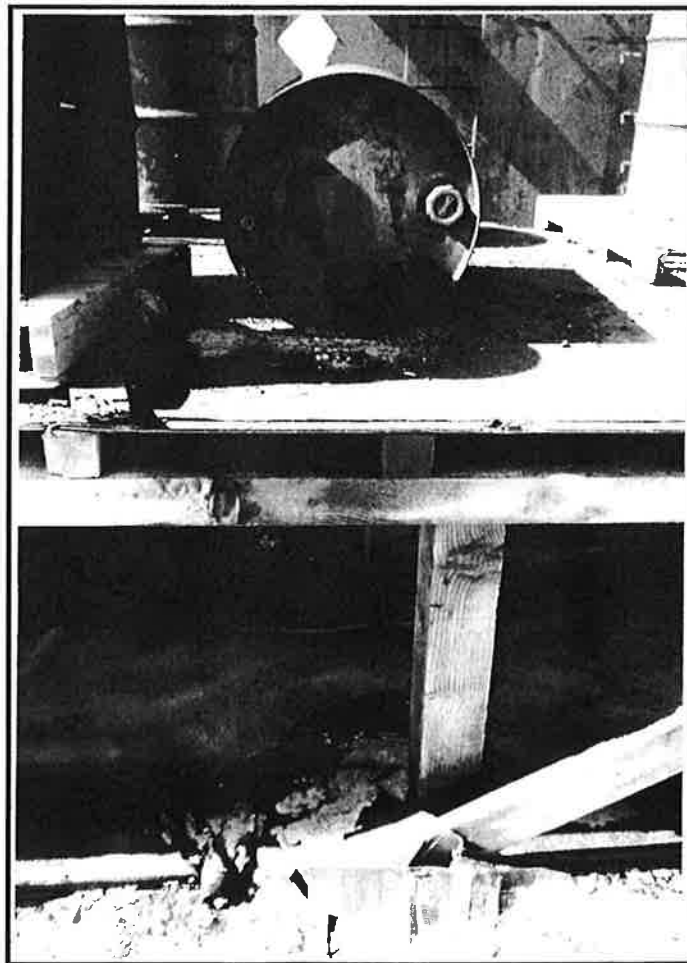
**PHOTO 12:**  
One of the 8 drums described  
above is leaking.

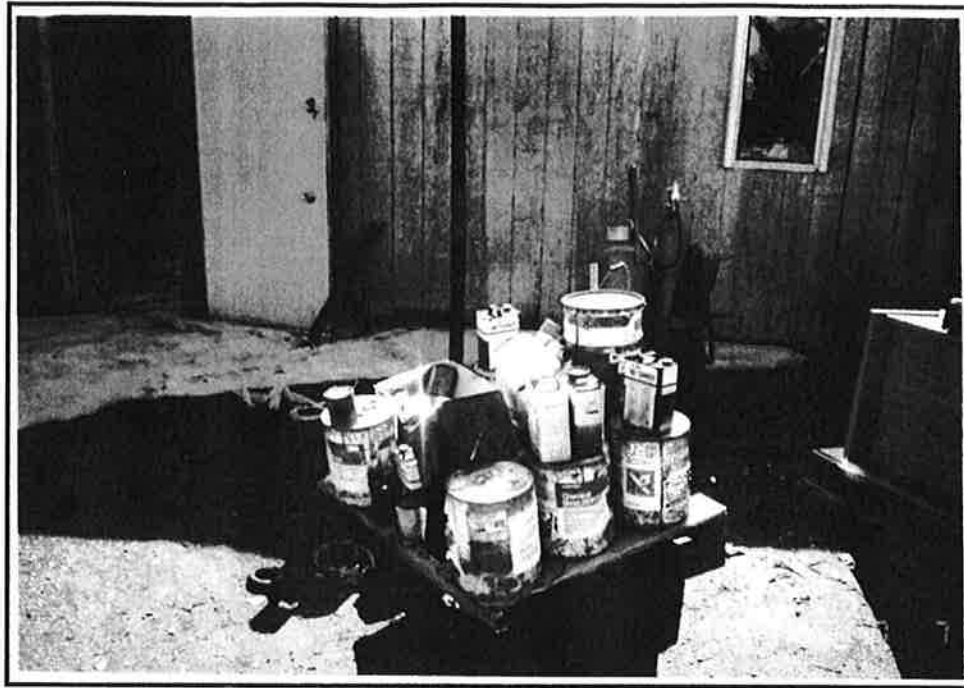
**PHOTO 13:** Pallet of flammable solvents and two nitrogen cylinders located on the north side of the Storage Building.

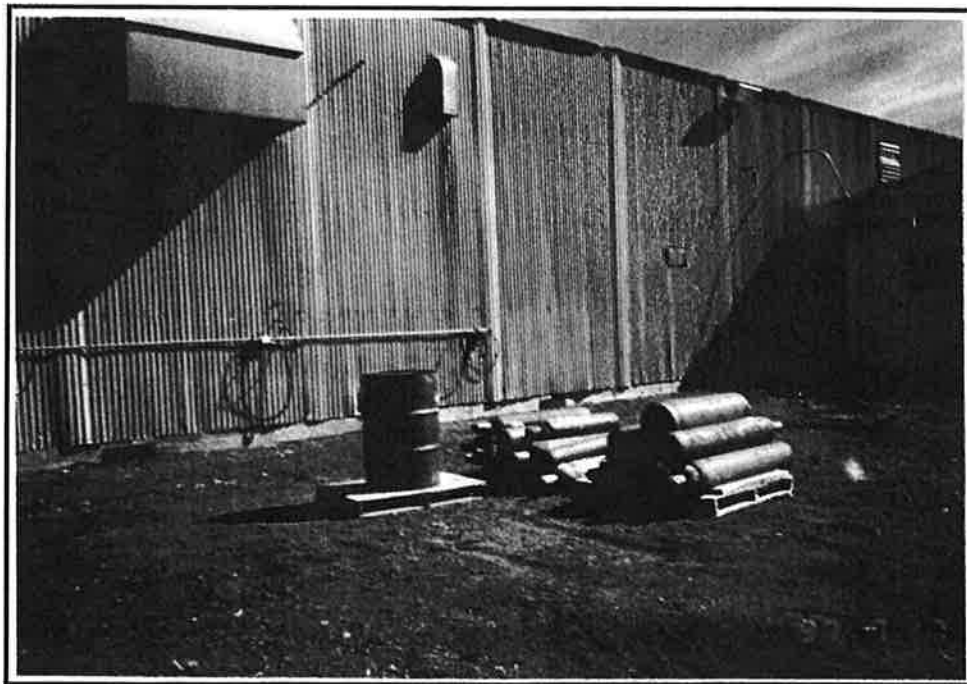
**PHOTO 14:** Two pallets of compressed gas (acetylene and oxygen) cylinders on west side of Service Shop. Not labeled empty or full.

- Characterize and dispose of all regulated or hazardous waste found in South Pad's Service Shop building and annex Storage Building..
- Compressed gas cylinders were stored horizontally on pallets and haphazardly in several locations on site. According to 29 CFR 1910.101, the storage of all compressed gases in cylinders must be done according to the Compressed Gas Association Pamphlet P-1-1-1965. They are not labeled as to whether they are empty or full. If they are full, they should be chained upright in a designated storage area that does not allow exposure to temperature extremes. Additionally, storage areas for flammable compressed gases should be posted NO SMOKING and have appropriate fire extinguishers available. Acetylene and Oxygen cylinders were observed on the same pallet outside of the Service Shop. Flammables and oxidizers are incompatible and pose fire hazards. If the cylinders are empty, they should be shipped out to be refilled.

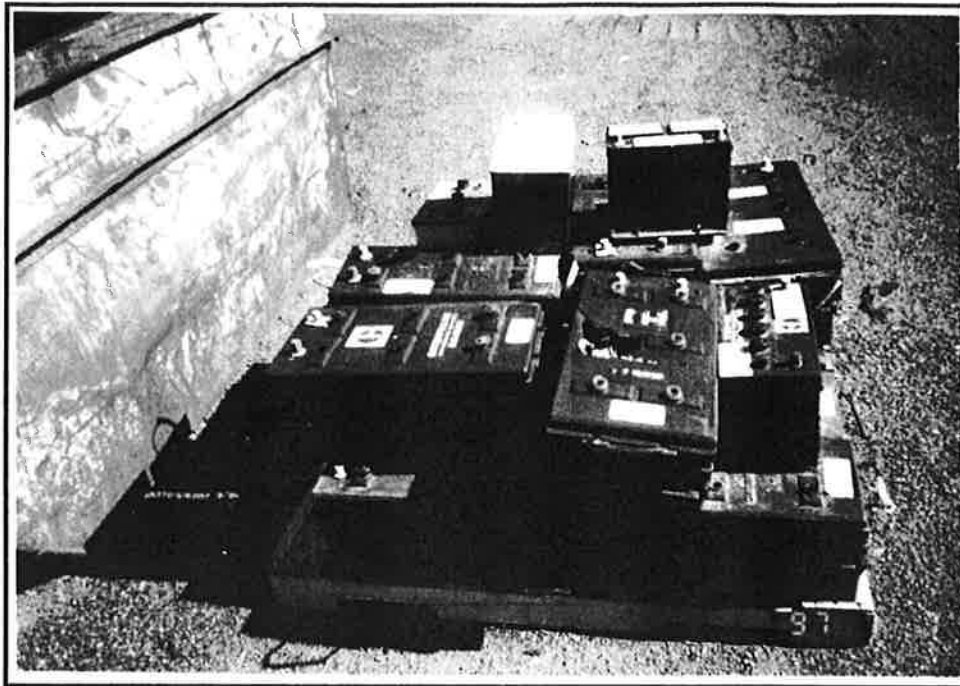
**PHOTO 15:** Used lead-acid batteries stored on pallet east of entrance gate.

- Automotive batteries were stored on pallets or directly on the ground and open to the environment. Lead-acid batteries should be brought to designated battery storage areas only if there are no leaks or missing caps and they are placed in leak-proof containers. Records should be kept that include battery identification number, generator, and disposal date. This record should also be updated annually for recycling shipments.

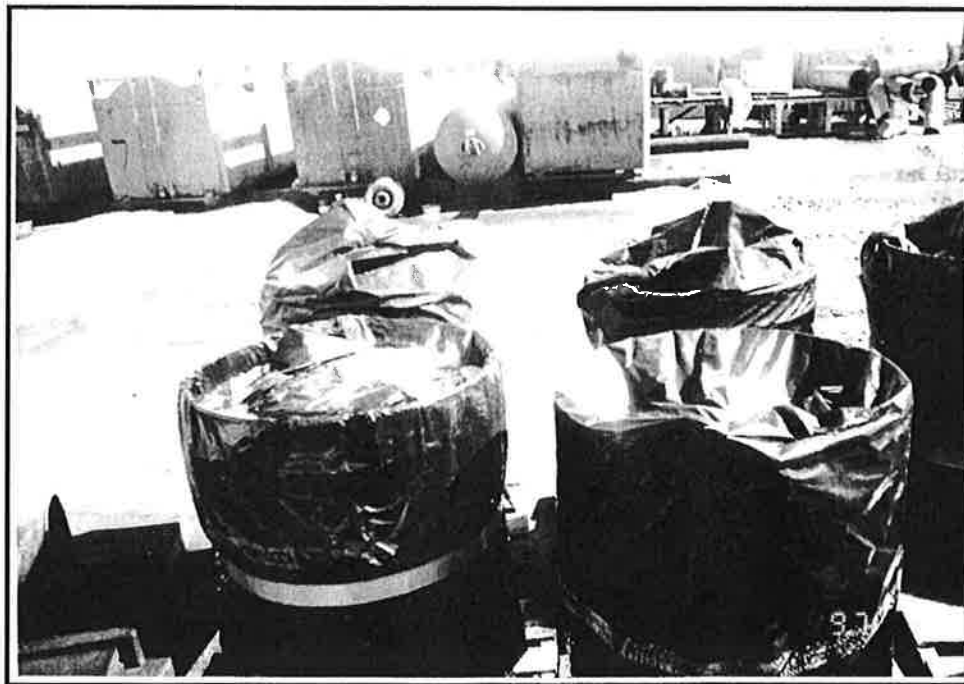
**PHOTO 16:** Four of the 7 overpack drums reportedly containing hazardous waste. The drums are unlabeled and have product on top.

- The seven drums of reported hazardous waste should be sampled and tested to characterize the waste and determine appropriate disposal methods. Any unlabeled container whose contents cannot be identified by process of knowledge or other acceptable means should also be sampled and handled accordingly. Label these drums after characterization and store appropriately or dispose of them.

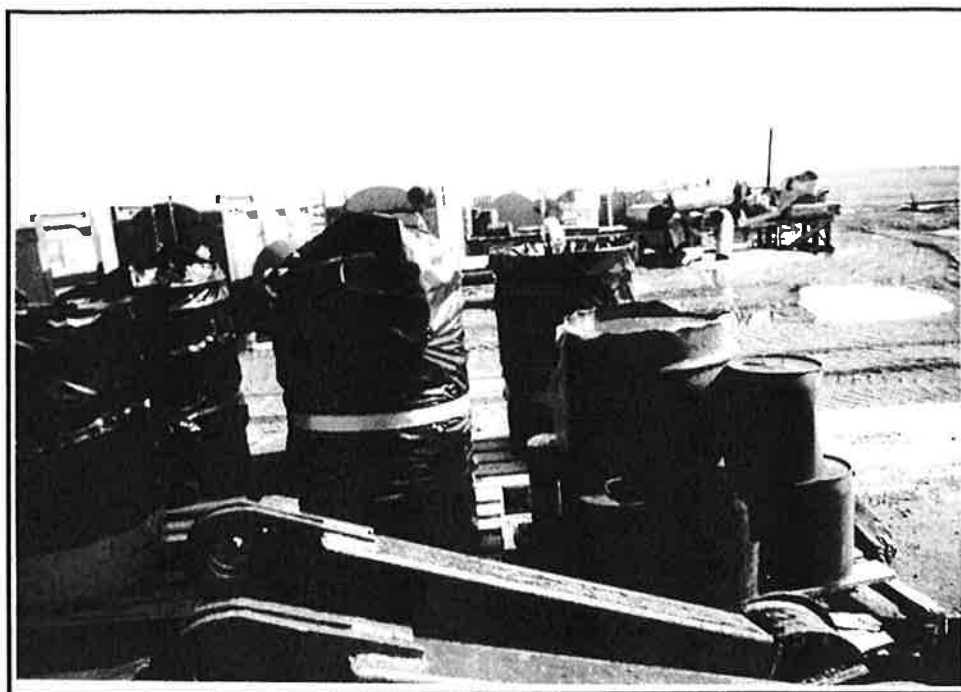
- Besides the junk vehicles, ASTs, and unwanted products previously described, the waste materials onsite include used lead-acid batteries, seven overpack drums of uncharacterized waste, several empty drums, scrap metal, and empty compressed gas cylinders. Some batteries were stored on a pallet (Photo 15) just east of the entrance gate, although a few batteries were found on the ground near the buildings. Seven overpack drums with only plastic bags as covers are located south of the platform of unused product drums described above. Chris Cleveland reported the contents to be hazardous. Some of these drums had free product on top of the plastic and were leaking onto the ground (Photo 16). Just south of these drums is a half of a drum that is full, open, and unlabeled resting on top of a pallet of unlabeled and rusted 5-gallon cans (Photo 17).

**PHOTO 17:** More reported hazardous waste drums, plus a cut drum that is full, unlabeled, open, and resting on top of a pallet of unlabeled cans.

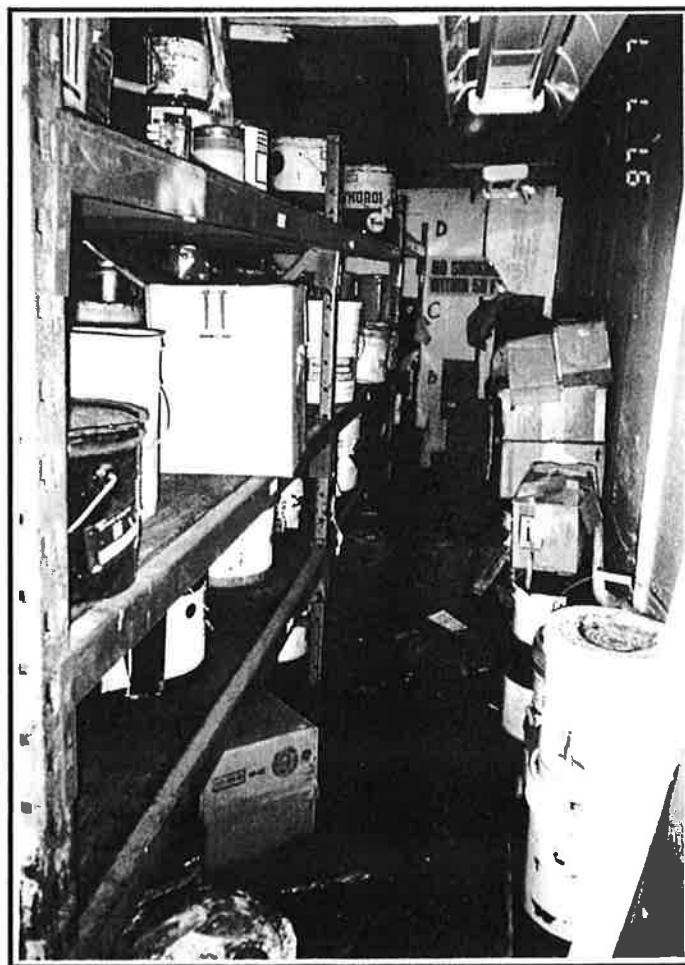
Cleveland, newer items are placed here from time to time. At the time of the site reconnaissance, the floor of the building was covered with ice and water. The flammable storage room located in the southwest portion of the building (Photo 18) contains over fifty 5-gallon containers of various flammable materials as well as several smaller containers including Methyl Ethyl Ketone Oxide (97% active oxygen). This room does not meet federal regulations for flammable storage rooms inside of buildings. Some violations include an unclear aisle, incompatible substance storage, containers in poor condition, and the lack of a self closing fire resistant door.

**PHOTO 18:** Inside storage Building, south-western most conex is a flammables storage room.

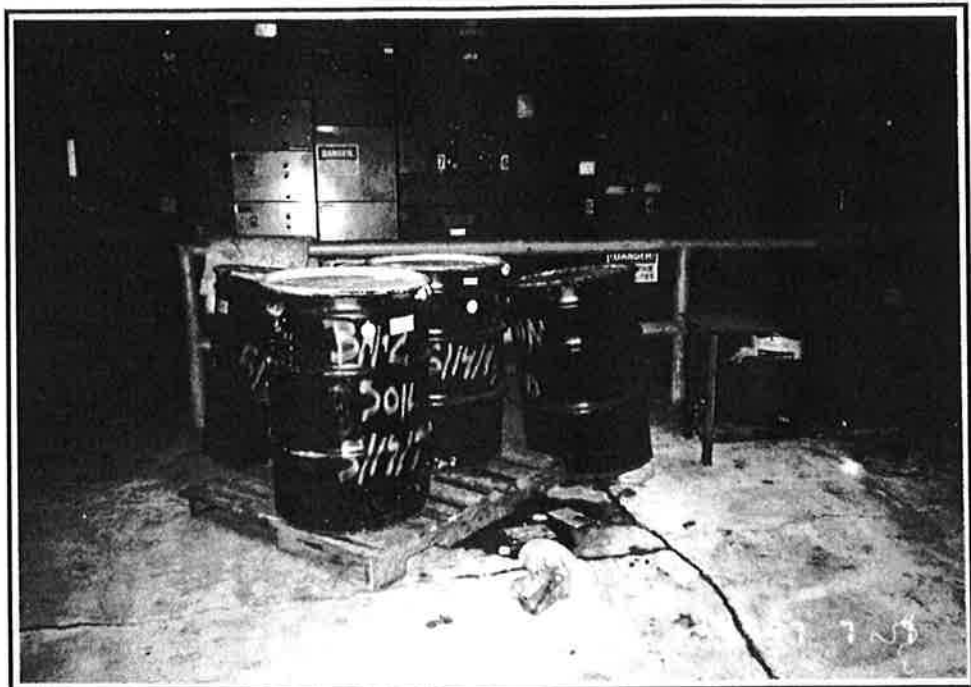
**PHOTO 19:** Inside Service Shop - 4 drums of contaminated soil dated 5/14/93.

- The four overpack drums containing contaminated soil in the Service Shop may be considered hazardous waste. It is dated May 14, 1993 and has exceeded storage time limitations set in 40 CFR 262.34.

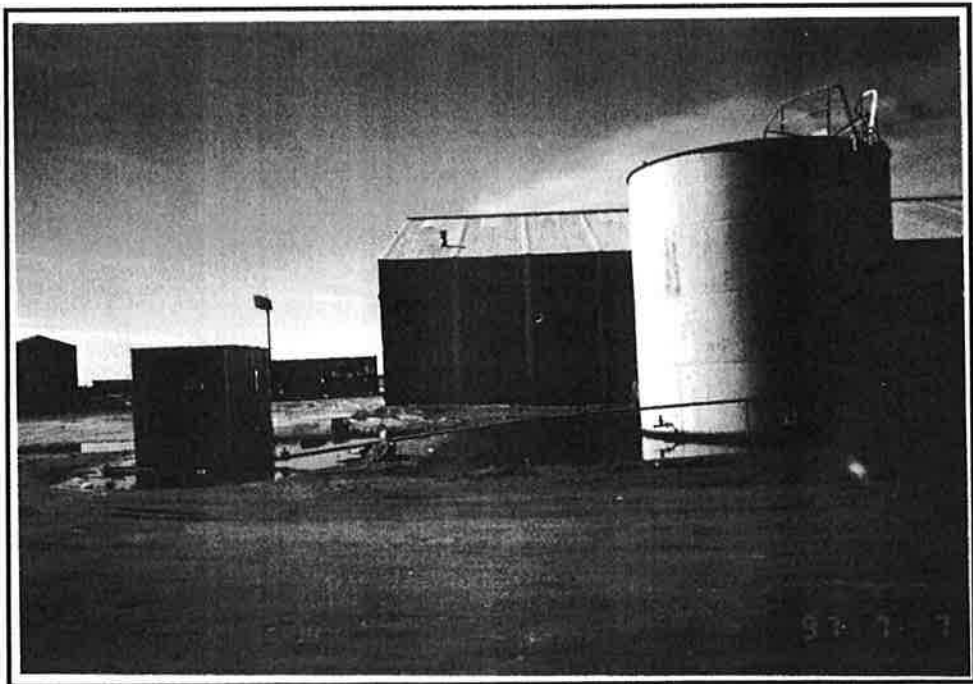
**PHOTO 20:** Bulk fuel AST and dispensing station - two dikes full of water.

- There is potential for soil contamination at the abandoned fuel tank farm and dispensing area. The 45,000 gallon AST and associated above ground piping is rusted and has higher potential for seepage near the joints and valves. Both diked areas are subject to contamination due to the inherent likelihood of spills in this area and the overflow of rainwater and snowmelt from them to the surrounding area.

- The area around the 45,000 gallon AST and dispensing area should also be sampled for contamination. There is a high potential for contamination from seepage from rusted joints and valves and from spills during filling operations. Rainwater and snowmelt have overflowed the secondary containment, possibly contaminating the surrounding areas.

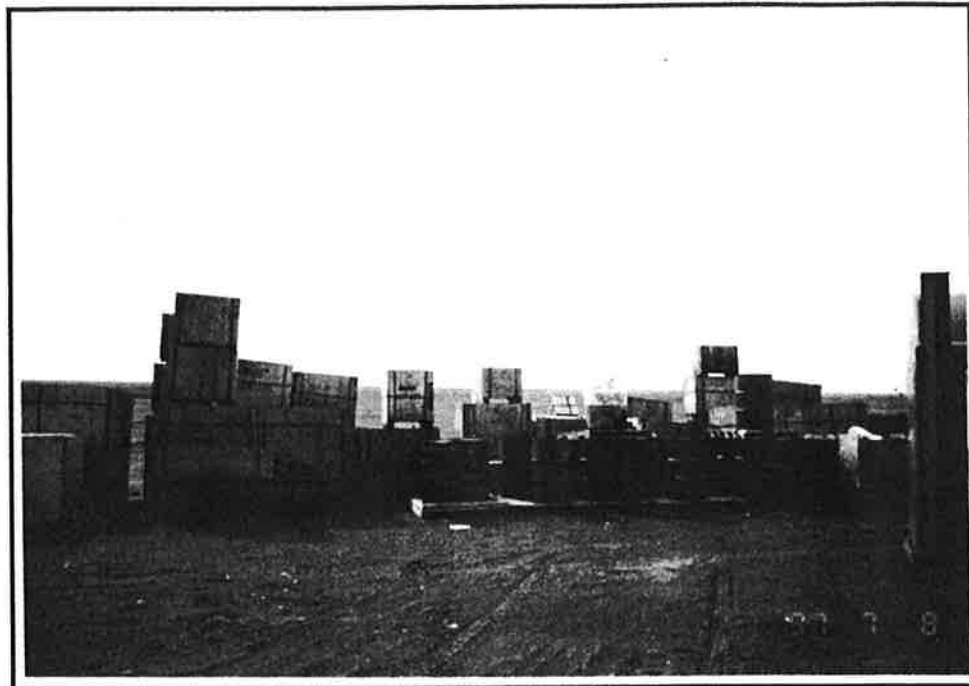
**PHOTO 21:** Adjacent (CIPM) property - SW corner - 28 crates of ethylene glycol plus 16 drums; 5 of which are hazardous "Isocyanate compound".

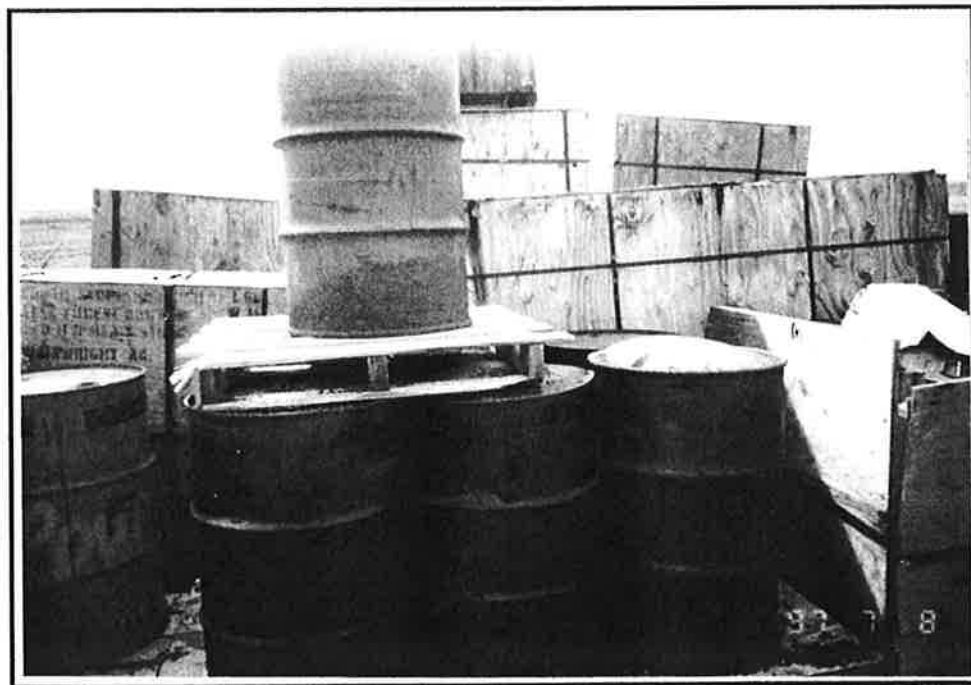
**PHOTO 22:** Adjacent (CIPM) property - close up of above drums. Note: rust, dents, holes, and bulging indicate poor condition and potential for leaking.

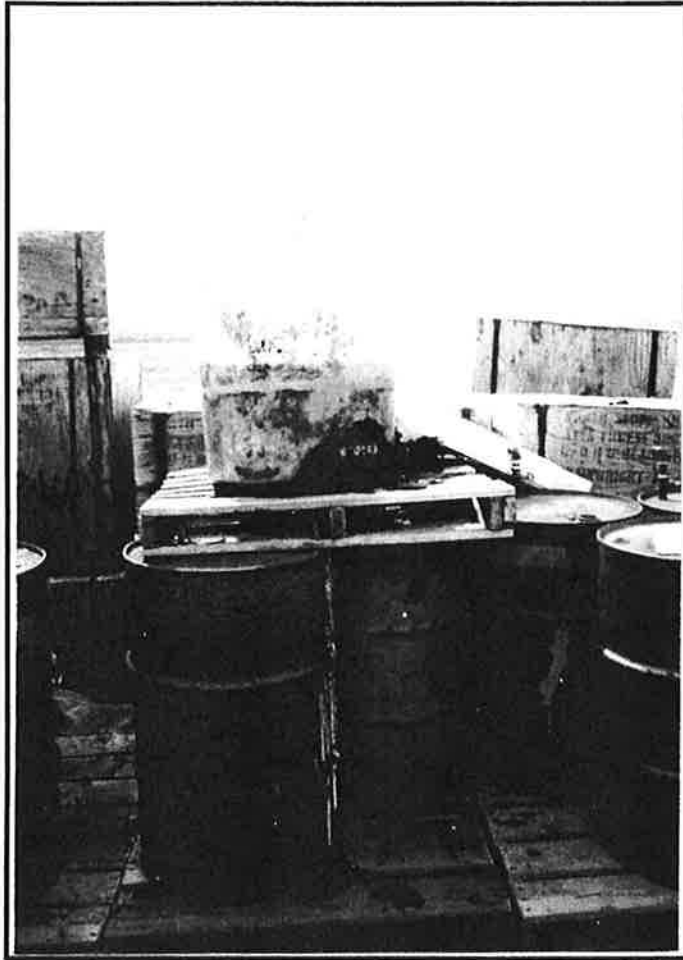
stored on top of the other drums, has leaked onto a drum containing hazardous material (Photo 23).

**PHOTO 23:** Adjacent (CIPM) property - close up of drum pile. Note: degraded leaking drum of acid on top of hazardous drums.
