Department of Environmental
Conservation

DIVISION OF SPILL PREVENTION & RESPONSE
Contaminated Sites Program

RE: Decision Document: Eaglecrest Ski Area
Corrective Action Complete with Institutional Controls Determination

CBJ - Eaglecrest Ski Area
3000 Fish Creek Road
Juneau, Alaska 99801
Section 31 T 41 S R 67 E CRM

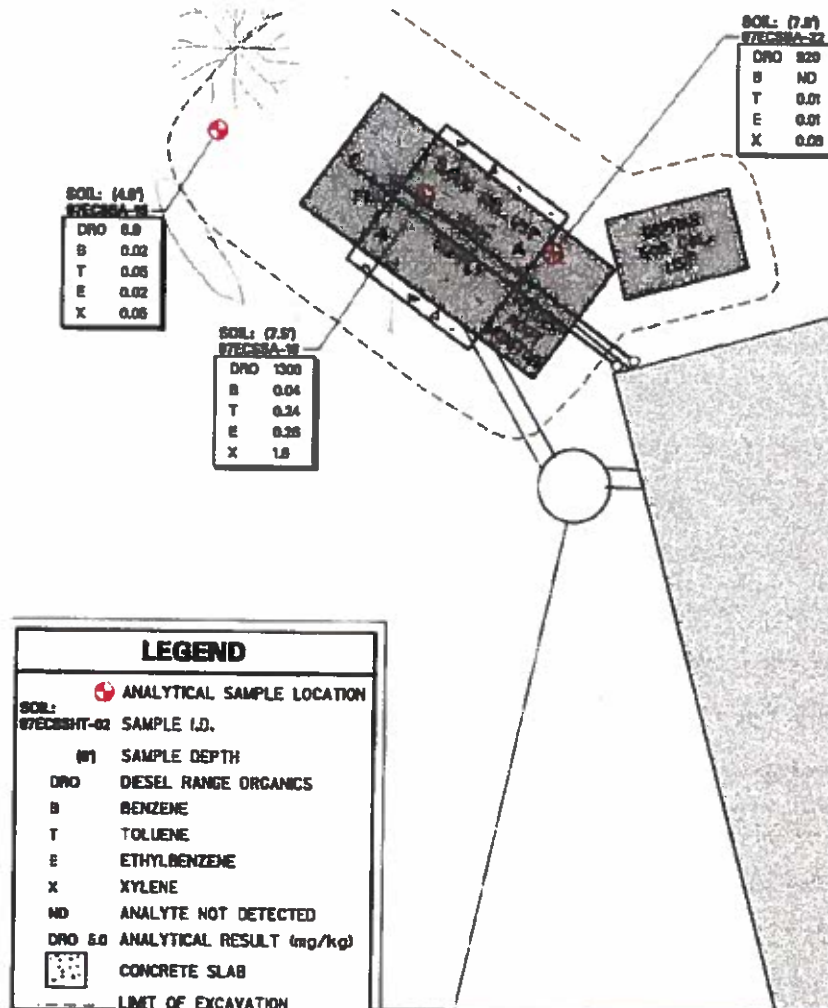
Figure 2. Ski Lodge USTs (dark polygons) & confirmation sample locations

As the results in Table 2 indicate, minimal hydrocarbon contamination was present on the side wall at the northern limit of the excavation. Levels of contamination remaining at the bottom of the excavation are above approved cleanup levels for DRO. Depth BGS constraints did not allow the excavation of all contaminated soils to the vertical extent before installation of a new double-walled heating oil UST. CDI recommended an additional release investigation if determining the vertical extent of contamination was deemed necessary by DEC.

On September 18, 1997, a concrete pad was prepared in the former UST excavation to anchor placement of a new 8,000 gallon double-walled UST. Although the volume was not estimated, DEC approved transport of all contaminated soil from the former Ski Lodge UST pit to a contaminated soil storage area on CBJ commercial property located at the end of Commercial Blvd in Lemon Creek valley.

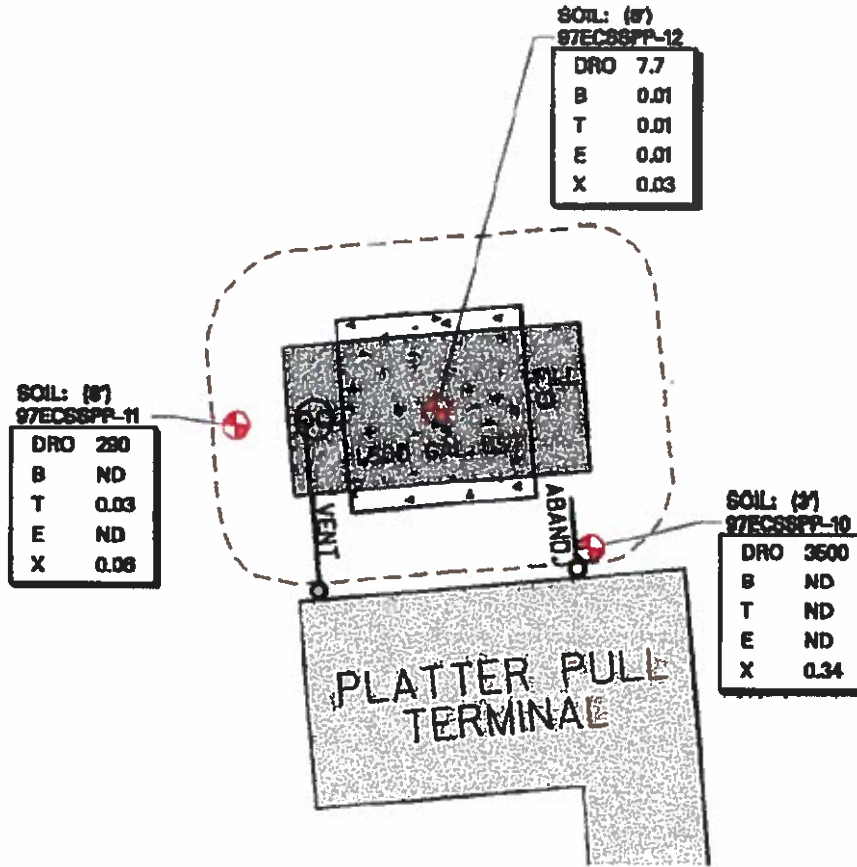
Figure 3. Platter Pull (dark polygon) & confirmation sample locations

The three confirmation soil samples that CDI collected from the excavation were analyzed for DRO and BTEX. The results of the analyses are presented in Table 3, and the corresponding sample locations are shown in Figure 3. Samples 97ECSSPP-11 and 97ECSSPP-12 were collected from soil remaining in the bottom of the excavation and Sample 97ECSSPP-10 was collected from the sidewall under the abandoned supply line. Concentrations of DRO in soil remaining in bedrock depressions at a depth of eight feet BGS are below cleanup levels. A thin lens of stained soil less than one foot thick over bedrock extended toward the lift terminal building under the abandoned piping run.

Although a volume was not estimated, the contaminated soil excavated from beneath the tank and side walls was placed in a temporary on-site stockpile. With DEC approval, Channel transported all contaminated soil to the storage site in Lemon Creek. CBJ installed a pipeline to connect the Platter Pull Lift Terminal generator to the newly installed UST at the Ski Lodge. Based upon visual observations and field screening results, CDI considered the excavation clean and backfilled the pit with clean soil. A de minimis lens of contaminated soil associated with the supply and return piping could not be removed without significant risk of damage to the lift terminal building and remains in situ.

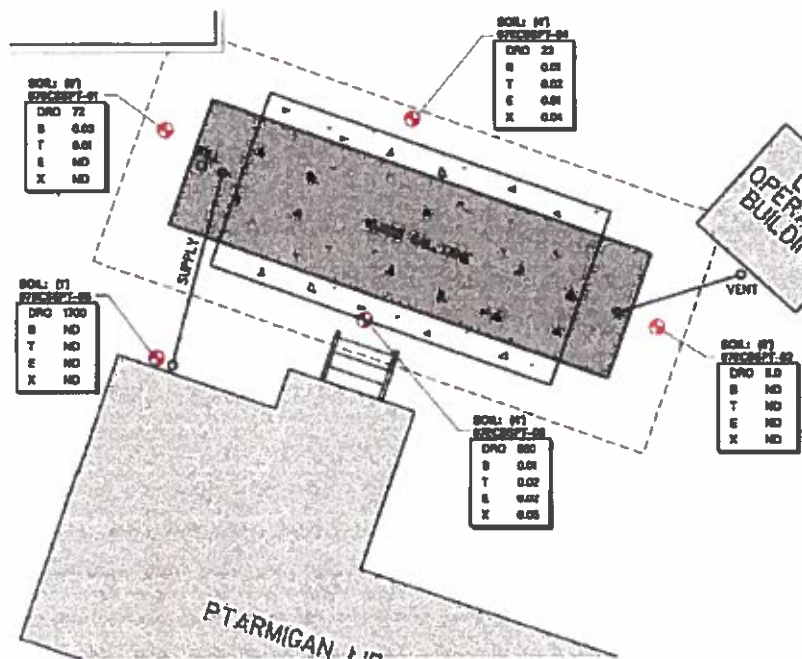
Figure 4. Ptarmigan Lift Terminal UST (dark polygon) & confirmation sample locations

and the sampling locations in Figure 4. DRO concentrations in remaining soil were higher than cleanup levels on the west wall and under the supply and return lines to the terminal building.

With DEC approval, an undetermined volume of contaminated soil removed from beneath the tank and the side walls was transported to the storage site in Lemon Creek. Due to saturated soil conditions, the new 8,000 gallon double wall diesel fuel tank was installed in a separate excavation 20 feet east of the 10,000 gallon UST pit. CDI concluded the source of release is likely fuel transfers and a leaks from pipe joints. For a short period of time petroleum may have leached from a de minimis volume of remaining soil contamination into surface water runoff to Fish Creek, located down gradient from the site.

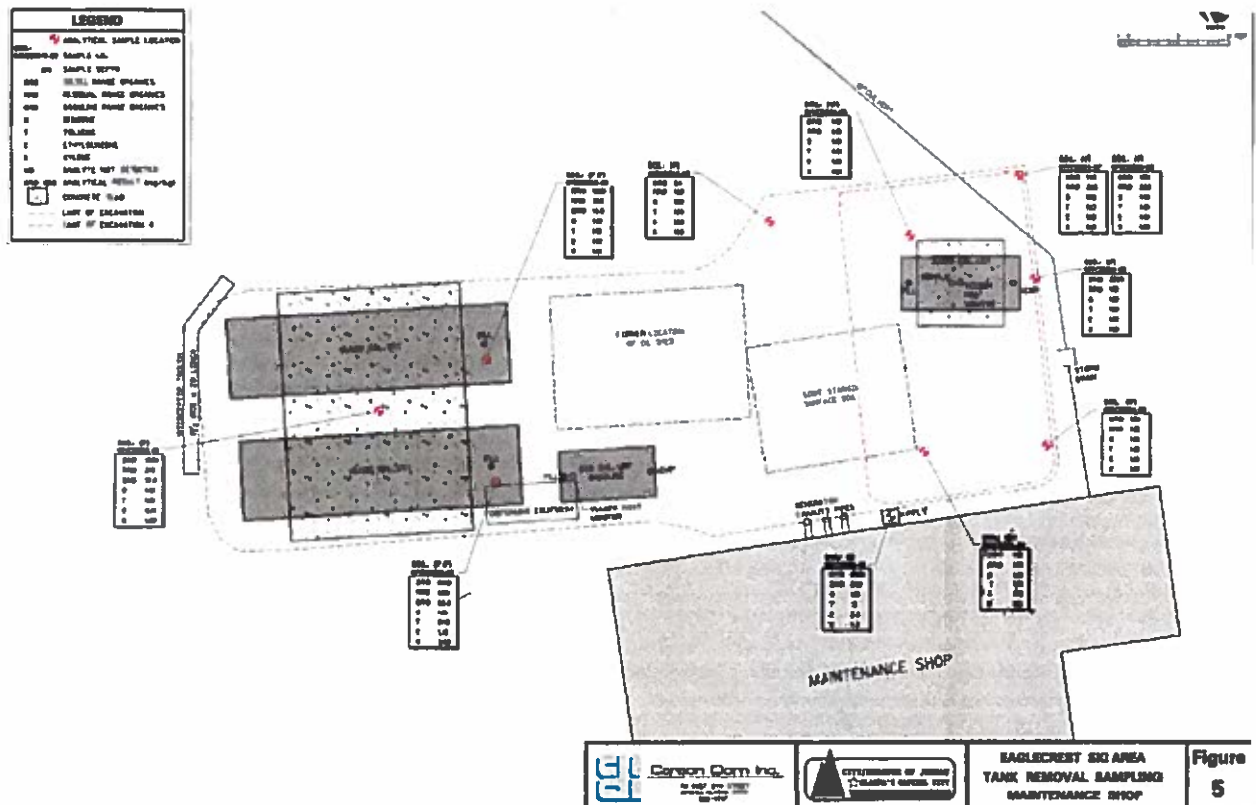
Figure 5. Four Maintenance Building USTs as darkened polygons & confirmation sample locations

During the 1991 Phase 1 Site Assessment, petroleum contamination was identified at shallow depths near a former oil shed on the east side of the Maintenance Building. Analytical soil samples collected from an investigation trench in this area had DRO concentrations of 4,500 mg/kg at a depth of 3.5 feet BGS. As part of the 1997 UST removal and contaminated soil cleanup, these soils were removed and added to the on-site temporary contaminated soil stockpile. In addition, stained soil removed from under generator exhaust pipes were also added to the contaminated soil stockpile. When excavation reached within 2.5 feet of the two 10,000 gallon tanks, CDI observed staining of subsurface soil. When excavation approached the gasoline UST, subsurface soil appeared bright gray in color and had a gasoline odor.

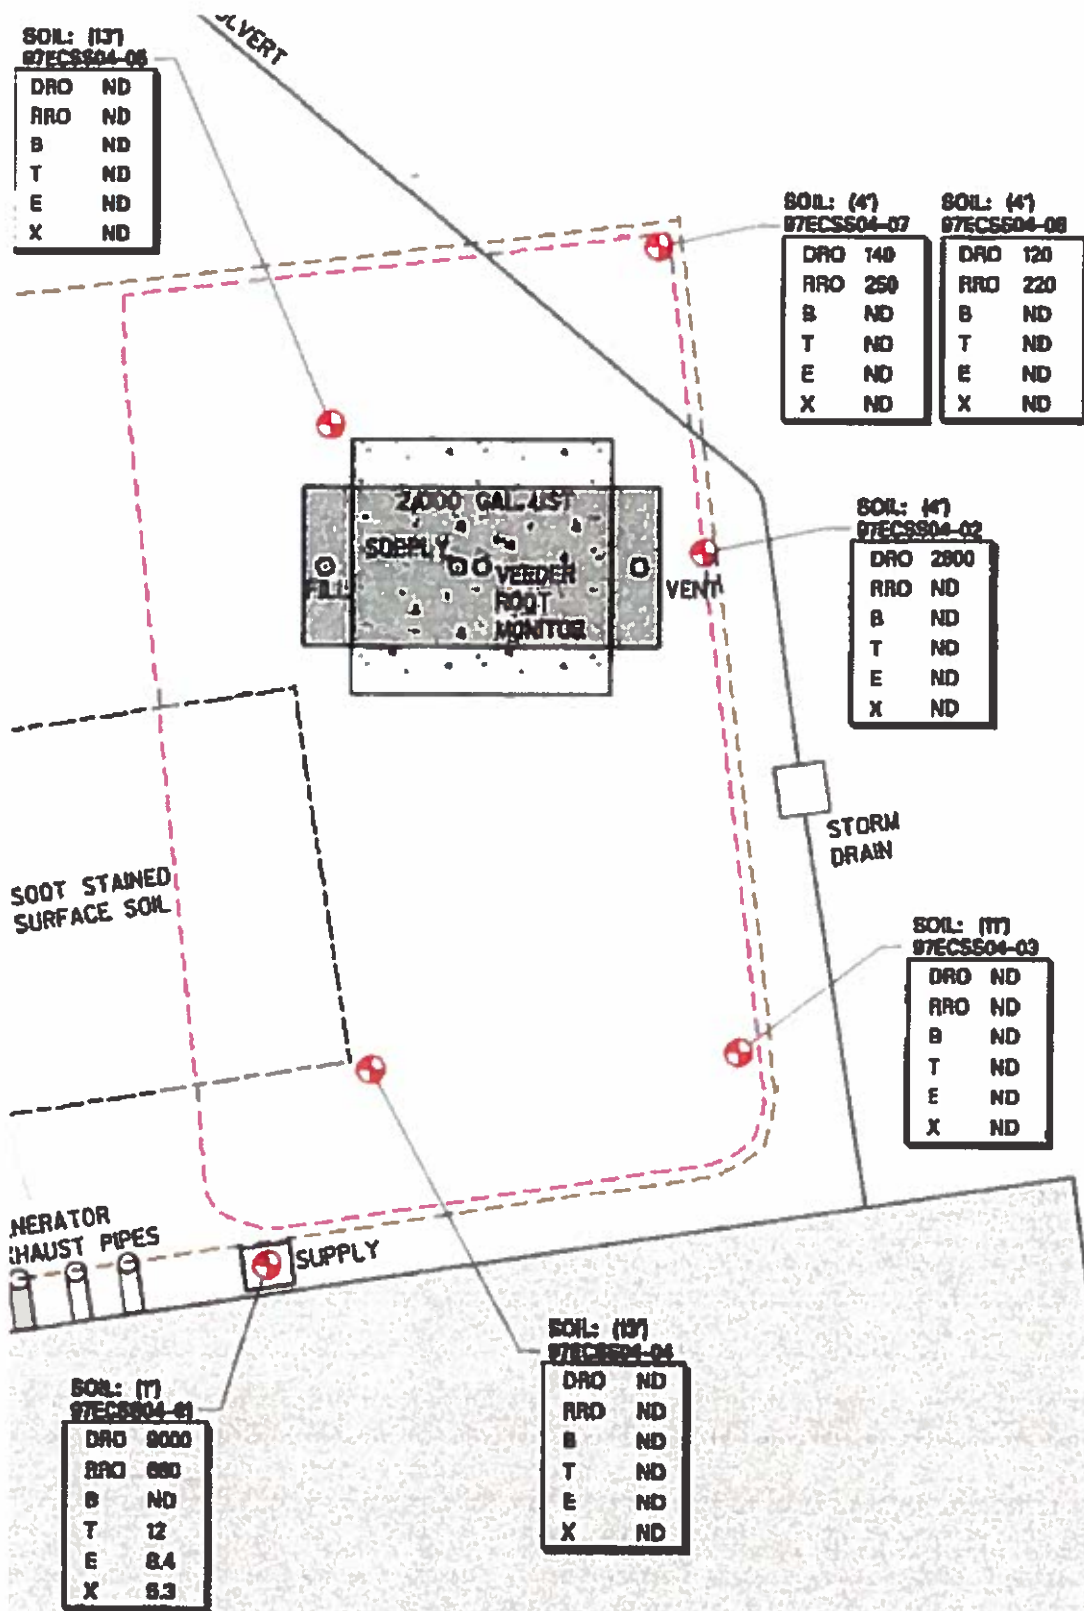
Figure 5a. Maintenance Shop 2,000 gallon UST Removal Site

Removal of the 2,000 gallon diesel tank on October 1, 1997 began with pumping out the diesel fuel, removing the concrete hold-down slab and excavating overburden soil. As the tank was lifted out of the ground, CDI observed sheen on soil below the UST and below the supply and return piping. As groundwater seeped into the excavation, Channel moved quickly to transfer stained soil from the footprint of the tank to a lined on-site stockpile. To extend vertical access to contaminated soil, excavation water was pumped into the 2,000 gallon UST positioned near the excavation. The depth of removal ended when clean soil appeared at a depth of 13 feet BGS in the excavation. As removal expanded laterally to accommodate the installation of two new 12,000 gallon USTs, it came within five feet of the building foundation to the west and a utility line to the south. CDI collected soil confirmation analytical samples at these limits as indicated in Figure 5A.

The samples collected from the eastern and southern limits at four feet BGS had DRO concentrations above cleanup levels of 9,000 mg/kg and 2,800 mg/kg respectively. Concentrations of RRO and all BTEX compounds in analytical samples were below laboratory reporting limits. Analytical results for samples collected from the northeast, northwest, and southwest corners of the excavation floor at four feet BGS indicated that contaminated soil removal reached the lateral limit of contamination. Contamination in remaining soil is located where structures limited access (i.e. building & utilities). COCs were not detected in soil samples taken at depth (13 feet BGS) within the excavation. The analytical results are displayed in Table 5A and the sampling locations in Figure 5a.

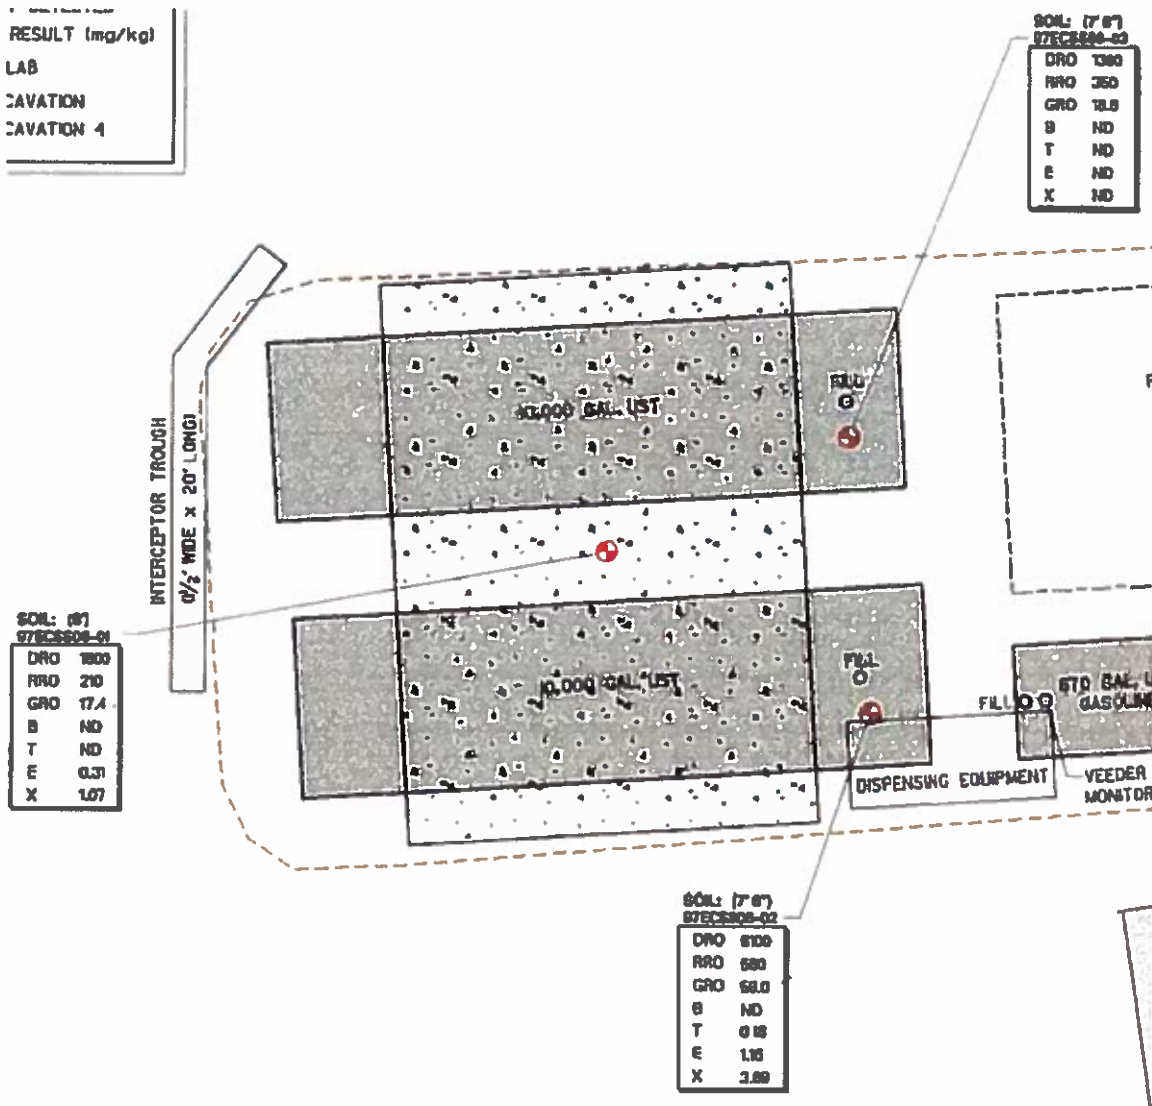
Figure 5b. Maintenance Building USTs

Upon removal the two tanks appeared to be in good condition in spite of contaminated soil surrounding all ports and piping connections. Sheen and brown emulsion visible on the excavation water was removed using absorbent pads. The release is likely the result of poor fueling practices, leaking dispensers, faulty piping or a combination of all three.

CDI collected a confirmation analytical sample from remaining soil at the center of the pit between the twin USTs at a depth of eight feet BGS and one sample from under the fill end of each tank at a depth of seven and one half feet BGS. DRO concentrations in the samples ranged between 1300 and 6100 mg/kg (Table 5B). The lateral extent of a narrow lens of contaminated soil extending beyond the perimeter of the twin USTs pit was not found. Contaminated soil saturated with water was stockpiled and drained in the center of the pit between the UST removal excavations before transport to the stockpile site in Lemon Creek.

In late October 1997, DEC visited the site with CBJ and CDI to discuss remedial options. Concern over possible contamination of Fish Creek prompted DEC to request that CBJ perform a release investigation of groundwater for contamination and ensure that the contaminated soil stockpile be remediated after the close of the 1997-1998 winter ski season. Prior to the closure of the site in preparation for the winter ski season, the excavation behind the Maintenance Building was leveled to grade. Roughly 150 cubic yards of contaminated material was removed from the pit. With DEC approval, an undetermined volume of soil was transported from the site to the contaminated soil stockpile in Lemon Creek for storage.

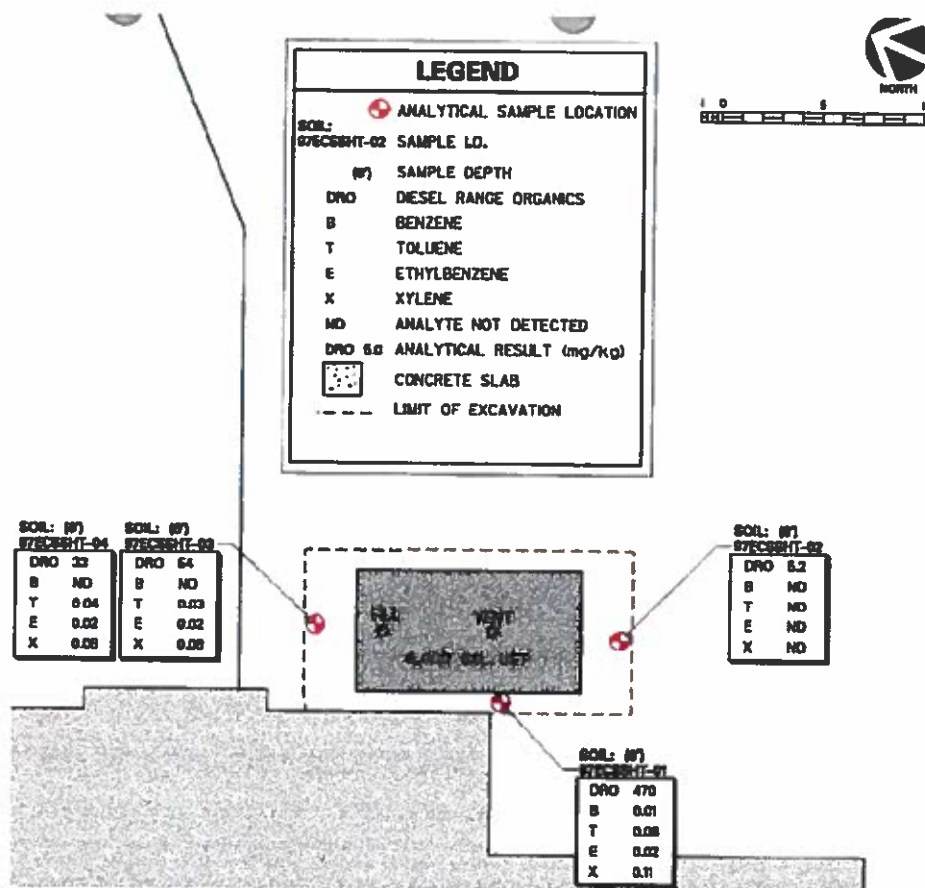
Figure 6. Hooter Terminal

CDI collected three analytical confirmation soil samples (and a field duplicate) from native soils in the side walls of the pit. Results of the DRO and BTEX analyses are presented in Table 5, and the corresponding sample locations are shown in Figure 6. Due to the rapid infiltration of water into the pit, collecting a sample from the bottom of the pit was not feasible. As the results in Table 6 indicate, minimal hydrocarbon contamination was present in most of the excavation; although elevated levels of DRO (470 mg/kg) were encountered in the center of the western side wall of the excavation.

A pipeline was installed to connect the Hooter Lift Terminal generator to the newly installed tank at the Ski Lodge. Based upon visual observations and field screening results, the excavation was considered clean and was backfilled.
