Department of Environmental Conservation

DIVISION OF SPILL PREVENTION AND RESPONSE Contaminated Sites Program

Re: Decision Document: Residence - 6295 Steese Highway HHOT

Cleanup Complete Determination

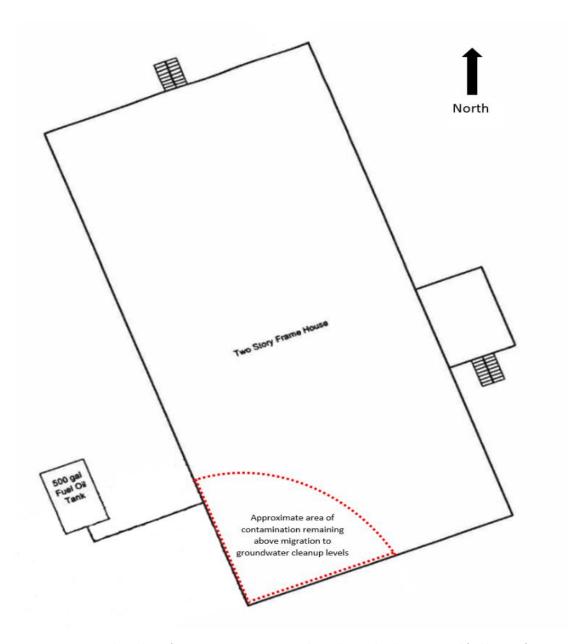
Soil and groundwater contamination at the site have been cleaned up to concentrations below the approved cleanup levels suitable for residential land use, with the exception of some soil contamination remaining under the foundation of the house at the southwest corner. It has been determined that the remaining impacted soil does not present an unacceptable risk to human health or the environment. Analytical groundwater samples collected in 2008, 2010, and 2019 have demonstrated that groundwater has not been impacted above cleanup levels.

Figure 2: Approximate boundary of contamination remaining above cleanup levels. Figure modified by DEC from original image in Excavation, Stockpiling, and Remediation of DRO Contaminated Soils at 6295 Steese Highway Chatanika, Alaska (2006).
