May 15, 2017

Subject: Little Port Walter – Fuel Line Snag Report

ATTACHMENT 1
PHOTOGRAPHIC LOG

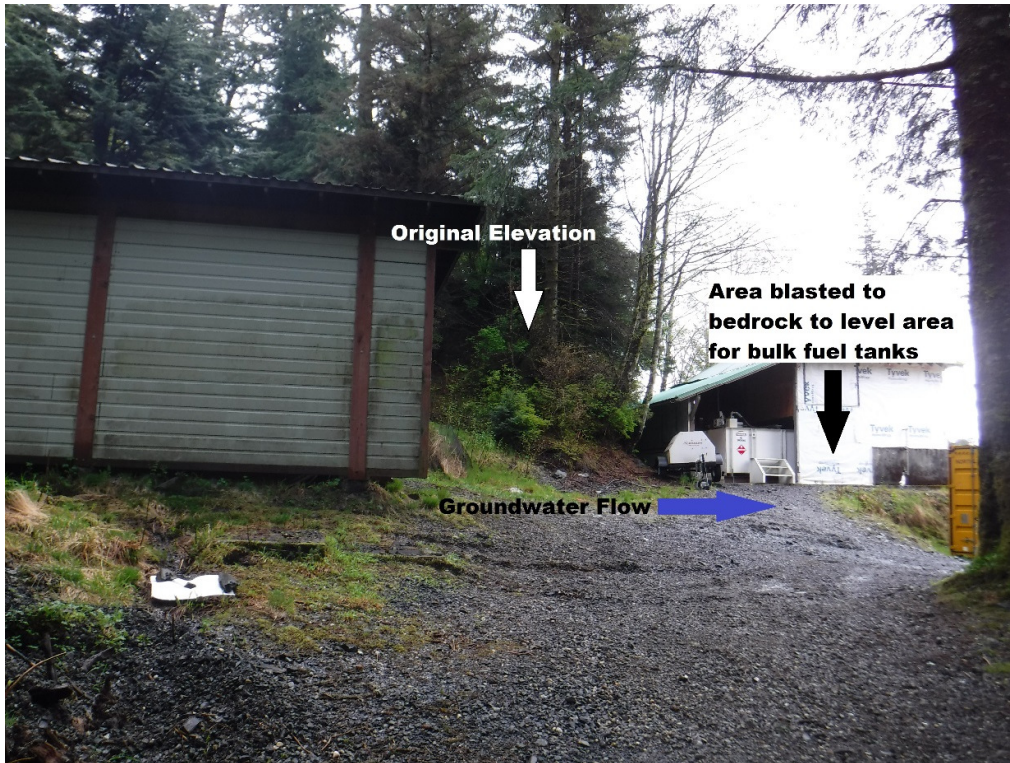
The weather conditions on Sunday, May 7, 2017 were overcast with a continual moderate to heavy rainfall throughout the day. In support of the construction of the generator shed, the hill in the immediate vicinity was excavated after blasting to bedrock and the gravel used to level the area for the generator shed and bulk fuel tank storage area (Attachment 1, Figure 1). There is no soil between the bedrock and the gravel layer. Groundwater flows just below the gravel, 12-24-inches, along the surface of the bedrock from uphill (north) to downhill (south).

Figure 1. Workshop and generator shed area: Blasted bedrock to build structures.

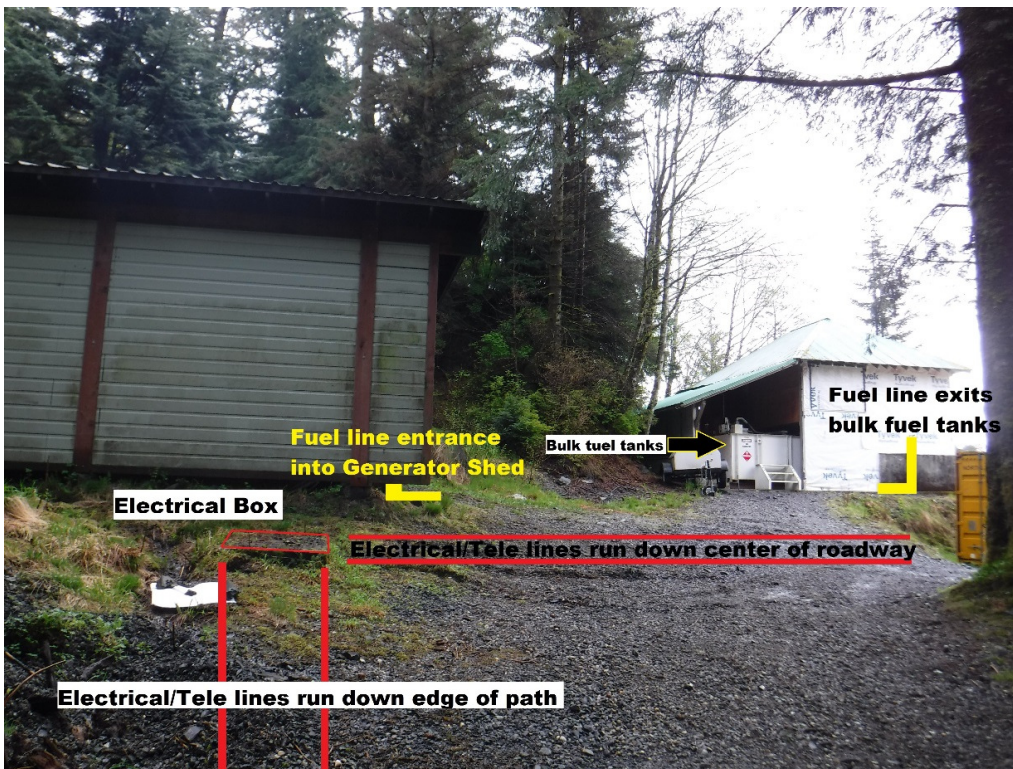
Figures provided by NOAA were reviewed for potential locations of soil contamination and to support utility locate information (Attachment 2). After arriving onsite via charter plane, Ahtna walked the entire site with NOAA field/maintenance staff locating all known utilities. The approximate locations of electrical, telecommunication, and fuel lines were noted by Ahtna before any field work commenced. The majority of utility lines are running within or alongside the gravel trails/paths throughout the site. The electrical panels were located within each structure and fuel line entrance/exist points were also noted (Attachment 1, Figure 2).

Figure 2. Workshop and generator shed area: Utility locations.

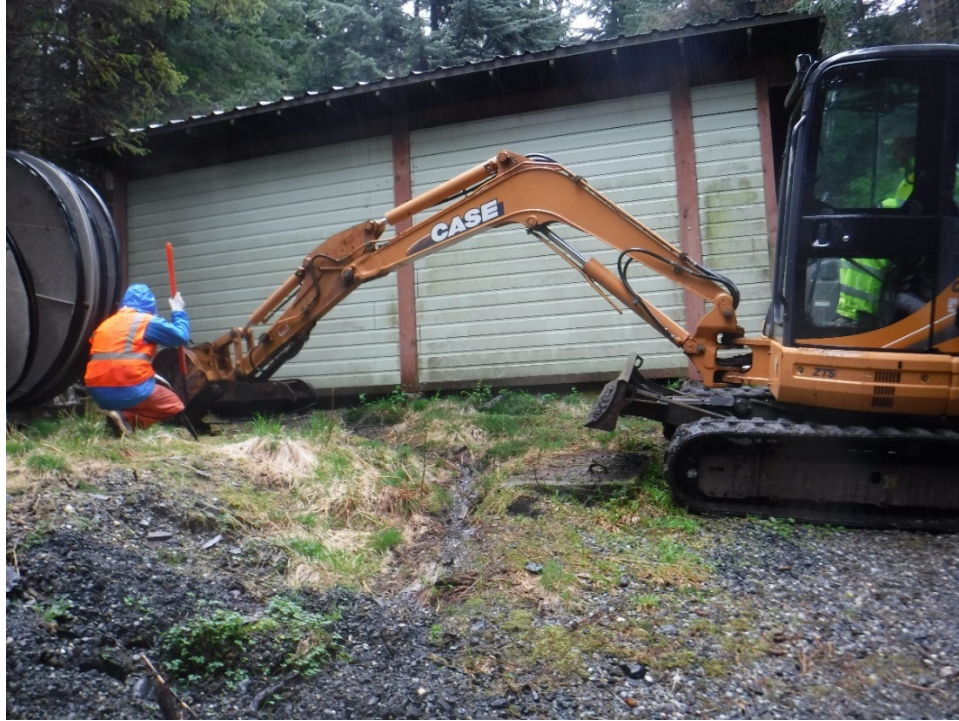
Figure 3. Workshop and generator shed area: Ahtna operator and spotter.

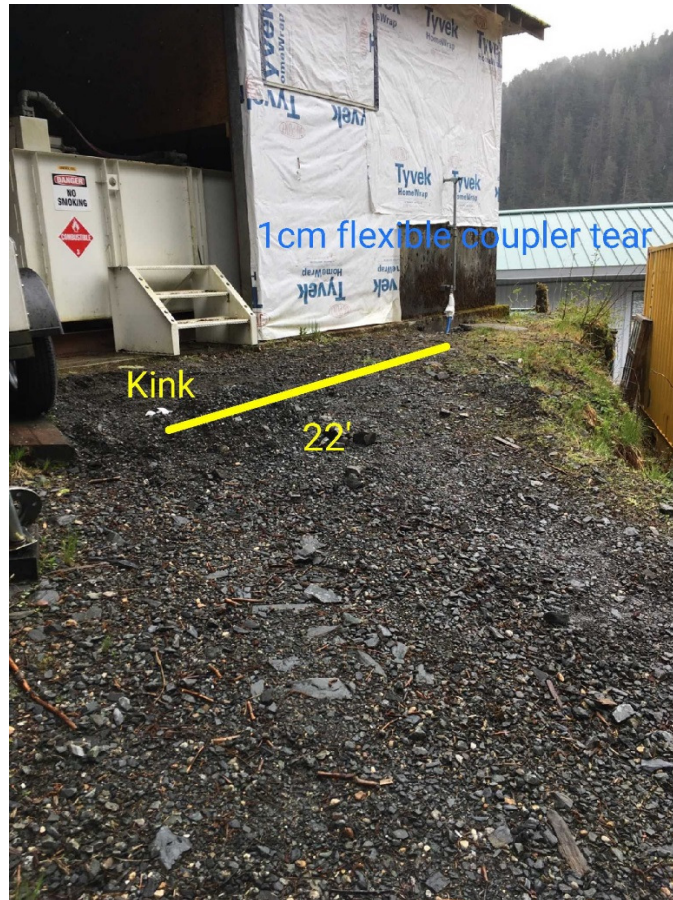
While excavating at the edge of the gravel roadway near the bulk fuel tanks, the tooth of the excavator caught the 1-inch interior diameter double walled diesel fuel line running to the generator shed. This took place approximately 22-feet north of the fuel tank outlets (Attachment 1, Figure 4). The spotter was able to signal the operator to stop prior to fully severing the line. The spotter inspected the kinked fuel line and determined it did not breach. The operator immediately followed the fuel line to the bulk fuel tanks and noticed a small leak (1-cm) in the flex fitting attaching the fuel line to the structure. The spotter was unable to see the leak because they were on the opposite side of the excavator bucket. The operator used his glove to reduce the flow of the leak. The kink of the fuel line occurred at 40-48-inches from the concrete pad (bulk fuel tank area). The fuel line was believed to run in the more direct path to the far NE corner of the generator shed.

Figure 4. Workshop and generator shed area: Location of kink and leak.

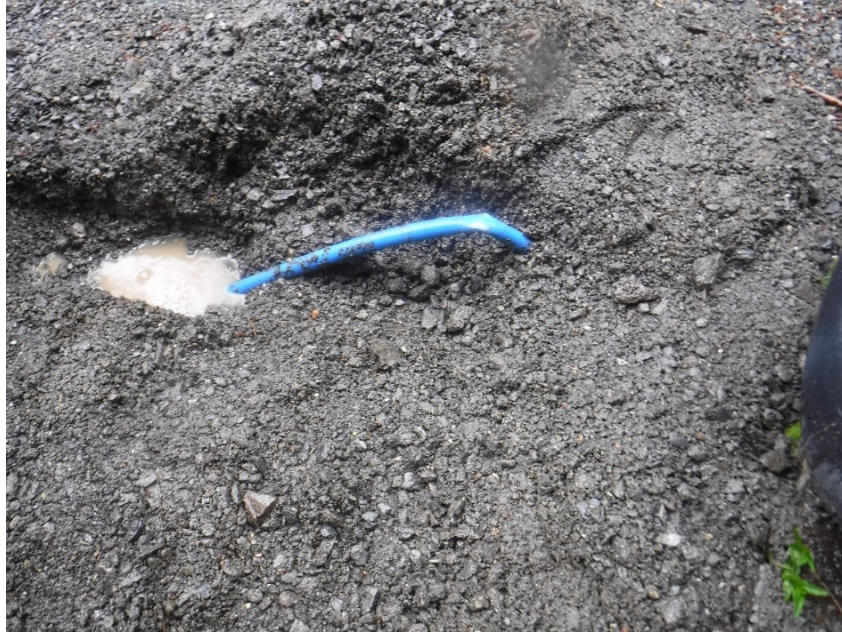
Figure 5. Workshop and generator shed area: Kinked fuel line.

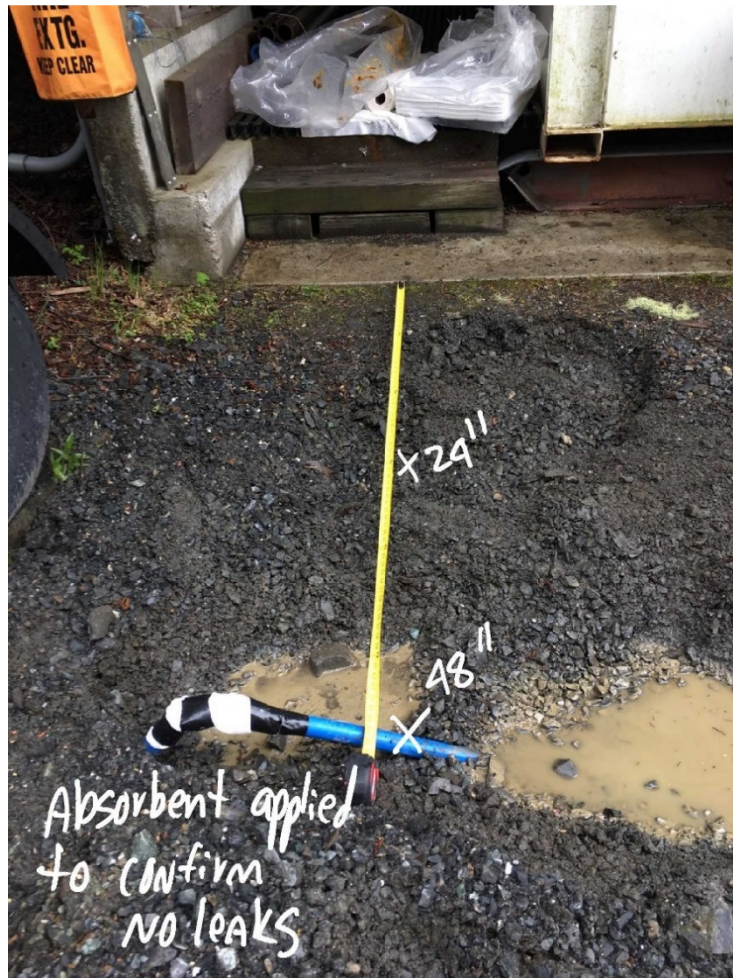
Figure 6. Workshop and generator shed area: Location of kinked fuel line.

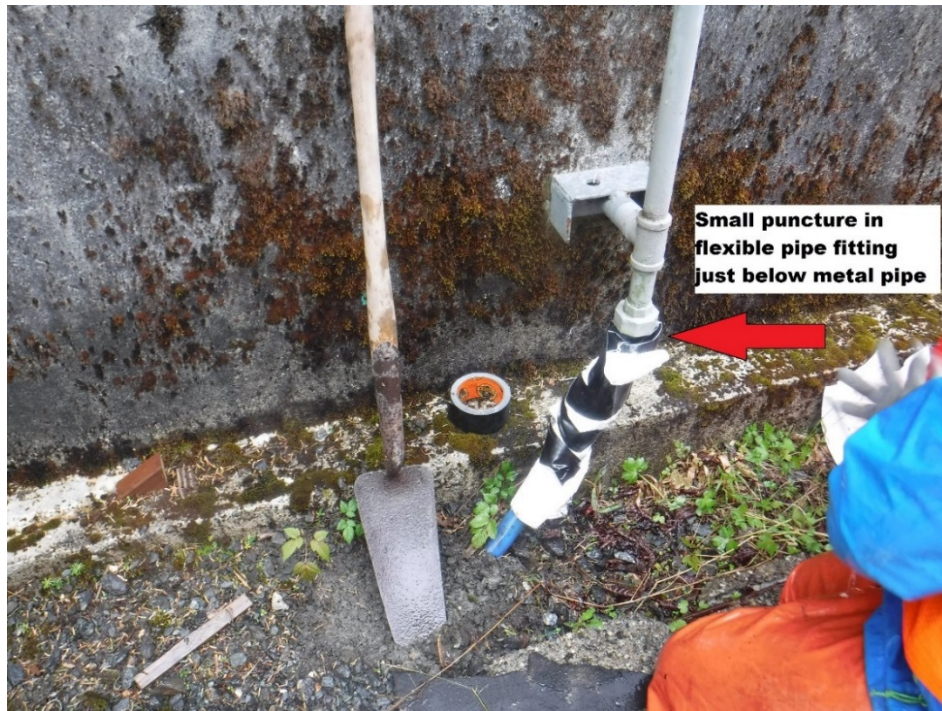
Figure 7. Workshop and generator shed area: Location of leak.

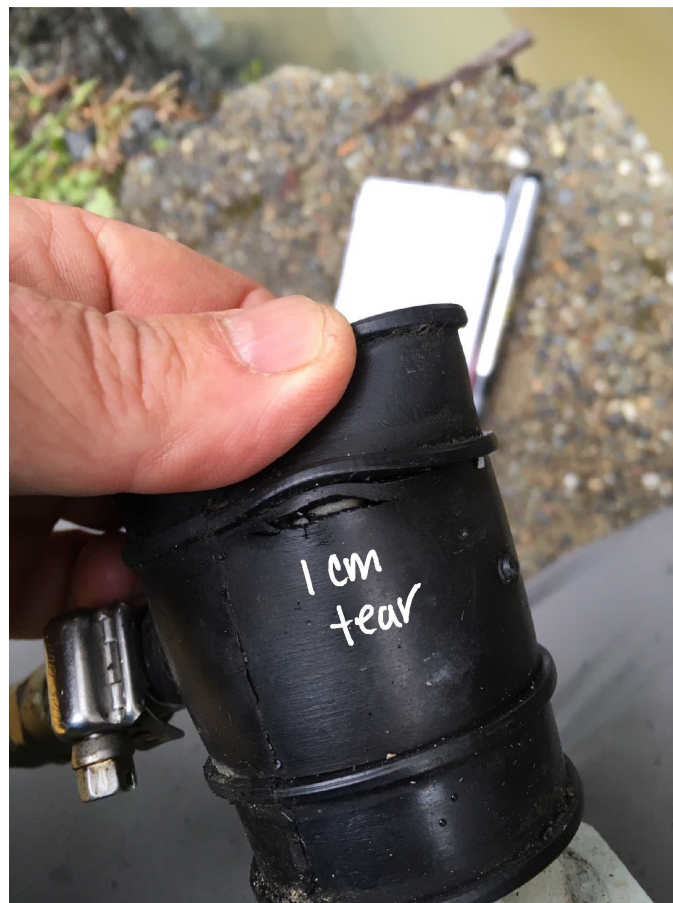
Figure 8. Workshop and generator shed area: Flex fitting leak.

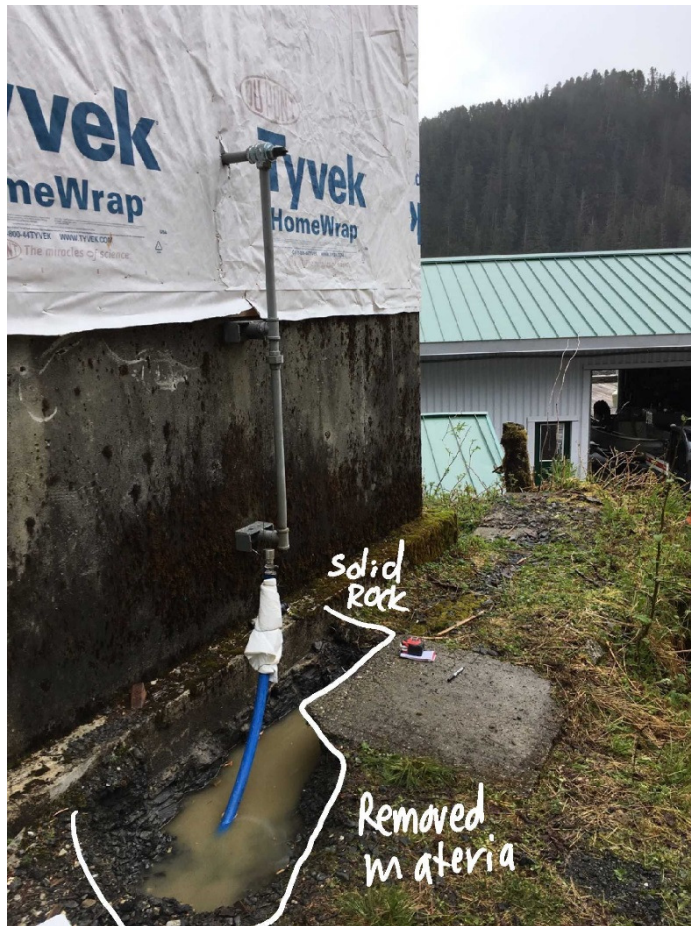
After the release of additional fuel loss was eliminated, Ahtna used an empty wheelbarrow, two 5 gallon buckets, and shovels of varying blade widths to excavate the material and groundwater directly below the small leak. The material (gravel) was excavated straight down to bedrock, north (direction of groundwater flow) to bedrock, and south (direction towards generator shed, upstream) 2-feet. All excavated material was collected in the buckets and then placed in a wheel barrow. This excavated material was subsequently mixed/aired out to help release any volatiles.

Figure 9. Workshop and generator shed area: Removed material.

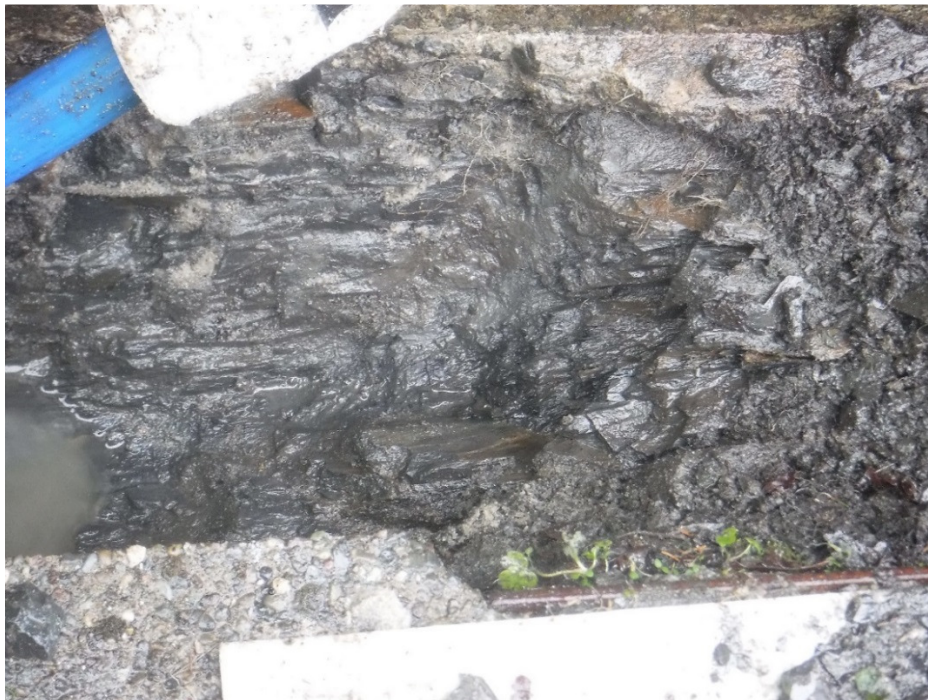
Figure 10. Workshop and generator shed area: Removed material to bedrock.

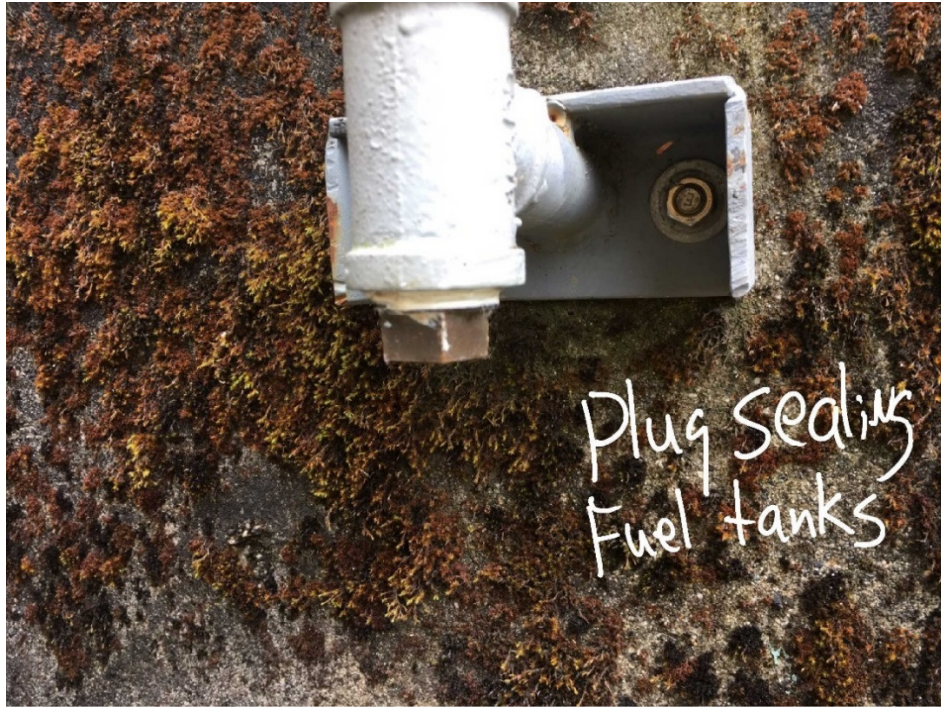
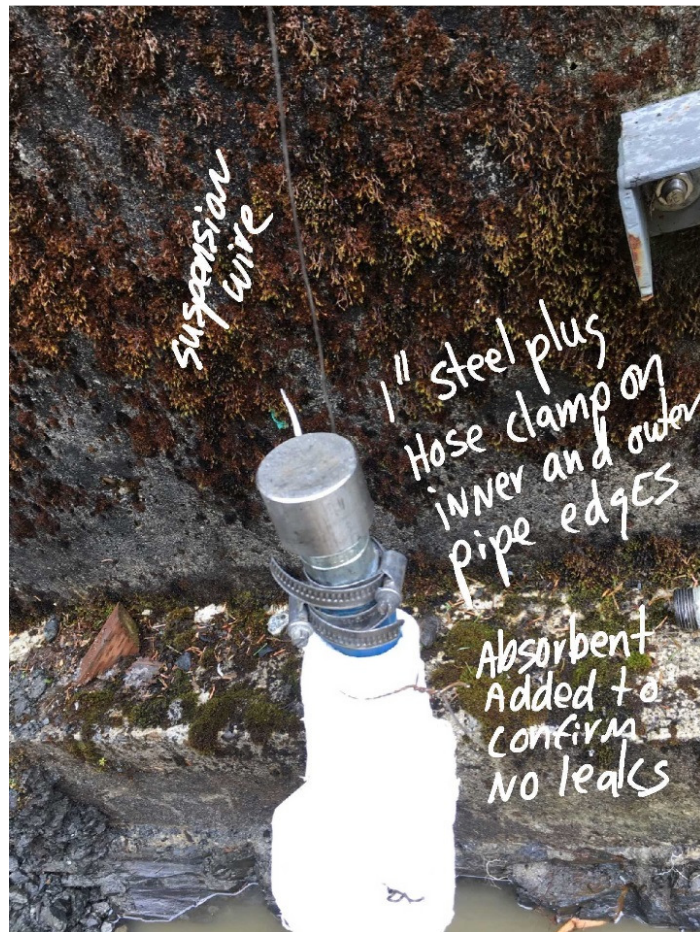
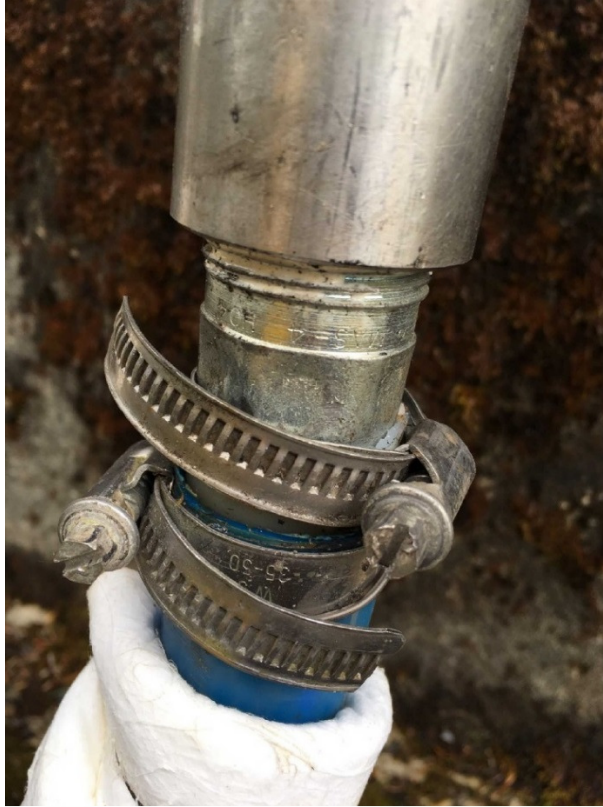
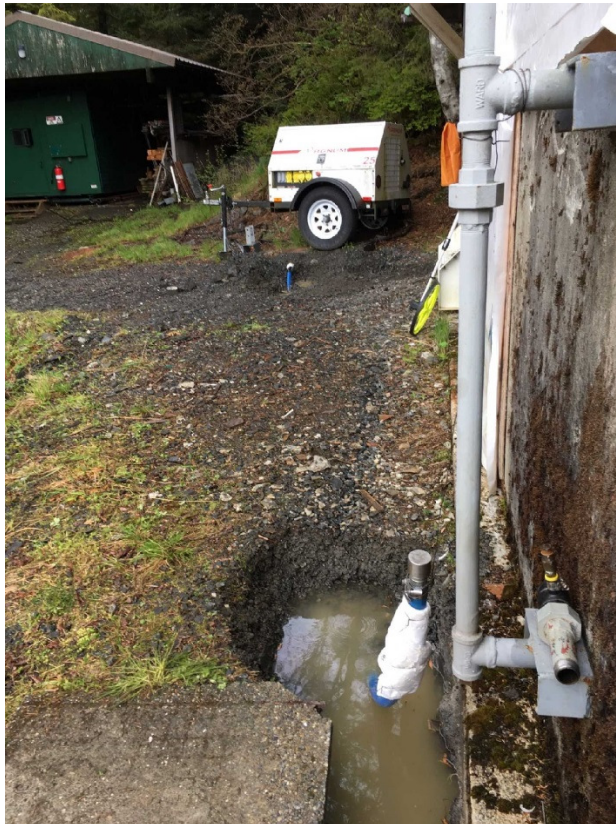
Figure 9. Workshop and generator shed area: Ahtna repairs.

Figure 10. Workshop and generator shed area: Ahtna repairs.

Figure 11. Workshop and generator shed area: Ahtna repairs.

Figure 12. Workshop and generator shed area: Ahtna repairs to both locations.

The following day (Monday, May 8, 2017), the excavated material stored in the wheelbarrow was moved into a sealed fish box and secured with plastic. Both areas of the fuel line (kink and dripping flexible coupler) were re-inspected. The flexible coupler was removed and fuel was noticed inside the pipe within two inches of its top. This pipe was disconnected and drained an additional 3-feet back into the line with a rubber transfer hose, a snug metal plug was double hose clamped to the open end, and the entire array was suspended several feet higher than its previous location. A cap was also installed on the fuel take side. No diesel was observed in either of these procedures. The as-left conditions/repairs were shown to NOAA onsite maintenance staff (Attachment 1, Figures 9-12).

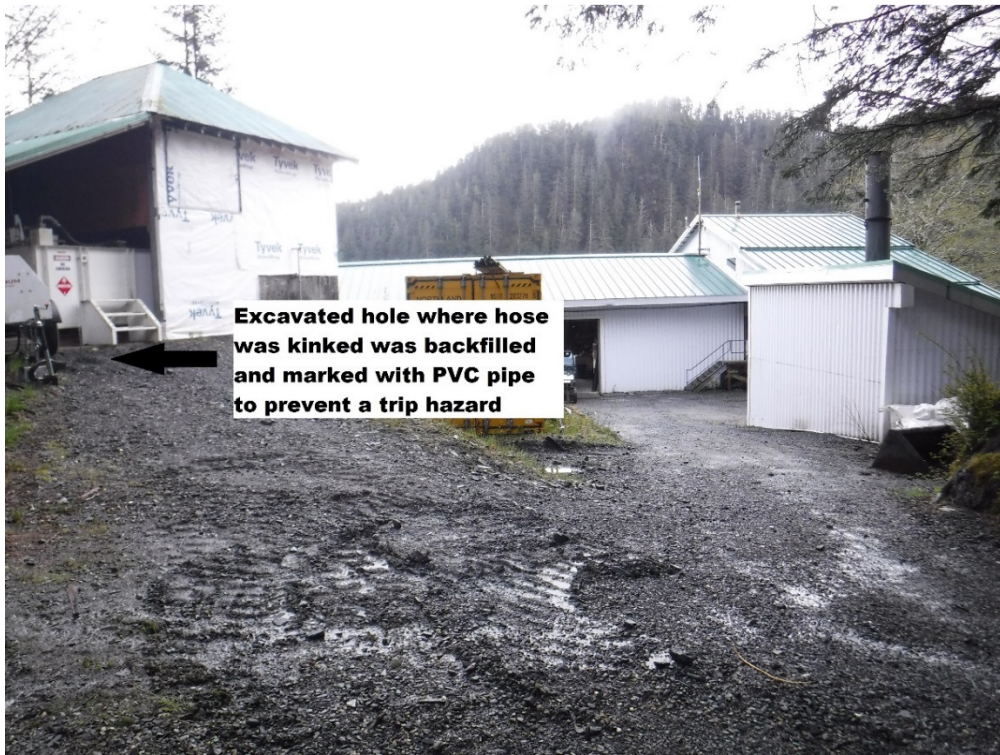
Figure 13. Workshop and generator shed area: Backfilled areas.

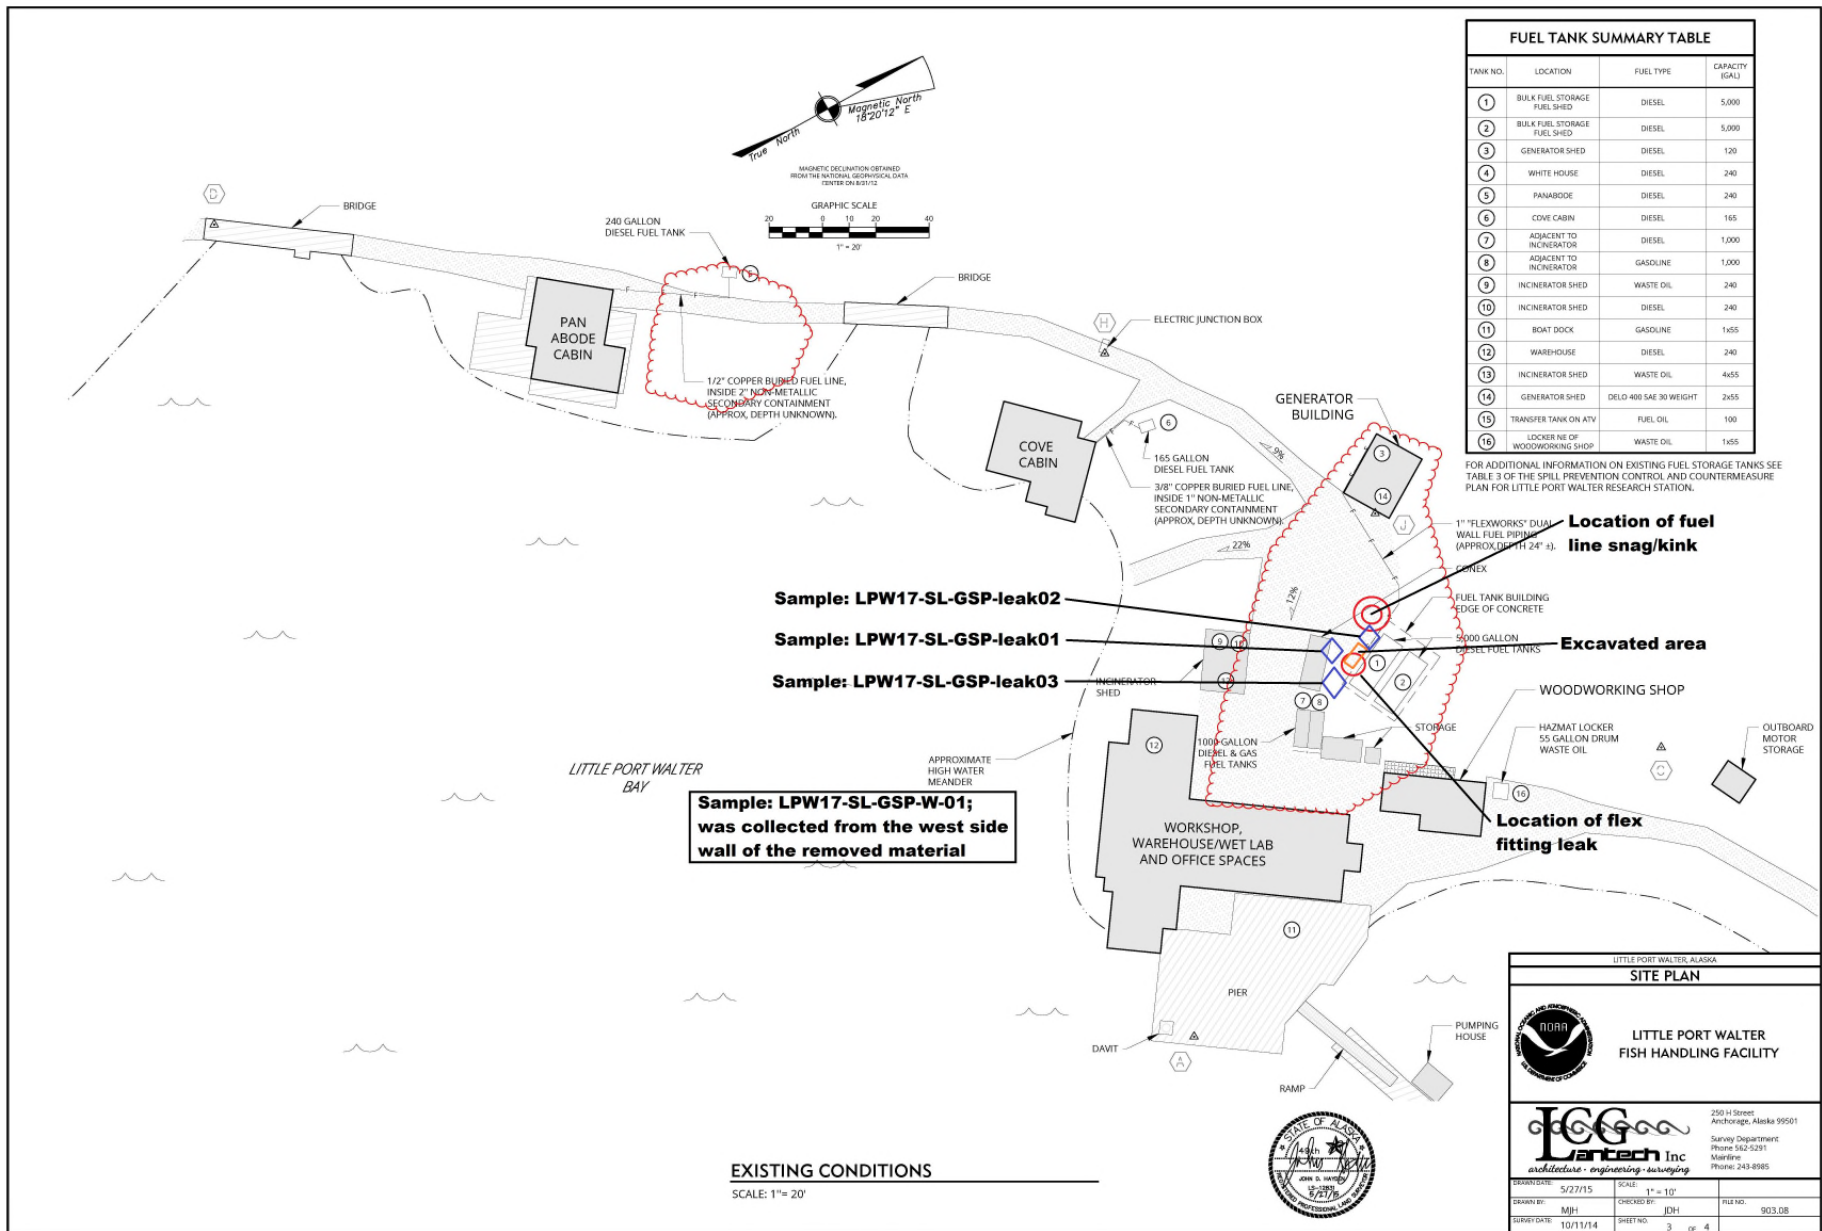
- LPW17-SL-GSP-leak01 was collected 2-feet west of the excavated material;
- LPW17-SL-GSP-leak02 was collected 3-feet north (upstream) of the excavated material; and
- LPW17-SL-GSP-leak03 was collected 2 feet south (downstream) of the excavated material.

Sample: LPW17-SL-GSP-W-01;
was collected from the west side
wall of the removed material
