Alaska Department of Environmental Conservation

Brownfield Assessment

Lot 1, Block 1
Prospect Creek Airport
Environmental Management Plan
Dalton Highway Milepost 137, Alaska

By:
OASIS Environmental, Inc
March 25, 2010

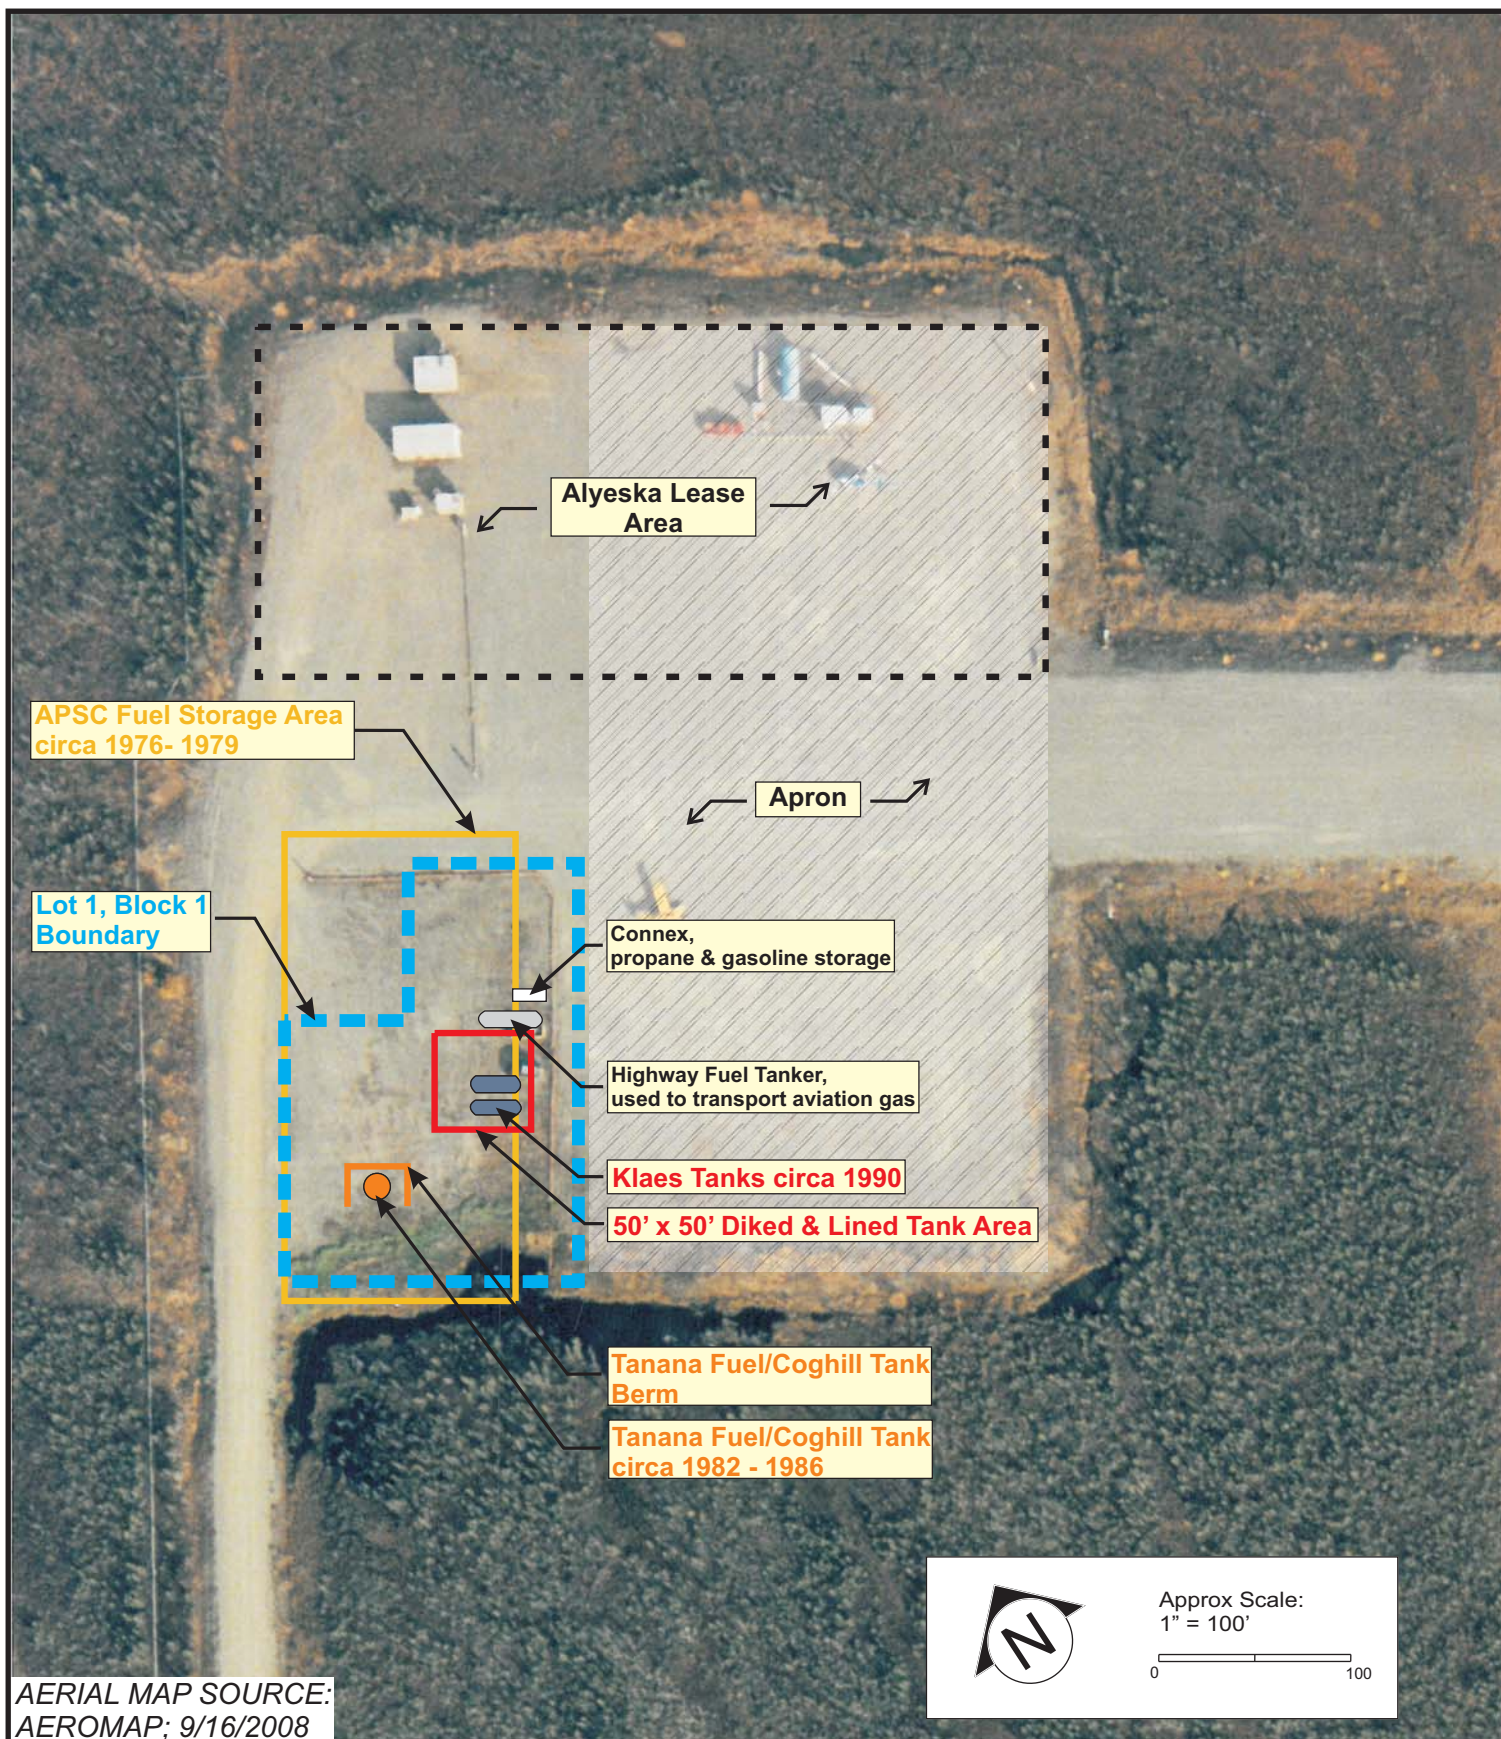
Figure 3: Lot 1, Block 1

- **Volume of subsurface contaminated soil:** The depth, extent, and volume of contaminated soil under the old liner are not known. Estimating from a photograph dated July 1996¹⁶ (See Photograph 2) and Figure 3, the square liner was approximately 500 square feet.
- **Presence of petroleum hydrocarbons in surrounding environment:** The 1999 Phase I/II ESA¹ states that all of the surface waters around the apron have a visible sheen present. However, the cause of this sheen is not known. Anecdotal evidence suggests that the runway, ramps, and apron were regularly sprayed with oil to reduce dust. Runoff from the oiled runway and ramp may have caused sheen in the surrounding surface water.

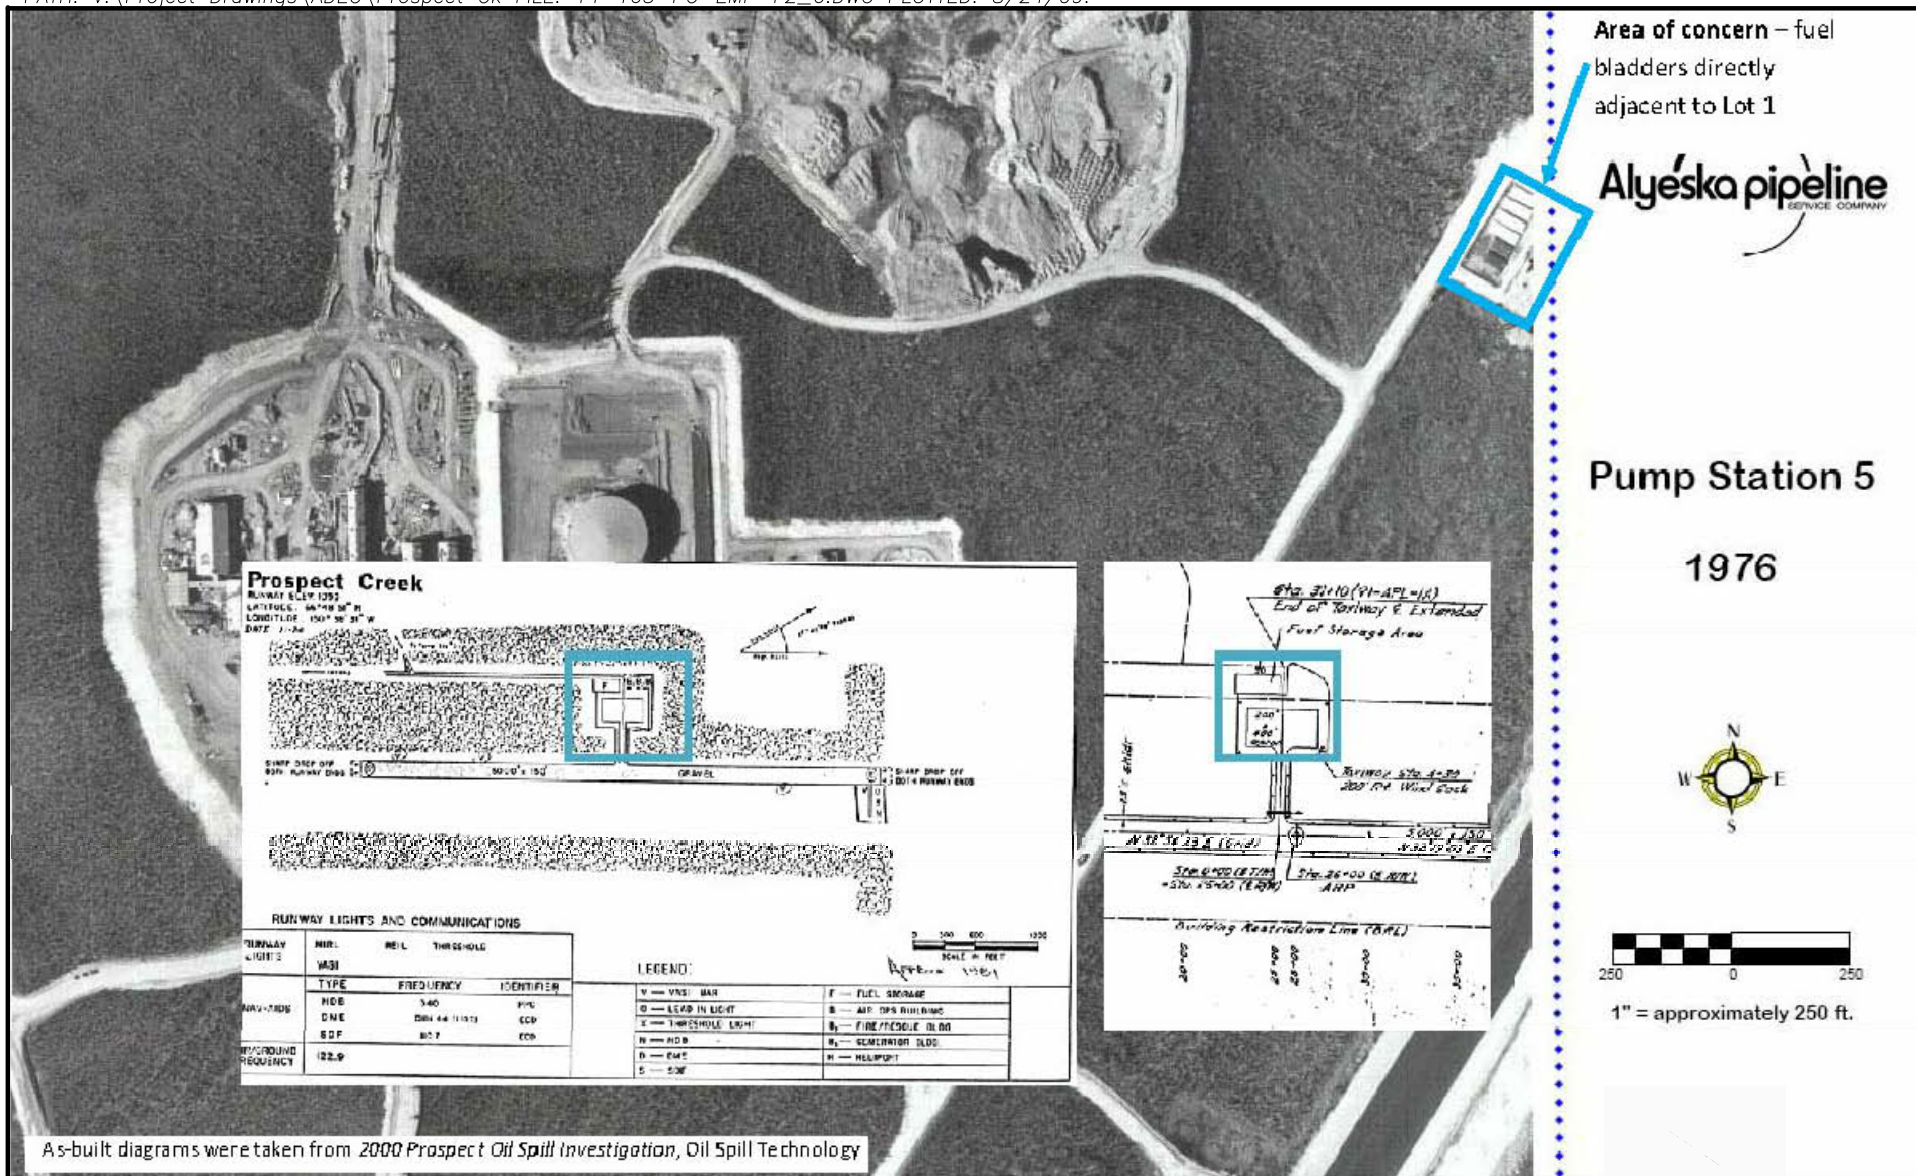
1976 APSC FUEL STORAGE

The 1976 aerial photograph⁵ (Figure 4) indicates that APSC had a large fuel bladder adjacent to and possibly partly on Lot 1. Available records regarding the APSC 1,600- gasoline spill indicate that the release was within containment and picked up by a vacuum truck. However, it is possible gasoline was released through tears in the liner, and no confirmation samples exist to corroborate that soil was not contaminated.

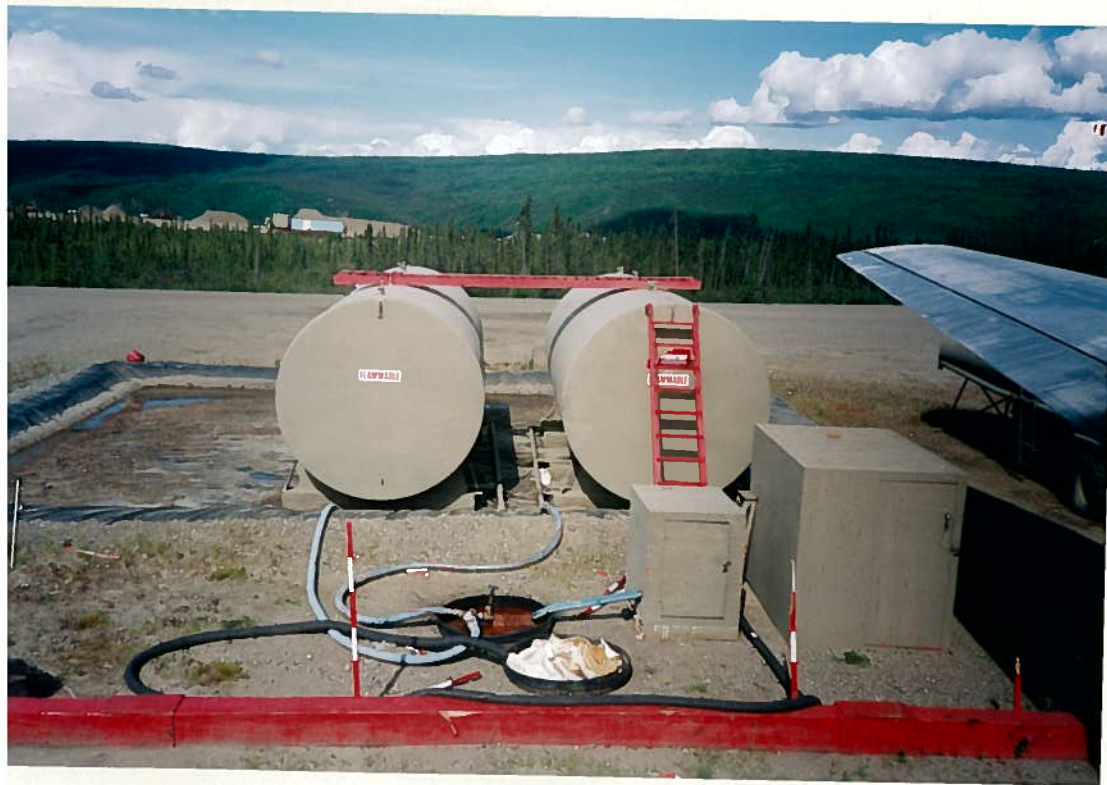
Photograph 2

Attached is a photograph of the Fuel Pit at Prospect Lot 1 Block 1 on July 1996.

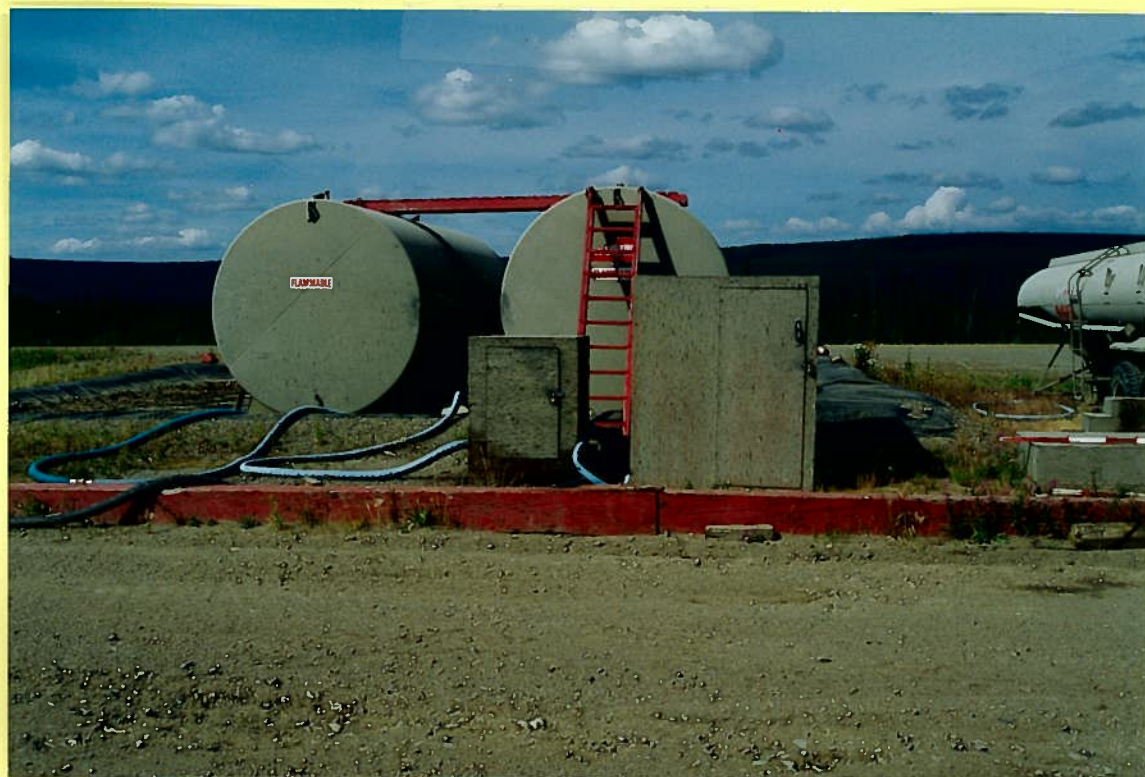
Hoses (2)
on ramp.
open containers

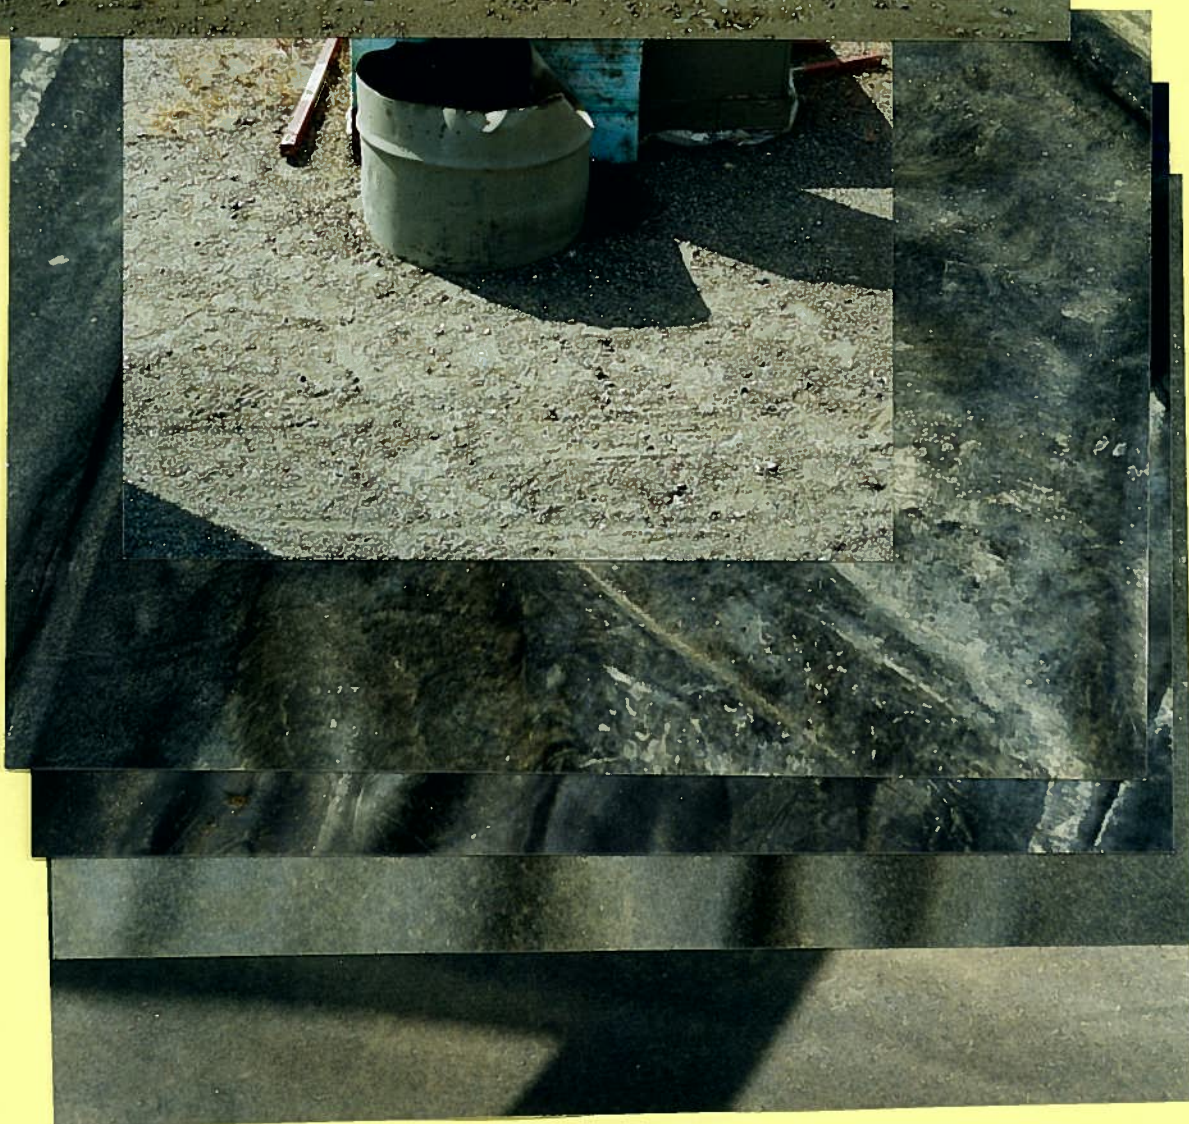
Various
Tears in
liner

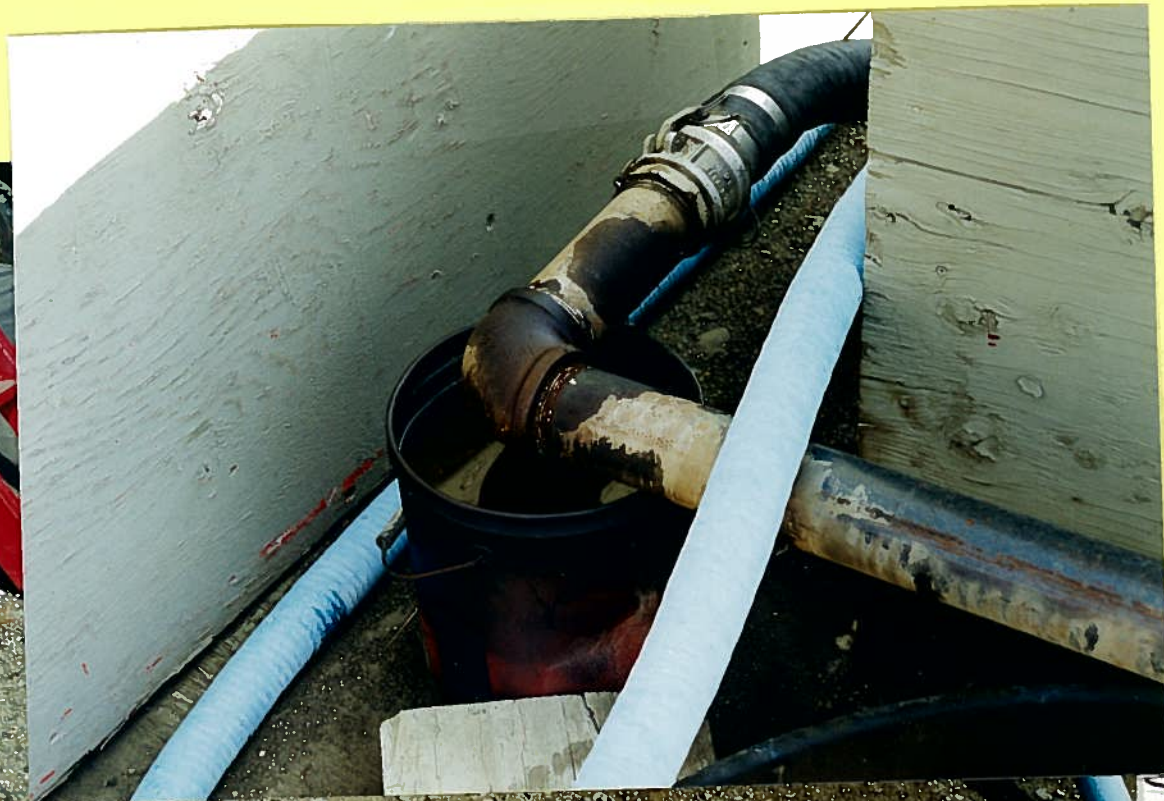
open
container
almost full!

Leaks -
open containers
possible
spray(?) of
pump house.

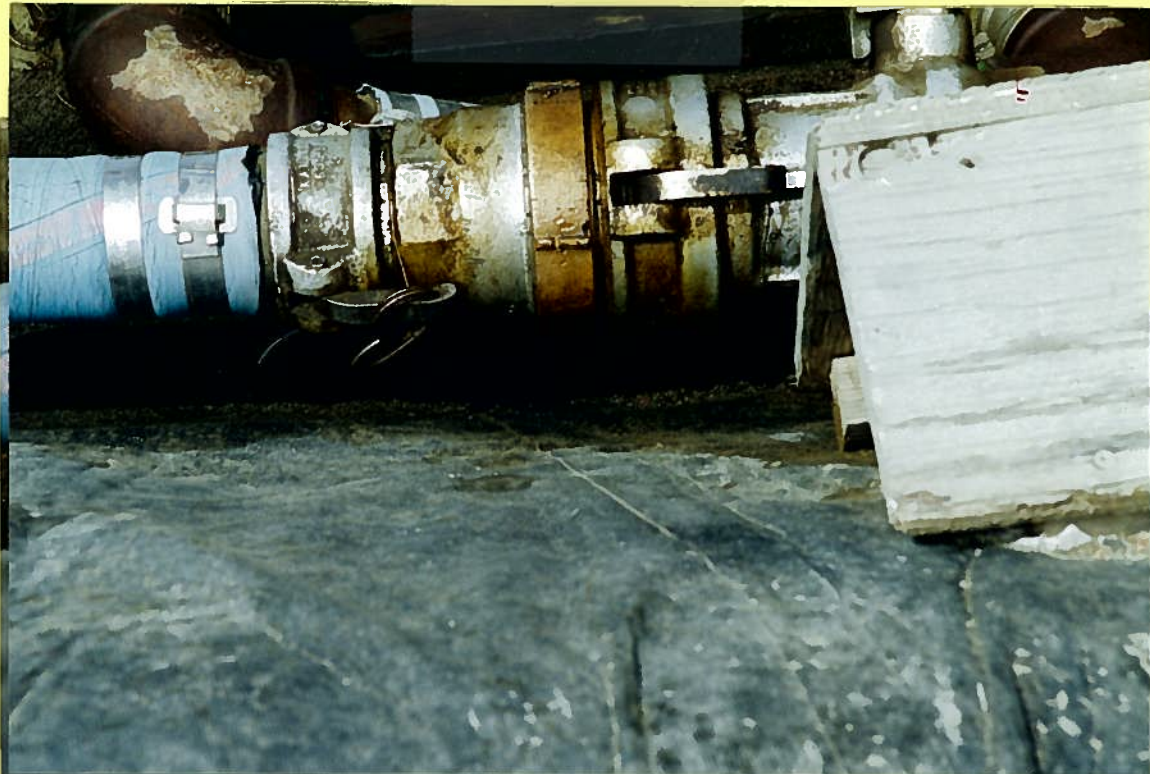
Several pictures
"to catch an
active leak"

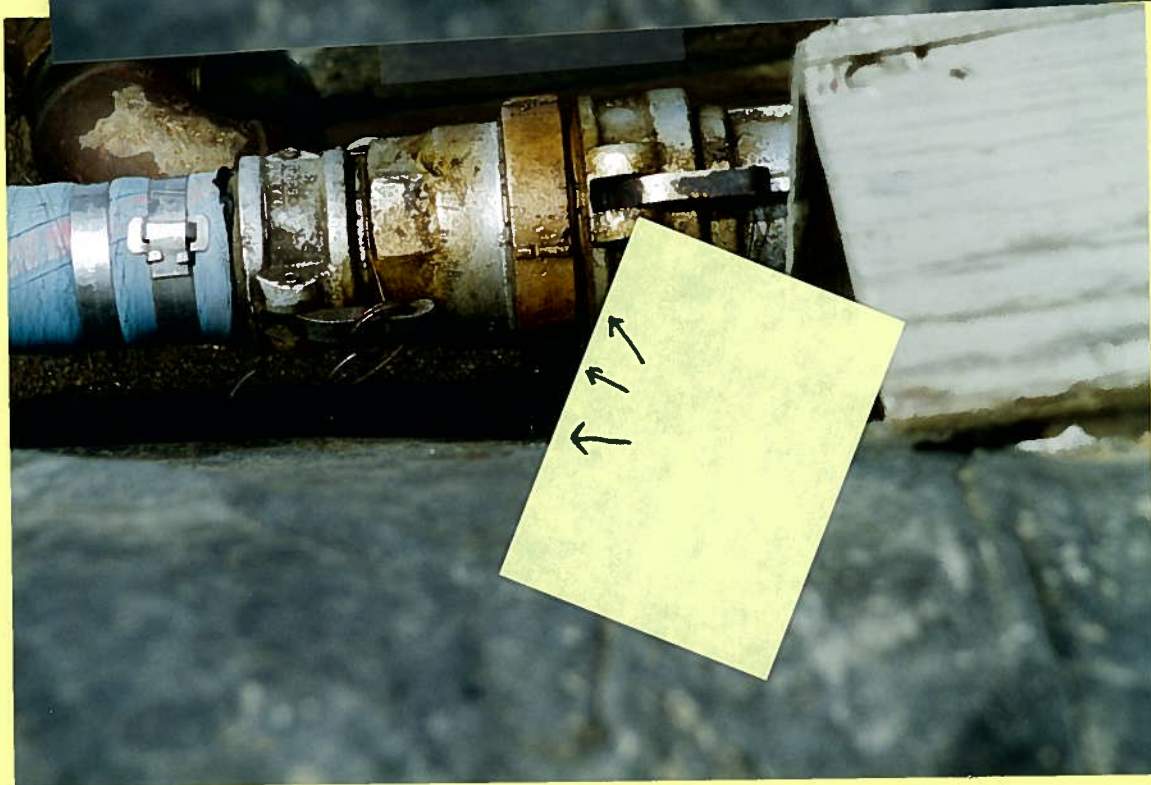
Success
