REF: Demolition of CHPP (Project No. 8046), JBER-R, Alaska

SUBJ: Notice of Completion of all Demolition Activities and Summary of Soil Contamination Encountered during the Project and Foundation Left in In-Place

SITE OVERVIEW
SOIL REMOVAL LOCATIONS

JBER Richardson P8046 CHPP Demo Below Grade Concrete Structures Remaining in Place

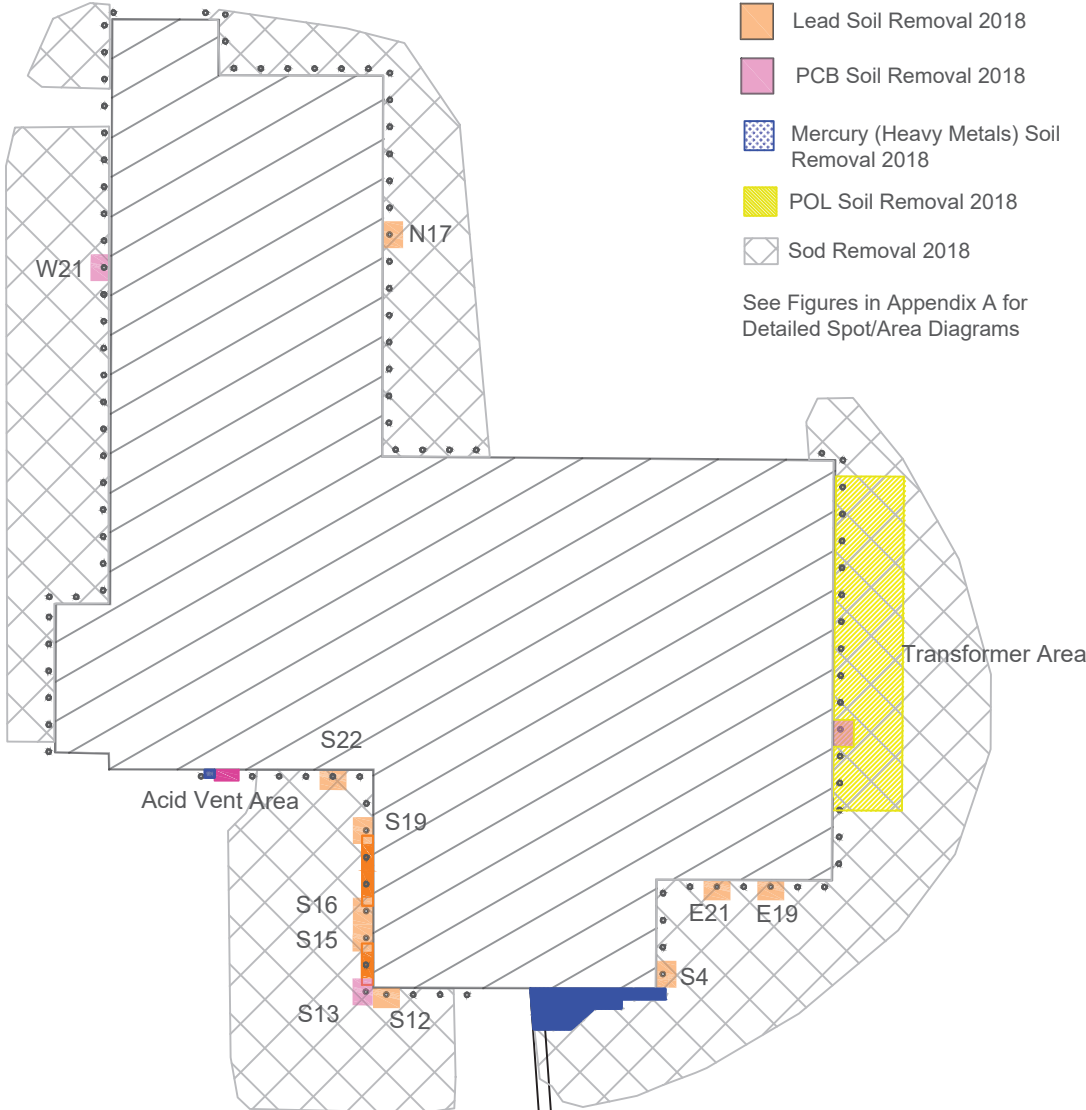
FIGURE
1

- 1) Old Transformer Area: While a total of 1,431 tons of POL polluted soils were removed from the Old Transformer Area, the confirmation sampling of the sidewall at the south end of the excavation showed polluted soils remaining above the clean-up level in this area. Confirmation sampling on the north end of the excavation showed no evidence of contamination above project action levels at this location. However, the south end polluted

soils at this location is connected to the large area of contamination left under the former CHPP basement floor.

3) Fuel Pump House: One super sack of POL contaminated soil was removed from a spot (AOC04-02) by the Fuel Pump House. This was a spot previously identified in the 2012 PA/SI as having benzene above the project action level. However, after the removal some POL contaminated soil still remains in the area outside the project limits.

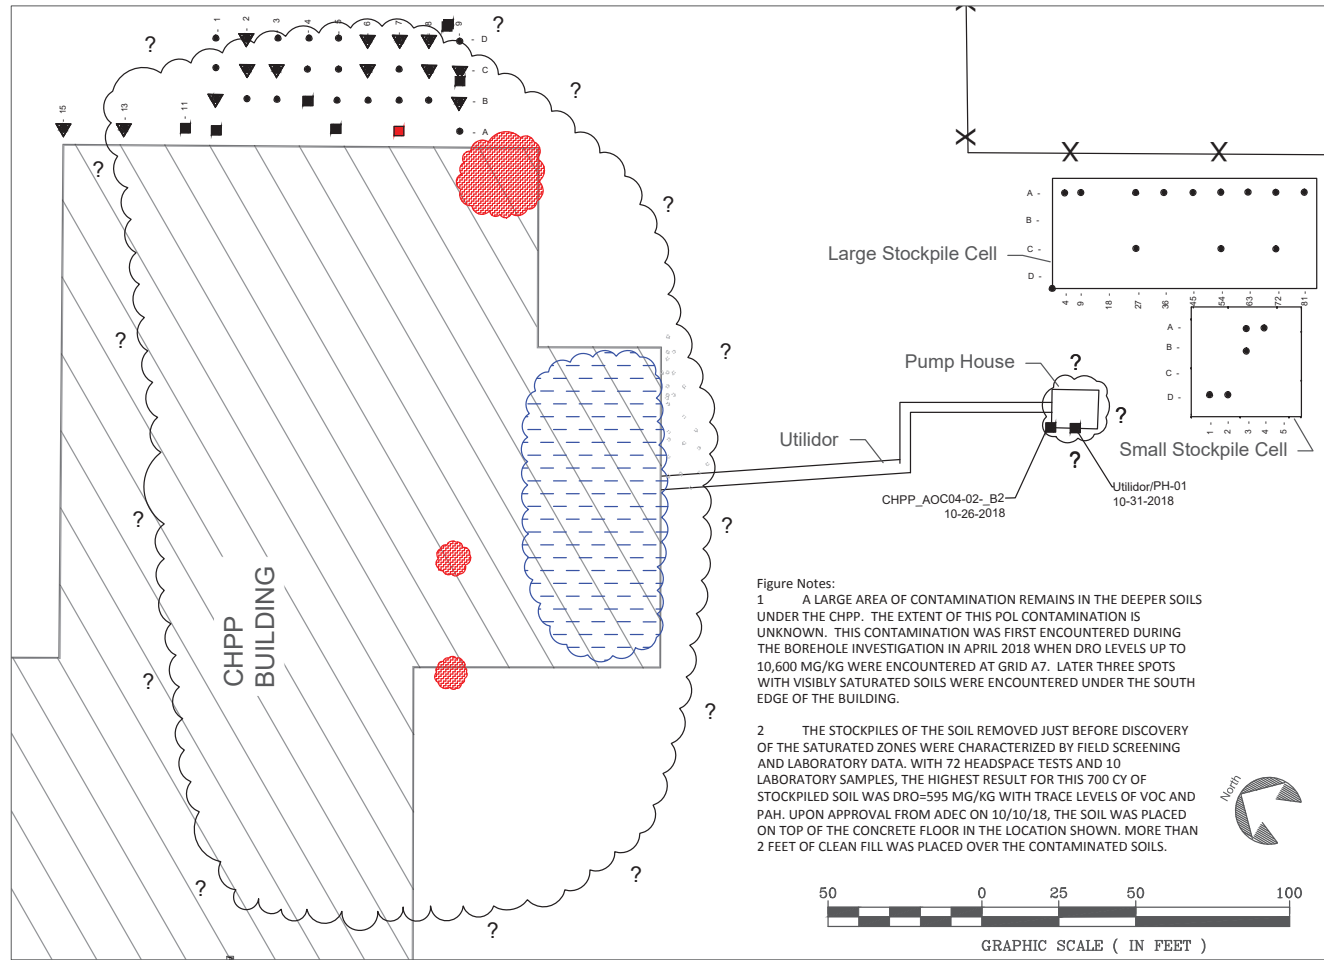
Locations of the Samples with Detected POL Remaining On Site

2) Under Basement Floor of CHPP: One large area of POL contaminated soils remains at the site below the Basement Floor near the former locations of the south and east sides of the building. The full extent of this area is unknown, as delineating it was outside the scope of the CHPP demo project. Based on visual observations, soils represented by a characterization sample (CHPP_XC_500_E7) are part of an area of contamination that appears to extend over a large area below the floor of the basement and in the ground water throughout much of the southern and eastern part of the CHPP.

The southern and eastern limits of this contamination was not anticipated. The project's 2012 Preliminary Assessment/Site Investigation (PA/SI) investigation did not identify any area of concern, this included research into JBER-R historical records. Please note that this contamination was not encountered during demolition of the north and west walls of the CHPP, and it appears to be limited to the south and east ends of the CHPP. Before excavation was stopped, some contaminated soils from this area that had inadvertently been removed were placed back in the excavation in the area with known contamination remaining.

Figure Notes:
 1 A LARGE AREA OF CONTAMINATION REMAINS IN THE DEEPER SOILS UNDER THE CHPP. THE EXTENT OF THIS POL CONTAMINATION IS UNKNOWN. THIS CONTAMINATION WAS FIRST ENCOUNTERED DURING THE BOREHOLE INVESTIGATION IN APRIL 2018 WHEN DRO LEVELS UP TO 10,600 MG/KG WERE ENCOUNTERED AT GRID A7. LATER THREE SPOTS WITH VISIBLY SATURATED SOILS WERE ENCOUNTERED UNDER THE SOUTH EDGE OF THE BUILDING.
 2 THE STOCKPILES OF THE SOIL REMOVED JUST BEFORE DISCOVERY OF THE SATURATED ZONES WERE CHARACTERIZED BY FIELD SCREENING AND LABORATORY DATA. WITH 72 HEADSPACE TESTS AND 10 LABORATORY SAMPLES, THE HIGHEST RESULT FOR THIS 700 CY OF STOCKPILED SOIL WAS DRO=595 MG/KG WITH TRACE LEVELS OF VOC AND PAH. UPON APPROVAL FROM ADEC ON 10/10/18, THE SOIL WAS PLACED ON TOP OF THE CONCRETE FLOOR IN THE LOCATION SHOWN. MORE THAN 2 FEET OF CLEAN FILL WAS PLACED OVER THE CONTAMINATED SOILS.

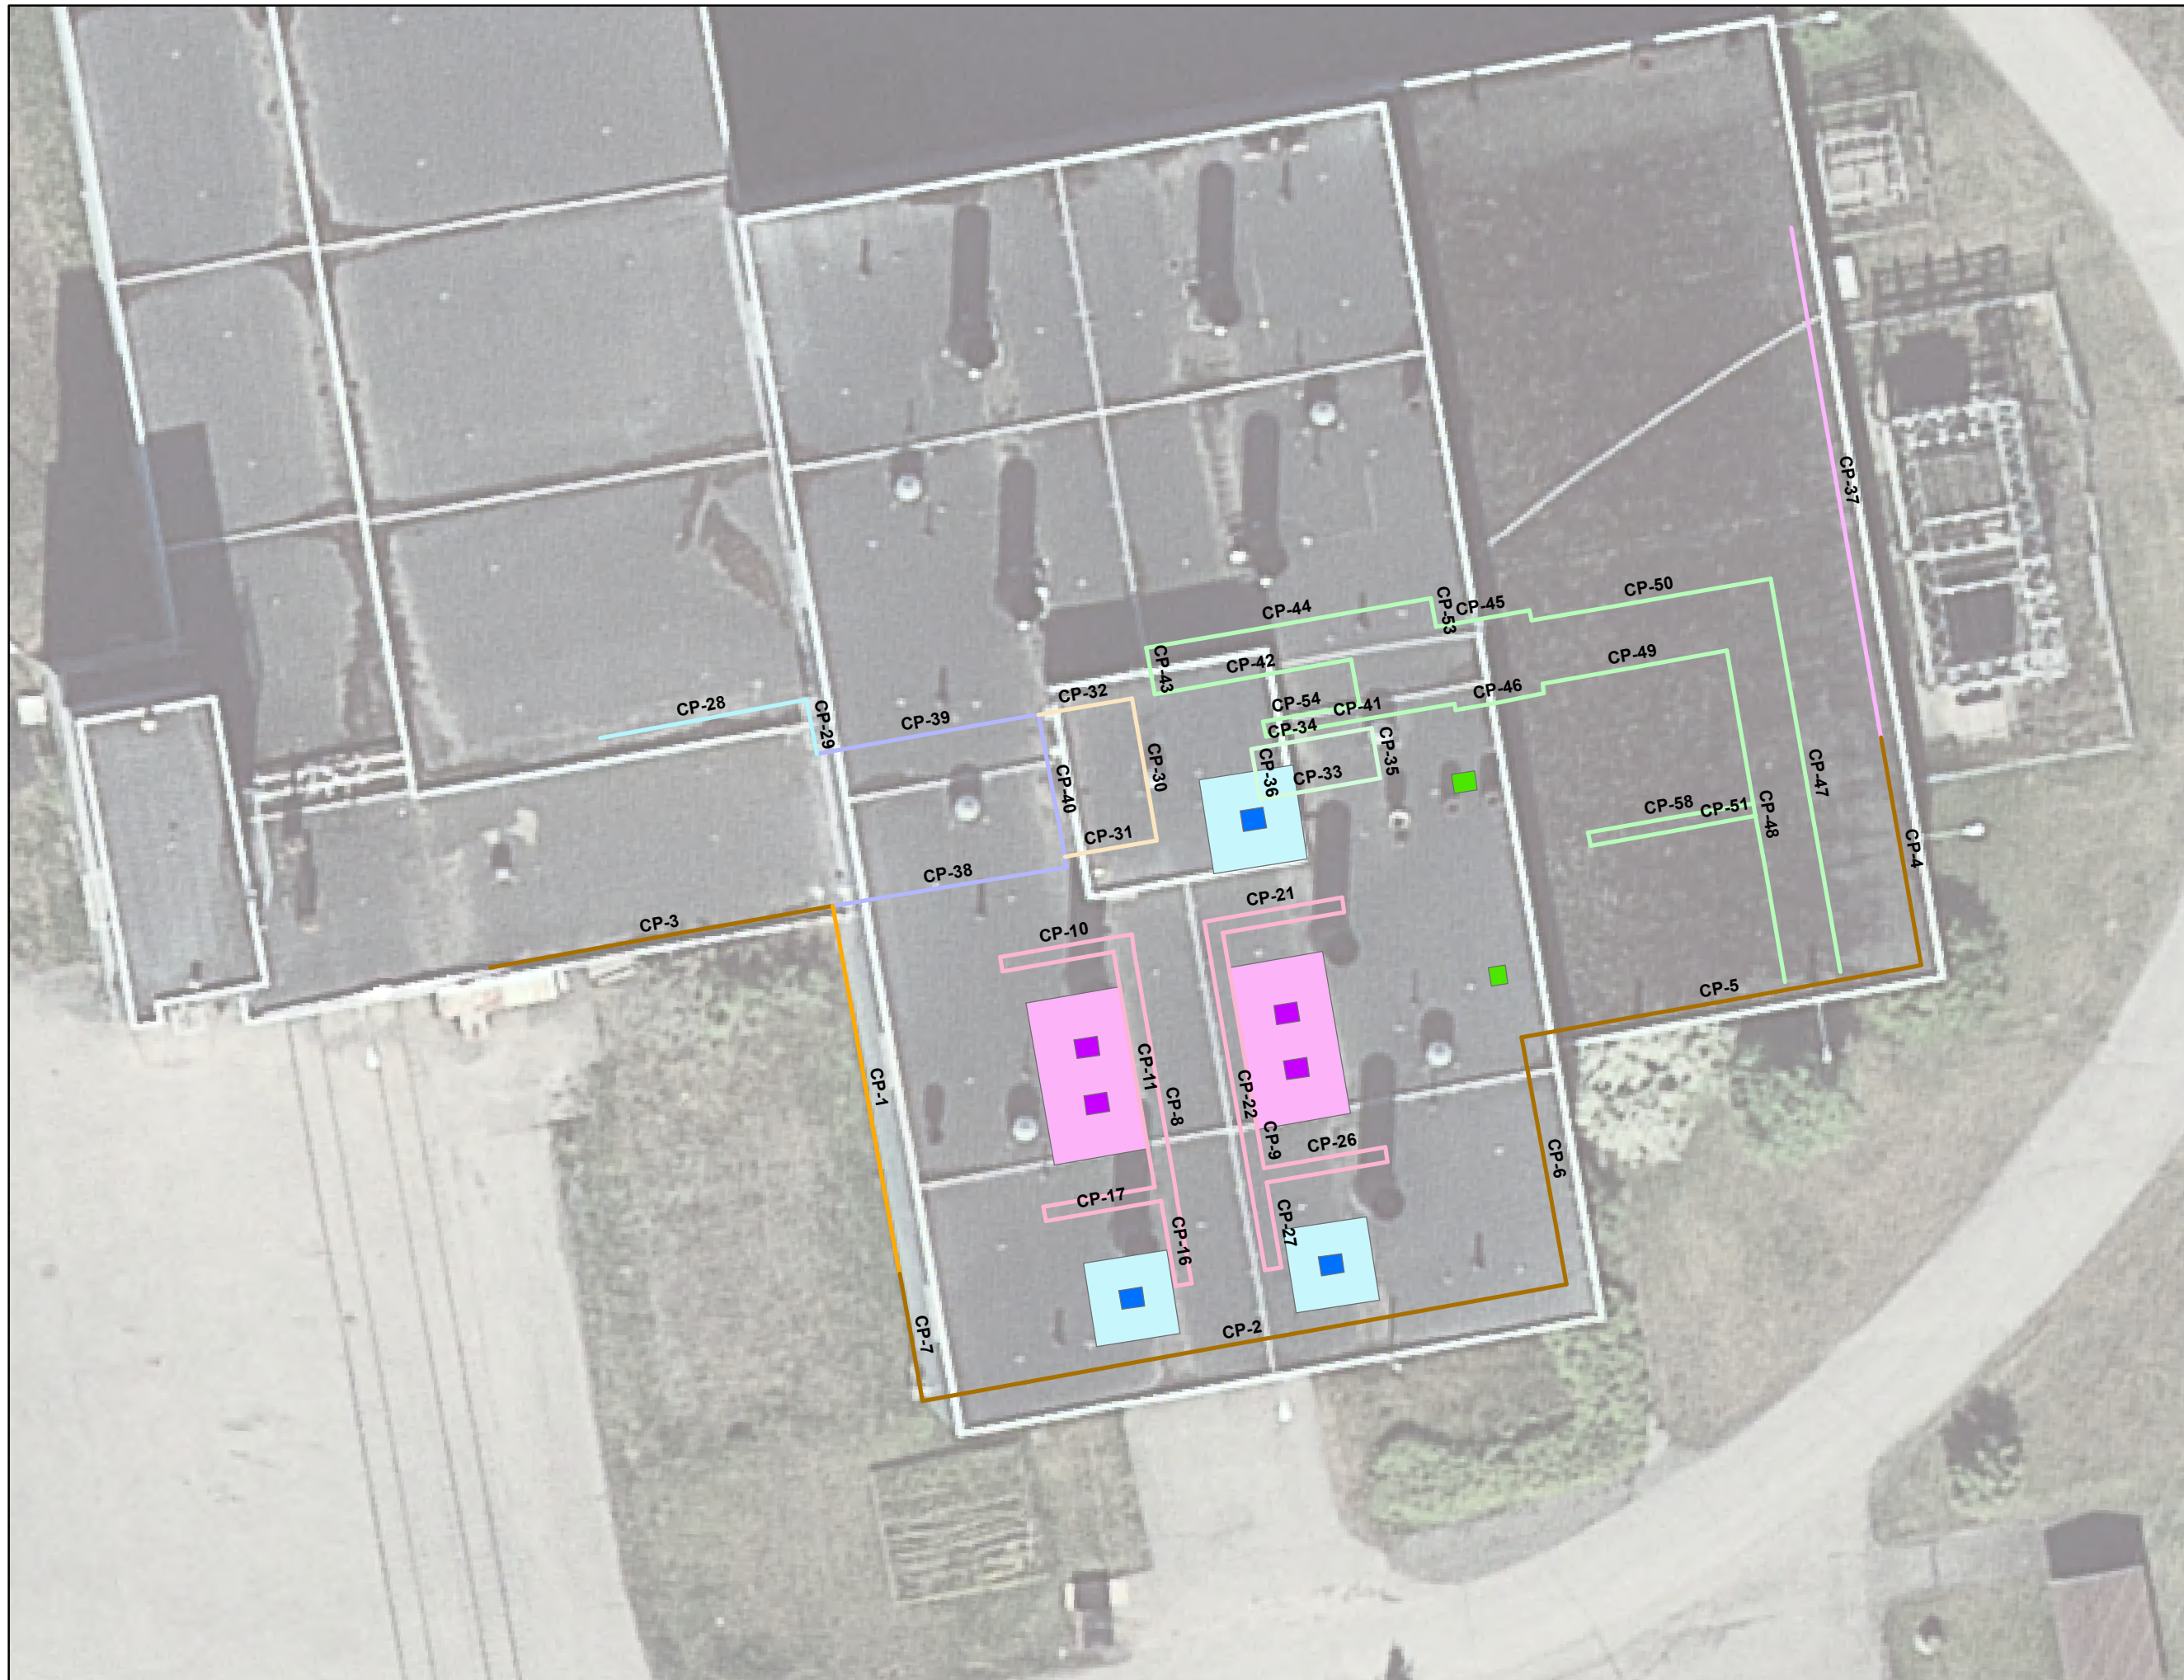
5) Remaining Concrete Structures: As background to why these partial foundations remain in place, on September 25, 2018 during the demolition and excavation activities, differing site conditions were encountered. Petroleum contamination was encountered under the turbine and boiler room basement floors and outside of the west foundation wall of the boiler building. To access these areas located approximately 30 feet below the groundwater surface, the project had a ADEC approved dewatering program in place. The dewatering permit required the discharge to be shut down if a sheen was detected. Maintaining dewatering activities was essential to limit the exacerbation of contamination within the excavation and for completion of foundation demolition, backfill, and compaction. After a series of meetings and discussions between September 25, 2018 and

October 10, 2019 among representatives of DU (K.Hook, S.Hatzis), CEI (S.Durand), EMI (L.Helgeson) JBER (M.Prieksat, S.Scheevel, T.Berg), DLA (E.Wolfe) and ADEC (J.Halverson), the consensus among the stakeholders was that these soils and partial foundations should remain in place. Attached is a Figure *JBER CHPP Demo Below Grade Concrete Structures Remaining in Place* which outline where the concrete foundations remain in place.
