**KASAAN LIBRARY  
117 KASAAN STREET  
KASAAN, ALASKA**

**PROPERTY ASSESSMENT AND CLEANUP PLAN**

**DECEMBER 2019**

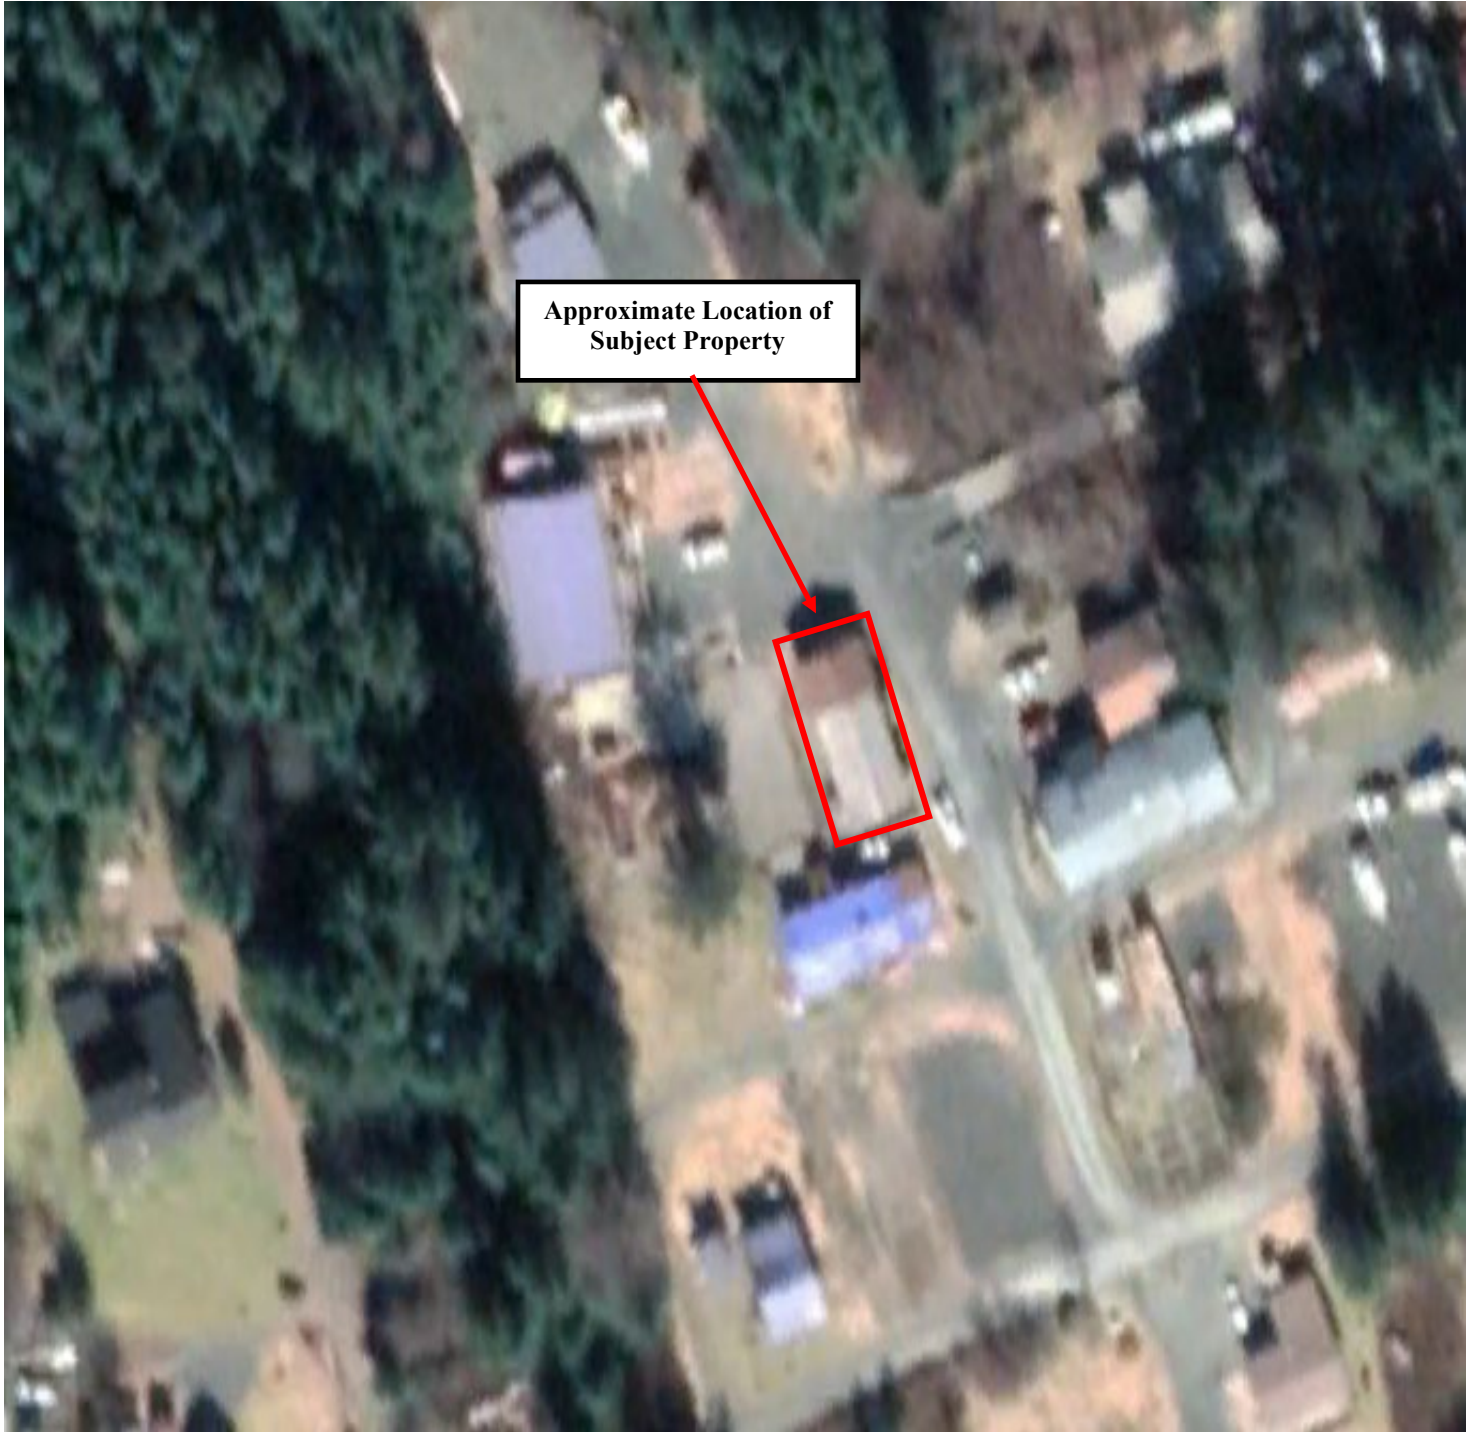
**Figure 3**

The March 26, 2019 aerial photograph, included as Figure 3, showed the subject property remaining the same as in the previous photograph, however, the building to the west of the library appeared to have been removed and a slab was in place. The building that was located to the south of the subject property in this aerial photograph was not observed during the site reconnaissance.

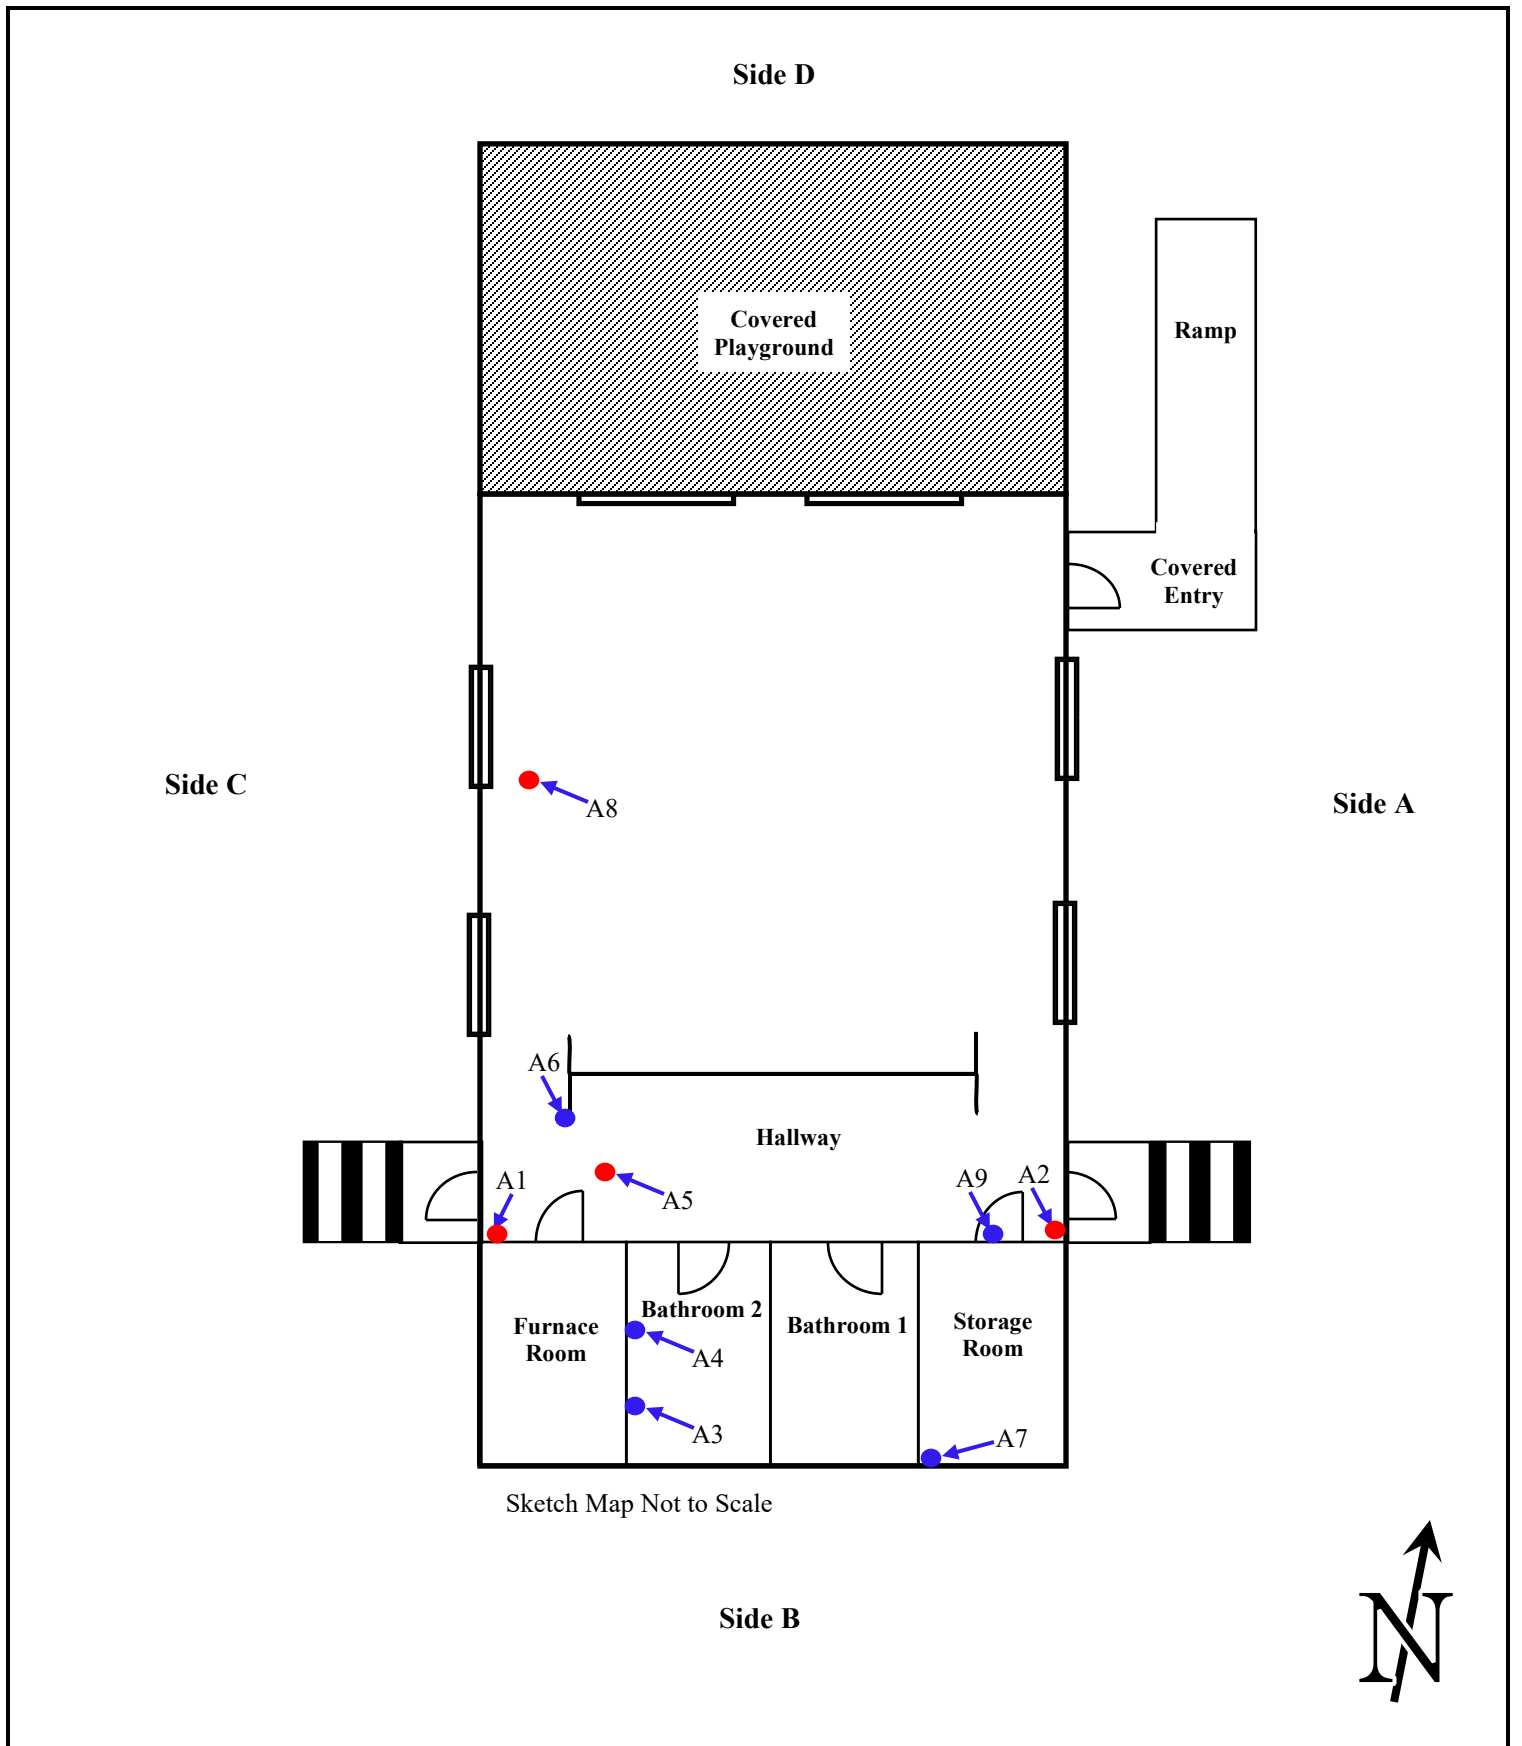
A total of 22 bulk samples (9 samples with 13 additional layers) were collected from PACBM identified in the inspected portions of the building on the subject property. According to the National Emissions Standard for Hazardous Air Pollutants (NESHAP), Asbestos-Containing Materials (ACMs) are defined as containing at least 1 percent asbestos; including but not limited to chrysotile, amosite, tremolite, actinolite, and crocidolite asbestos. Four of the samples collected in the building were found to be “asbestos-containing” according to the NESHAP definition. Joint Compound samples from two main wall samples were found to contain 2 percent chrysotile asbestos and two samples from the “popcorn” ceiling texture in the main room of the library and in the hallway were found to contain 3 percent chrysotile asbestos; and are therefore “asbestos-containing” according to the NESHAP definition. The sample locations are depicted on Figure 5; ACM analytical results are summarized in Table 2; and PLM analytical

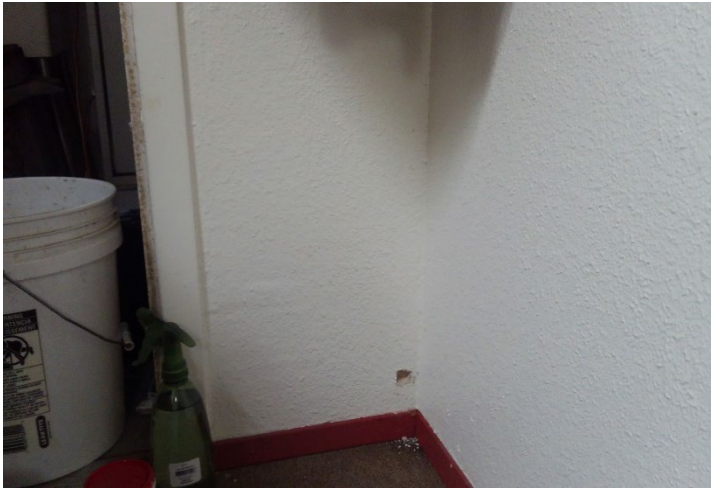
Photo 13. Sample A-1, Library, Corner BC, Wall Material

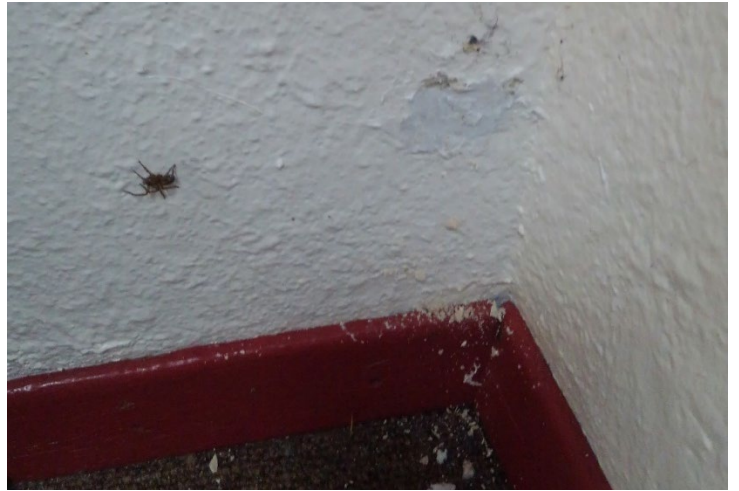
Photo 14. Sample A-2, Library, Corner AB, Wall Material, Post-Patching

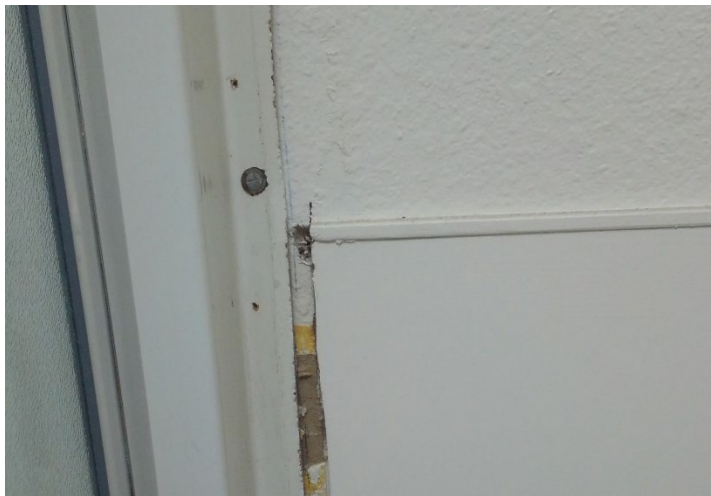
Photo 15. Sample A-3, Bathroom 2, Wall C, Mastic and Tape

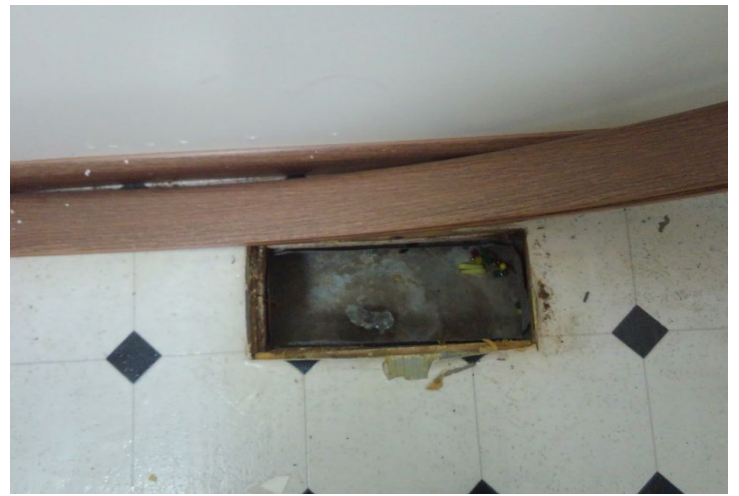
Photo 16. Sample A-4, Bathroom 2, Wall C, Flooring and Mastic

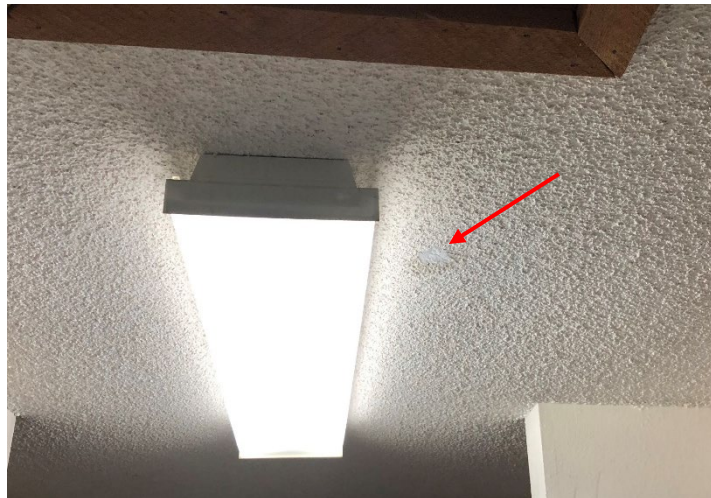
Site activities were conducted on October 31, 2019. No LBP was identified on the subject property. ACMs were identified in the joint compound and ceiling texture in the hallway and main room of the building on the subject property. The items containing ACMs are in good condition. Prior to building renovations, it is recommended that any ACMs that may be disturbed during renovations be abated by appropriately trained professionals to reduce the potential for human and ecological contact and to comply with applicable regulations.

Photo 17. Sample A-5, Hallway, Ceiling, Ceiling Texture

It is recommended that the ACMs identified during preparation of this PACP and during previous asbestos inspections on the subject property be abated, packaged appropriately for shipping, and transported to an appropriate disposal facility, or encapsulated. It is also recommended that the AST be equipped with secondary containment.

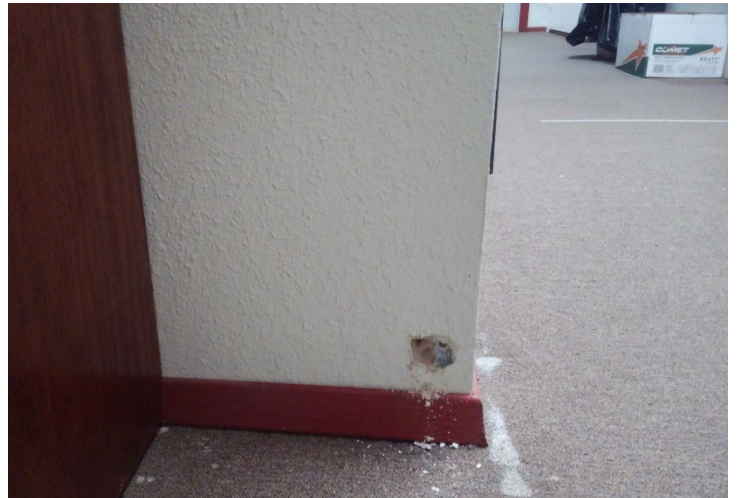
Photo 18. Sample A-6, Hallway Divider Wall, Corner CB, Wall Material

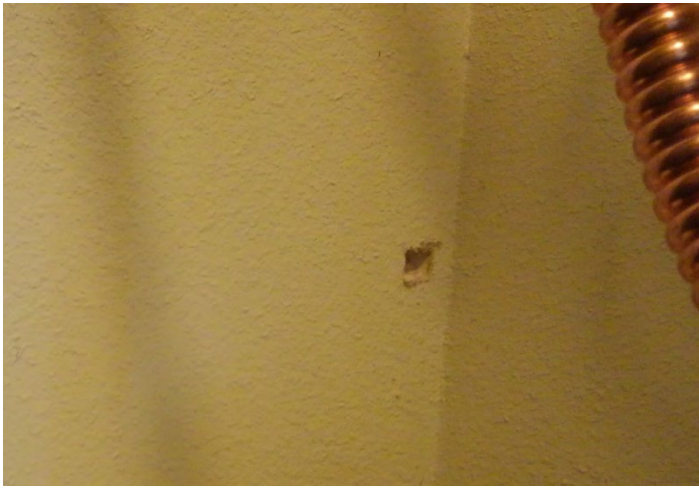
**Photo 19. Sample A-7, Storage Room, Corner BC, Wall Material**

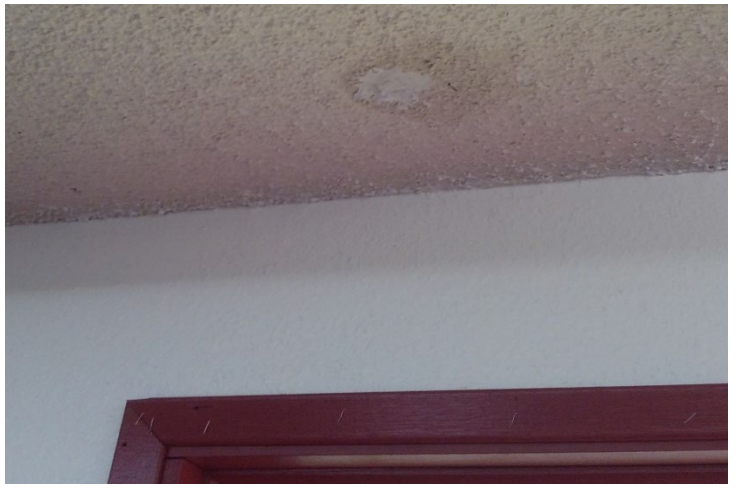
**Photo 20. Sample A-8, Library, Ceiling Texture and Wall Material**
