**LEVEL I
ENVIRONMENTAL SITE ASSESSMENT
FOR CLOSEOUT OF LEASED PROPERTY
FORMERLY KNOWN AS THE SERVS DOCK FACILITY
VALDEZ, ALASKA**

June 1995

Project 5103-030.S5

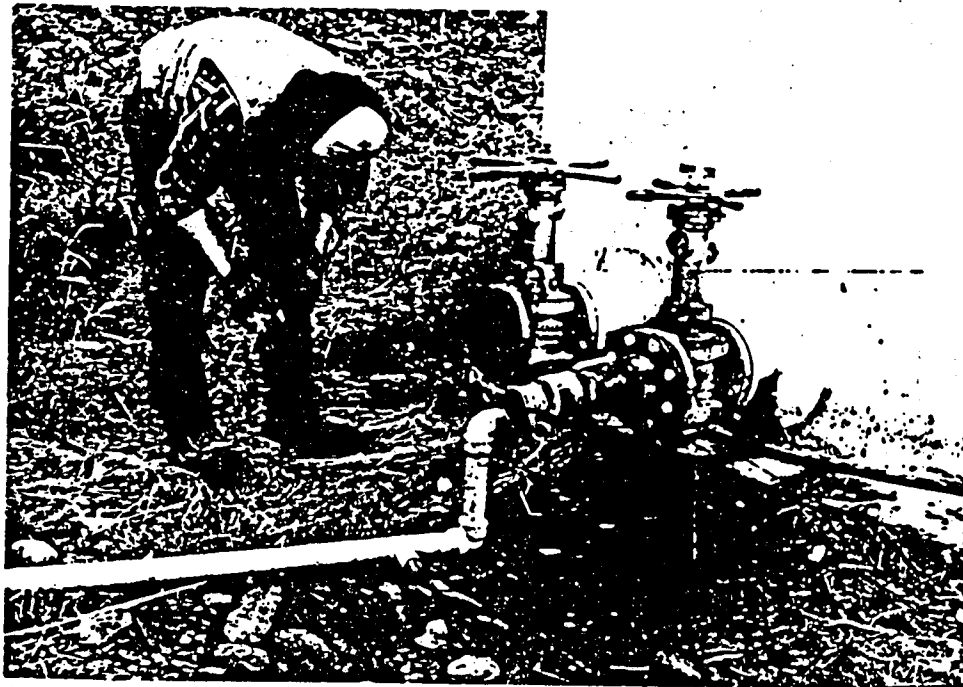
Stopcocks and product-line fittings around both tanks had obvious leakage over time as evidenced by dark soil staining and strong petroleum odor (see Appendix A, Photo 2). In addition, soils surrounding product lines extending through the containment dike exhibited dark staining and strong petroleum odor (see Appendix A, Photograph 3).

- The above-ground storage tanks appear in good physical condition and are presently empty. Product has been released to soils in the bermed containment area through loose fittings and leaking stopcocks, as evidenced by soil staining and strong petroleum odor. The extent of subsurface soil and possible groundwater contamination is unknown.

Photograph 2: Soil staining near above-ground tanks.

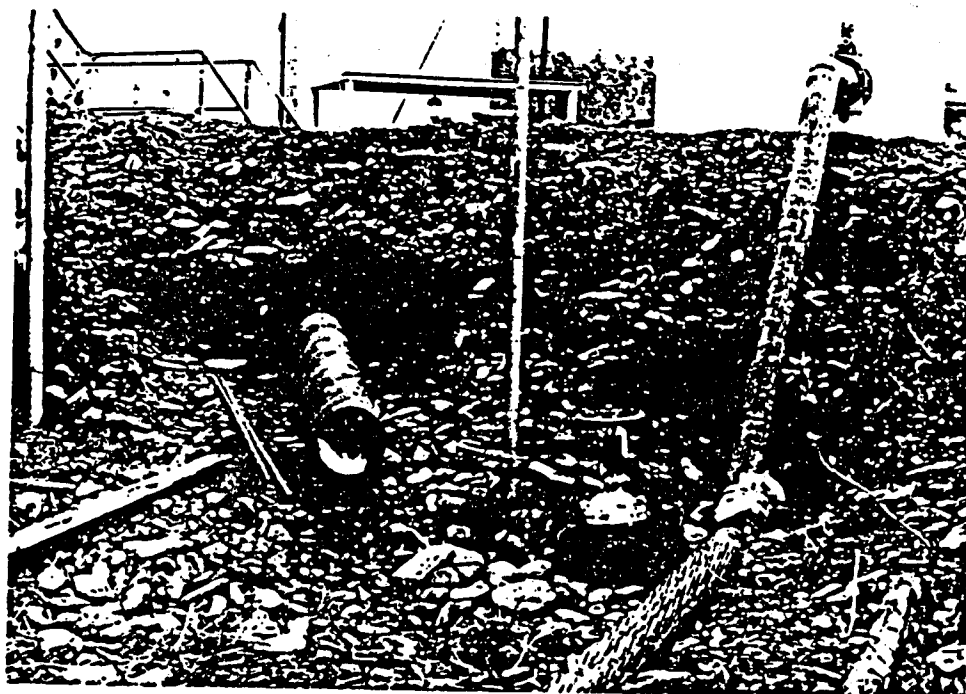
- Soil staining, strong petroleum odor, and analytical results of soil near product lines in the containment berm indicate product has been released outside of the bermed containment area. The extent of subsurface contamination is unknown but is likely centered around product lines which provide a transportation path.

Photograph 3: Product lines exiting through containment berm.

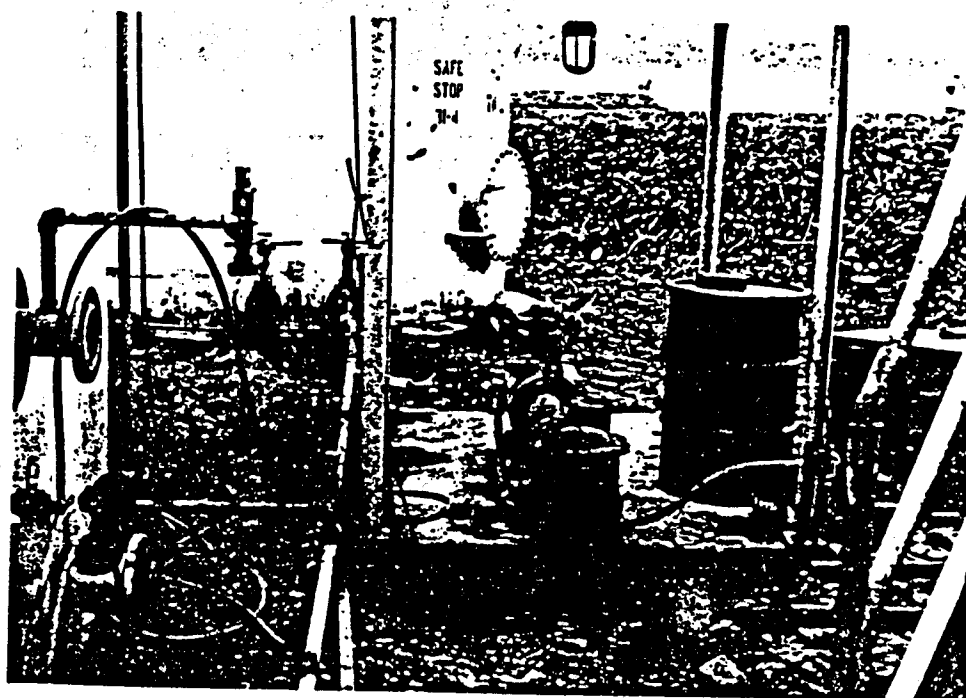
- One 55-gallon drum labeled "calcium carbide" is abandoned near the above-ground tanks. Calcium carbide is a highly reactive chemical when mixed with water and is classified as a hazardous waste. On-site personnel should be notified as to the possible health & safety hazards. ANI recommends the contents of this drum be sampled and that the drum be disposed of in a proper manner upon receipt of analytical results.

One half-full 55-gallon drum is located inside the containment berm and is labeled as calcium carbide. Calcium carbide is highly reactive when coming in contact with water and is classified as a hazardous waste. The drum is closed and appears in good condition and does not appear to have discharged to surrounding soils (see Appendix A, Photograph 4).

Photograph 4: Location of 55-gallon drum labeled "calcium carbide."

- The 55-gallon drum labeled as calcium carbide should be containerized in an overpack and sampled. After analytical results are obtained, the container and its contents should be disposed of in a proper manner in accordance with State and Federal Regulations. If the drum's contents are found to be calcium carbide, the drum and its contents should be disposed of as a hazardous waste.

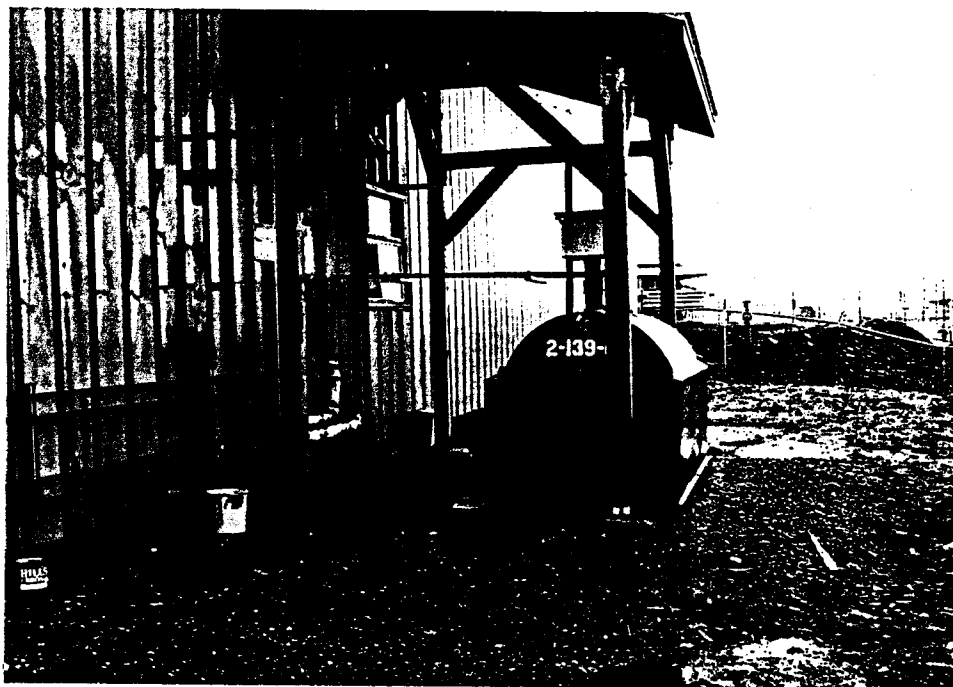
Fuel-oil for the furnace and unit heaters is stored in a 500- to 600-gallon capacity double-walled AST staged outside the blue building on its south side (see Figure 2 for location.) The lines extending from the tank are wrapped with white absorbent material at the point where it is attached to the blue building. According to information found in the Alyeska Spill Report database, a release of approximately 0.5 cups of diesel fuel occurred from these pipes on October 16, 1994 (Spill No. 1994555). Immediate action was taken and the pipes were wrapped with absorbent material to prevent further releases. The impacted gravels in the area were removed. Due to the snow and ice cover around the AST, a more thorough assessment of this area was planned for after snow melt.

Photograph No. 1: May 8, 1995; Heating oil AST next to Blue Building

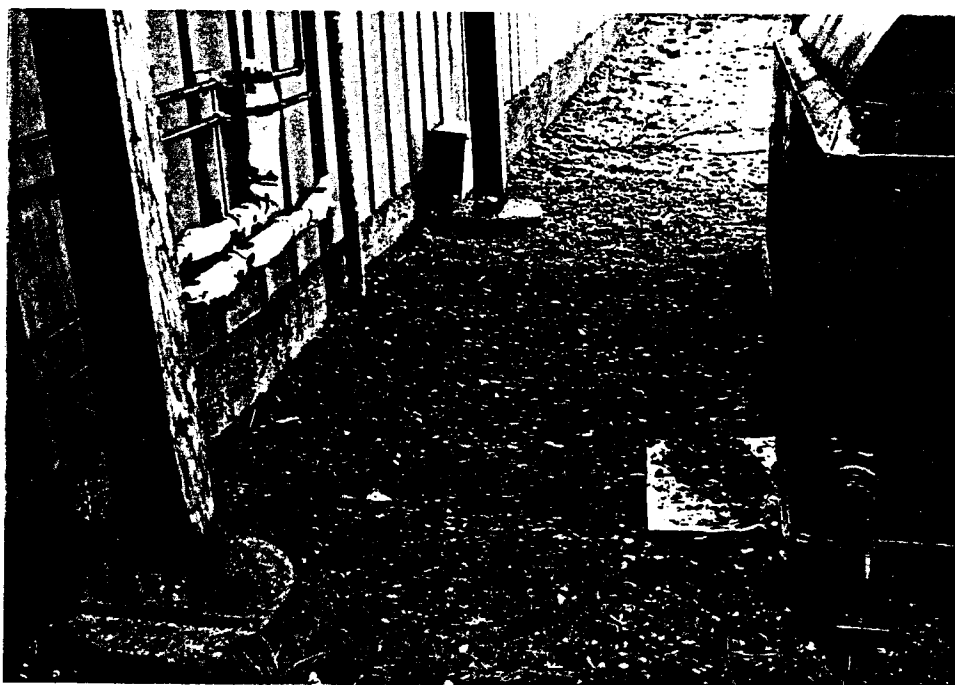
At this time, the site had been in use by Petrostar since February 1995. Erin Hanson accompanied EMCON personnel during this visit as well. At the time of this visit, no area on the site was observed to have any noticeable amount of surface impact from operations associated with SERVS' previous use of the site. In the areas where the former offices and their heating fuel ASTs were located, there also was no noticeable amount of surface impact. In the southwest corner of the facility, a small material stockpile had been placed on a sheet of reinforced Visqueen[®]. The material consists mostly of large coarse, angular sand mixed with some small, well-rounded gravel. The material had no apparent sheen or hydrocarbon smell.

Photograph No. 2: May 8, 1995; Surface soils in vicinity of AST with wrapped pipes next to Blue Building

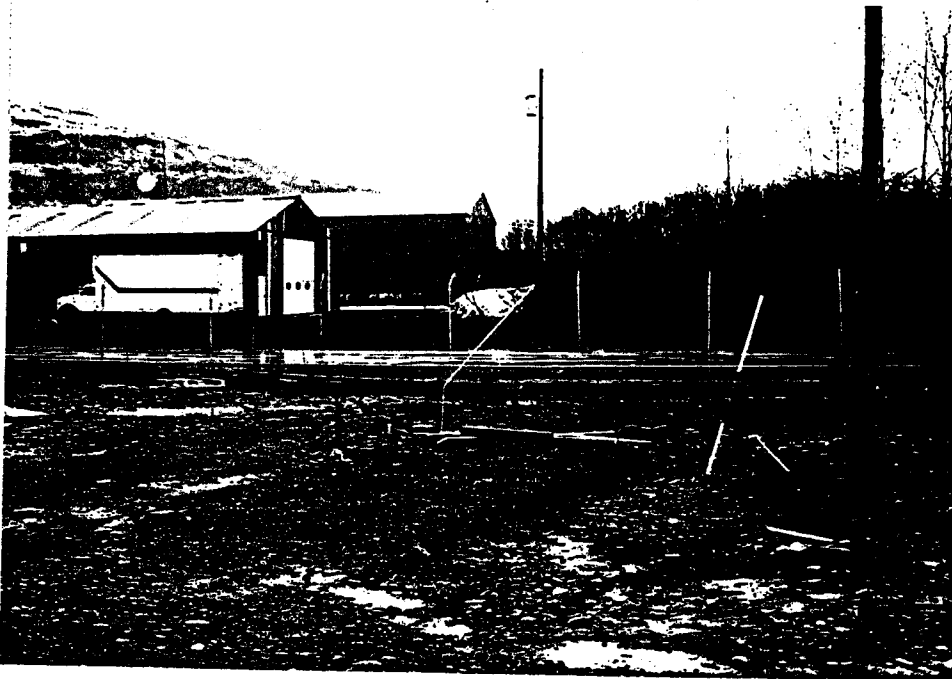
Ms. Hillman and Mr. Rasmusen both stated that waste batteries were stored separately from the other waste streams in a heated mobile building (petroleum, oil and lubricants [POL] building) formerly staged behind the silver building. The POL building has been moved to SERVS' current operational facility and is still in use as a product storage and waste battery accumulation point. Ms. Hillman and Mr. Rasmusen both stated that the rear (east end) of the blue building had a petroleum-products distribution rack which resulted in the staining of the floor in that area.

Photograph No. 4: May 8, 1995; Former POL Building Location

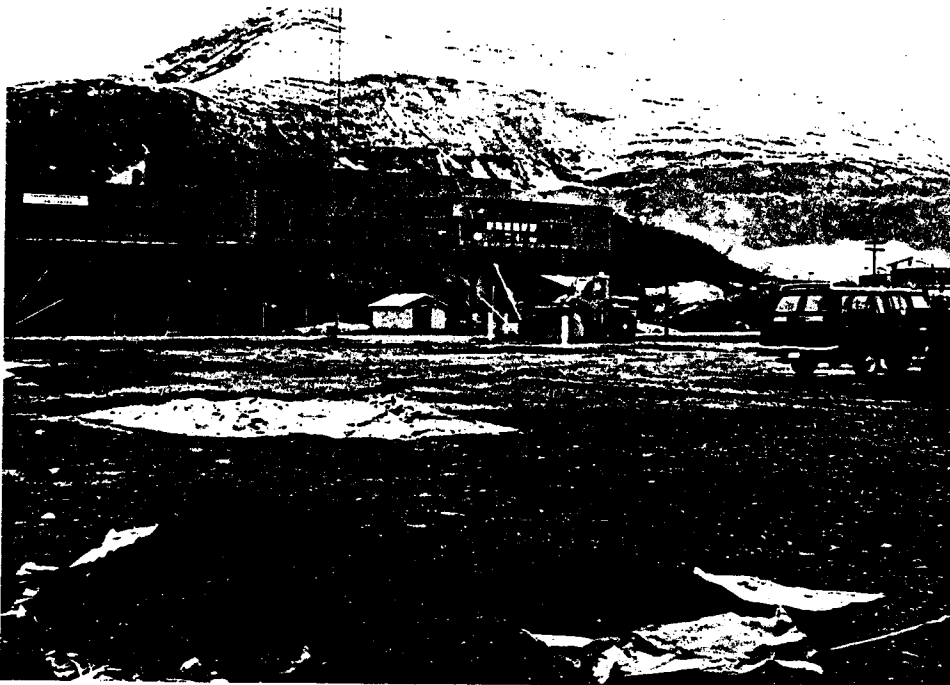
During the site visit conducted in May, Stan Jepson was able to provide background information about the small material stockpile located in the southwest corner of the site. He indicated it was material left over from the construction of the antenna array which is still on the site. This material was used as a bedding material in the trenches excavated for the installation of the electrical system associated with the array.

Photograph No. 6: May 8, 1995; Small material stockpile with open parking area behind
