Department of Environmental
Conservation

DIVISION OF SPILL PREVENTION AND RESPONSE
Contaminated sites Program

December 21, 2015

Re: Baker Oil Tools - Delores Drive
ADEC Hazard ID: 25935
Baker Hughes Nikiski Completions Facility
ADEC Review comments on Phase II Site Characterization Report October 15, 2015 and
Progress Report – Routine Ground Water Monitoring November 6, 2015

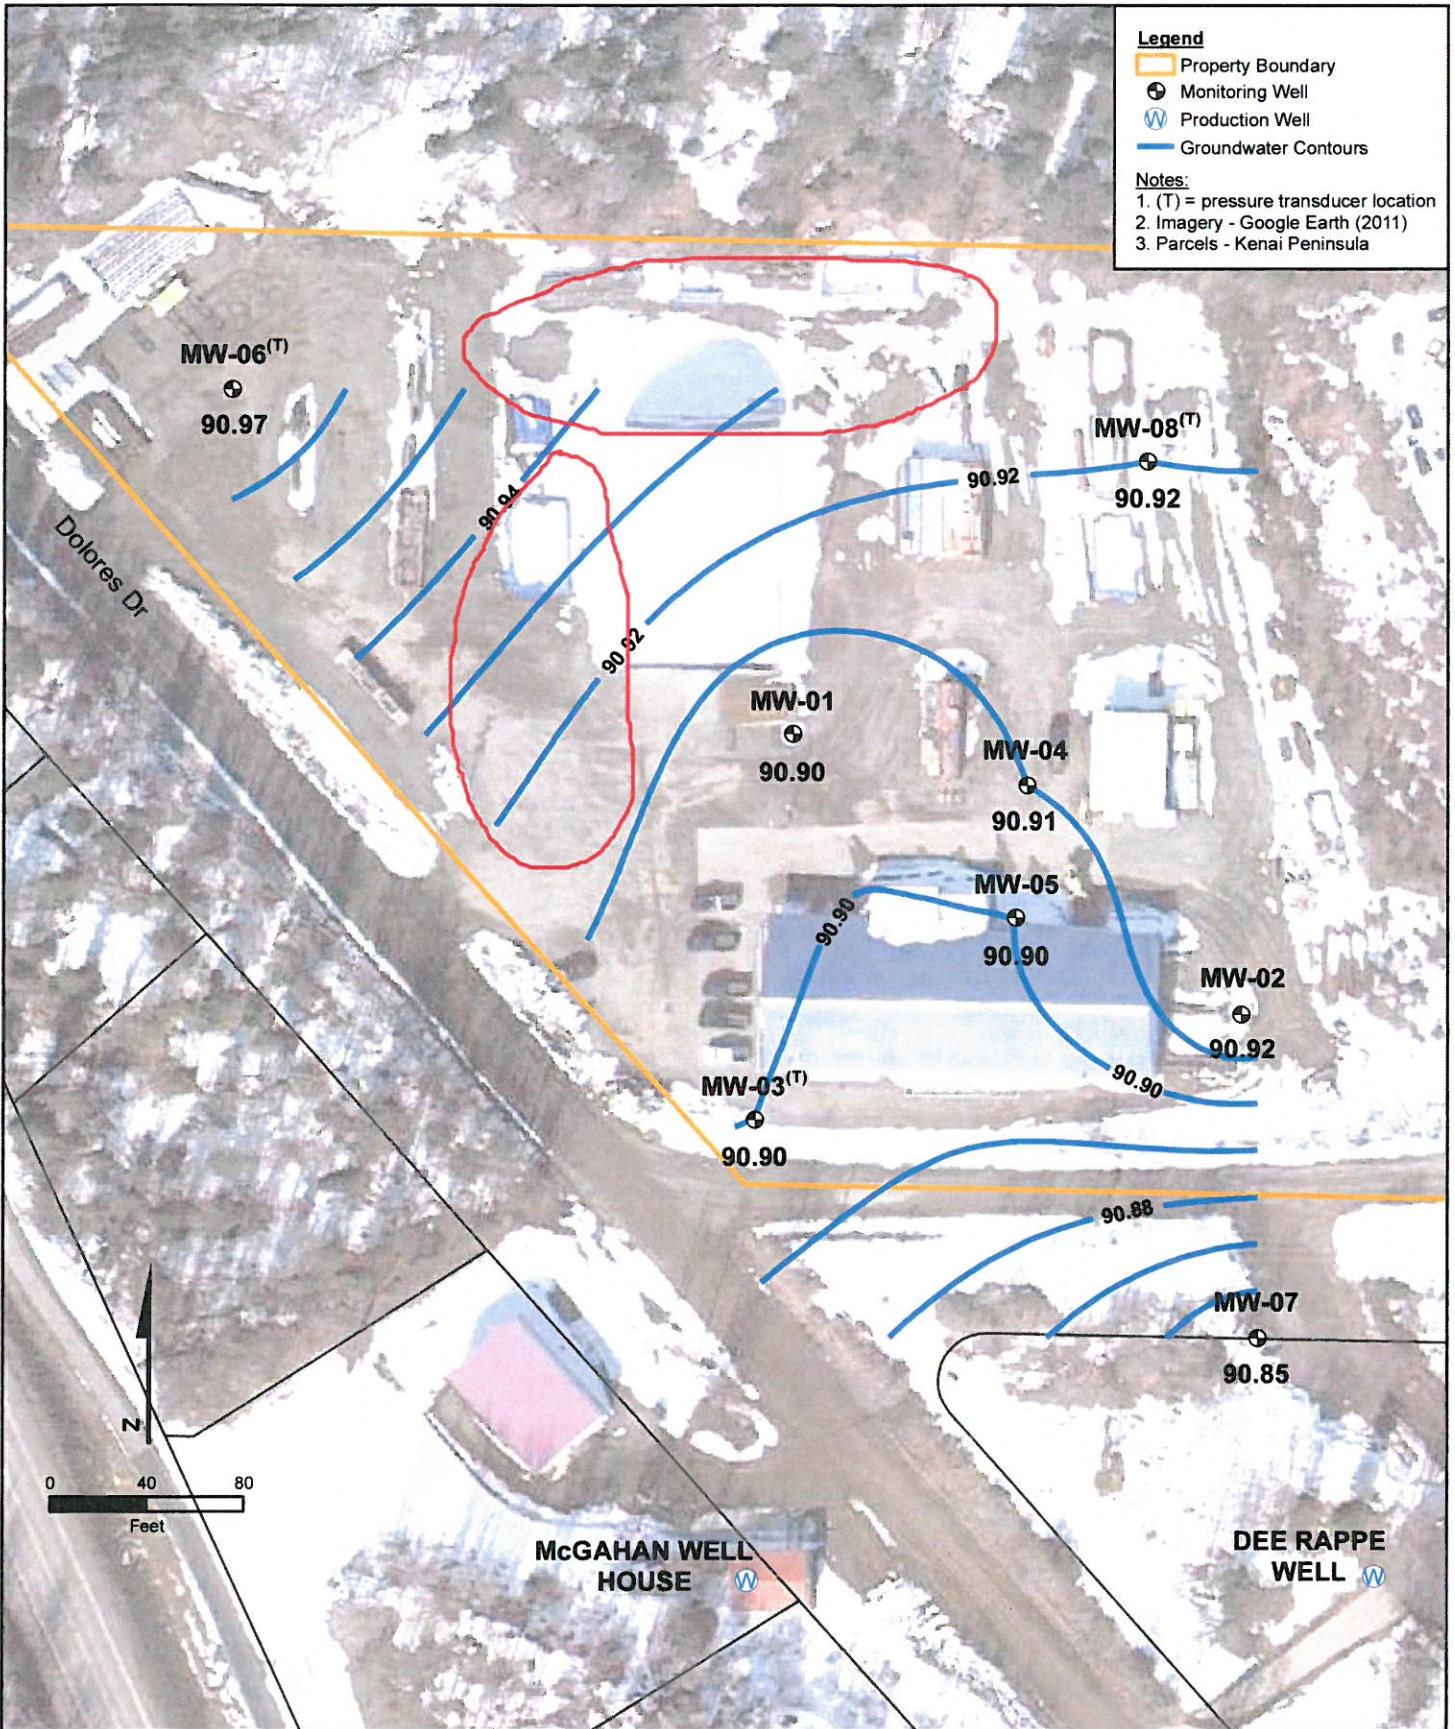
Attachment: Figure 2 Groundwater Elevations and Inferred Contours with ADEC modifications

The unusually flat water table gradient of this aquifer may be influenced by the Nikishka Bay Utilities production wells. These wells withdraw groundwater at high rates, and may drawdown the water table in a manner that creates concentric groundwater elevation contours around the pumping wells. This was identified in the 1989 Hart Crowser investigation. The Hart Crowser elevation survey included additional groundwater elevation data points collected across greater distances, encompassing a larger area. This allows small groundwater gradients to be measured with greater certainty and accuracy. Their survey includes ADEC's MW-1, former MW-4, and the original McGahan Utilities' well.

The water level contour maps presented in your reports show a southerly groundwater gradient. This may be a consequence of the high pumping rates of groundwater withdrawal from the Nikishka Bay Utilities production wells, however our understanding of the regional groundwater flow in the area, is that groundwater most likely flows to the north.
