**ROZAK ENGINEERING**

September 28, 1999

RE: Kenai Airport Fuel Service  
UST Facility ID #2187, Reckey #90230026801  
Interim Remedial Action Report #2

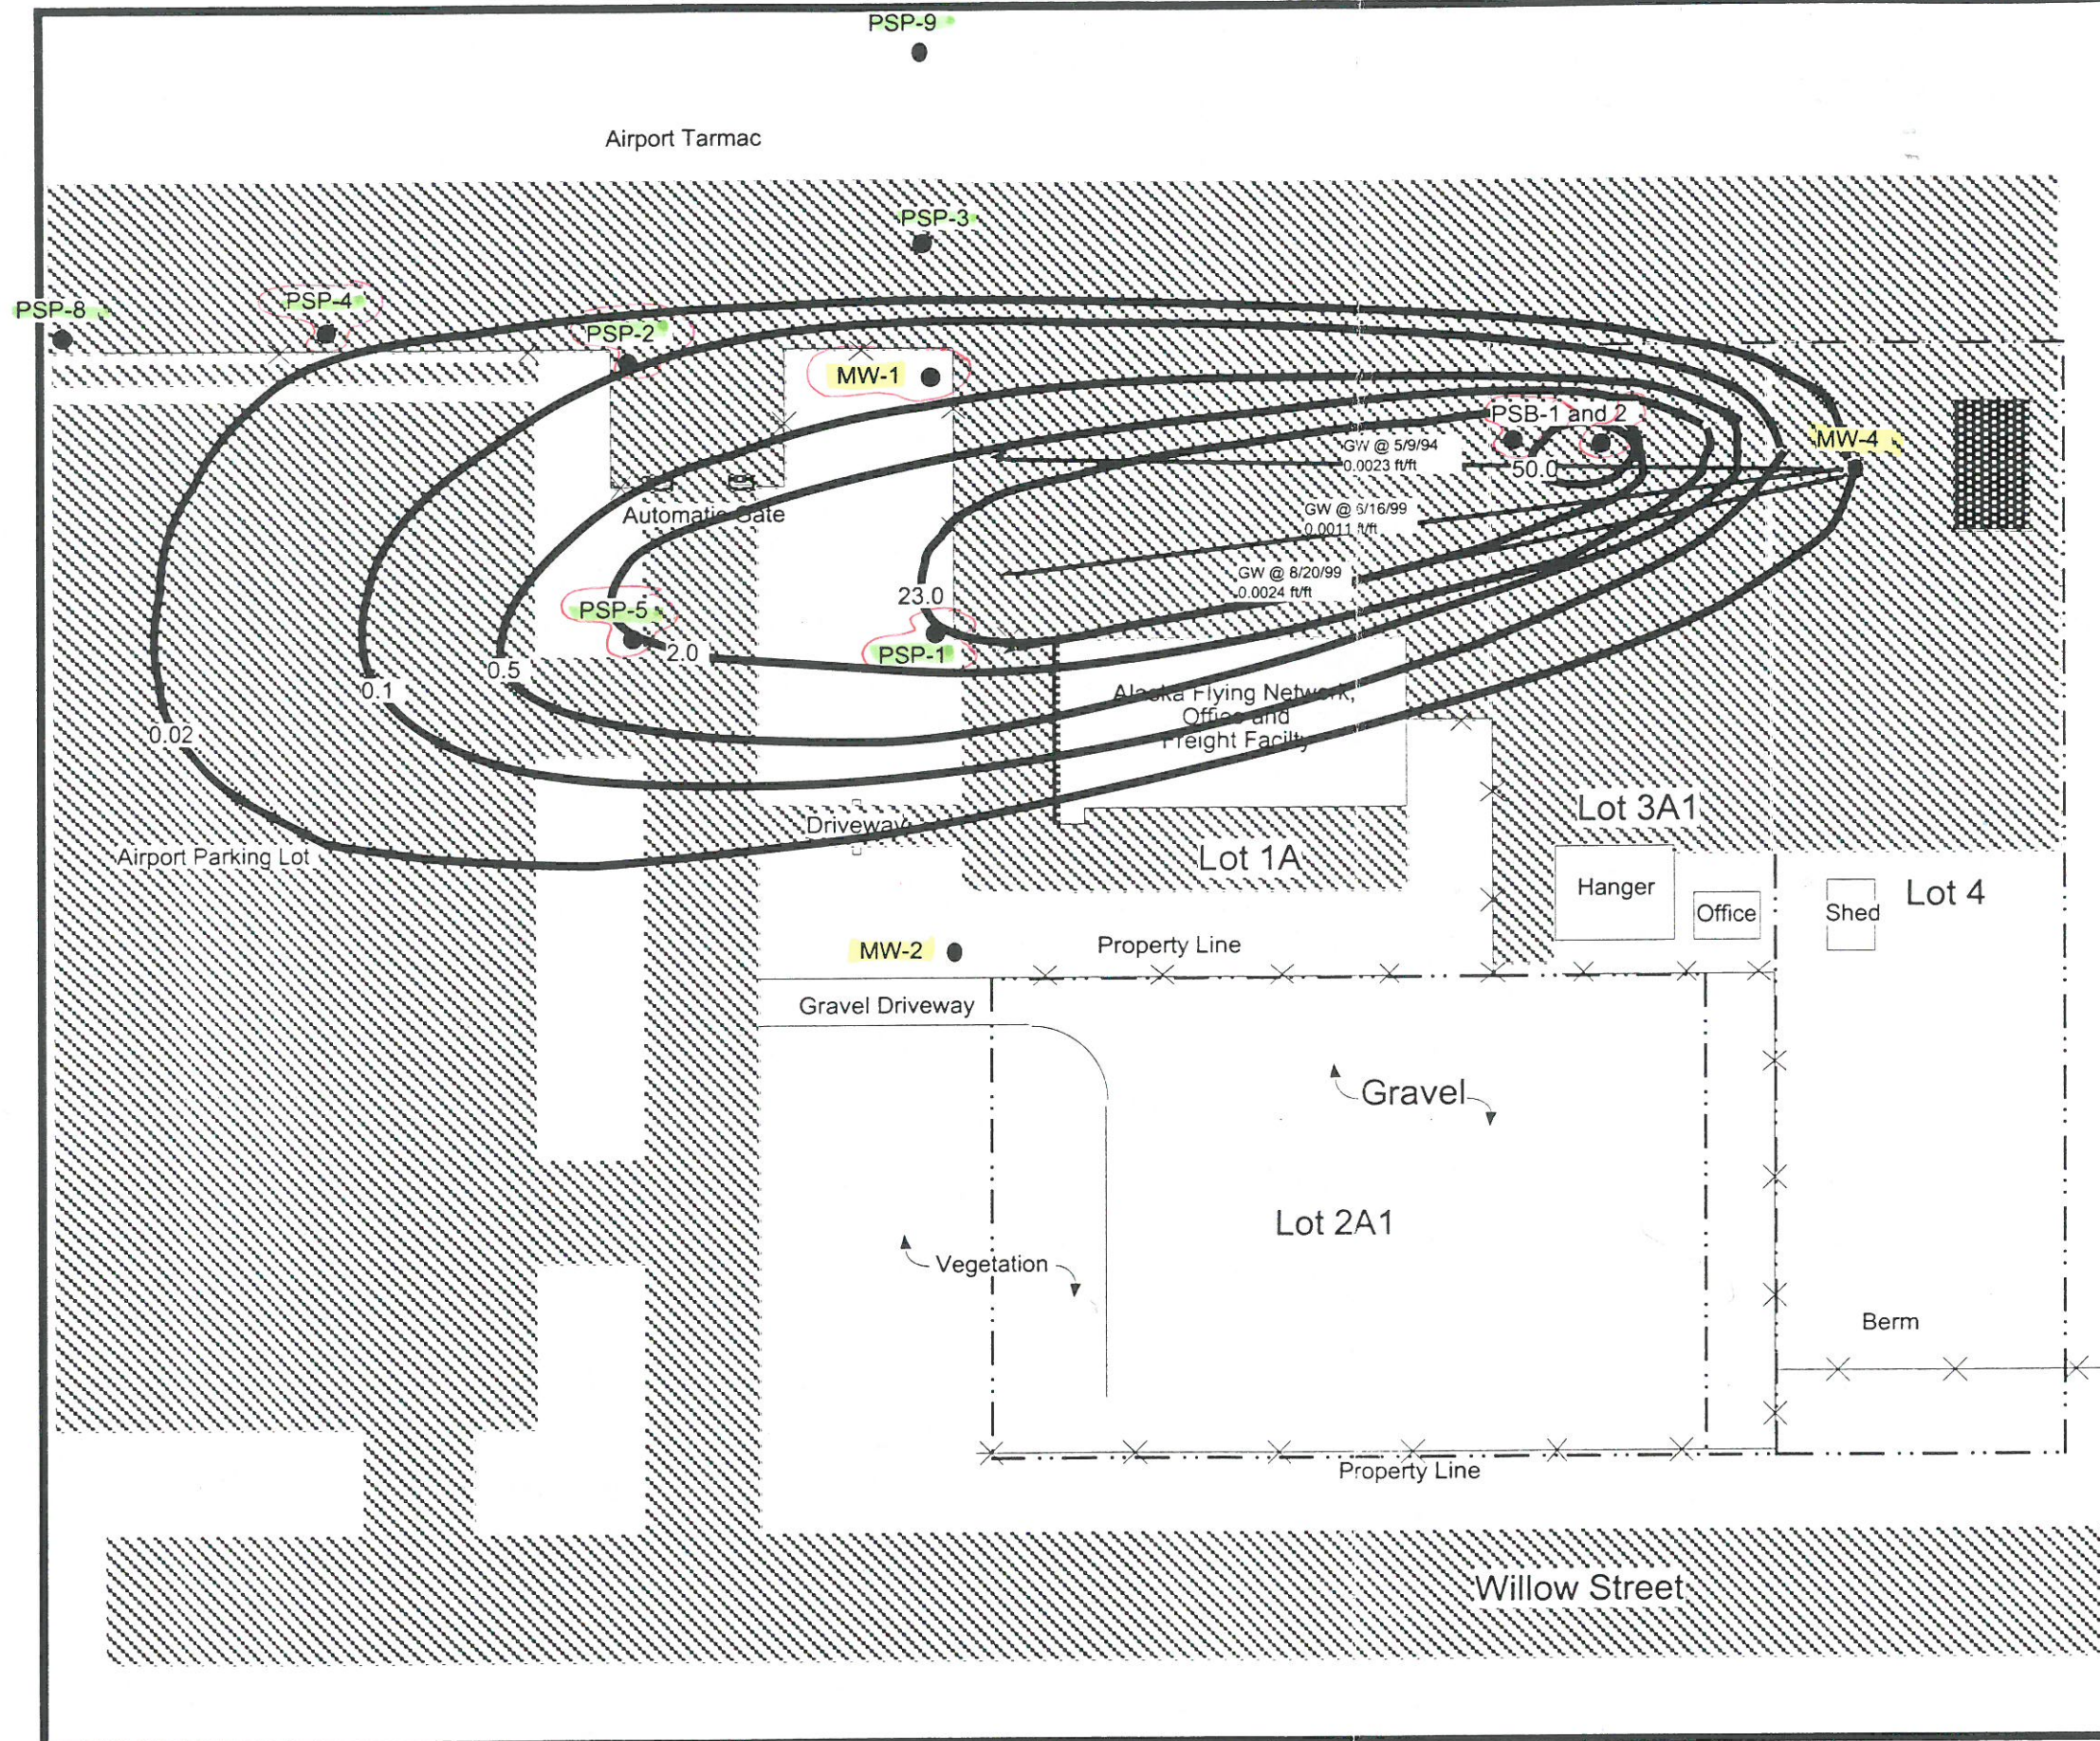
Figure 1. Estimated Benzene Contamination Contours

Benzene concentration contours were developed using the analytical data and are plotted in Figure 1. Recent analytical results from MW-2 and MW-4 (quarterly water samples collected on 6-16-99) were also used in estimation of the contours. It is evident from the contour map that contamination, in excess of cleanup standards, has moved off-site from the KAFS facility. The groundwater direction and gradient fluctuate during the year, but the average gradient is about 0.002 ft/ft, and the general direction is south to southeast.

Historical BTEX contamination levels for MW-1 are plotted in Figure 2. It is evident from the figure that the levels of BTEX are decreasing at the MW-1 location. Contamination levels have dropped significantly since 1994. Additionally, it does not appear that the contamination is moving down-gradient as a pulse, as is reflected by relatively low BTEX contamination levels found at sites PSP-2, PSP-4, and PSP-5 (see Figure 1).

The next step in the remedial action is to install several additional monitor wells at locations PSP-1, PSP-5, PSP-6, and another well farther down-gradient in the Kenai Airport parking lot. In addition, we propose to confirm the assumptions used to calculate groundwater velocity and retardation. Specifically, we will measure the hydraulic conductivity of the aquifer by performing a slug test using MW-1, we will collect two soil samples to measure bulk density, porosity, and fraction of organic carbon, and we will measure the dissolved oxygen content in the up-gradient and down-gradient groundwater to quantify biological activity.

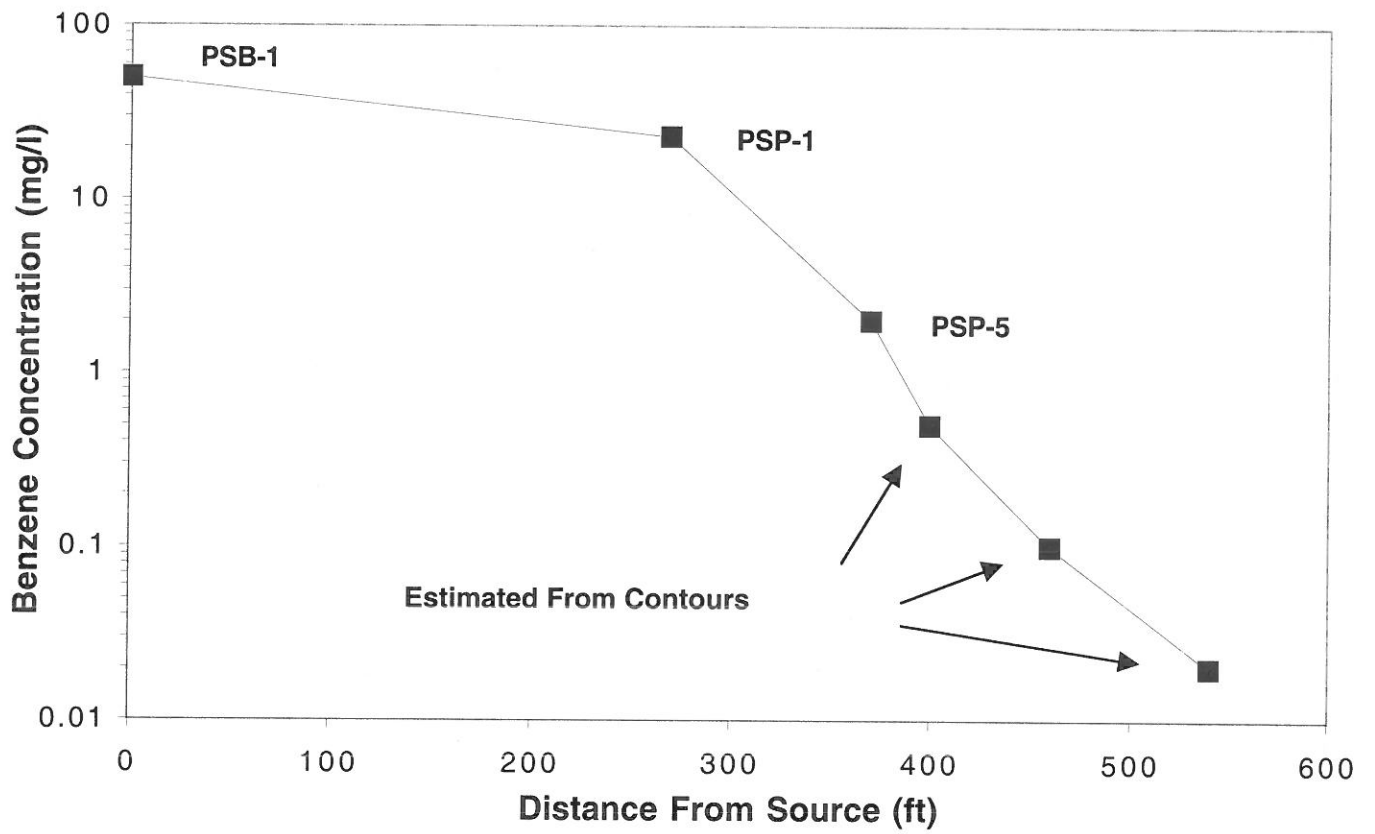
Figure 3. Benzene concentration as a function of distance from source.

Figure 3 shows groundwater contamination levels as a function of distance from the source area. Groundwater contamination level at the source was not measured, but was estimated using soil concentration data from PSB-2. It appears from the data that degradation is occurring beneath the asphalt, but this drop in concentration could be due more to dilution of the contaminant than to biodegradation. However, a dramatic decrease in benzene level can be seen between the PSP-1 and PSP-5 locations. This is probably due to volatilization and biodegradation of contaminants in the uncovered area between PSP-1 and PSP-5. There is a shallow swale located between PSP-1 and PSP-5, and groundwater is only about 3 feet below ground surface during most of the year. Given the physical characteristics of the soil, diurnal temperature fluctuations and barometric tides would cause significant gaseous exchange between the atmosphere and the soil to depths of several feet. Diurnal water fluctuations of up to 6 cm have been recorded in fine grained unconfined aquifers with shallow water tables (less than 10 feet). More than sufficient oxygen would be available for microbial degradation of the contaminants under this scenario.
